# Whitehall Hotel, (Church Hall), Broxted, Essex, CM6 2BU.

Heritage Statement for the hotel buildings. Surveyed 24 08 2016.

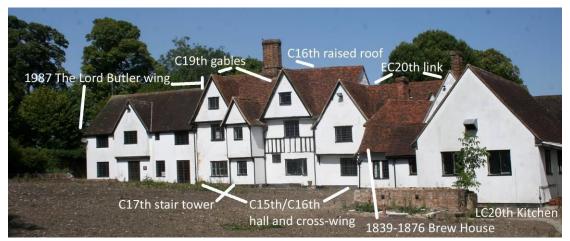
The southern elevation outlining the phases of the building.

The western end (LHS) of the building is a LC20th construction called the Lord Butler Wing which was opened in 1987. The main house consists of range with a central chimney stack with rebuilt diagonal shafts and a cross-wing to the east which is jettied suggesting this is the original front of the house facing as it does the church.

Originally built as a hall house in the LC15th the fixture holes for the high end can be seen in the westernmost wall of the timber-frame. The hall was subsequently floored over and the roof height raised above that of the cross-wing and the massive chimney stack installed. This would have been done most likely in the MC16th when it became fashionable.

The stair tower, placed centrally in the facade, still retains part of the newel post and the framing suggests it would have been added in the C17th, again as fashion demanded.

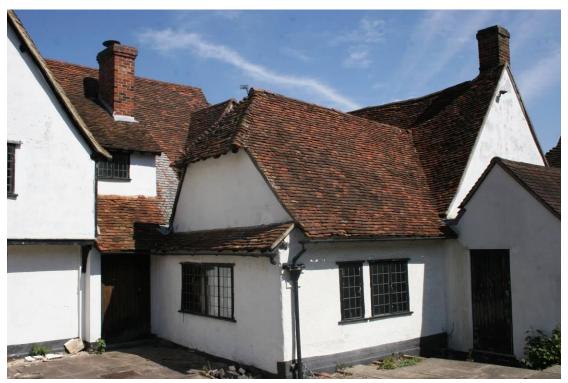
The Brew House with EC20th link behind.

To the SE of the House is the Brew House. This is a timber-framed structure with some unusual features and a large firestack. Internally it resembles a C16th or C17th Kitchen but its actual age may prove contentious. The building is not shown on the 1839 Tithe Award while all the other buildings are. It appears on the 1876 Ordnance Survey in its present plan and so is likely a Victorian addition reusing an old building.

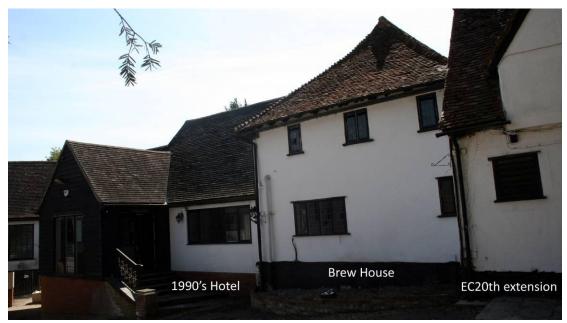
The northern elevation of the Brew House.

The Brew House has been connected to the main house via an EC20th utility building that houses the boiler room. The map evidence indicates the northern elevation was again extended in the later C20th. The Brew House has a whole bay taken up with a living room, (now a wide corridor) and bedroom. The framing for this is very suspicious and is likely a C20th caprice.

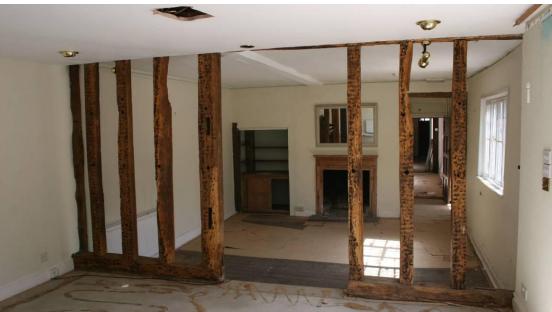
Looking E from the Lord Butler Wing at the exterior wall of the original house.

The external western wall can be seen from the Lord Butler Wing and the axe finished studwork is drilled with 1.25in fixtures holes for a trestle, dais and canopy indicating this was the high end of an open hall house.

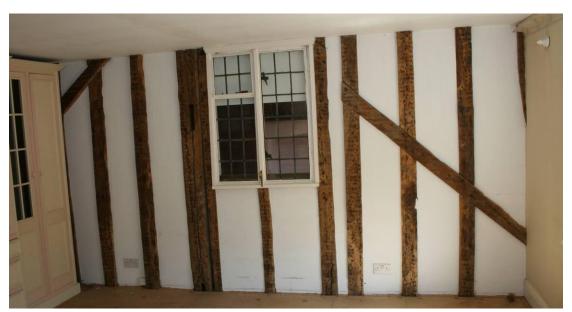
The exposed frame in the room above.

In the room above it can be seen the frame was extended upwards to improve new first floor accommodation when the Hall was floored over. Later primary braces were added.

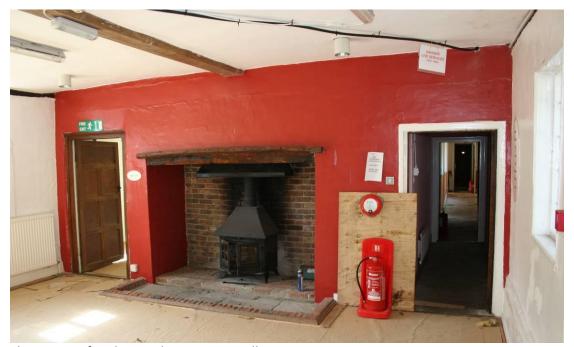
The massive fireplace in the Entrance Hall.

There is a massive firestack in the centre of the house that has been relentlessly remodelled. The first floor fireplaces have Tudor brick arched lintels and it is most likely the structure was originally built in the MC16th when the hall would have been floored over. The main axial floor joists can be seen in either side.

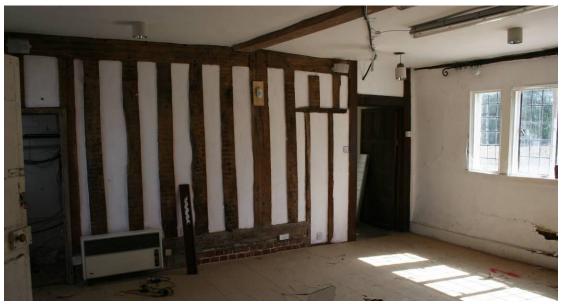
The lower wall of the cross-wing is visible in the Entrance Hall.

The frame of the close studded cross-wing is visible in the entrance hall and has three doorways superseding the original which is evidenced by a rebate and pegs for a doorhead against the northern end.

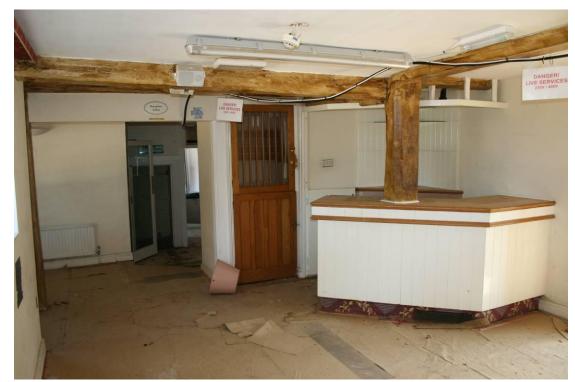
Looking E in the cross-wing. The original frame has been removed.

On the ground floor the cross-wing frame has been almost entirely removed. The dubious paintwork scheme most likely hides boxed in steelwork. The EC20th link still retains some period lino (in very poor condition) and the electric servant's bell system. The boiler room still contains a LC20th appliance.

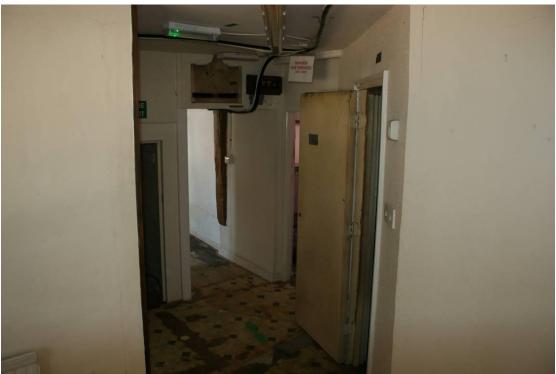
EC20th link with boiler room.

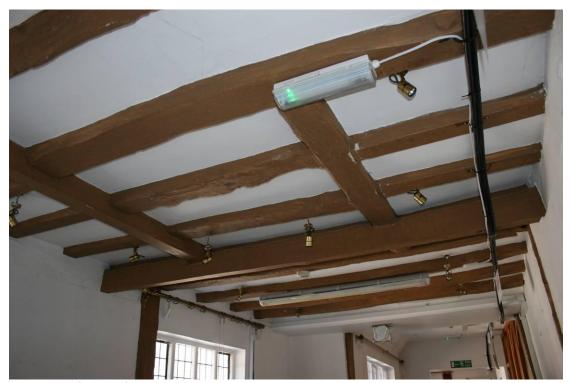
The ceiling frame of the room in the Brew House is not convincing.

The rooms inserted in the northern end of the Brew House are most likely C20th. There is an exposed frame but it is not convincing, being made of too many different types of timbers all painted to disguise them.

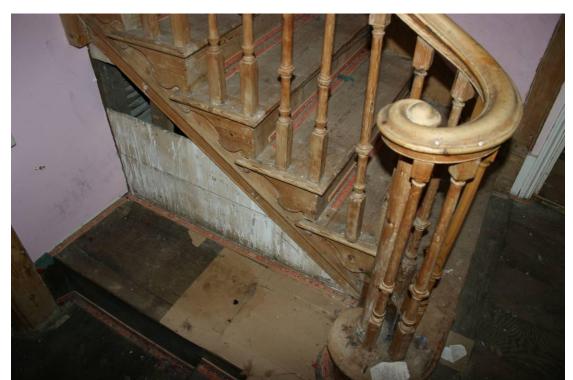
Staircase in the northern stairtower.

The large northern stair tower has an elegant open tread staircase with curtail step and handrail. Crucially for dating purposes the balusters are all machine turned spindles – a typically Victorian feature.

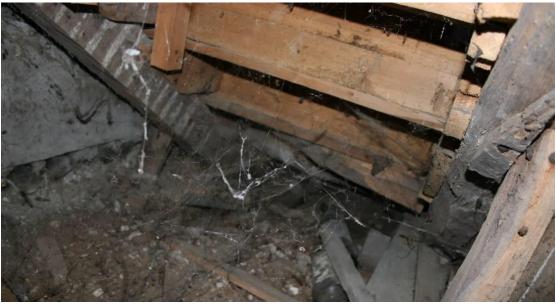
Looking under the stairs.

The supporting structure is made of reused timbers nailed with wrought iron nails. The treads appear much fresher and are pencil marked in places.

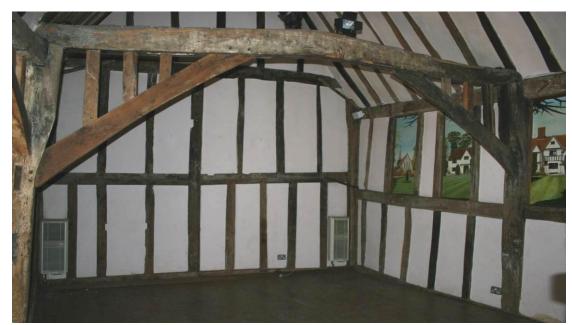
The Brew House looking N. Note the reused timbers and iron straps.

The Brew House was a separate building until the C20th. Historic mapping does not show it on the site until 1876. The frame has some peculiar features. The cambered tie-beams do not match and are set at different heights. The partition wall is made of reused timbers and held in place with contorted wrought iron straps. The top plate over the opening connecting the side room does not have any mortices but the storey posts have mortices for midrails implying the wall would have been fully framed. Some of the timbers are sooted but many are not. All these features imply a building that has been reassembled from parts of others.

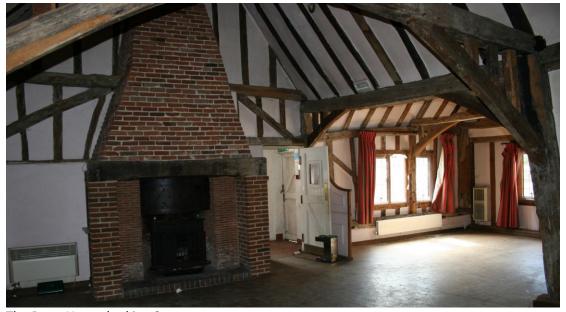
The Brew House looking S.

The fireplace is very well made with little signs of wear and many of the bricks are reused. Originally the brickwork would have been hidden or plastered over and there is no sign of this.

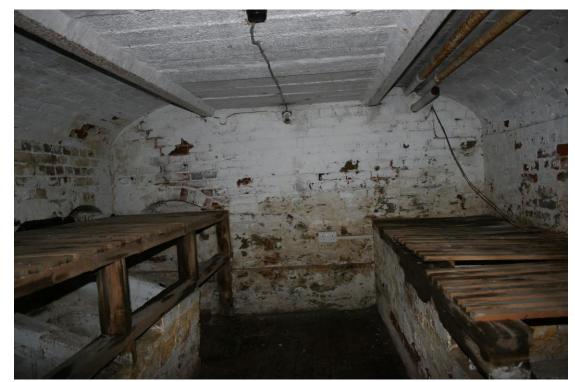
Brick vaulted cellar with wrought iron beams under the cross-wing.

The house has extensive cellars under the cross-wing and Entrance Hall build of EC19th red bricks with vaulted brick ceilings supported with wrought iron rails. There is a brick staircase with wooden tread plates. There are alcoves for bottles with rough gauged brick arches and brick platforms for barrels.

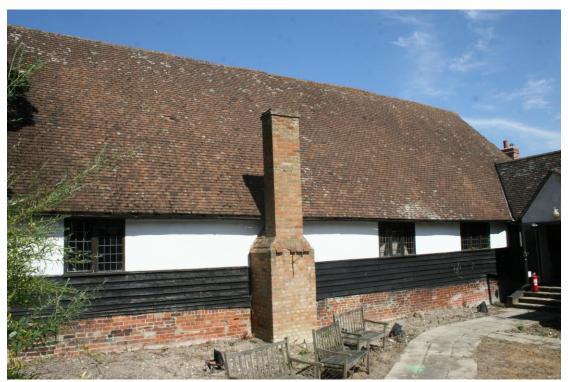
The southern elevation detailing the LC20th firestack.

The southern elevation has no opening for the midstrey. Instead there is a LC20th firestack with plain square chimney. The plinth brickwork is EC19th is character except where infilled. The Barn is joined to the rest of the hotel with a link designed in 1999. (UTT/1083/99/LB). The design drawings show that the connected buildings were built in 1991.

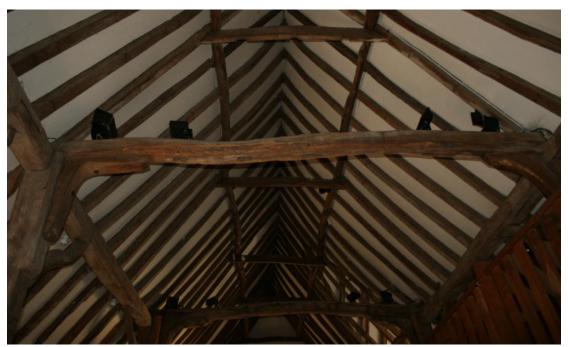
Detail of the roof structure.

The Barn has an oak timber-frame of 7 bays, with the midstrey porch in the third from the west. The Barn has been reassembled from another barn and reformatted as an aisled barn. All the original spandrels have been removed and replaced with bolted hanging knees in the style of c.1800. There are principal rafters connected to high collars clasping the side purlin.

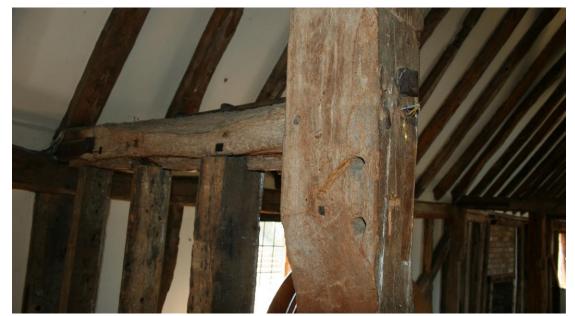
Detail of one of the arcade posts. Note the large iron nut.

There are several details to support reassembly. The scarf joints in the arcade plates have all been renumbered and some have oversized vertical pegs. The arcade ties are all different and secured with iron pull ties common to C.1800. The tie-beams are of differing profiles. There are many reused timbers including a window cill with mortices for diamond mullions.

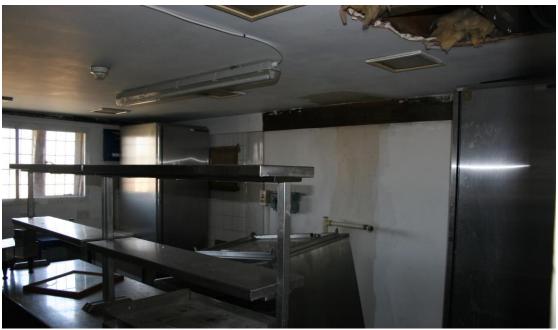
Detail of the Kitchen.

The end bays of the buildings have inserted partitions to form living rooms, WC's, a kitchen and offices. These are all LC20th and are most likely part of the conversion to a house rather than the later addition to the hotel. The damaged kitchen ceiling reveals patinated machined timbers. UTT/1087/81/LB requests internal alterations for a bedroom, bathroom, living room etc in October 1981.
