**Old Bakery Walden Road, Littlebury, Essex, CB11 4TA**  
Description and analysis of the house. Surveyed 15 06 2016.

This report describes and analyses the fabric of the building recorded during a visit on 15 06 2016 to English Heritage Level 3 as outlined in English Heritage. Understanding Historic Buildings – A guide to good recording practice. 2006. Page 14.

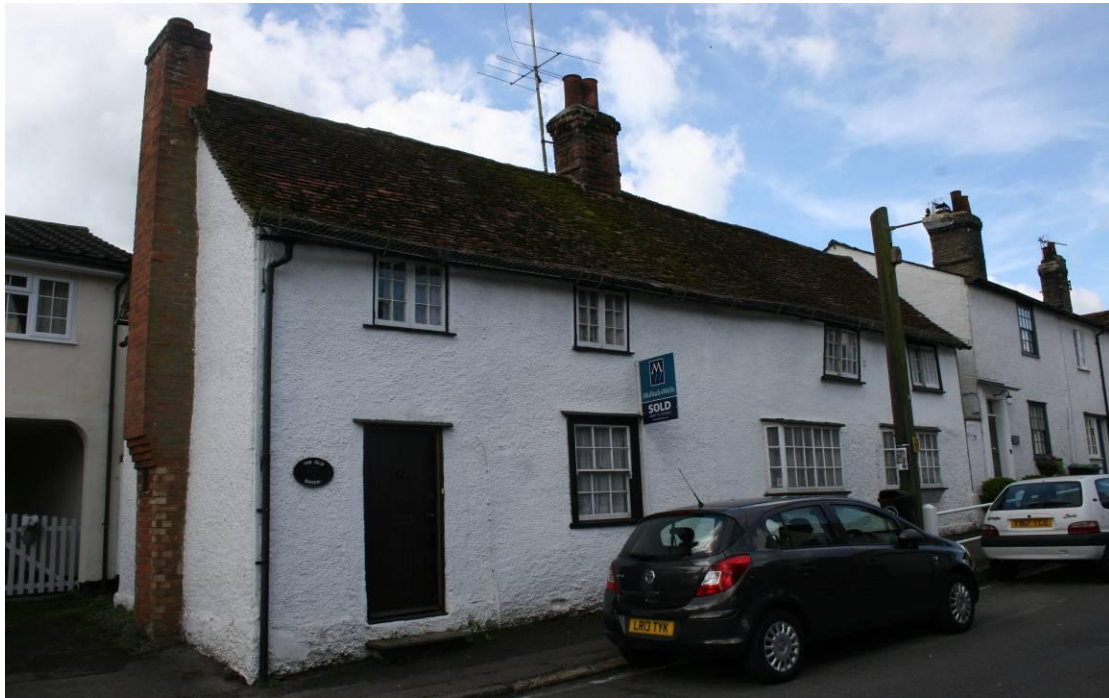
The Old Bakery. Northern elevation. 15 06 2016.

The timber framed building has pebble dashed render recently overpainted in a weather shield type paint that fills all the airbricks. The roof has been retiled with clay peg tiles and an asphalt membrane between the 1960's and 1980's. There is a centrally placed chimney stack with two canon barrel pots built of C19th brickwork. The rainwater goods are painted metal.

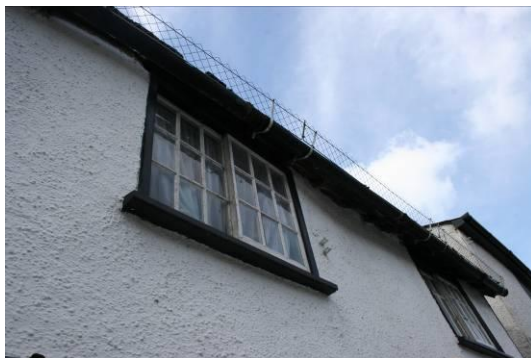
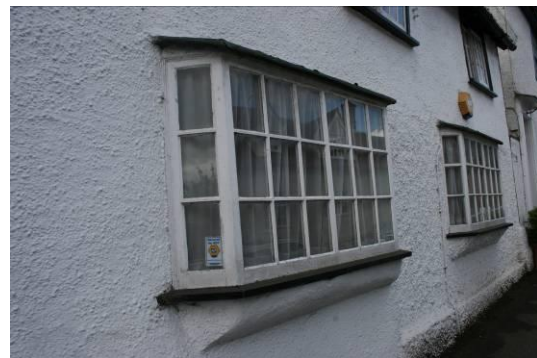
Detail of the EC19th horizontal sliding sashes and the LC20th oriel style windows.

There are two upper windows which are EC19th horizontal sliding sashes and two MC20th casements. The ground floor has a Victorian horned 6/6 sash and two LC20th timber oriels. The front door is LC20th made of bandsawn softwood with gate and ledger construction and modern hardware.

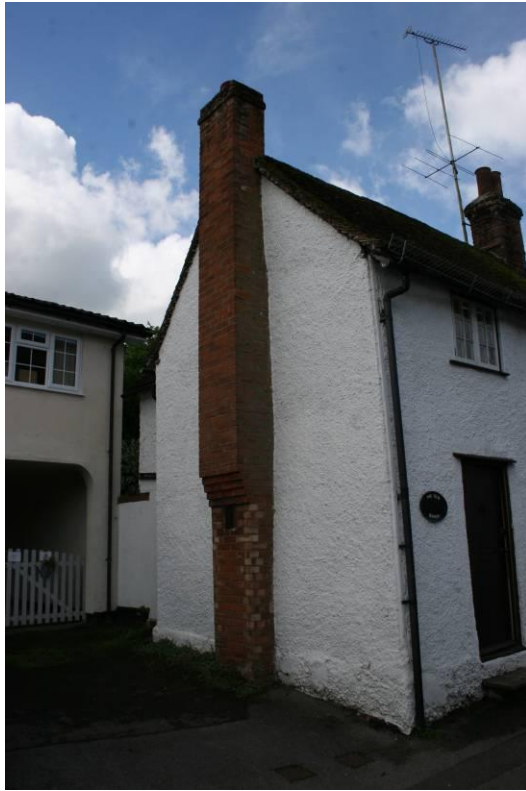
The eastern elevation.

The eastern elevation is rendered in pebbledash without openings. The exposed chimney of the eastern side has been cut back and rebuilt with Flettons. The upper part is also C20th with grey cement pointing. There is no fireplace inside. The rear extension under a corrugated asbestos roof is of brick and blockwork. The red tiled window sills were popular in the MC20th as were the plain timber casements.

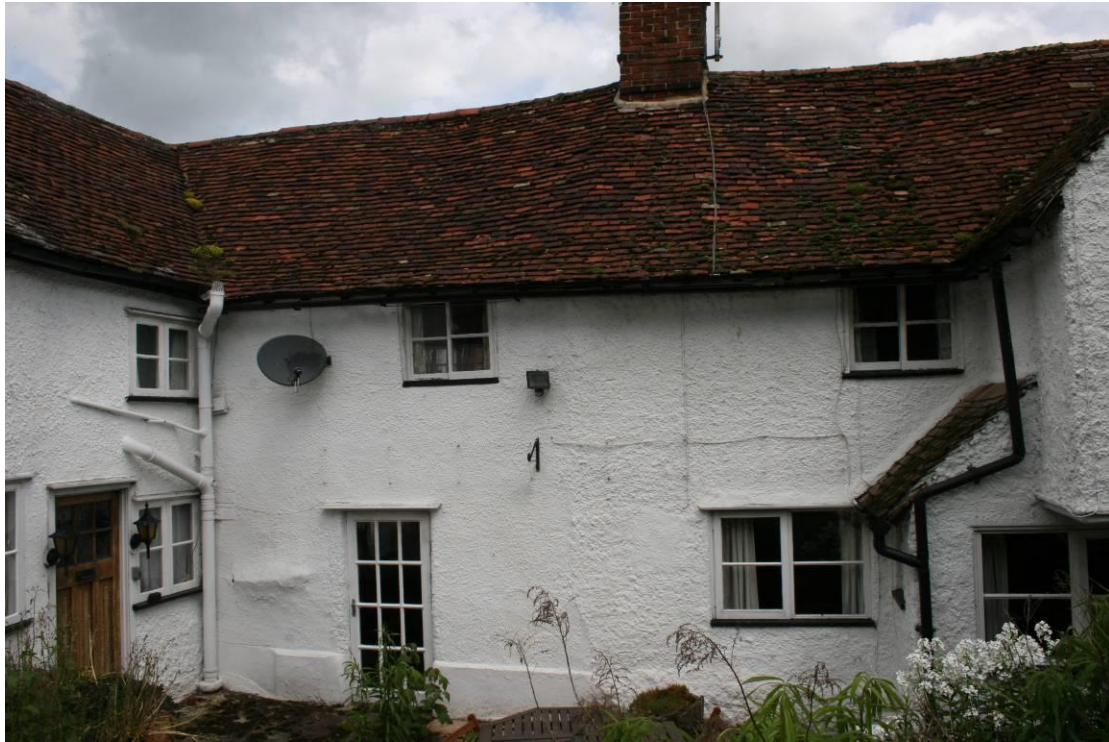
The rear of the house has been rendered in two episodes.

The rear of the house has a vertical joint in the render aligning with the chimney stack. Upstairs are two LC20th large pane horizontal sliding sashes matching in style the lower casement windows. There is a LC20th fully glazed garden door. Around the door is a low plinth.

To the LHS of the door the lath and plaster render has bulged out revealing that the nails have failed in this portion. It seems likely however that the house is mostly clad in EML as the weight of the pebble render would have pulled more of it off.

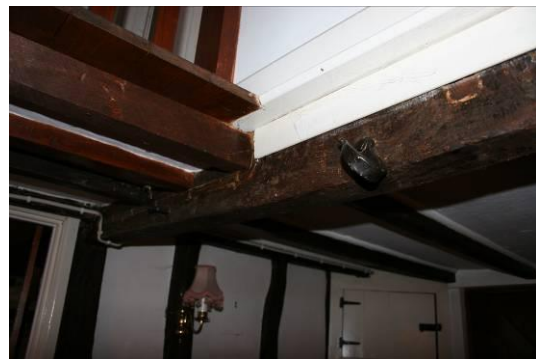
The original axial joist with empty mortices.

The building has four bays forming two cottages. The easternmost bay has the front door and Entrance Hall. Half of the original ceiling has been removed to insert a MC20th but Victorian style staircase. An original axial joist is visible jointed into the scantling frame of the western partition. The eastern wall, which should have a fireplace, is blank.

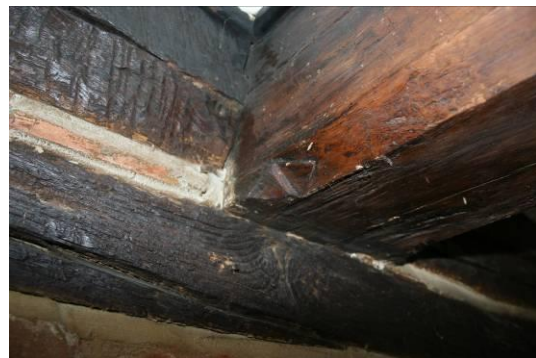
Detail of the decorative stop on the axial joist.

The ceiling frame has a single 9xin axial main joist, chamfered with a cyma stop embellished with small triangle. It is supported on a thin 3in deep lintel. The 2in wide common rafters are set on edge and peppered with nail holes for lath and plaster.

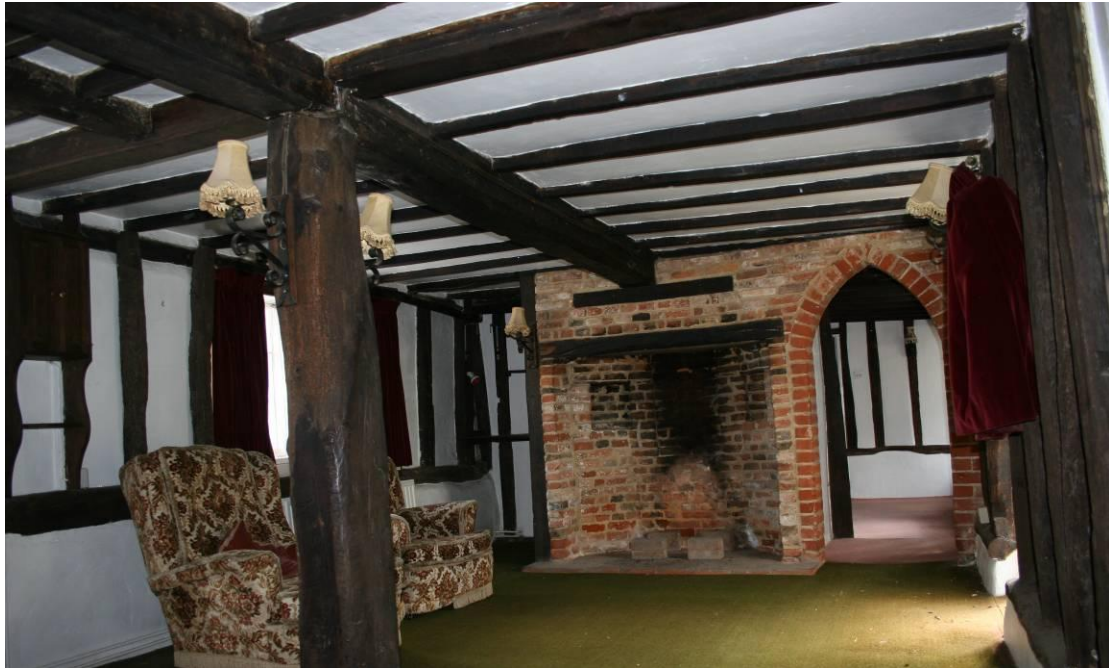
The large post replaces the original wall partition. Looking E.

The western part of the cottage has had its partition walls removed and the empty mortices covered with timber plates. The framing in the ceiling is consistent throughout and carries the same details. The fireplace has been built to the same design. The studwork in the southern wall is side nailed rather than pegged. The impression is that the building was originally divided into smaller dwellings and there is a trimmer beam in the ceiling for a blanked off staircase to the front of the house. The westernmost wall has primary braces, and interrupted studwork all of which appears reused.

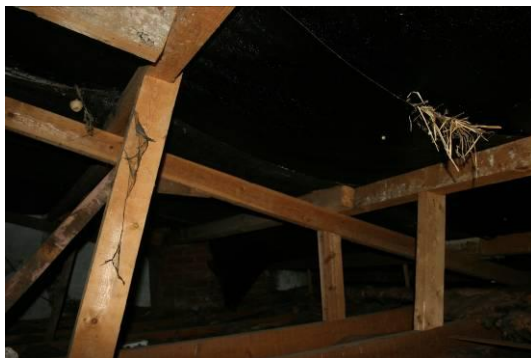
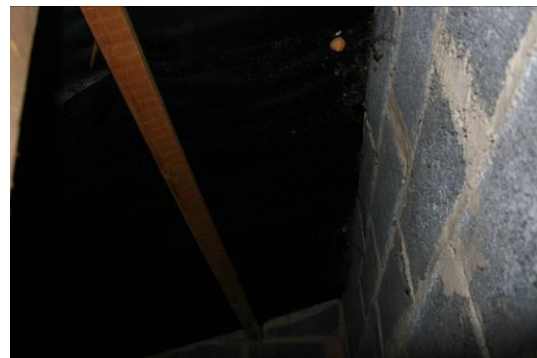
The structure of the low pitched roof and the medium density blockwork forming the wall.

The fabric of the Rear Extension can be seen in the roof void as being LC20th blockwork with a machine cut softwood frame. The asphalt membrane would date it to between 1965 and 1995.

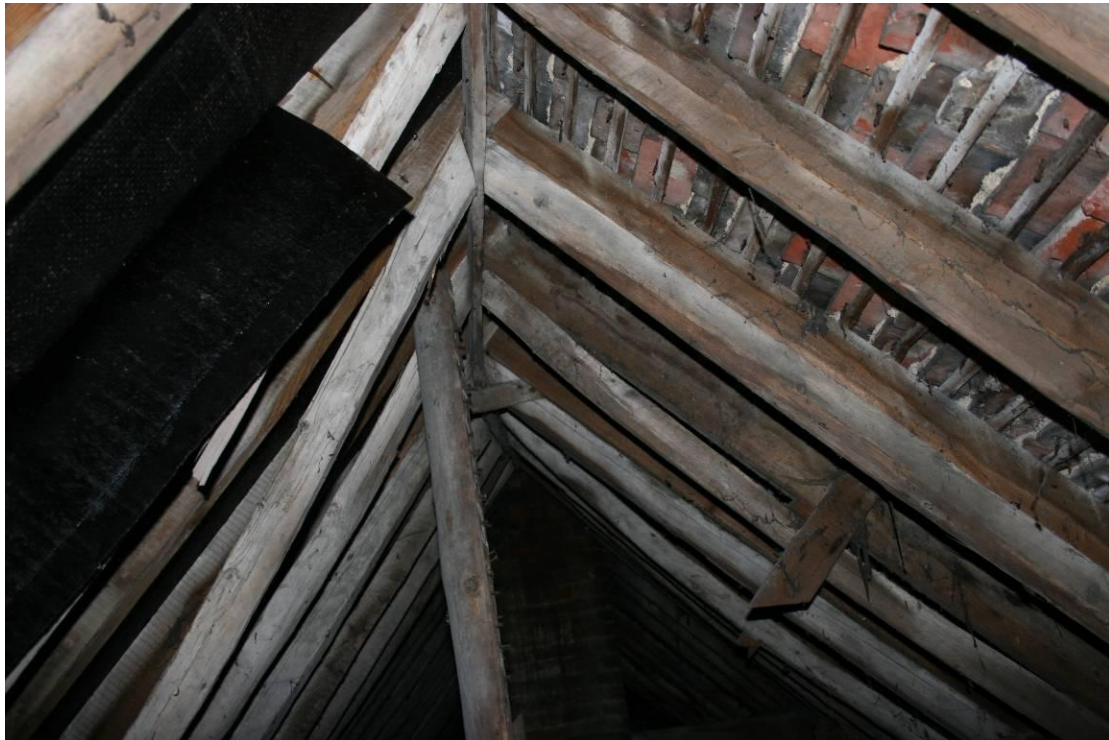
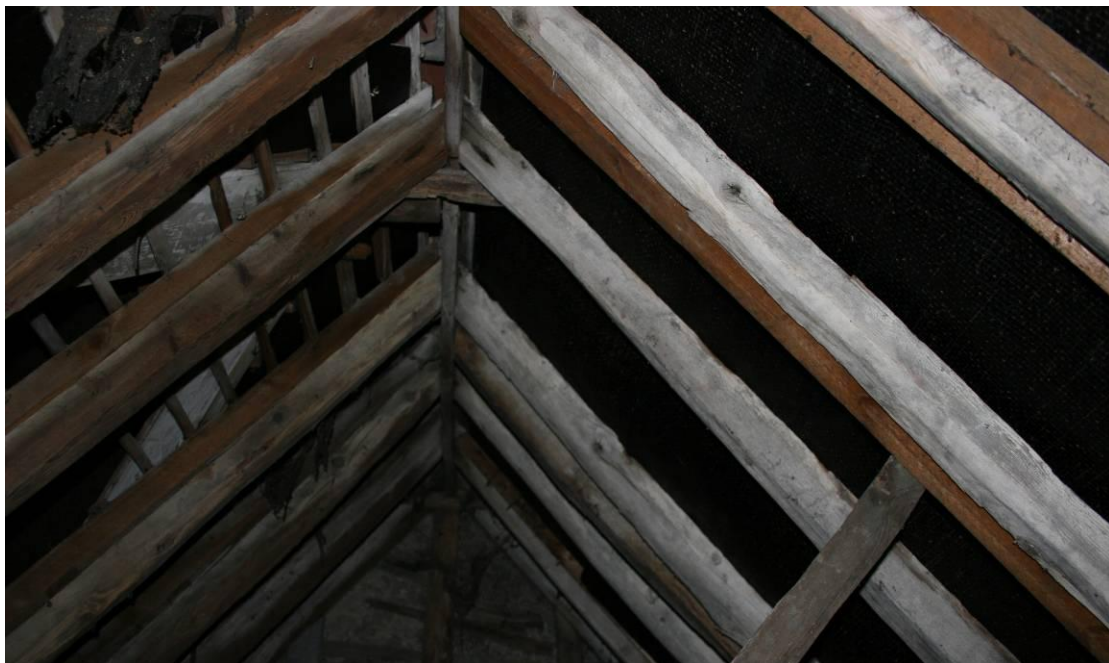
Looking E in the roof above Bedroom 3.

Looking W in the roof over Bedroom 2.

The roof is constructed of paired elm rafters nailed to a ridgepiece with occasional gussets. The roof has been heavily repaired in the C20th with machine cut softwood rafters. It appears the southern side was reworked in approximately the 1930's and the other in the 1970's to 1990's adding an asphalt membrane. The gable end can be seen to have been clad with EML over some of the older laths.

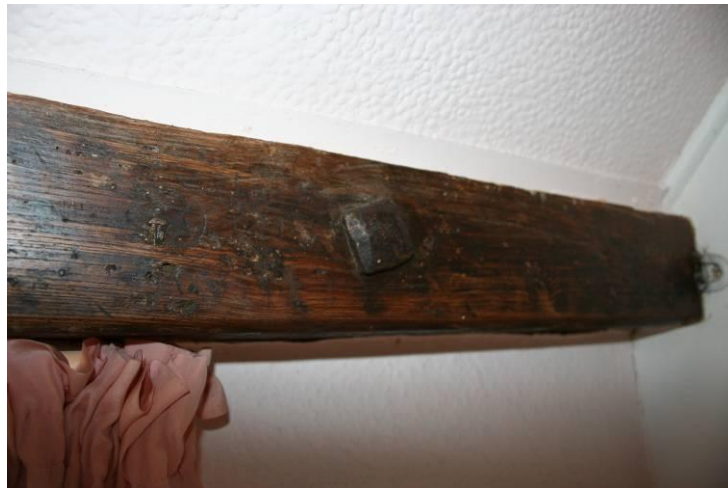
A square headed bolt in a repair clamp.

It is not possible to pass across the house upstairs. Instead there are two staircases. To the east the staircase leads to a landing connecting to the C20th Bathroom and the tiny Dressing Room. Of interest in the Dressing Room is a timber clamp fastened with a wrought iron square headed bolt and another with a rectangular headed bolt. These are characteristic of the EC19th and represent a repair to a failing top-plate.

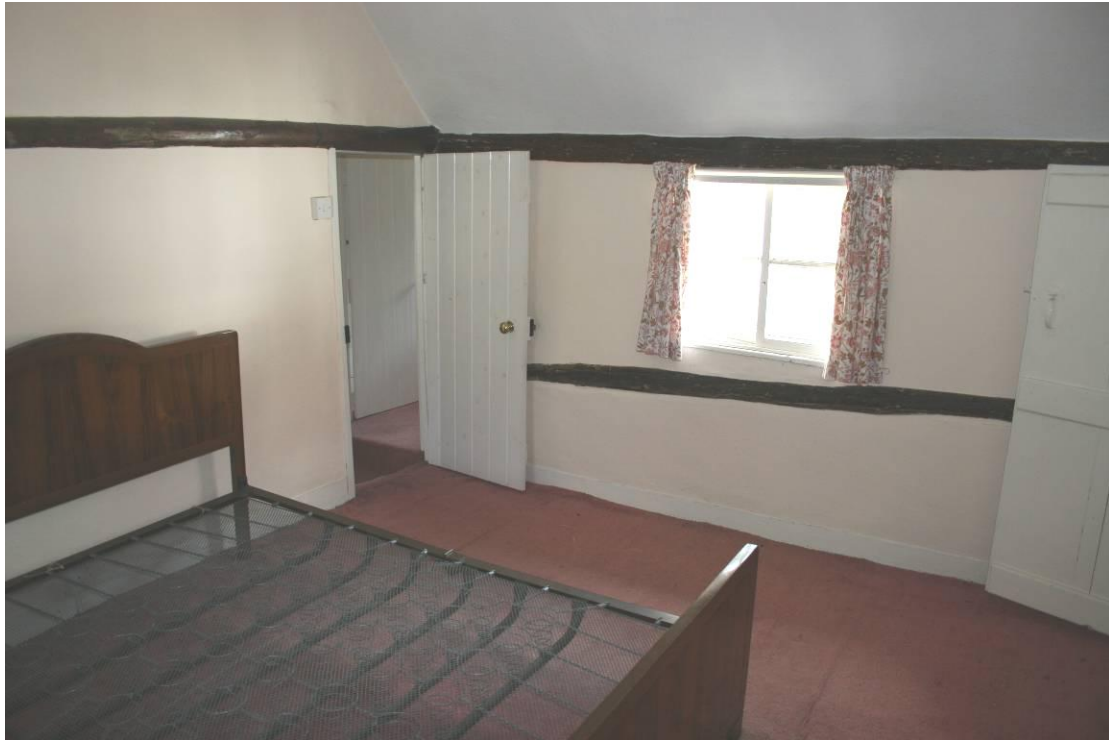
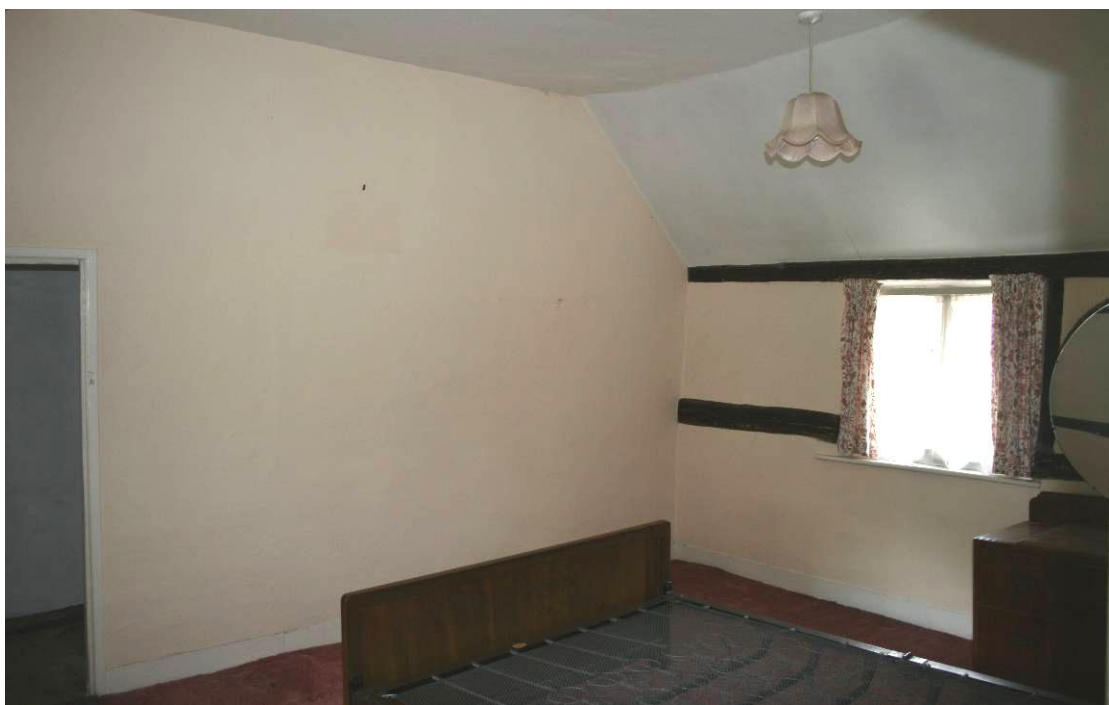
The frame is again visible in the walls of Bedroom 4. There is a very similar door and closet to that in Bedroom 3. EC19th ironwork repairs have been made to the tie-beam above the main door.
