52 Upper Brook Street, Mayfair. London. W1Y 1PG.
Description and analysis of the upper floors and ceilings. Surveyed 14 11 2014.

This new report comments on the newly exposed timbers forming the ceilings and floors of the two upper storeys, their design, fabric and form and likely date of construction and alteration. The findings are summarised on the last page.

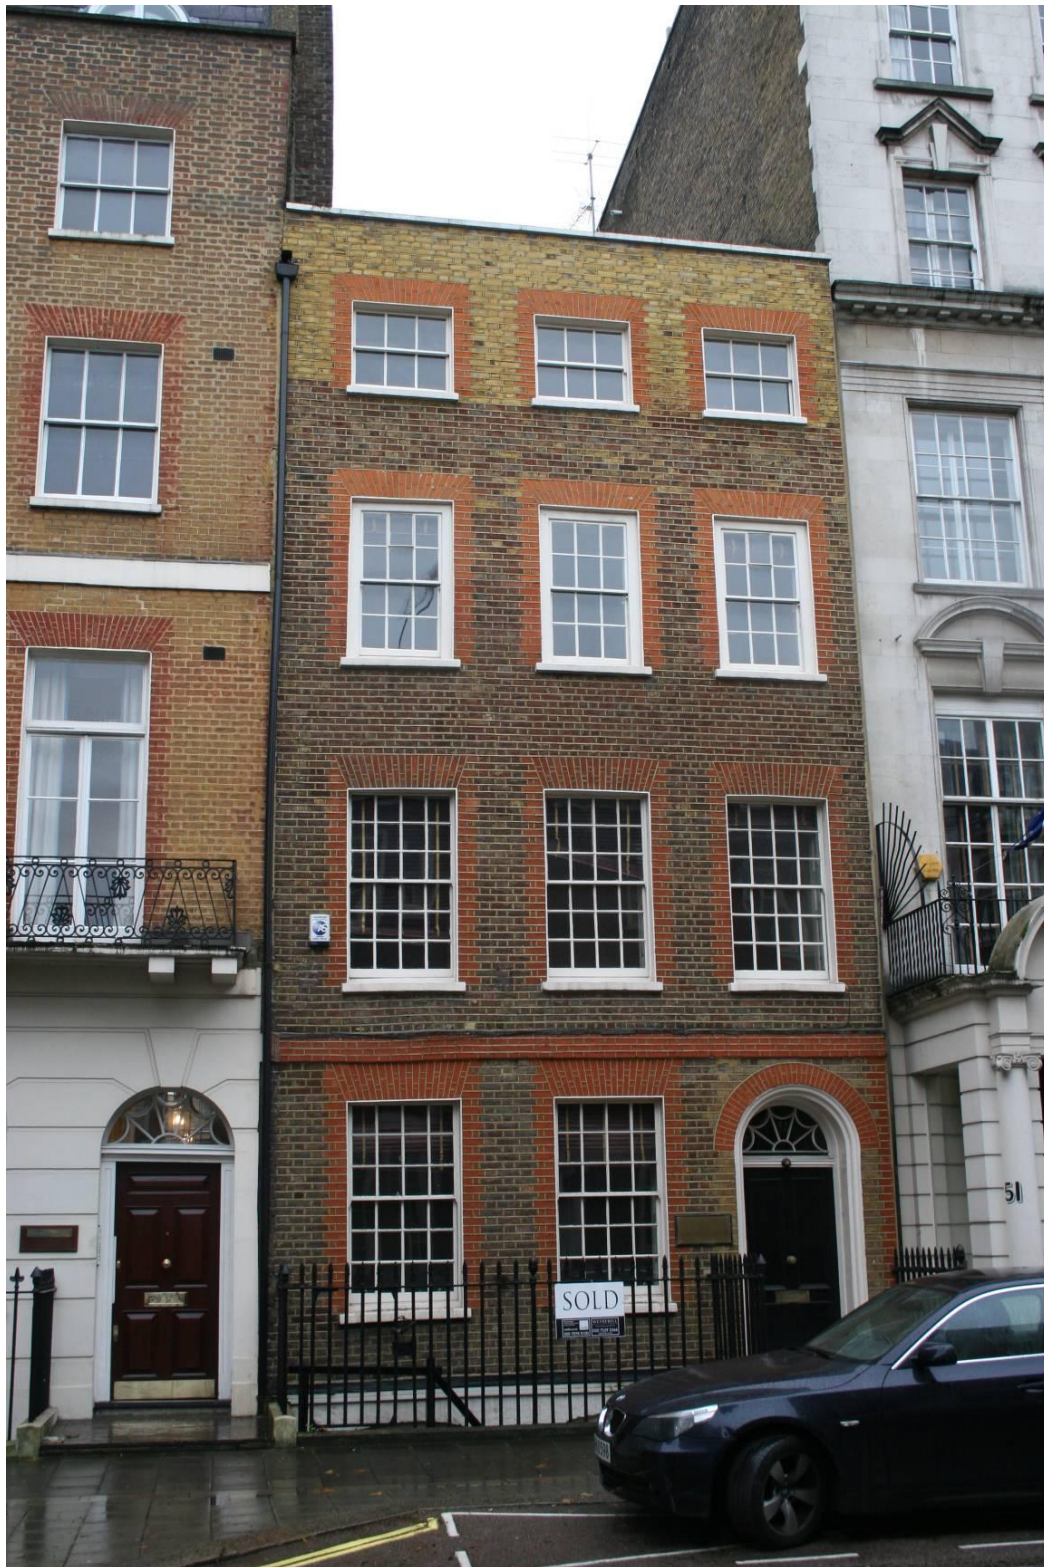
52 Upper Brook Street north elevation. The upper storey was raised circa 1873.

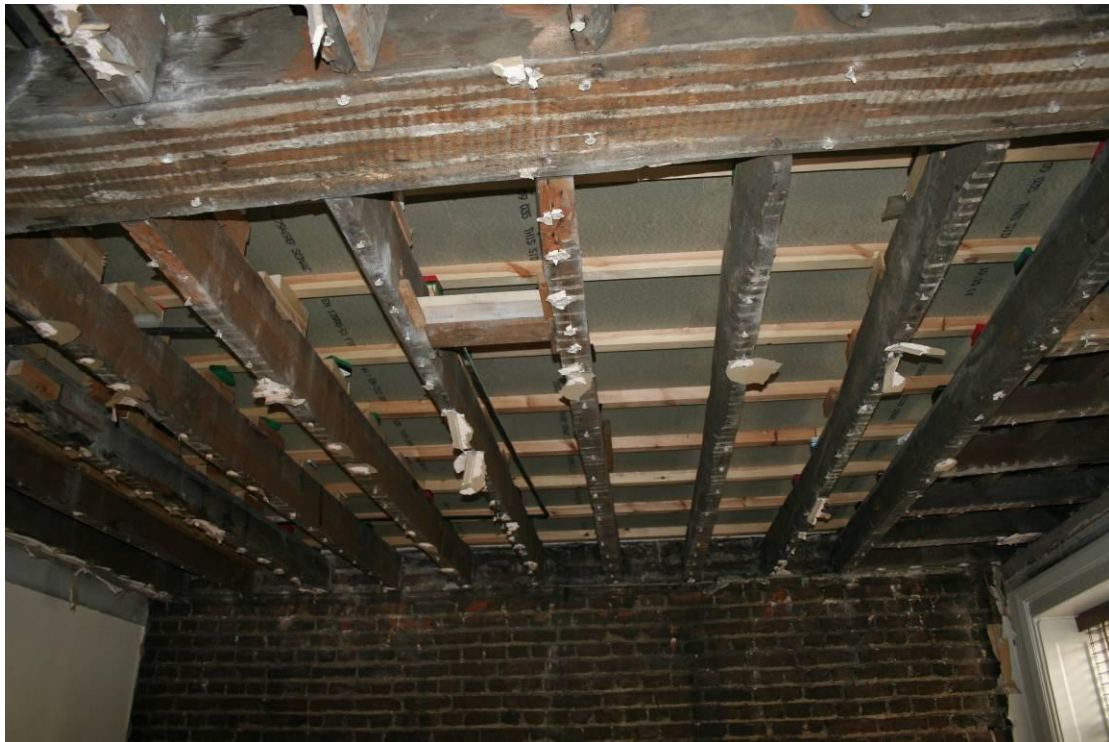
Second Floor. Room SF1 looking W. Ceiling Structure.

The original main joists are machine sawn softwood. The floor joists are cut from machined softwood. In places they have been rough chamfered with a spoke shave to allow the flush fitting of the original laths of which all have been removed. The long common joists are pegged into the main joists but at the front of the house short joists have been jointed as right angles with overlong tenons. Secondary battens are placed along the top of them and it is likely they formed the box gutter for the parapet of the earlier roof.

The ceiling was plaster-boarded and insulated with vermiculite granules. The galvanised plasterboard nails would indicate this was done in the 1970's or 1980's before the introduction of plasterboard screws driven by battery powered hand tools.

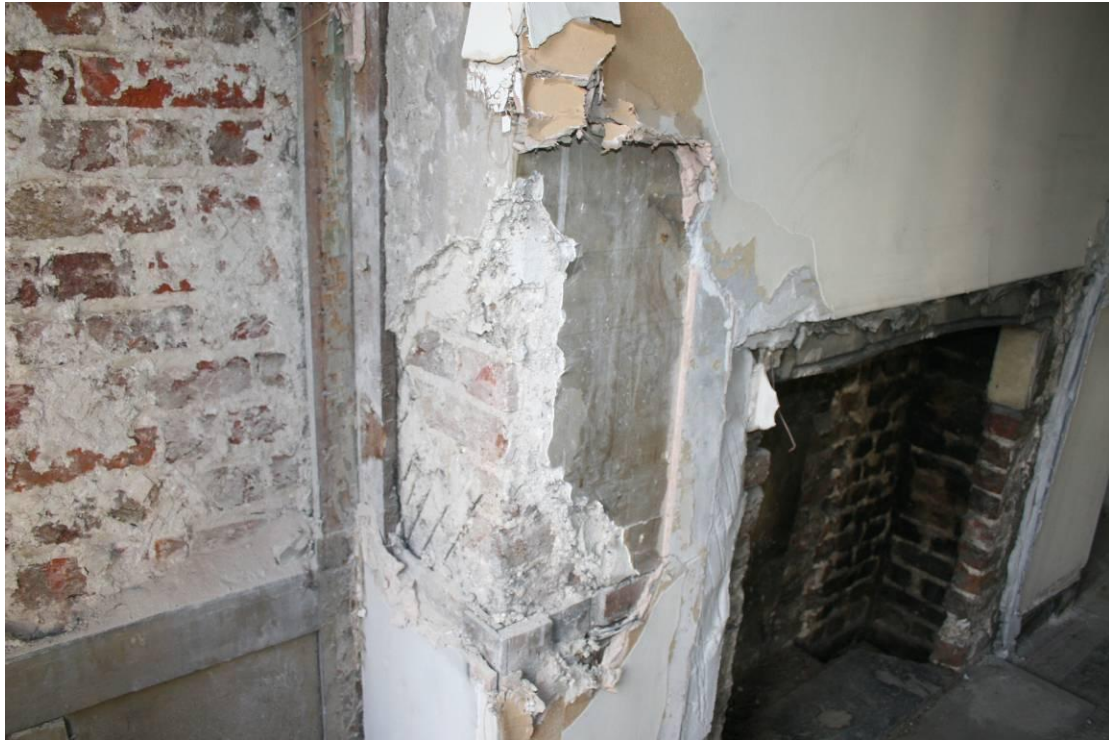
Early plaster work on the firebreast has been covered with LC20th render.

During the works all the LC20th plasterboard was removed from the ceiling and the walls. This revealed two small remaining timber panels either side of the firebreast. Stripping back the firebreast revealed the original plasterwork with an inch thick scratch coat and another inch thick top coat. The same sequence can be seen in the back room SF3 where the firebreast was boarded over. The panels and the firebreast are painted arsenical green, a very common Victorian colour that lost popularity in the last decade of the C19th.

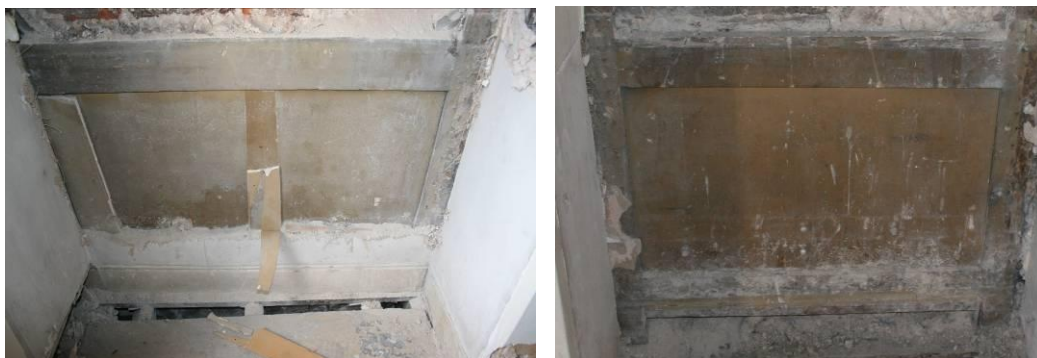
Details of the remaining panels either side of the fireplace.

It is likely both rooms were panelled throughout and this would account for the lack of render on the brick walls. Most of the panelling was removed in the C20th by the time the plasterboard was put up.

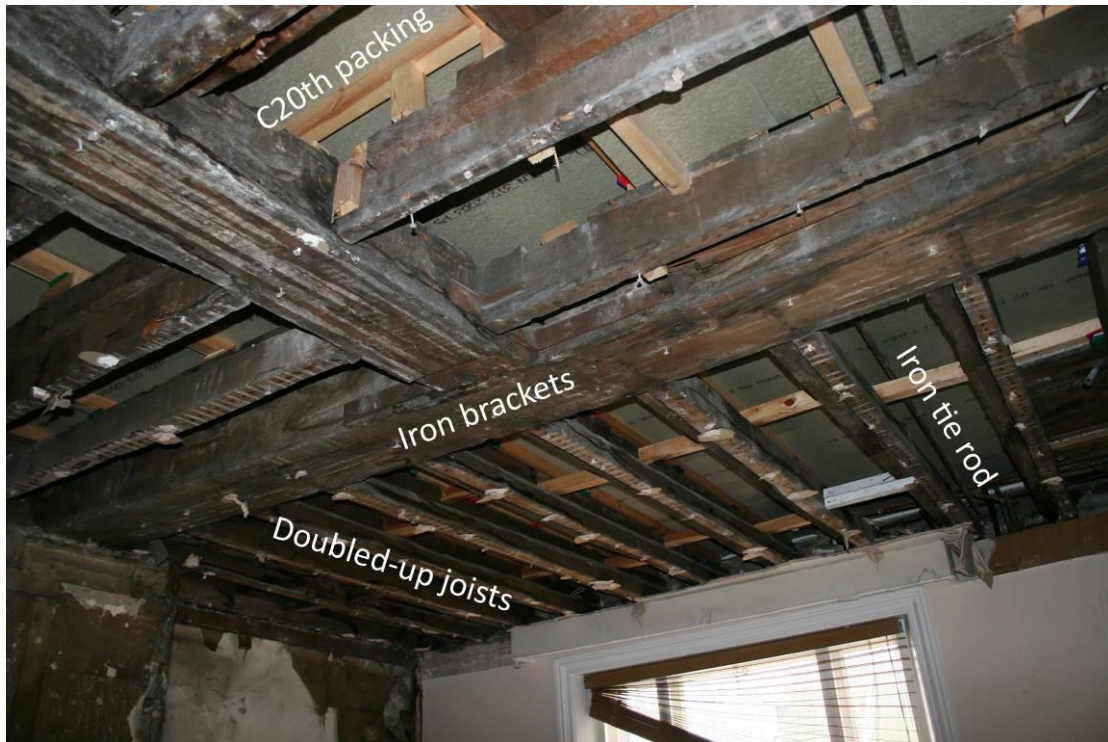
The ceiling in the back room SF3.

The ceiling in the back room SF3 has been rebuilt in the LC19th with doubled-up joists and wrought iron repair brackets on the main joists. The ceiling again sinks into the middle and this can easily be seen by looking at the varying depths of the C21st packing for the chipboard floorboards. Also noted were some wrought iron tie rods that have been removed from the timber and brickwork and left laying in the floor void.

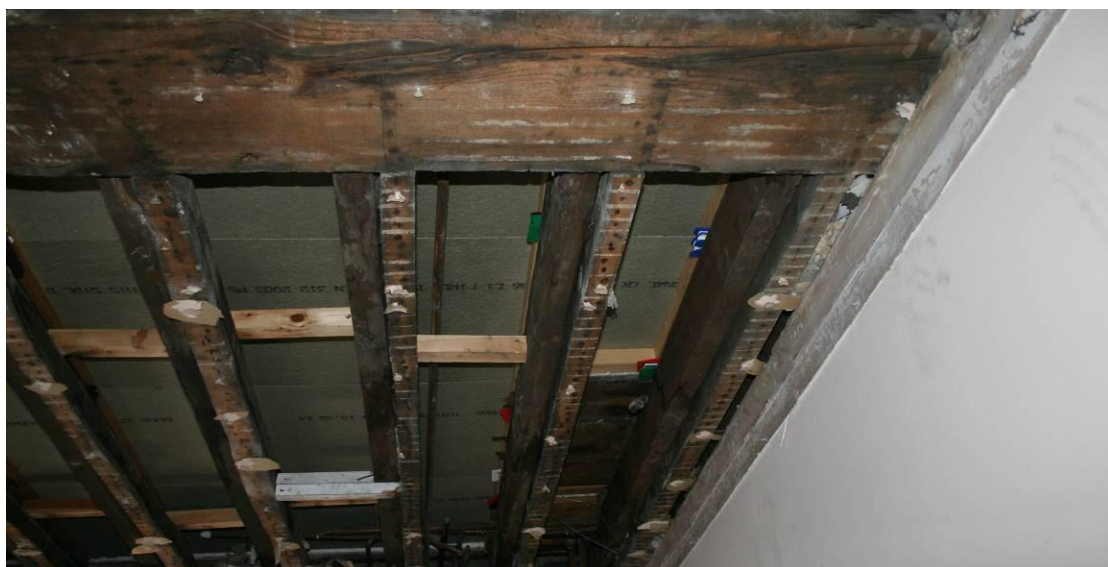
Detail of the doubled-up joists. Looking N.

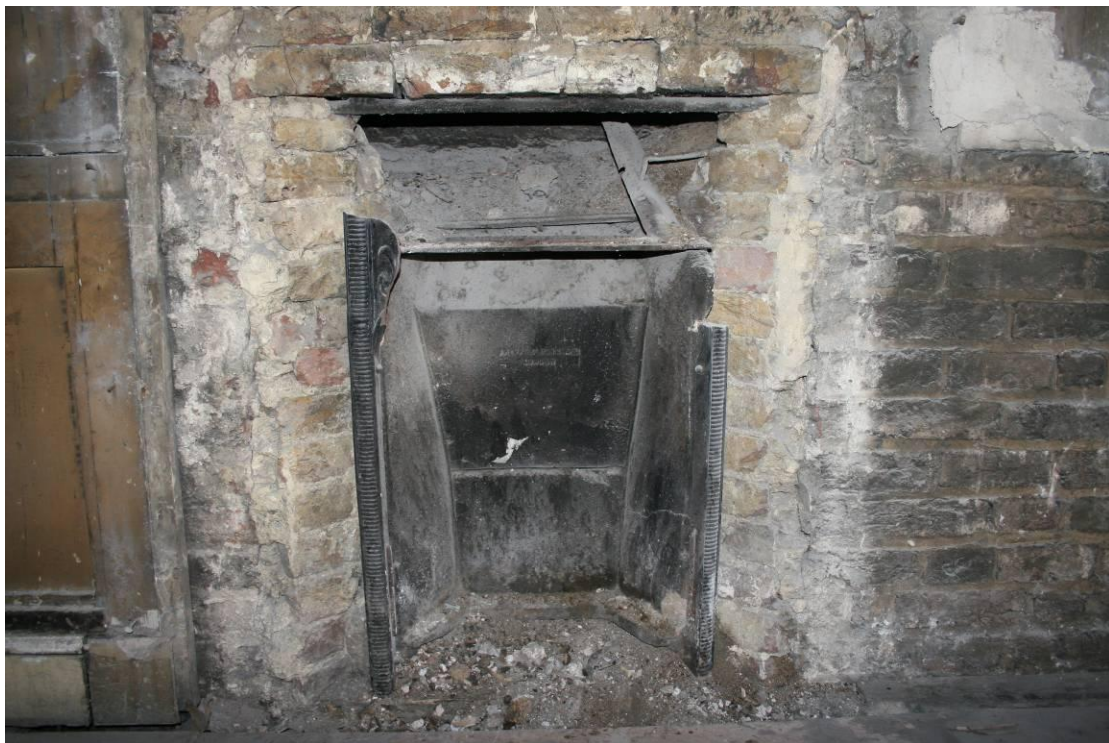
Detail of the fireplace.

Room SF3 has a L19th cast iron register plate fireplace branded Mt PALACE STOVES LONDON. Unfortunately it has been ruthless smashed before it was covered up. Ten minutes with a screwdriver could have removed it.

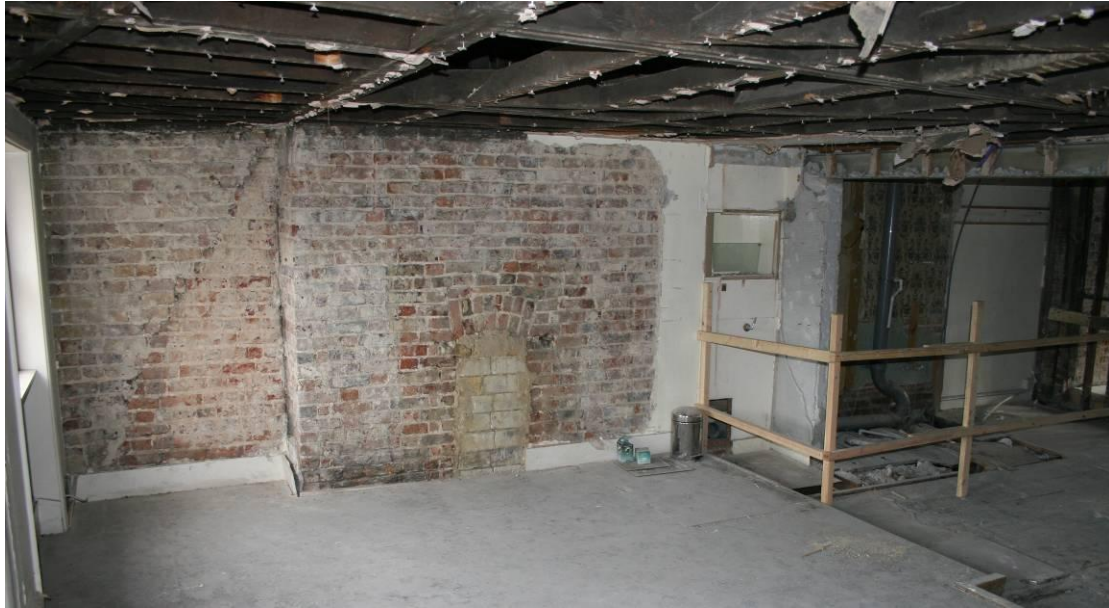
Looking SE in Room TF1. Note the line in the brickwork denoting the old roofline.

Room TF1 is very similar to its counterpart below. The brickwork at each end has been altered to raise a new ceiling with the insertion of the bright yellow London Stock bricks seen in the exterior facade. At the western end the line in the brickwork suggests the original brickwork extended forward of the older roofline.

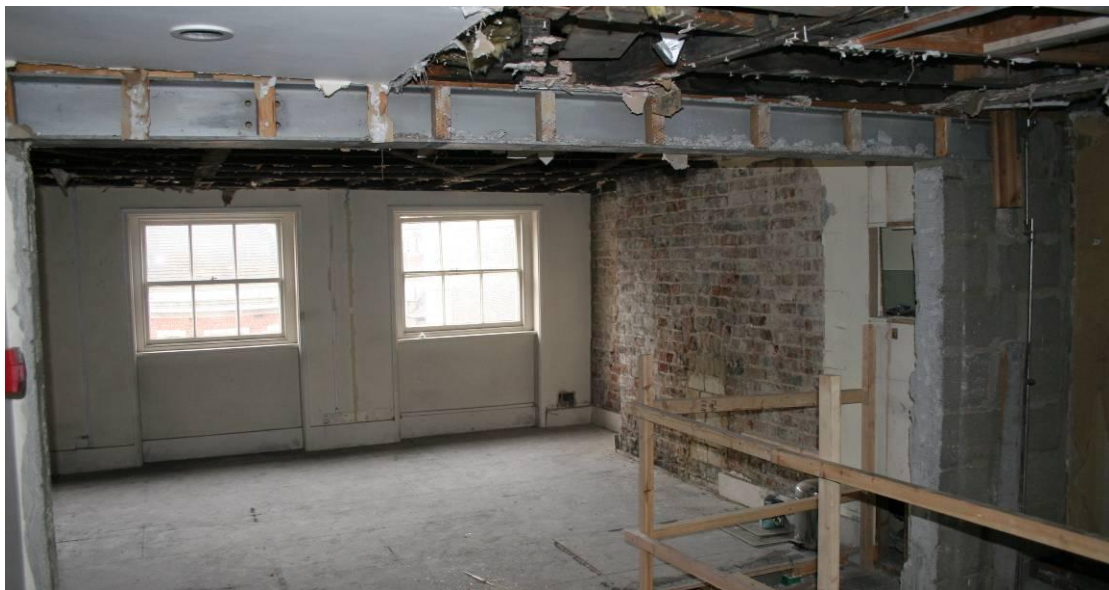
Looking N into Room TF1. Note the RSJ.

The rear main joist has showed signs of failure and has been reinforced with an RSJ supported on blockwork. The recent partition has been removed.

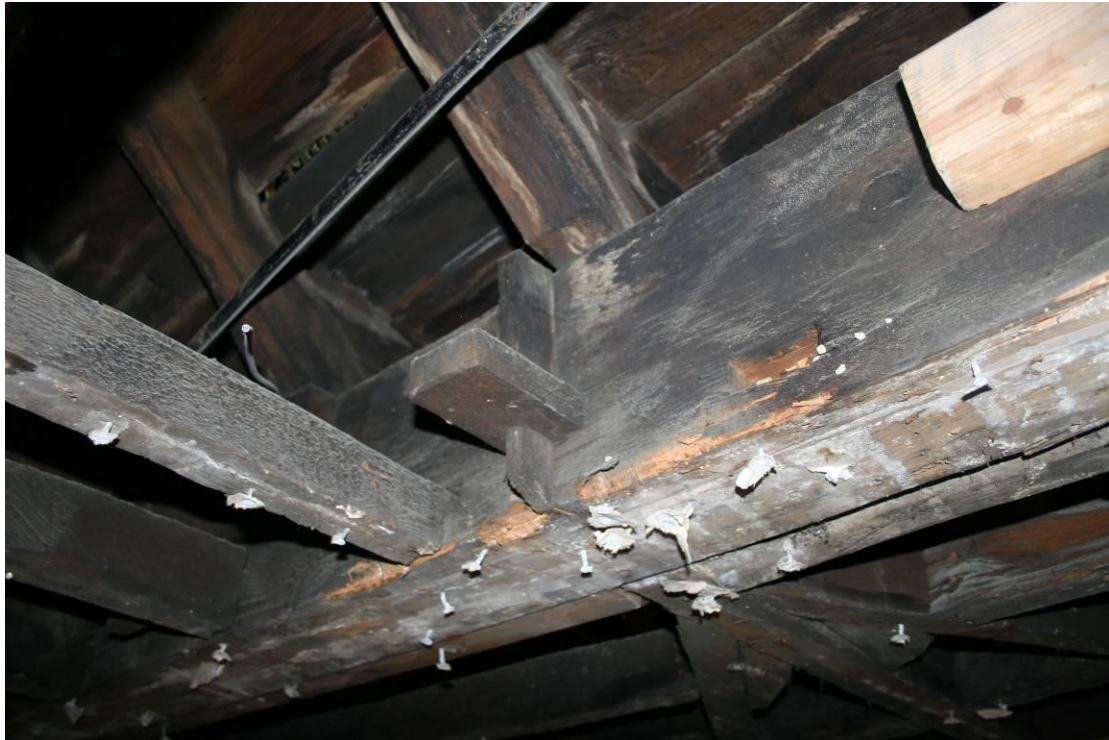
Detail of the main joist in the central valley.

Room TF3 at the back of the house has a very similar form of ceiling structure to that of Room TF1 at the front but it must be later. For one thing all the joints are pencil marked. Secondly the main valley joist has been reinforced with side plates and the narrow bridging joists for the new room are secured with mortice and wedges.

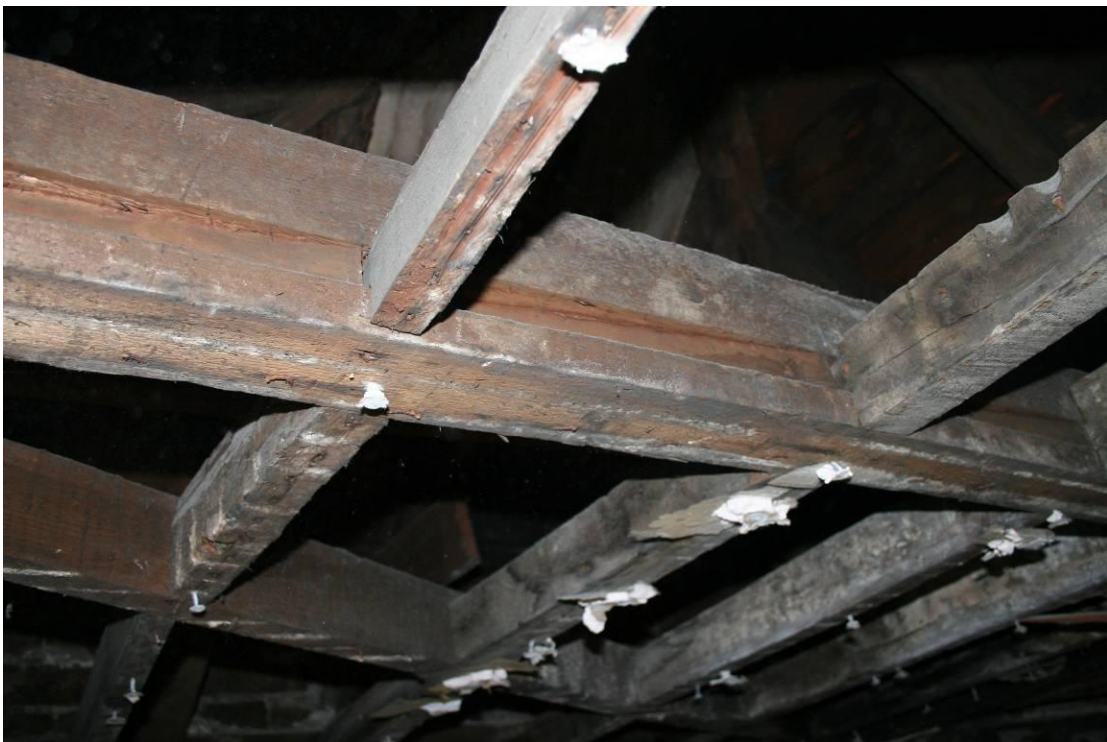
Detail of the main joist showing curved grooves to allow the common joist to be rotated in.

The flanks of the main joists are grooved to allow the common joists to be rotated in while the other ends are nailed in place against the primary braces. The main joists are numbered with a chisel point.

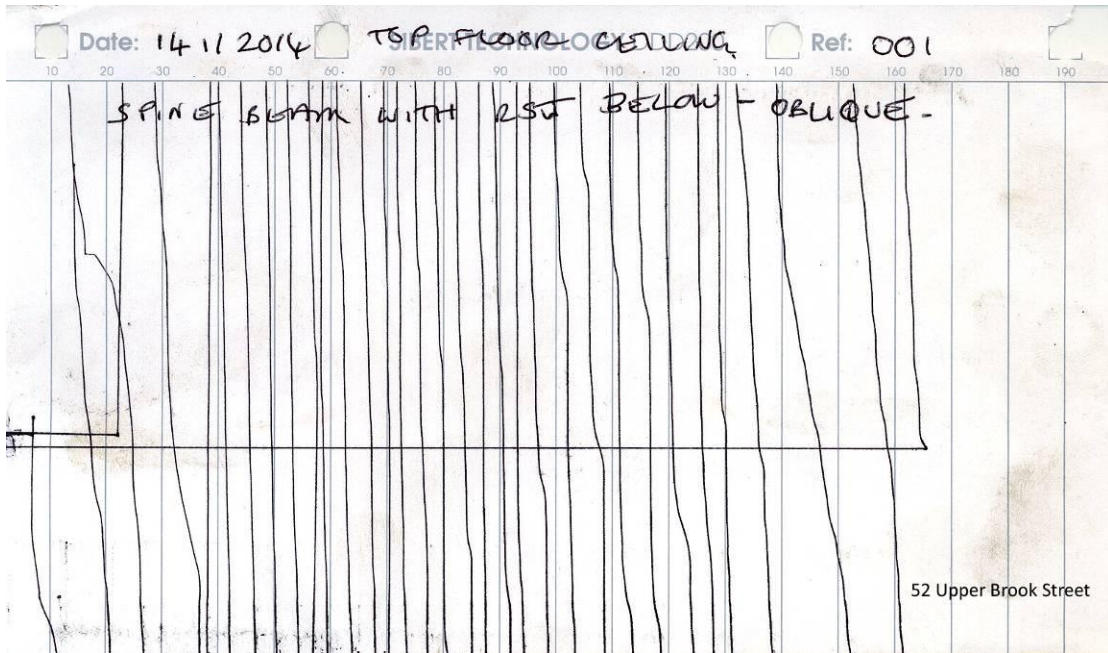
Drilling 001. Top Floor Room TF1 spine beam with RSJ

The softwood is relatively soft in comparison to oak for example. However it demonstrates a consistent density lessened only where the timber is obviously damp. Comparing the test sites with Drilling 004 shows that a normal dry timber compares well to the others.

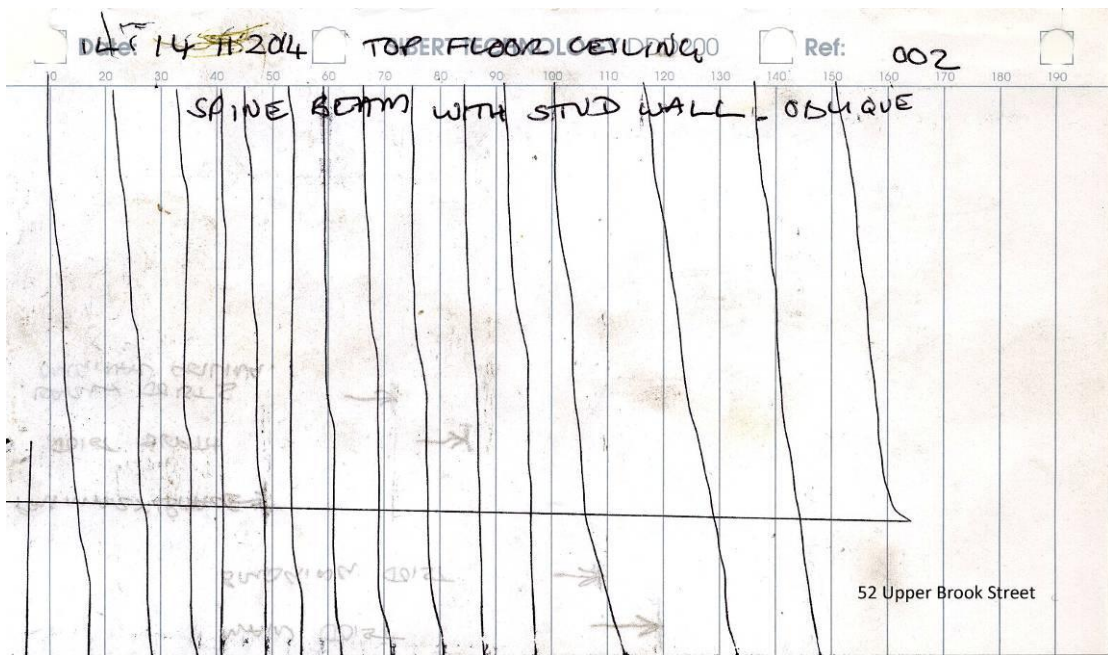
Drilling 002. Top Floor Room TF1 spine beam stud wall beneath.

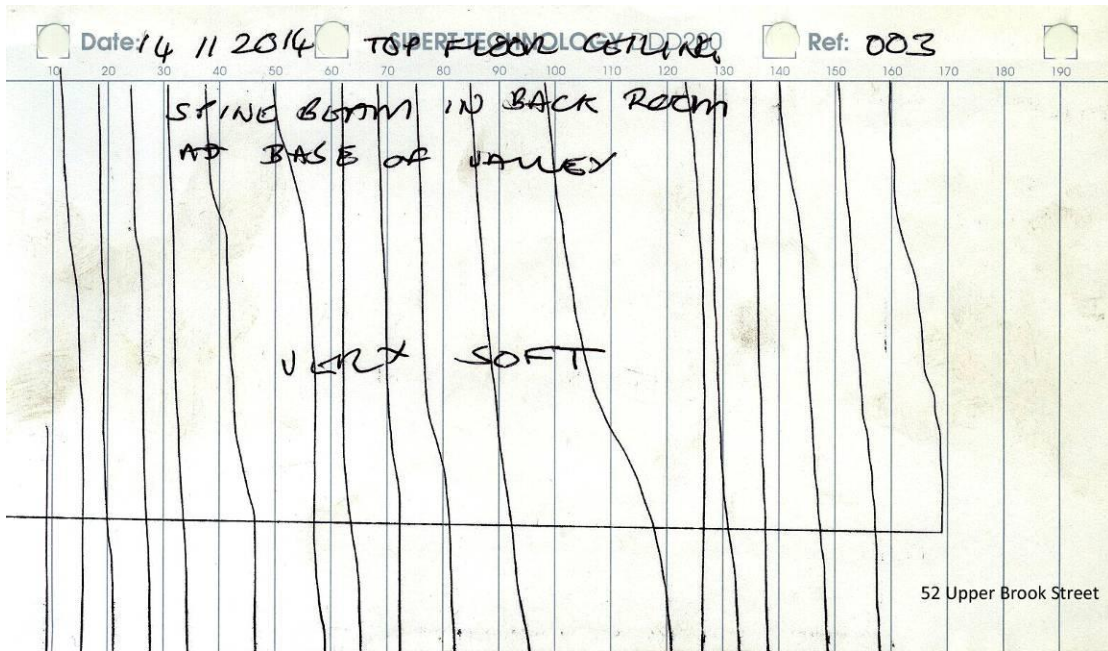
Drilling 003. Top Floor Room TF1 spine beam in TF3 at base of valley.

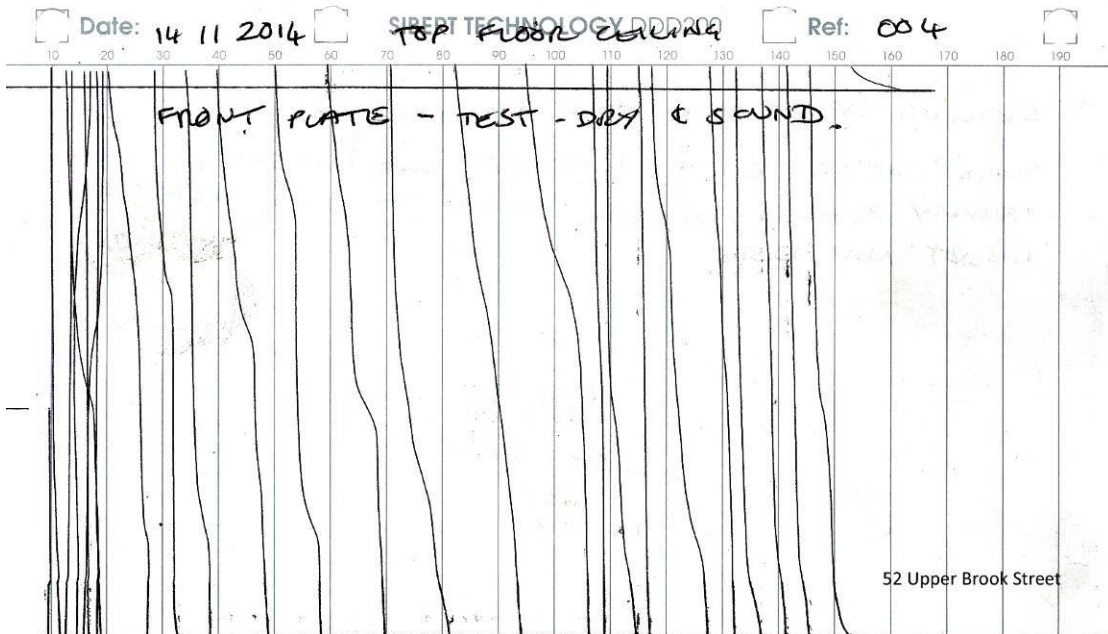
Drilling 004. Top Floor Room TF1 spine beam in the middle of the front room.
