52 Upper Brook Street, Mayfair London. W1Y 1PG.
Description and analysis of the roof structure. Surveyed 01 11 2013.

This report comments on the roof - its design, fabric and form and likely date of construction and alteration. The roof was examined from inside the southern bay and from the rooftop accessed by the fire escape ladders. No risks were taken and the roof was not climbed on. There is a summary on the last page.

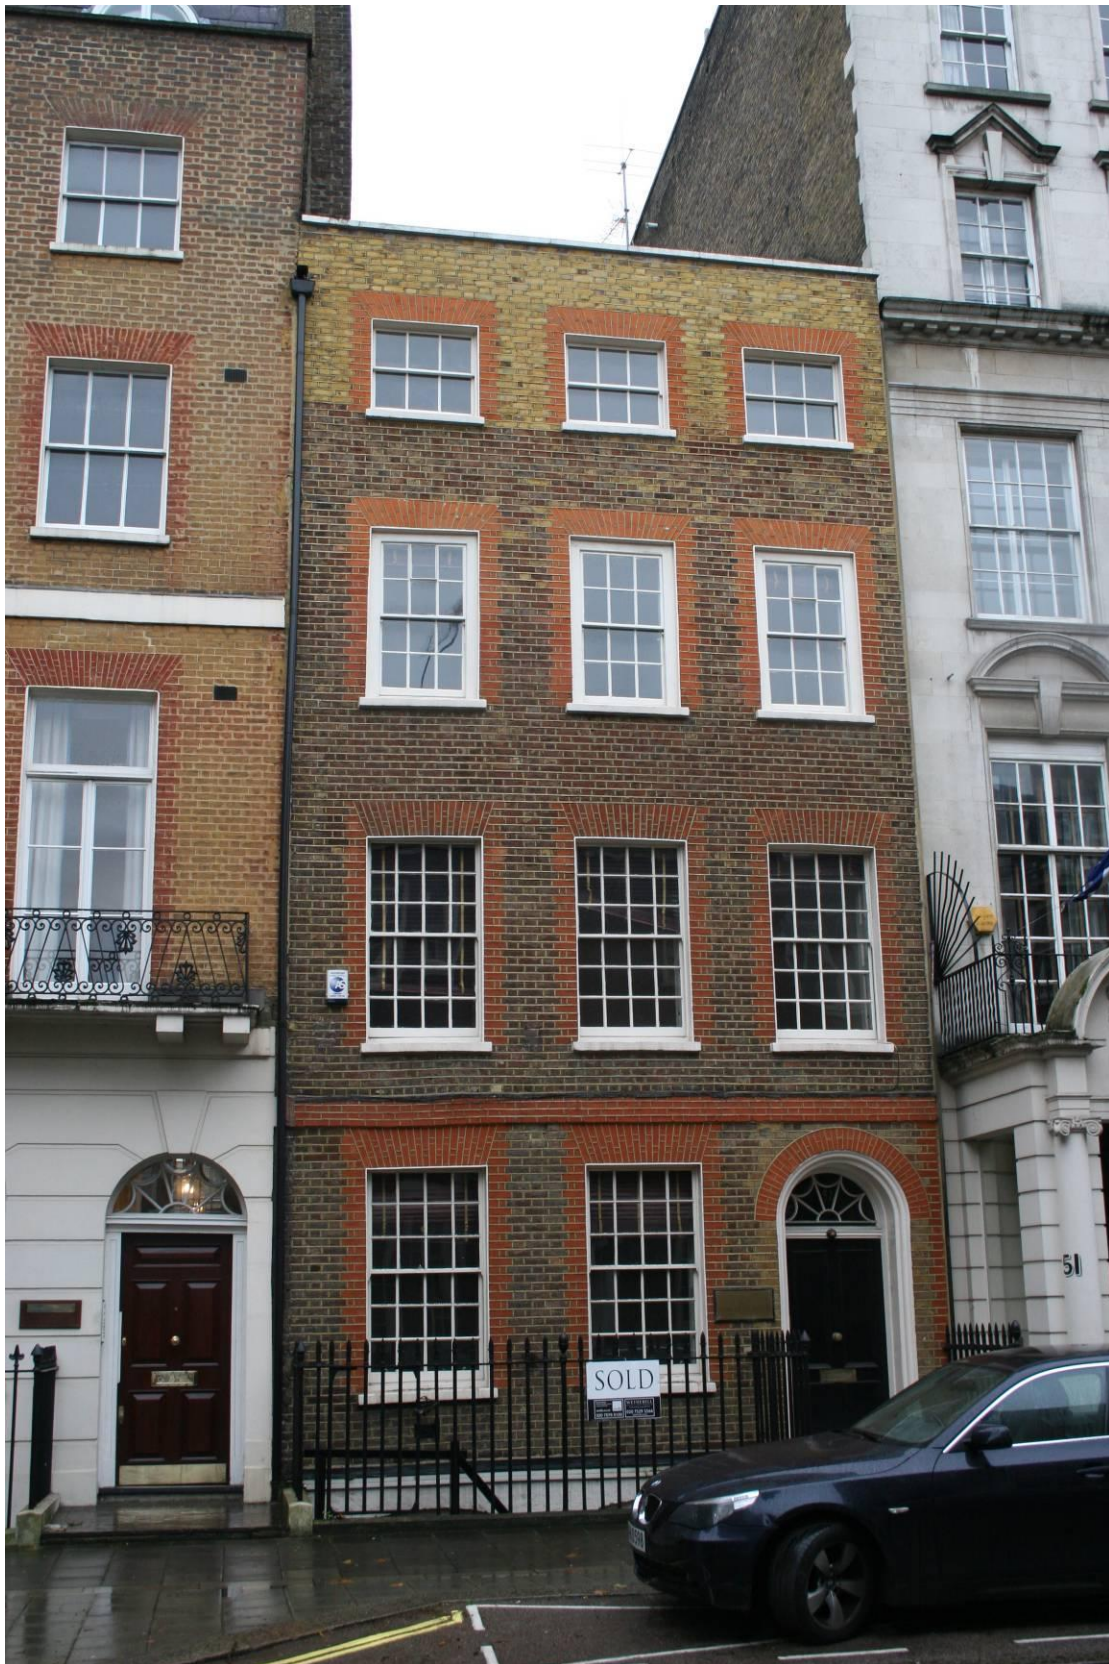
52 Upper Brook Street. The roof is not visible from the ground.

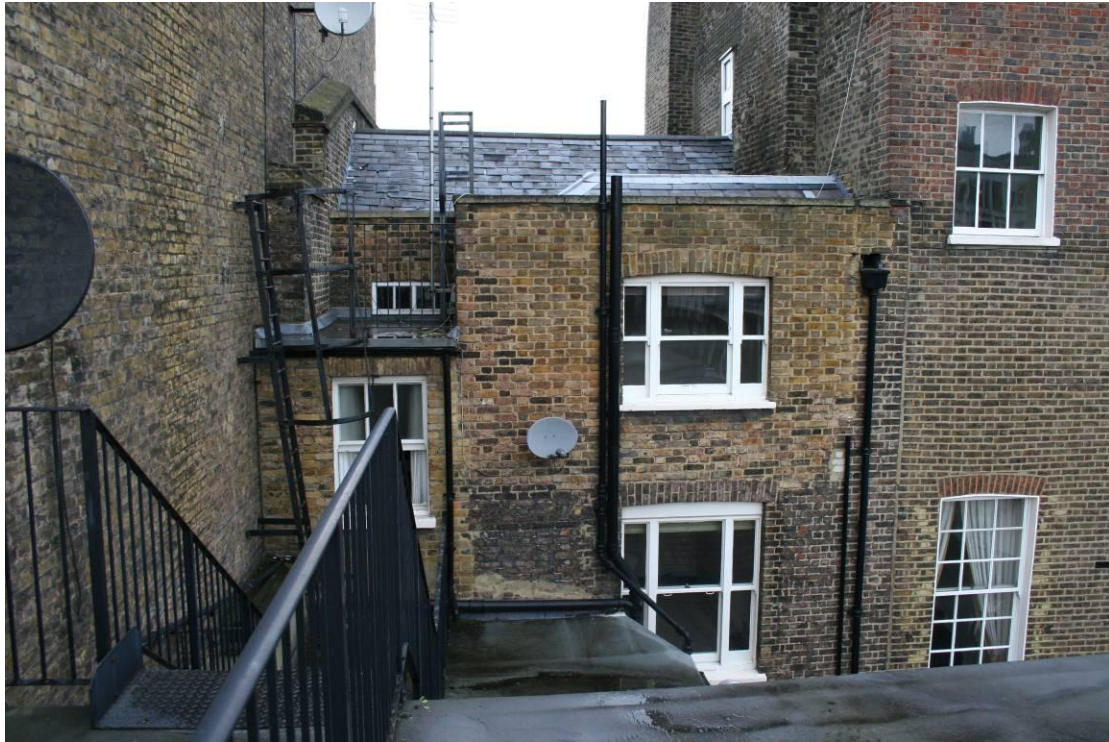
The rear of 52 Upper Brook Street looking N.

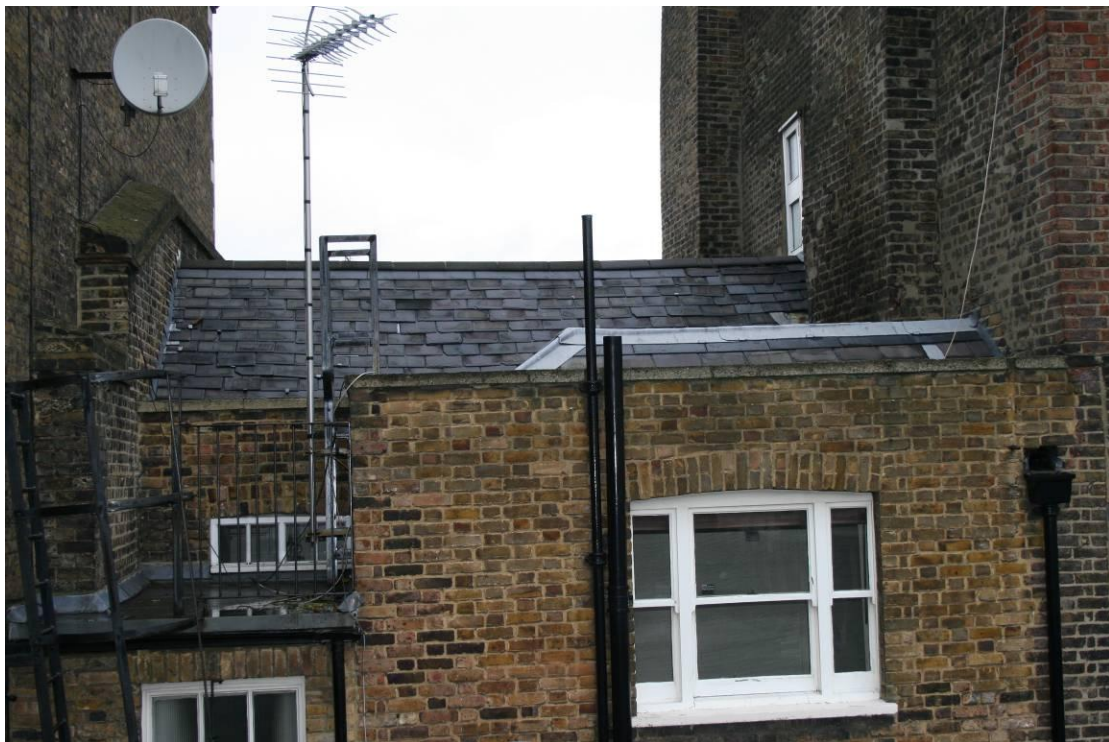
Detail of the rear of the roof. Looking N.

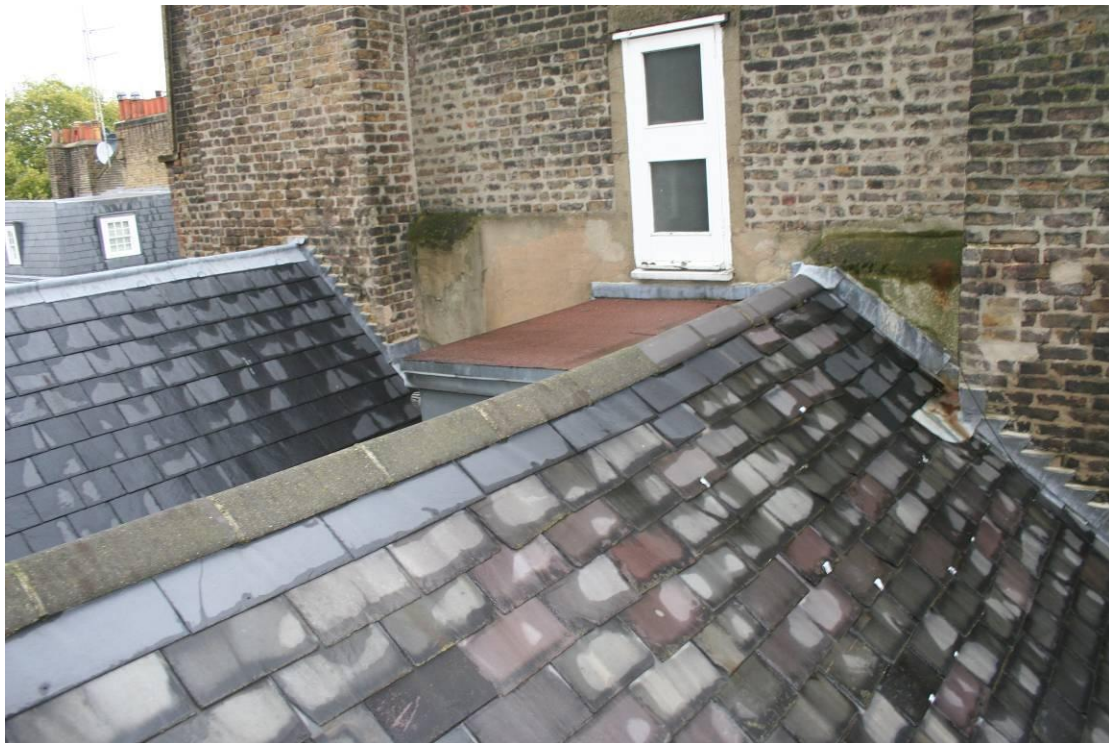
Detail of the roof looking NE. Note the flat roofed cubicle.

It was also noted that there is a flat roofed cubicle attached to the neighbouring property (seen in the photographs below the white access door). This is a EC20th addition and part of its structure can be seen from within the roof void.

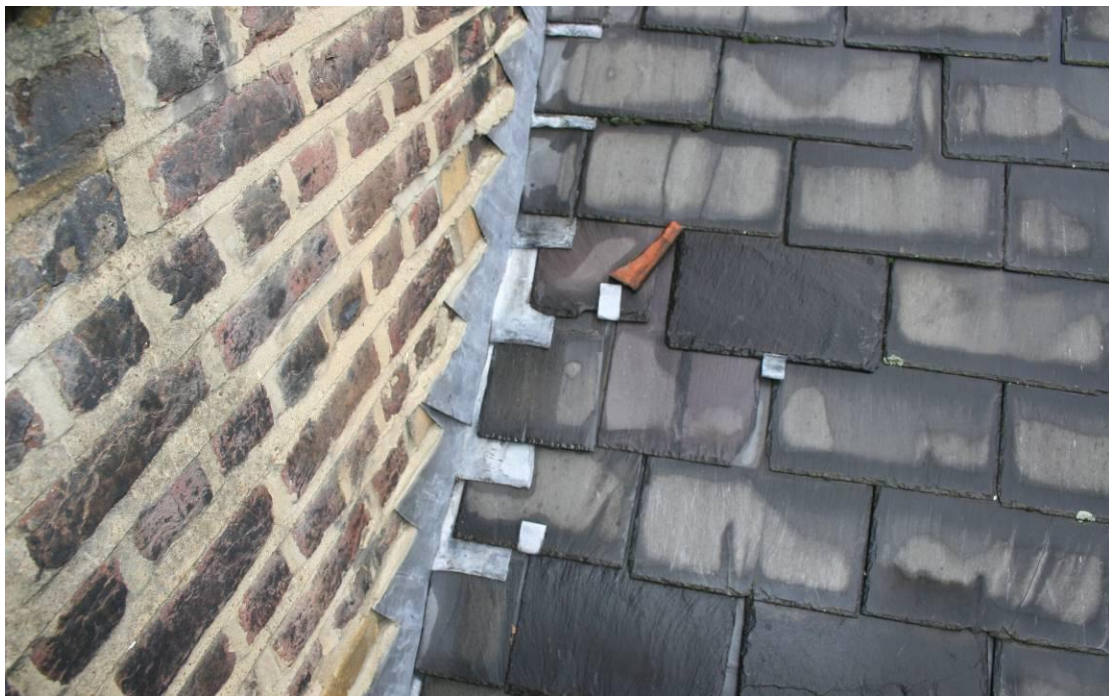
Detail of the western wall and roof junction.

It is evident that the roof has been extensively repaired in the last 13 years or so. (The Listing photograph shows the house before the facade was cleaned and repointed). All the brickwork in the side walls has been repointed with beige cement pointing which passes over the fresh lead flashings. There are scars in the brickwork to indicate that a previous mansard style roof was replaced by the current structure. A number of the grey slate tiles have fresh lead hangers put in as part of the repair scheme.

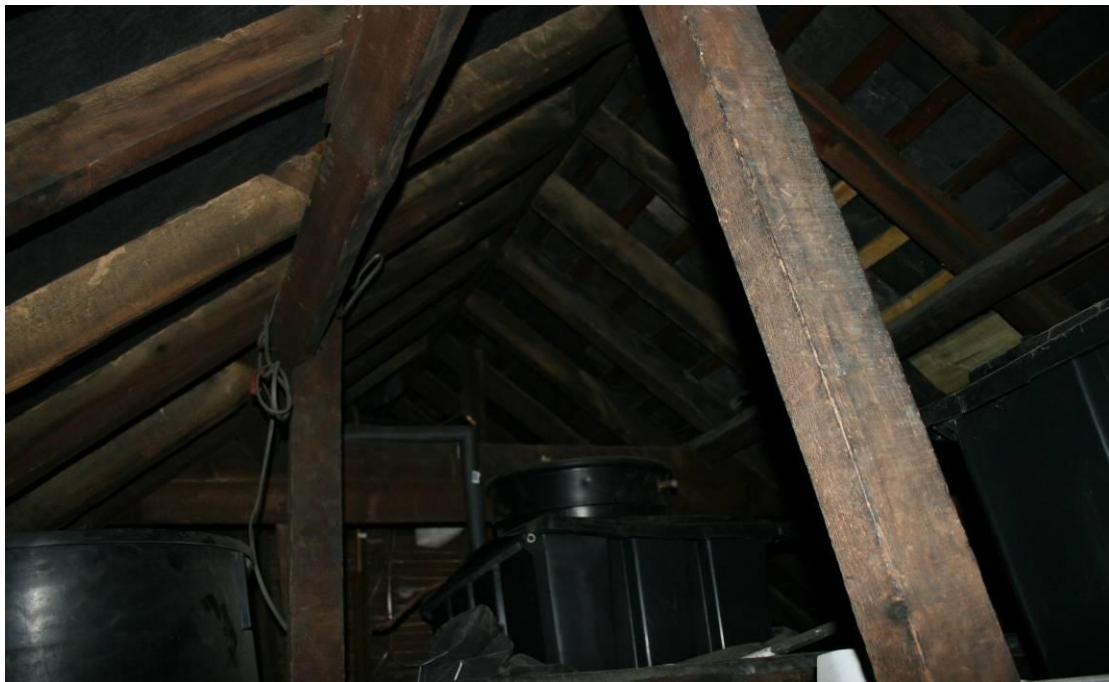
Looking W inside the southern roof void. Note the lath and plaster partition to the rear.

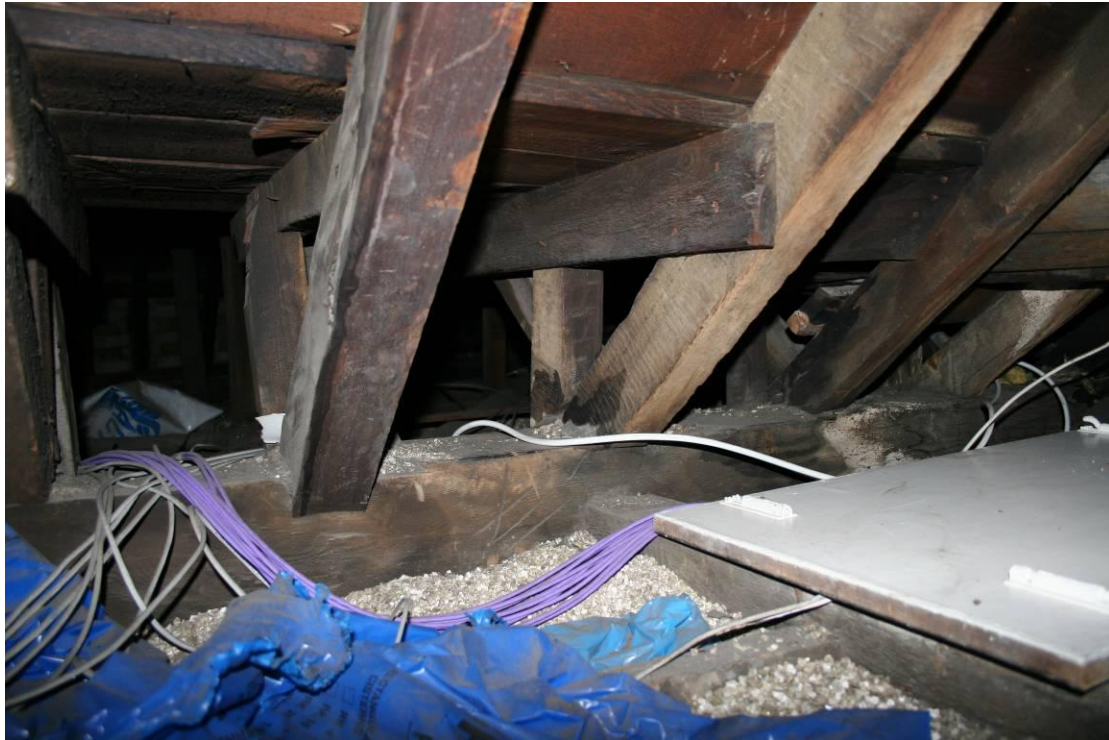
Looking NE from the access hatch.

The clasped side purlin roof is constructed of machine cut softwood with some reused timbers which are probably elm (denoted by their lighter colour and pitsawn finish). The structure has been stained with a dark brown compound such that most of the timbers look the same and only the grain of the timber can be used to judge its type. Most of the timbers are smooth but some bear the marks of a roller from being passed through a planing machine. The planks for the central water gully are machine sawn and supported on collars offcut from the same boards. The roof construction is entirely nailed with wrought iron nails – there are no visible pegs. The rafters are nailed in pairs onto a machined ridgepiece.

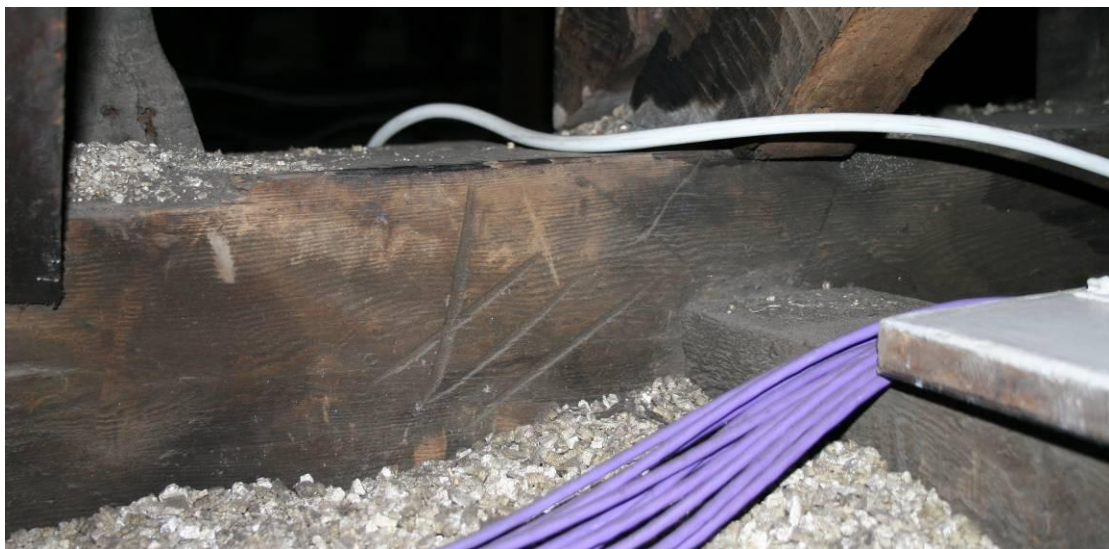
Detail of the main axial joist.

The main axial joist is smoothly finished and is marked XVI with a race knife. There are no corresponding numbers in the roof so this must either be a component number or a merchant's mark. Race knives were in common use right into the C20th.

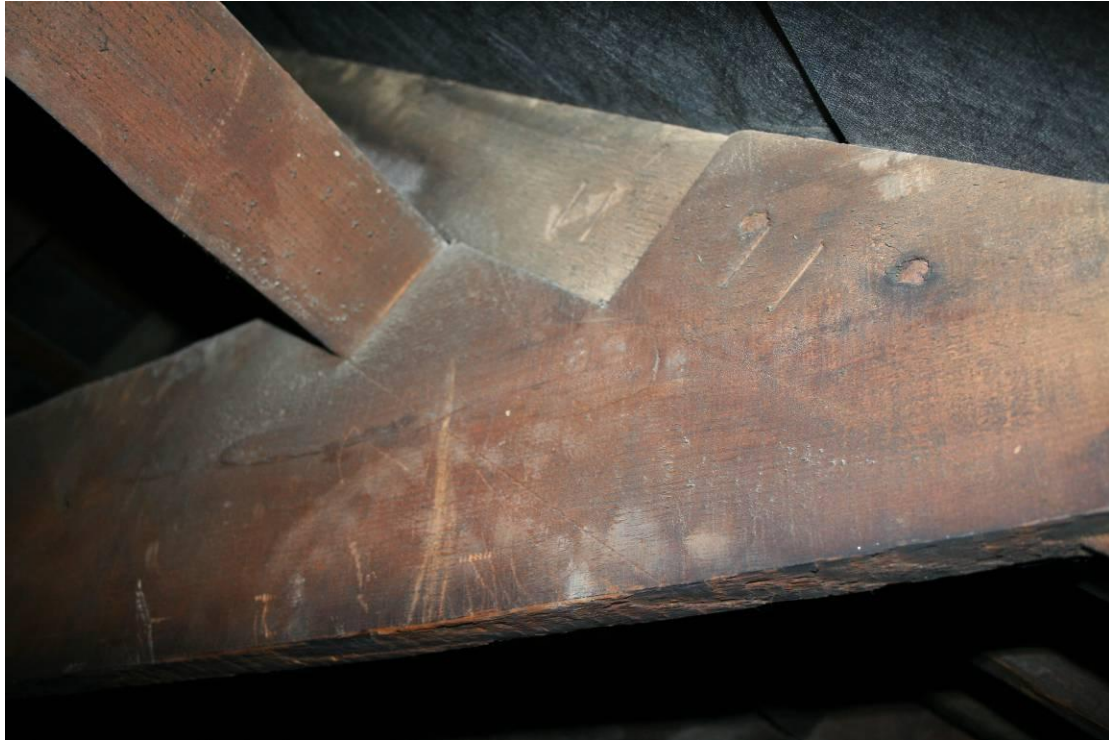
Carpenter's assembly mark in the collar above the access hatch.

By comparison, there is a true carpenter's mark on the main collar above the access hatch. Marked II with a chisel point, the collar is one of a pair and is side lapped and nailed to the principal rafter. The joints have been scored to mark them out. The purlin shown in the photograph above is a LC20th bandsawn softwood insertion which is not a pair for the more withered timber on the other side of the roof.

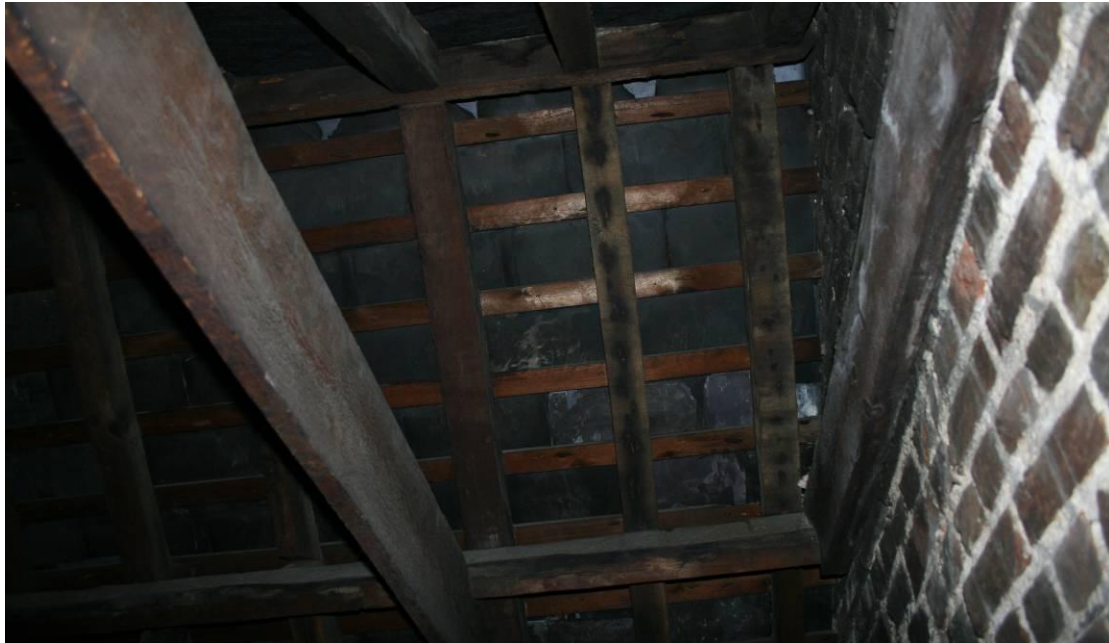
Looking up into the roof it can be seen that the roof has been rebattened on the southern side with machined and treated battens and that a number of the rafters have been turned over during the rebuild so that the old nail holes are visible on the underside. Photos follow.

Looking upwards to the south. Note the turned over rafters and C20th machine cut battens.

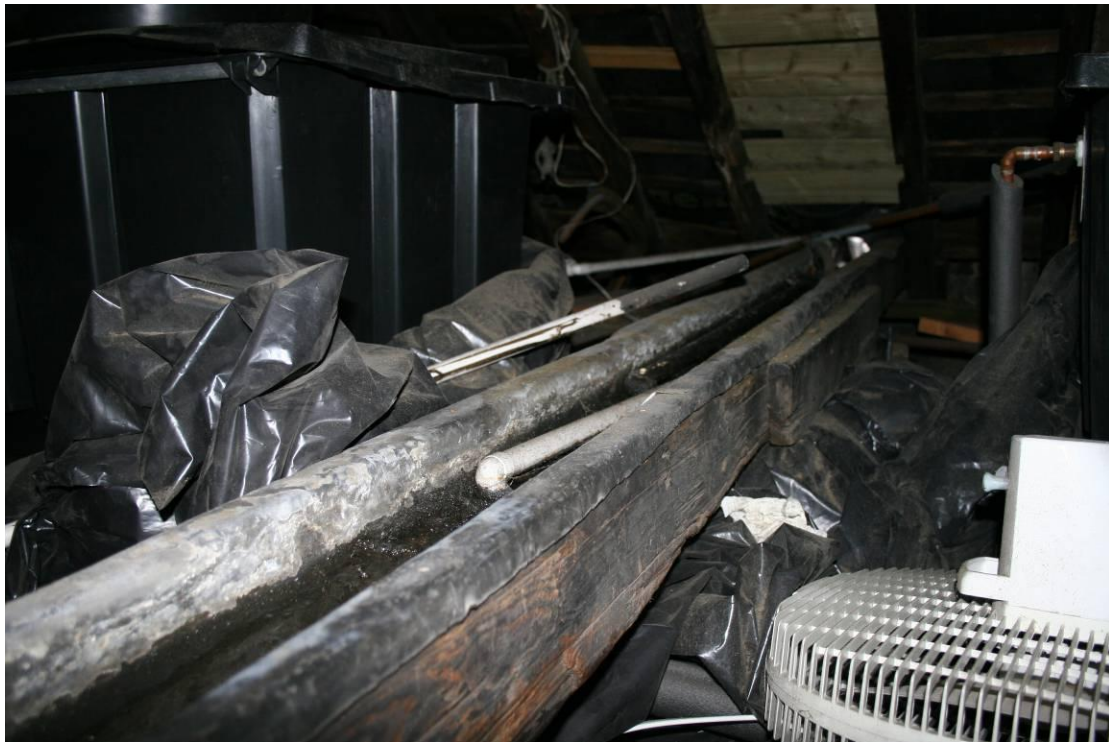
There is a lead lined drainage rill that passes across the roof from the central gully to vent to the rear. A section of roof has been very recently rebuilt above the rill and the fresh, tanalised or untreated timbers stand out with batch numbers pressed into them. The repair is fastened with Poxidriv screws. See following photo.

The lead lined drainage rill. Filled with moss and rubbish it needs to be cleared out soon.

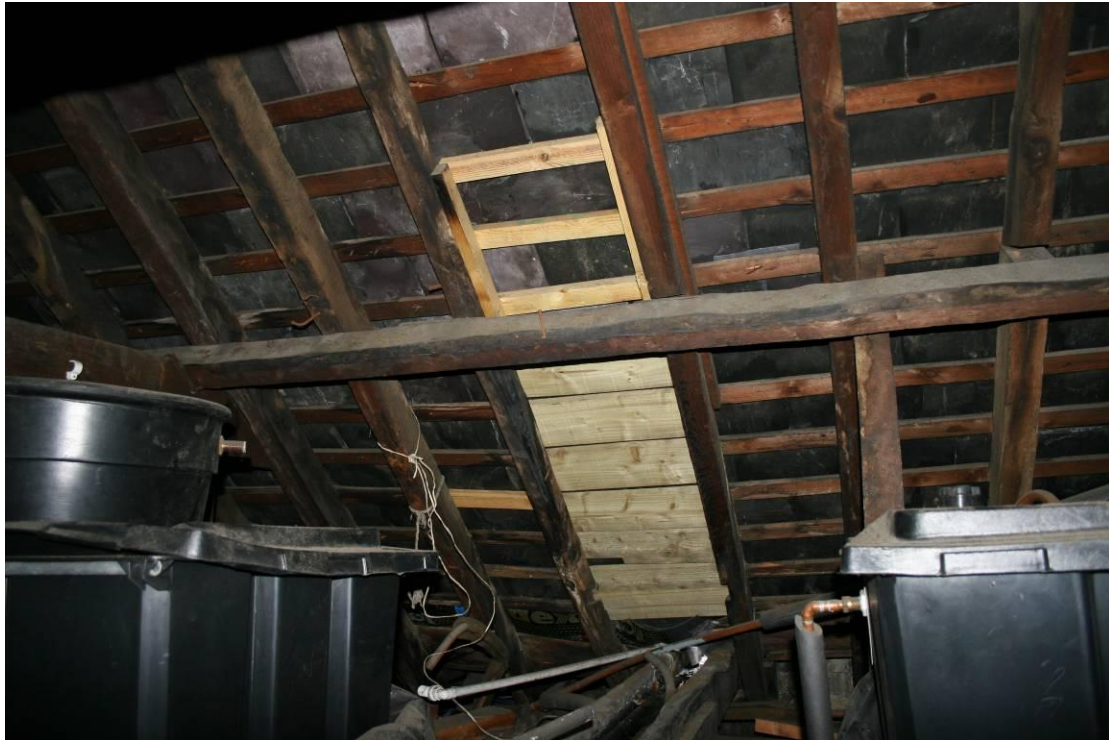
It is evident a small structure was recently removed from above the rill as there are two neat rebates in the rafters on either side of it. Below the rill can be seen a recent rubber membrane inserted beneath the leadwork for the flat roof. See following photo for detail.

The repaired roof above the rill. Looking SW. Note also the brand named rubber membrane.
