Phillips Farm, Edney Common, Chelmsford, Essex.
Description and analysis of a timber-framed barn and outbuildings at
Phillips Farm. Surveyed 05 10 2010.

This report considers the historic buildings to the east of the site. These are the timber-framed Barn and its outshot Stables and Piggery. These are recorded to EH Level 3. Also recorded to Level 1 are the C20th Piggery and the Offices converted some 12 years ago.

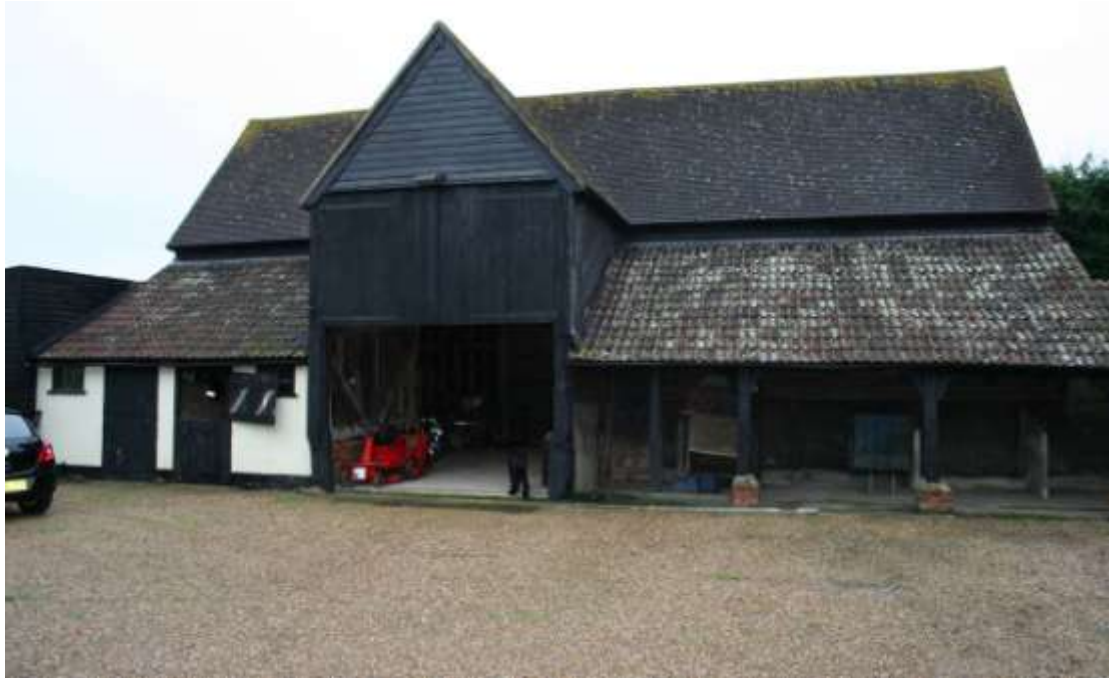
Western Elevation.

Western elevation of the Barn and the outshot Stables and Piggery.

This is the main elevation viewed from the courtyard. It consists of the midstrey porch with the lower doors removed, the Stables to the north and the Piggery to the south. The Stables and Piggery are described separately. The Barn walls are visible inside the outshots.

The timber-frame is clad externally with C20th machine sawn weather-boards painted with clad brushing tar. Inside the outshots the boards are original 10in pit sawn clap boards fastened with wrought iron nails. Those on the sides of the midstrey porch are 7in deep. These are all untreated.

The lower sections are rendered in grey cement over EML (Expanded Metal Lath) to about 1500mm. The whole Barn is raised on a plinth of red bricks, 65x110x220mm with creased faces, sharp arrises and some have horizontal pressure marks. There are 4 courses set on a coped plinth of at least 6 courses set in a 15mm bed of gritty white mortar. There is also a plain tile levelling course beneath the cill plates. The brickwork is clearly visible inside the midstrey porch and elsewhere.

The midstrey porch has lost its lower doors but the large pintles are in place. The upper doors are C20th vertically boarded, tongue and grooved, gate and ledger softwood doors on the original pintle straps. The door jambs have an entasis at ground level and are slotted for the leap boards. There are also mortices for drop bars to secure the doors.

The roof is a recent replacement with concrete plain tiles while the Stables and Piggery have LC20th double roman tiles.

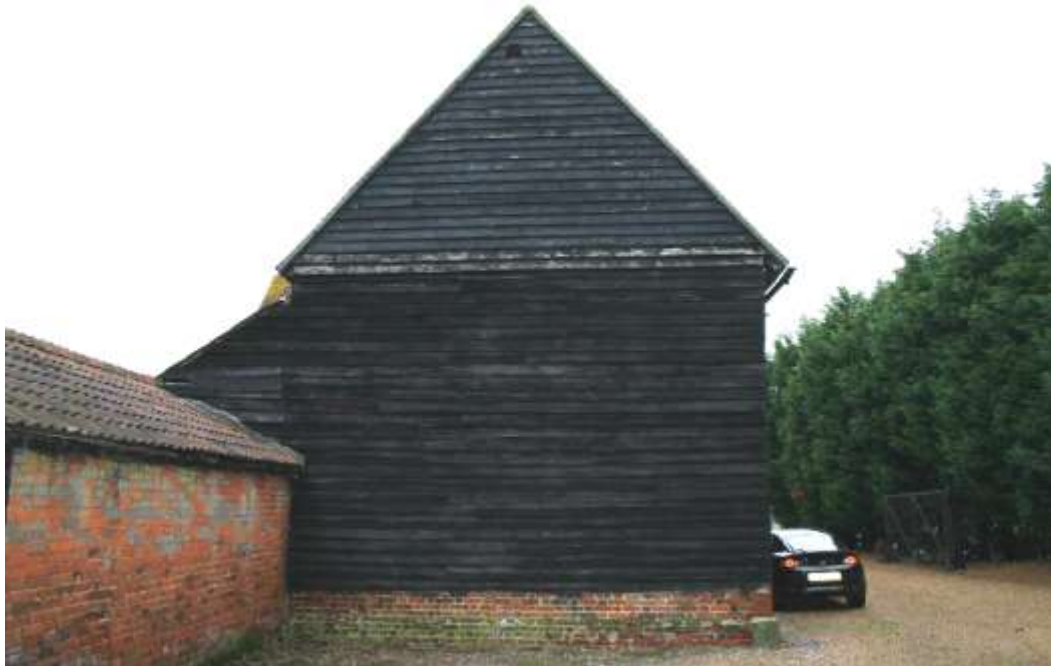
Southern Elevation.

Southern elevation is featureless save for an owl hole.

The southern elevation is clad mostly in planed LC20th 7in weather-boards with some showing the marks of a circular saw. The brick plinth is evident. The gabled end has a dry verge and is featureless save for a small hole near the apex which must be an owl hole.

To the west is the flank of the Piggery roof where it changes profile and here a few earlier 10in boards remain. The lower SW corner of the Barn is connected to the brick wall that forms the eastern side of the Piggery.

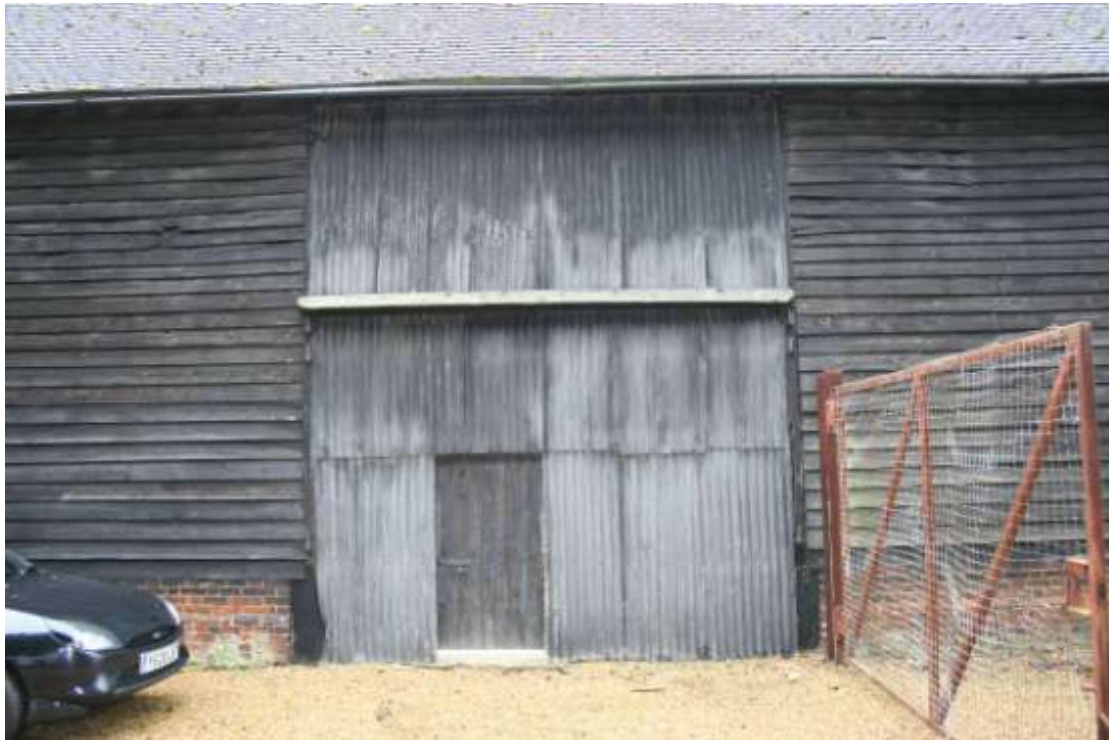
Inserted panel to replace upper and lower doors demarcated by pintle hinges.

The eastern elevation has an inserted panel to replace the original barn doors. This is a LC20th softwood frame clad with corrugated iron sheets. There is a pentice board 2/3rds of the way up and a single pedestrian door. This is a LC20th tongue and grooved, gate and ledger door with mild steel strap hinges and bolt all screwed on. It has an aluminium handle and a small maker's plate 'Edward Green Doors- Ingatestone'.

Like the midstrety porch the door jambs have the pintles for the original doors and the slotted entasis for the leap boards.

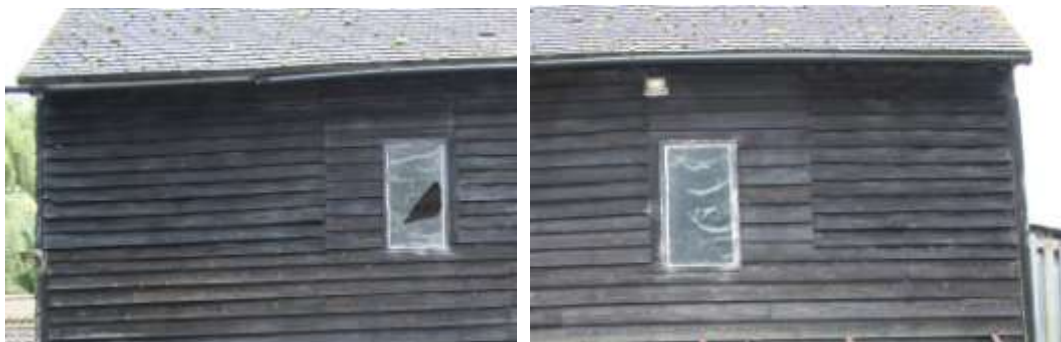
Both modern lights are set in boarded up openings for hatch doors.

There are two plain glass fixed casements that have been set in the boarded up openings for high level hatch doors.. A few of the upper weatherboards appear older but the rest are LC20th and all are fastened with galvanised French nails. Many are warped from water damage from leaking gutters. The rainwater pipes and gutters are plastic.

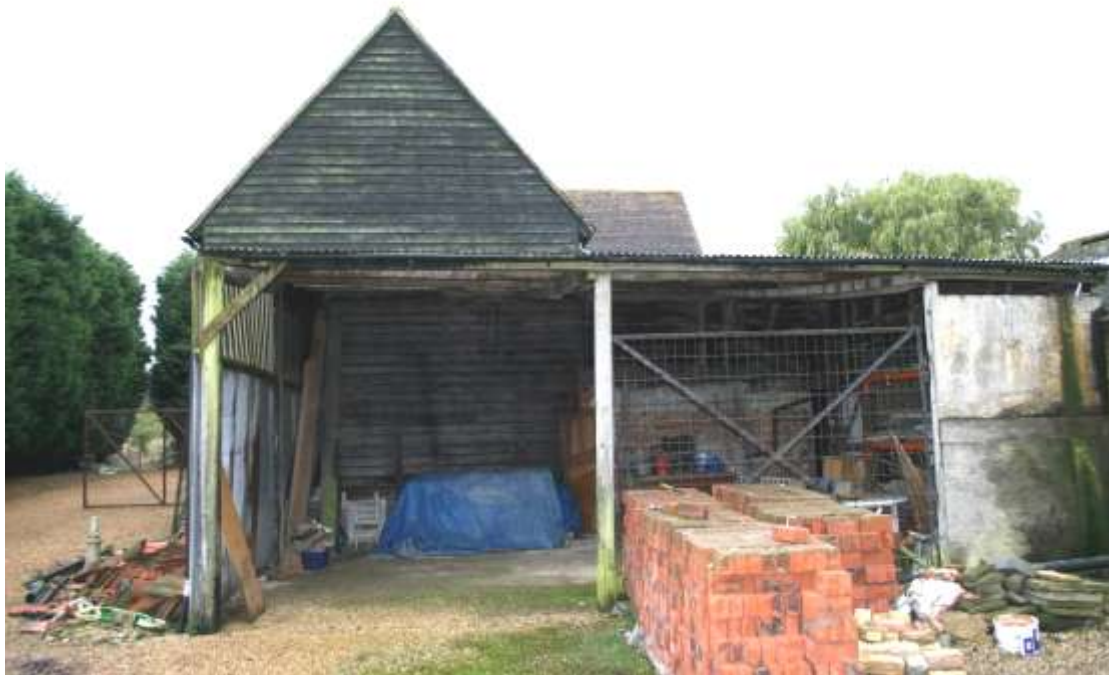
Northern Elevation

The northern elevation is shrouded in a LC20th tin shed.

The northern elevation is a reflection of the southern one except that the lower half is mostly shrouded by a makeshift LC20th shelter composed of oddments of machined timber and a corrugated iron roof. The southern wall of the outshot Stables has been rebuilt in Flettons set in grey cement. The weather boards are LC20th.

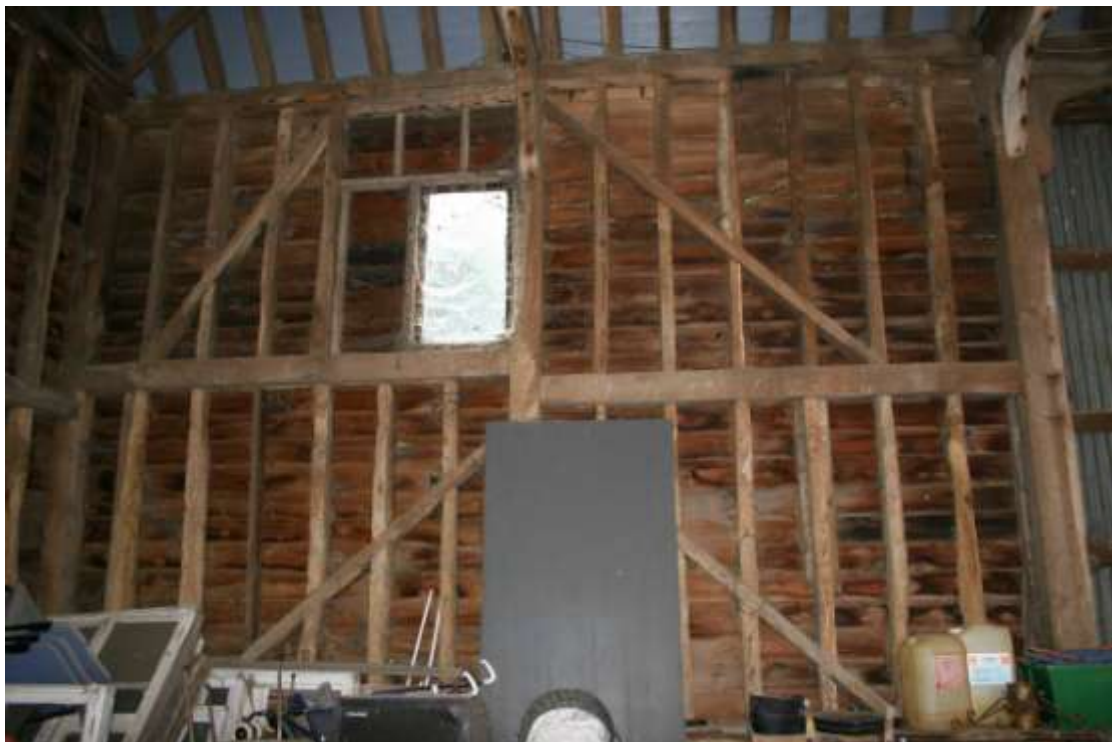
Bays 1 and 2 looking east. Note brace displaced to accommodate hatch frame.

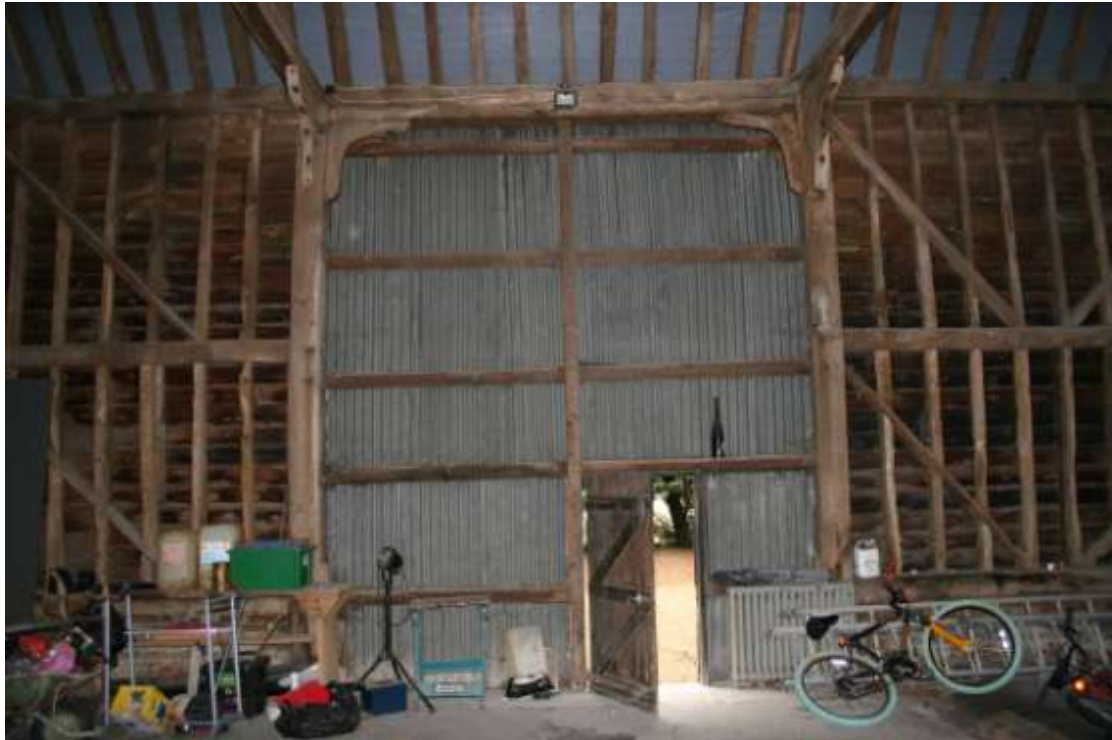
Bay 3, the midstrey looking east. The Barn doors have been replaced with a modern panel.

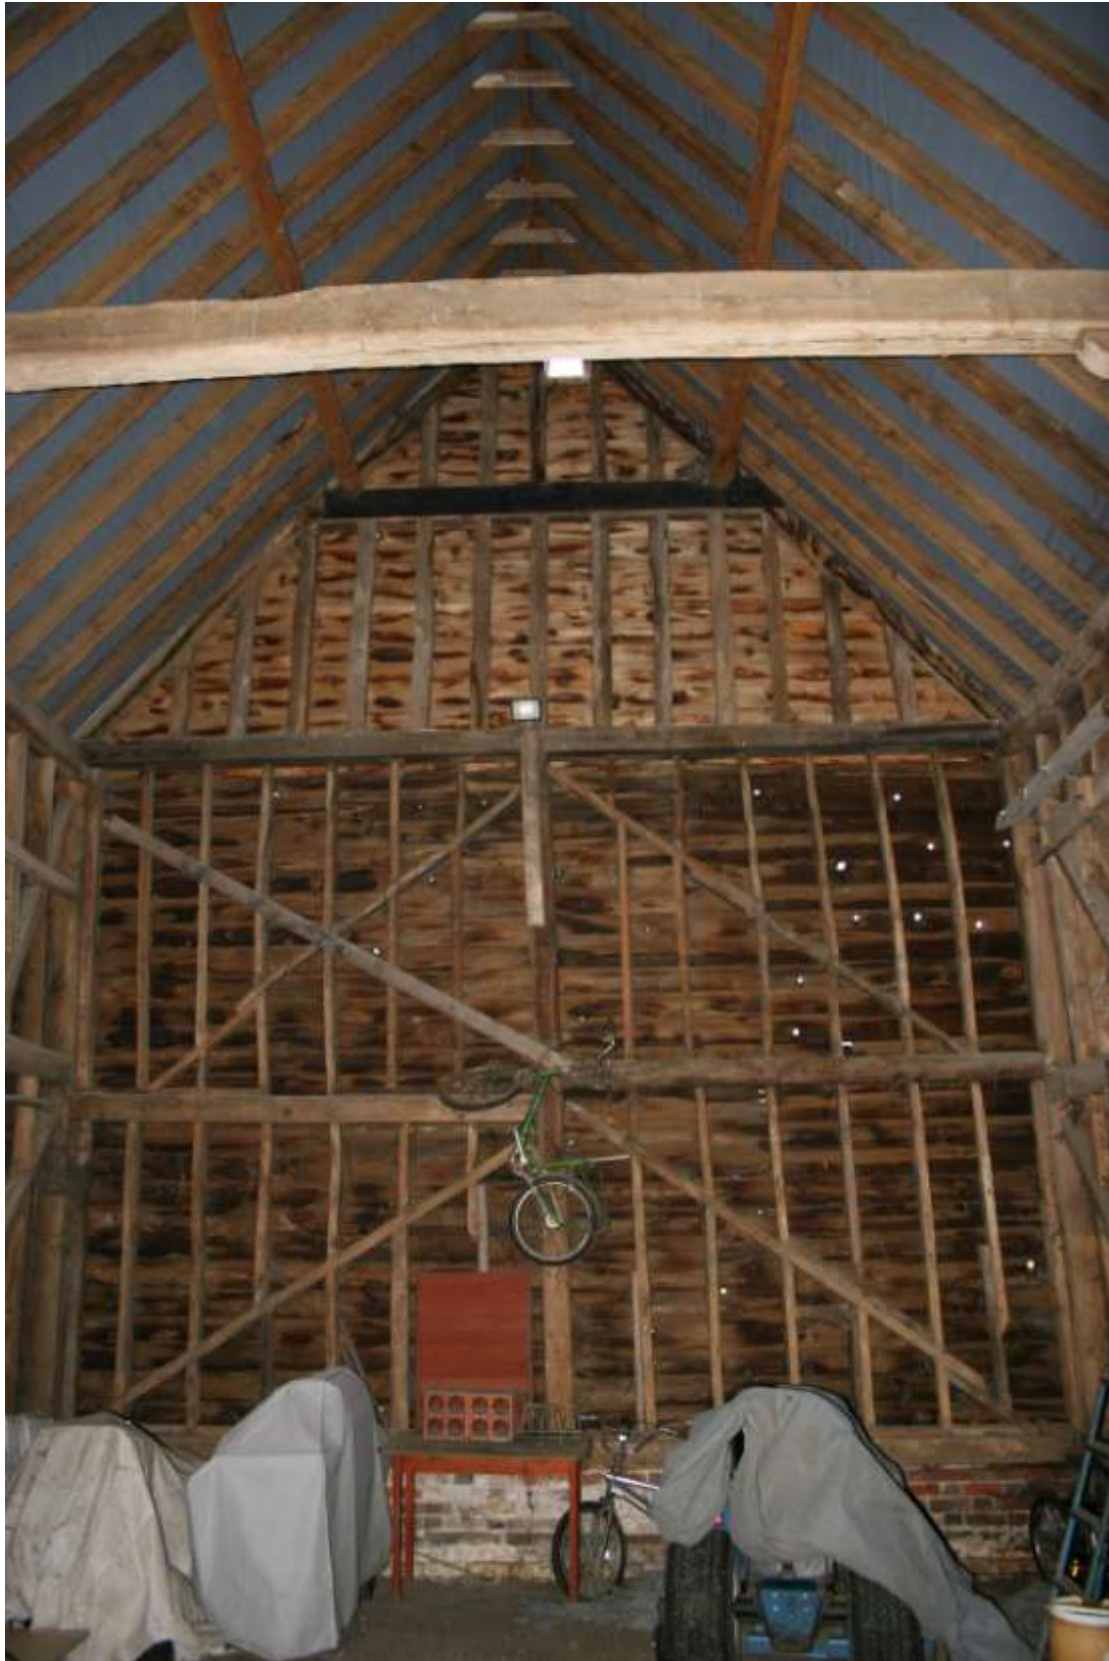
The southern wall has been rebuilt in the LC20th with some modern machined timbers.

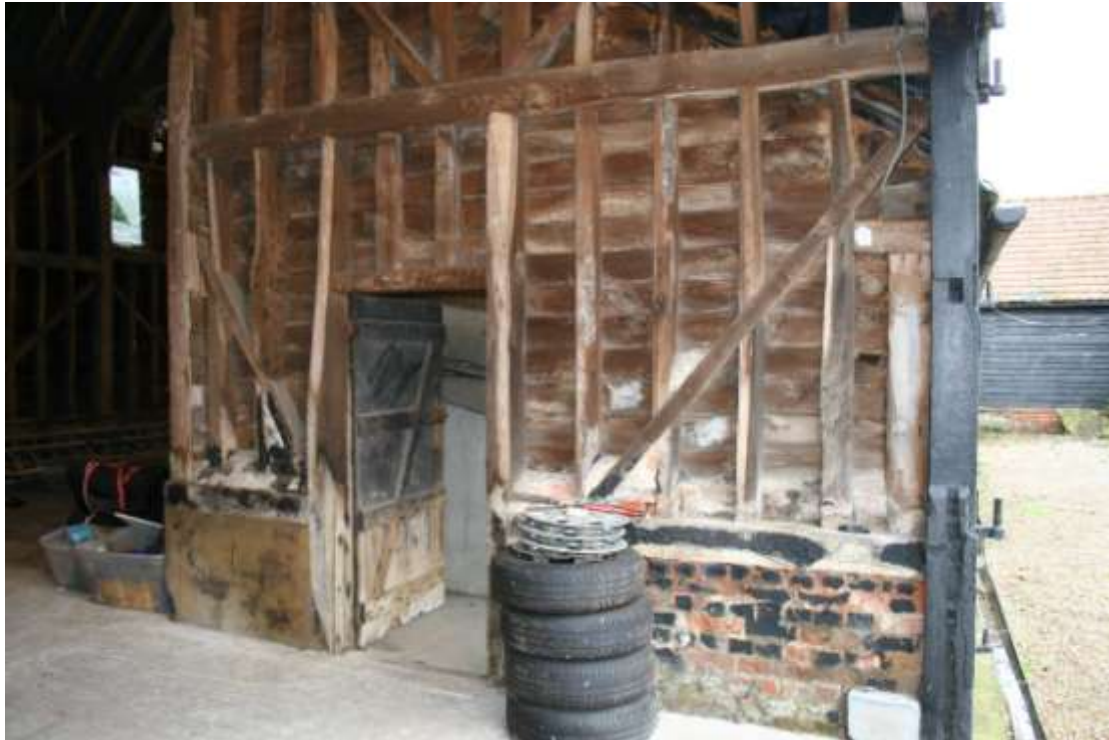
Midstrey porch with framed doorway, leap slot and mortice for drop bar. Note the inserted post to support the front plate of the Piggery.

The midstrey is framed in the same way and also has a fully framed pedestrian door in its southern flank with jambs pegged into the midrail. The door is a C19th vertically boarded tongue and grooved, gate and ledger softwood door with mild steel pintle straps with spooned terminals nailed on. It has a mild steel finger latch and slide-bolt both slot head screwed. A lock box has been removed and there are two redundant keyholes. The lower part has been sheathed in galvanised steel sheet on the Piggery side.

The plinth brickwork has been painted in hot tar up to the cill plate and up some of the studs and this is a common feature of these barns where frost has caused the brickwork to spall. There is also a short section that has been rendered with hair plaster.

On either side of the midstrey adjacent to the door jambs, short posts have been nailed beneath noggins to support the front wall plates of the Stables and the Piggery. Besides the midstrey door is a circular cat hole now blocked with rendered EML (Expanded Metal Lath). There are a few rat holes patched with metal plates and small blocks of brickwork.

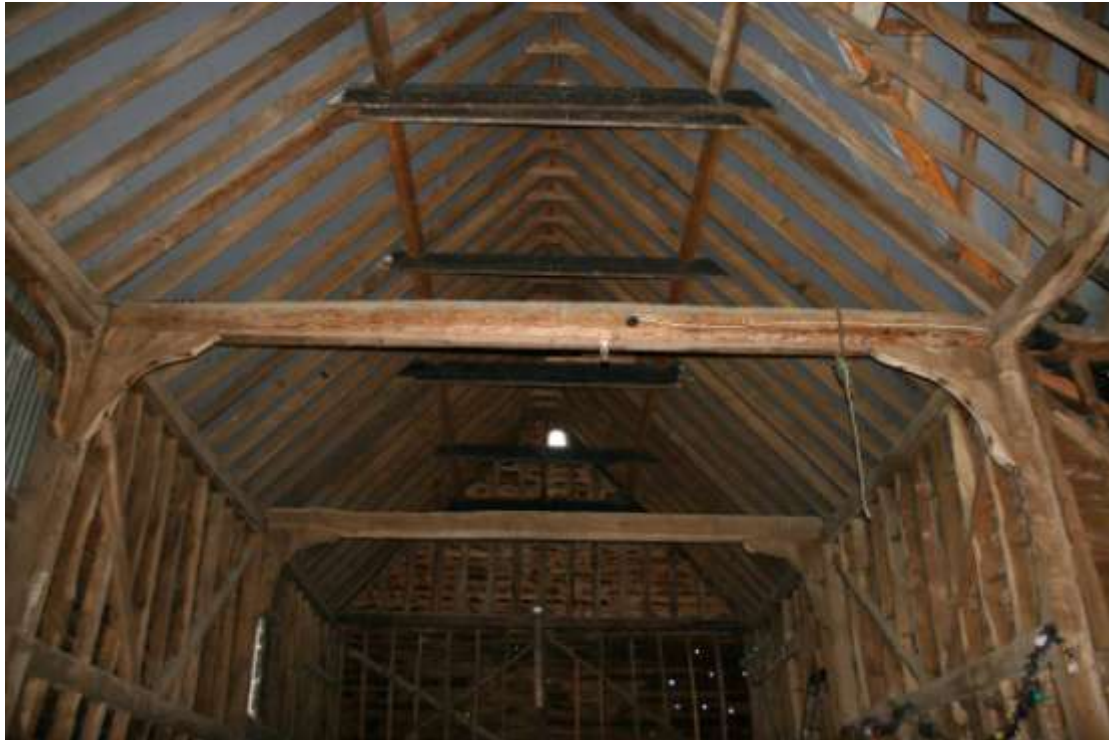
The roof has been largely replaced in the LC20th. Looking south.

The roof structure is a simple clasped side purlin truss-less construction where the principal rafters do not sit on the tie-beams. The rafters are paired onto a ridge-piece and secured with small gussets at the apex. The roof has been completely rebuilt with a blue plastic membrane and all the rafters in the southern half are new. The others are reused, some on the flat and others are quarter poles.

The collars are machined planks and are French nailed in pairs over the tie-beams and singly in the centre of the bays. They are painted black on one side only and this suggests that they too are reused. The collars pegged into the gable walls are original and much deeper.

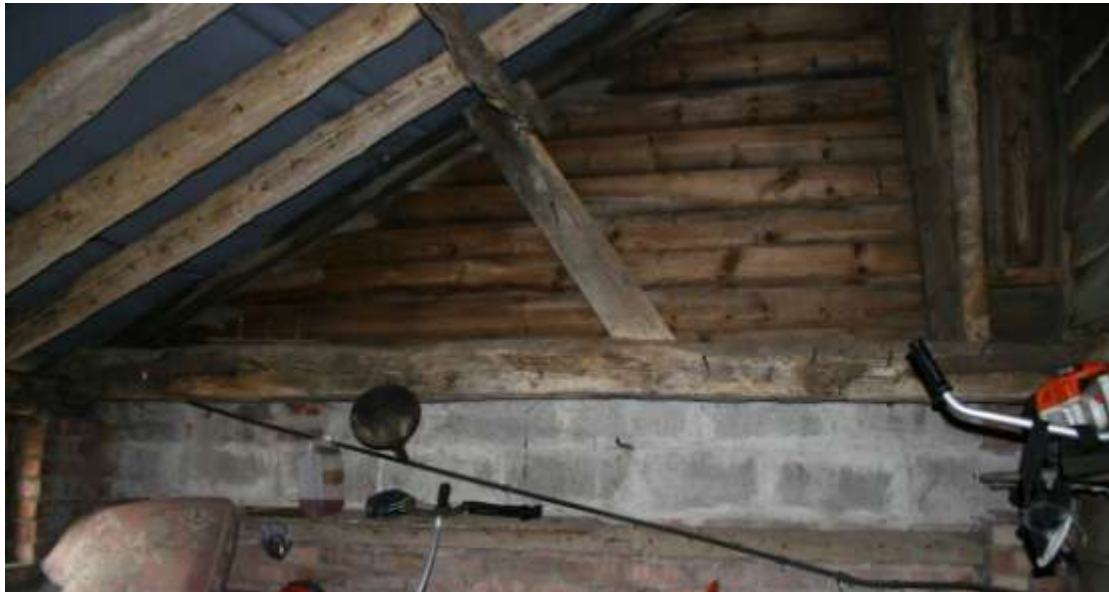
Northern wall. Tie-beam sits on the Fletton and blockwork inserted wall.

The northern elevation is composed of a Fletton wall bonded in grey cement and then finished with two courses of 220x220x440mm hollow blockwork. The tie-beam rests on the blockwork and is retained with two corroded iron L-ties. Above the wall is finished with C20th weather boards. The tie-beam is morticed on its soffit for a stud wall.

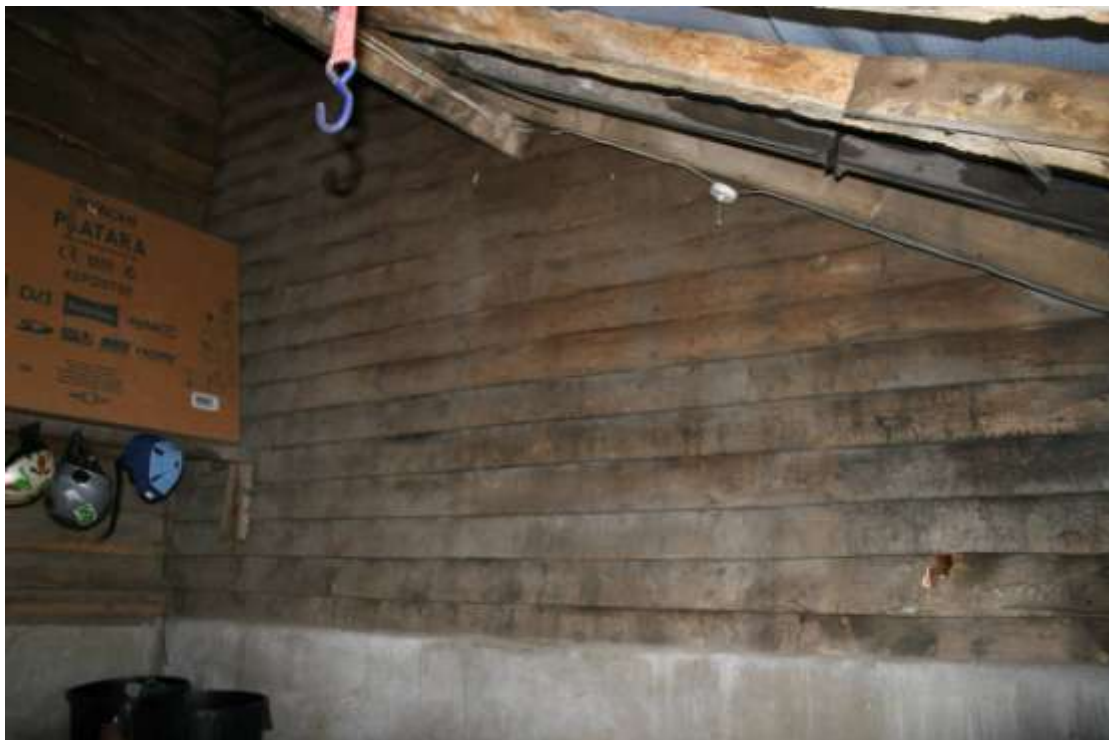
The southern elevation is the midstrety porch.

The southern elevation is the boarding of the midstrey porch and this differs from the main wall of the barn in that the boards are only 7in deep rather than 10in. The boards are bandsawn replacements. Below is a 1400mm high skirt of EML (Expanded Metal Lath) rendered with grey cement to match that visible in the Piggery.

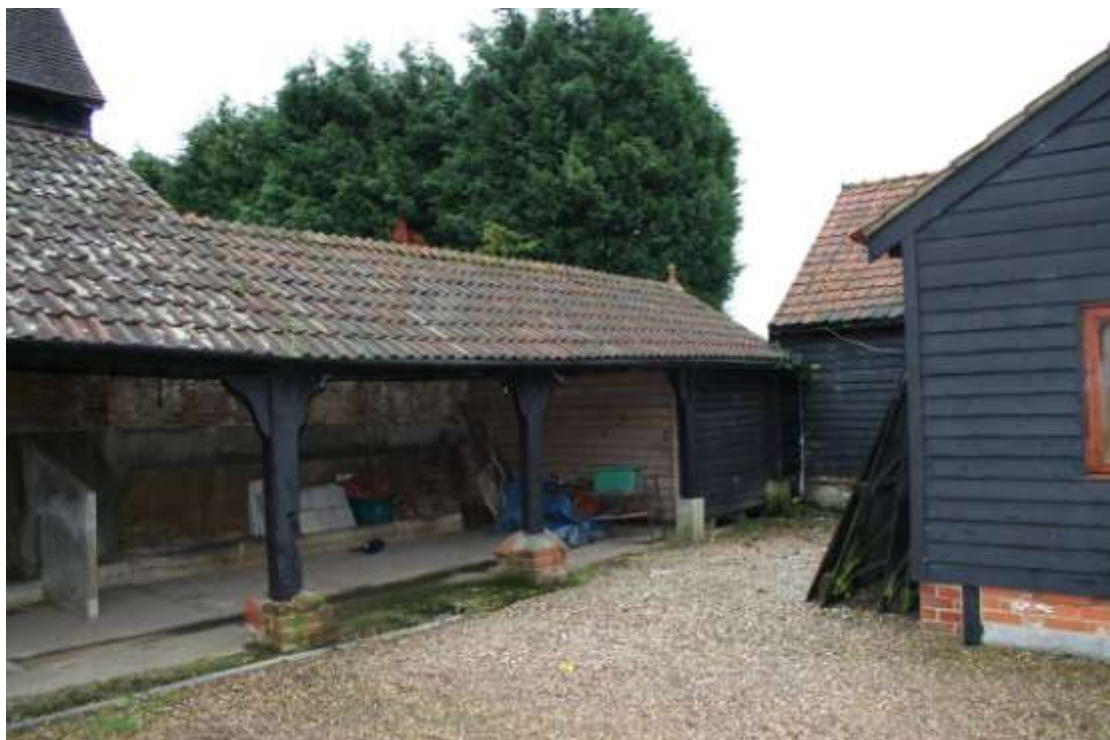
Bay 6 has been boarded in the LC20th.

Bay 6 at the southern end has been boarded in with LC20th machined softwood weatherboards and the interior converted into an office space (now abandoned). Here the posts are stood on concrete columns.

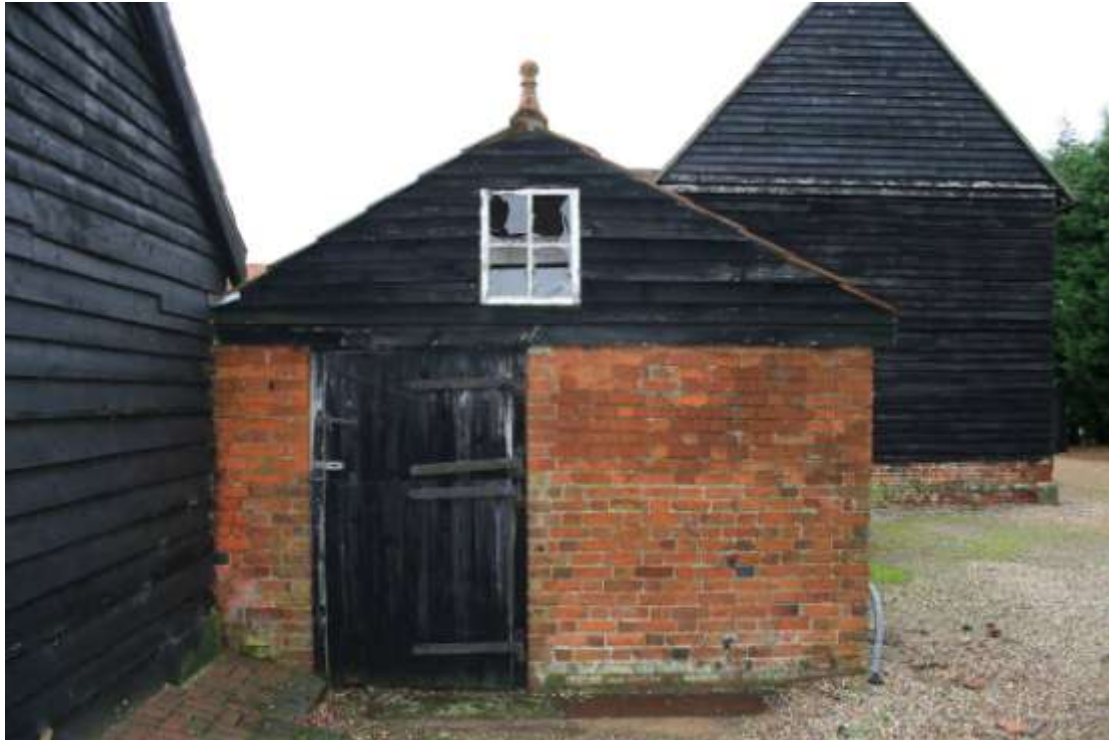
Southern Elevation

Southern elevation of the Piggery Stables showing inserted doorway.

The southern elevation is a weather-boarded gable end over a brick wall with an inserted doorway for split stable doors. The brick wall is composed of red/orange 65x110x225mm facing bricks with smooth faces, sharp arrises, faint horizontal pressure marks and shallow rectangular frogs. These are set in a 10mm bed of white gritty lime mortar.

The quoins are correctly closed but the doorway has jambs formed from London Stock bricks set in grey cement and are closed on the western jamb only. The brickwork is of poor quality because although layed in Flemish bond the courses do not follow through vertically. The interior brickwork, visible inside the Piggery is of very inferior quality and is described later.

The doors are identical to those in the Stables and have mild steel straps with cast hinges of the type very popular from the 1930's onwards. Above there is a four light fixed timber C20th casement. The weather-boarding is C20th, fastened with galvanised French nails and overlaps the roof tiles which must lead to water ingress.

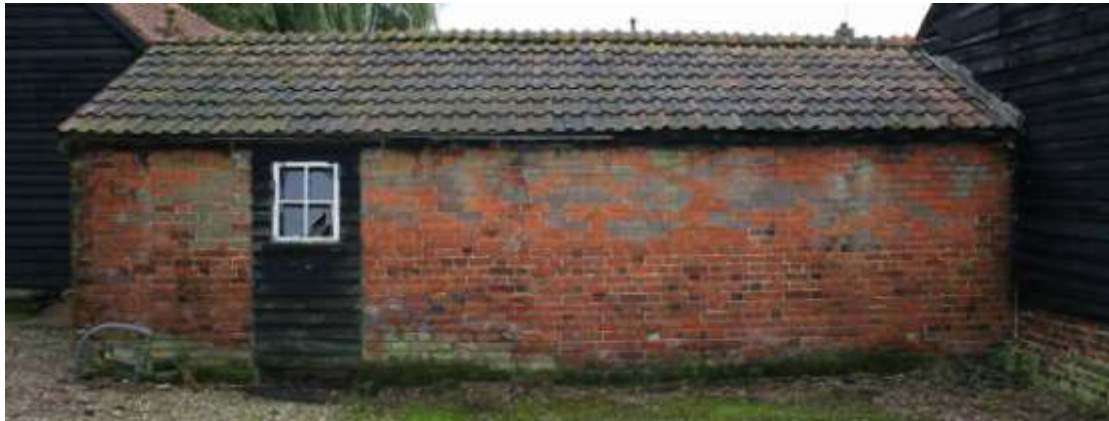
Eastern Elevation.

Eastern elevation of the Piggery stable.

The eastern elevation is composed of red/orange 65x110x225mm facing bricks the same as the southern elevation and is properly closed at each end. There are many pale purple bricks in the upper half as well as a large number of headers that look as though they have been burnt in a chimney. It is certain that the wall is built of reused bricks.

To the south is an inserted doorway into the closed stable/ office. The opening is full height to the top-plate and has no closer bricks either side. The doorway has been blocked with modern studwork and weather-boarding. There is an opening casement to match that on the gable end with mild steel hinges and aluminium stays - put in to serve the office.

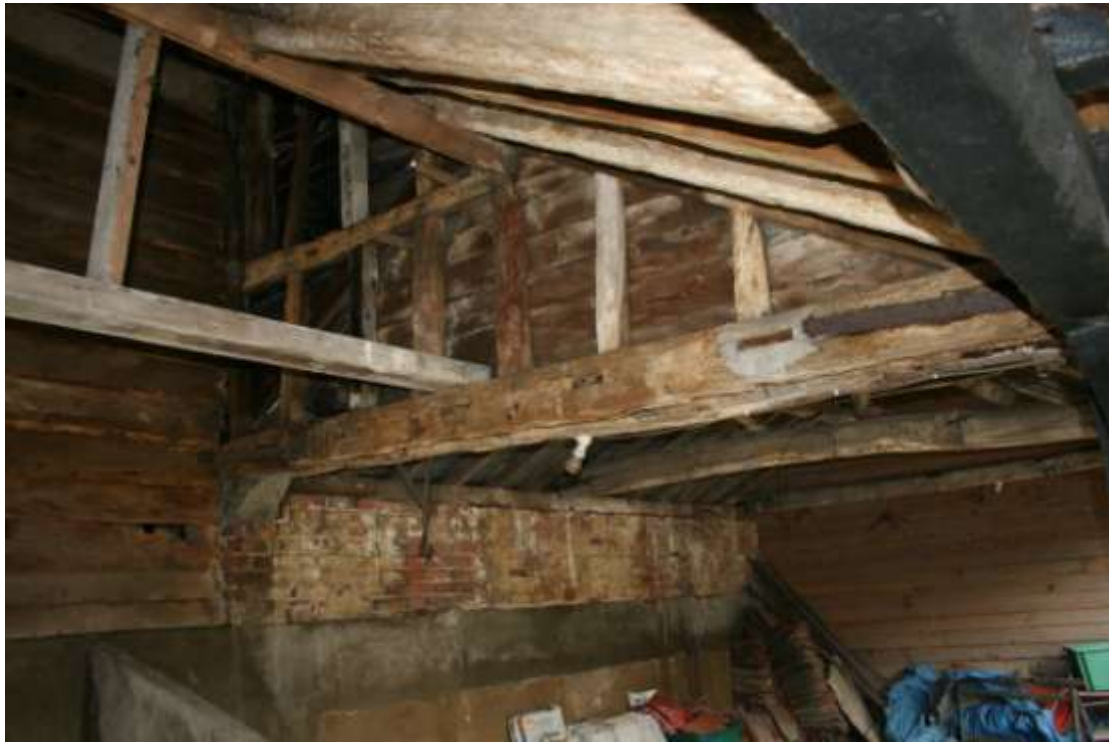
Post 3, Bay 3 has a double tie-beam and studwork partition. Looking SE.

The roof changes character in line with end of the Barn and it is evident that the Piggery has been extended. There is a double tie-beam. The northernmost one has weather-boarded studwork above and signifies the end of the earlier build. The tie-beam is secured with iron L-ties which are so corroded they may be mild steel. The beam also has mortices in its flank indicating it has been reused.

The wall beneath the double tie-beams has been rebuilt with grey cement pointing and an interesting concrete corbel. The rest of the wall is built of a variety of 60x110x210mm reds with creased faces and soft arrises set in white mortar and are limewashed. The southern part of the pig troughs below the brick wall was abandoned and filled with concrete to make a level raised platform.

The tie-beams on Posts 2 and 3 have a series of triangular rebates on the underside to nail studwork for partitions. The remaining nails are all C20th wire nails.

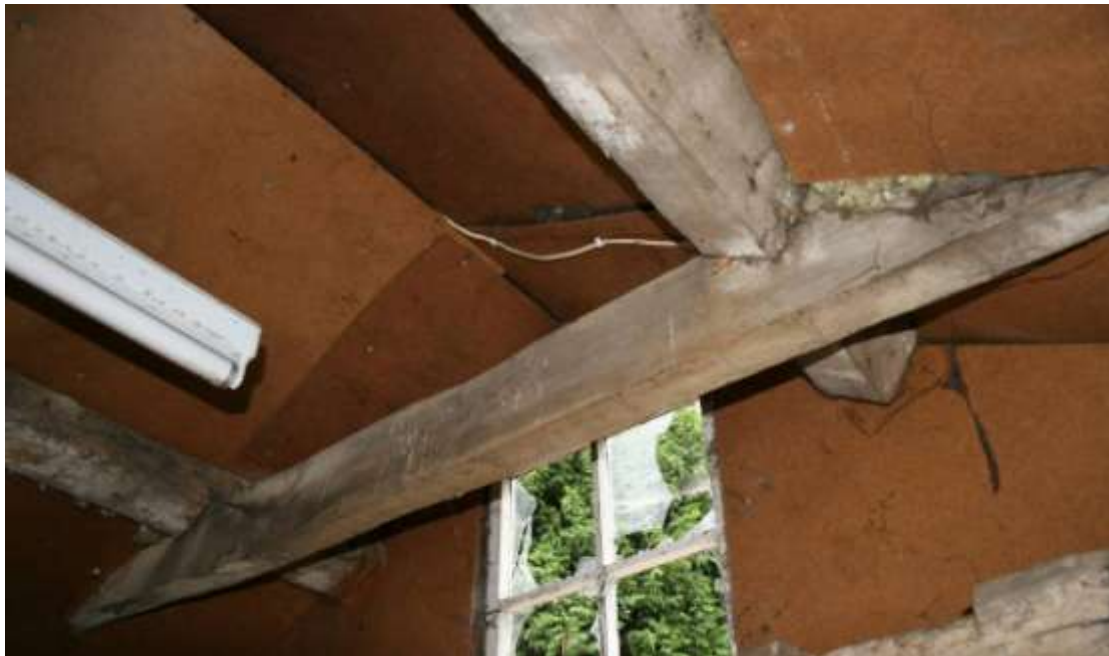
The collar in the stable/ office. Looking SE.

The roof structure in the stable/ office has been obscured by a layer of rockwool insulation clad with hardboard sheet. The walls are likewise treated and painted white. The room is no longer habitable.
