Historic Building Recording and Observation and Recording Report

St Mary's Old Church
Clophill
Bedfordshire

May 2016

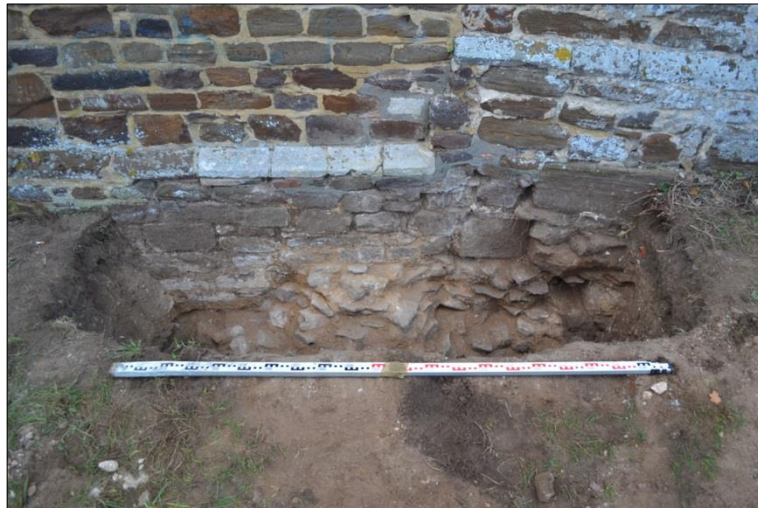
Plate 6: Eastern test pit showing earlier masonry below the foundation (Kenny 2011)

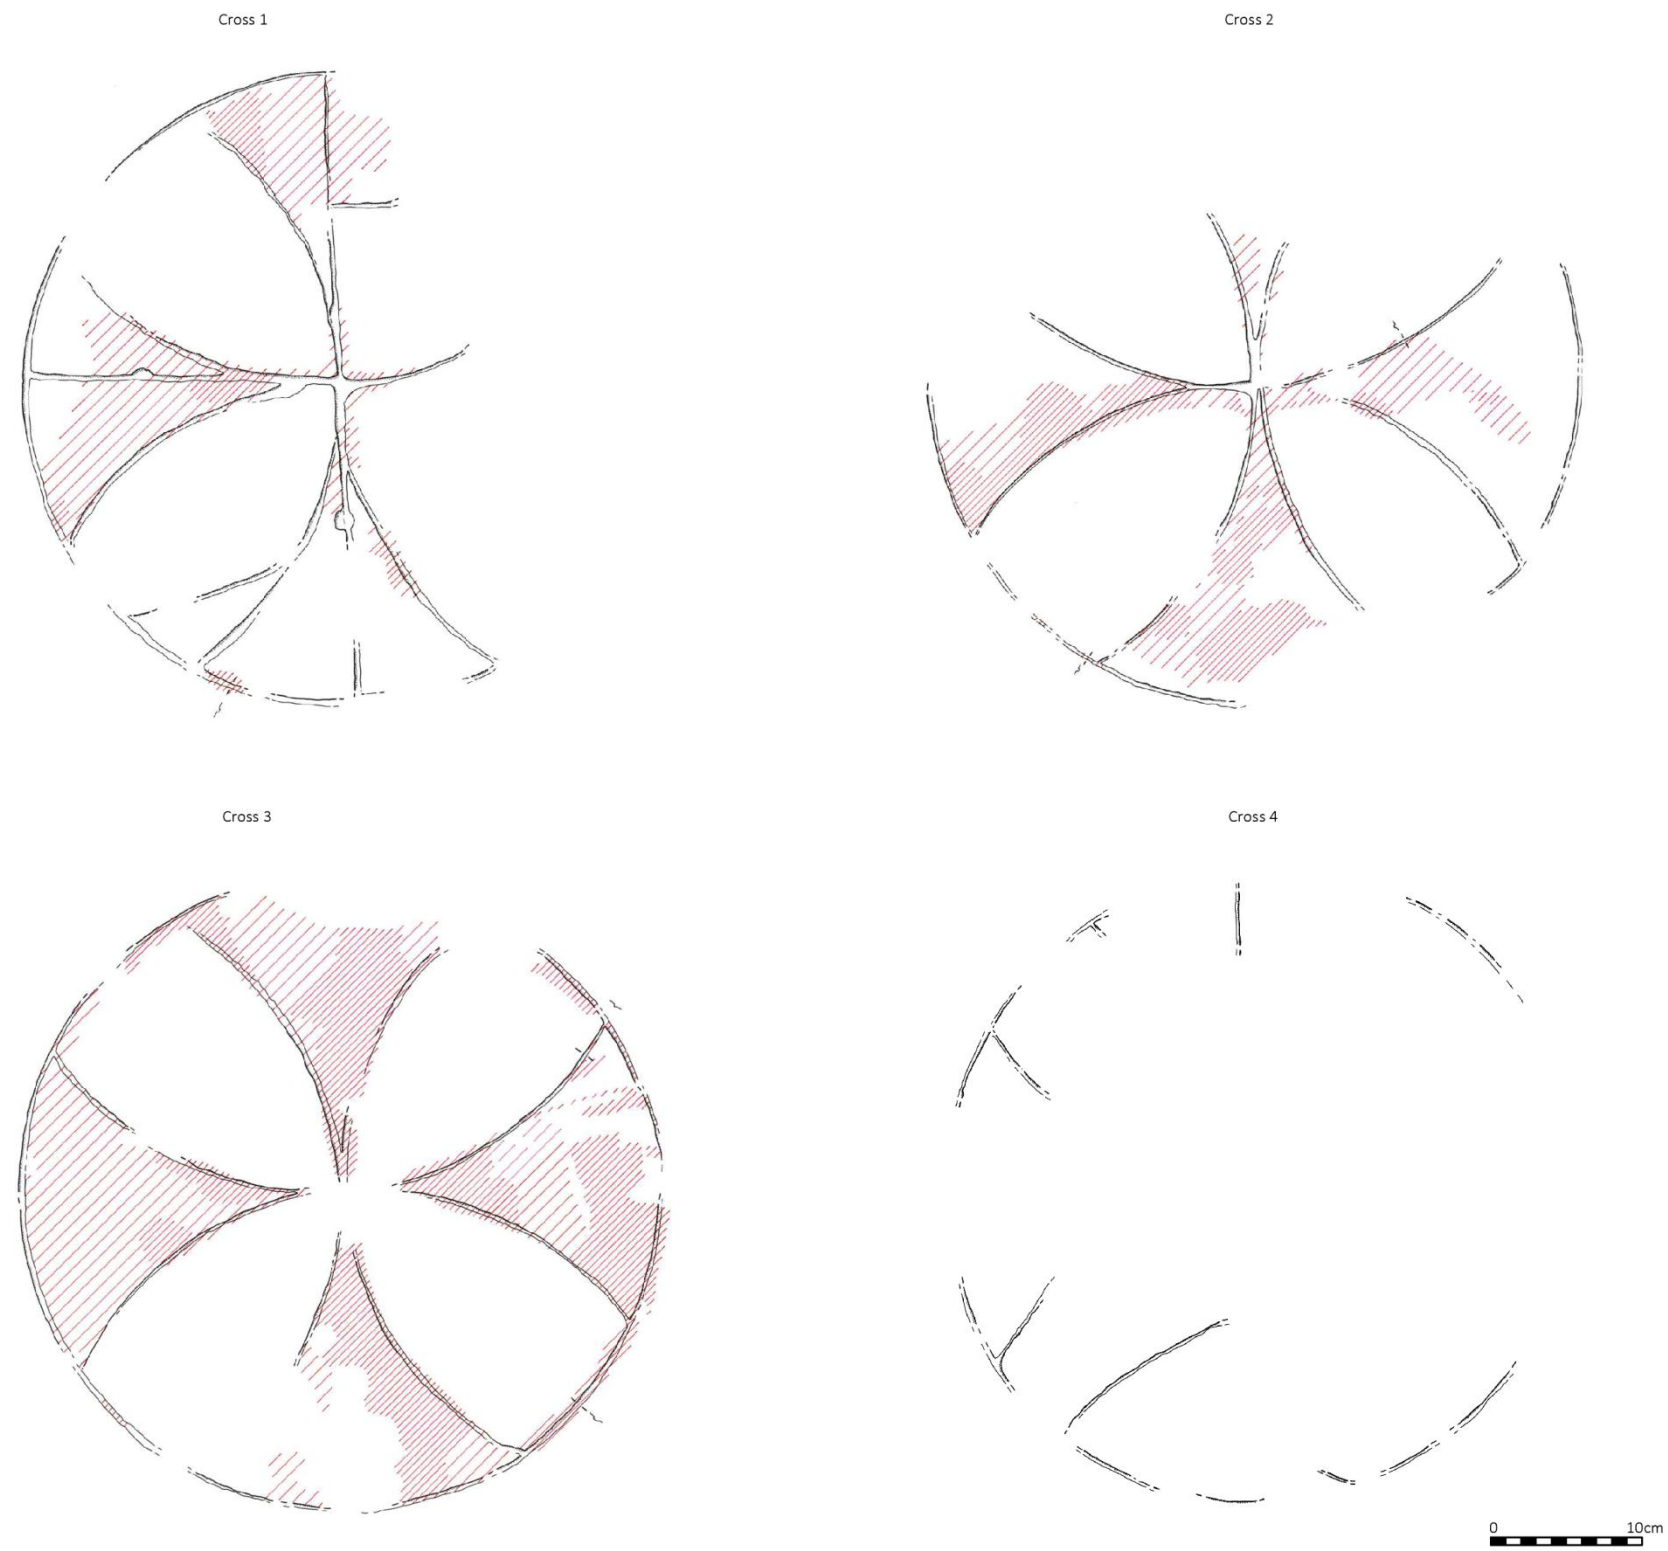
Figure 17: Consecration crosses (scale 1:5)

Three consecration crosses were exposed during the cleaning of the north wall and the faint remains of another was found on the south wall next to the door. None are complete. Indeed, Cross 4, which is on the south wall, comprises only a few lines. Traces of paint survive on the other three and all four of them are within an incised circle, but there the resemblance ends. Cross 1, which is at the eastern end of the north wall would have been 43cm in diameter, but the eastern side is lost (Plate 3). The central arms of the cross are painted white and these fan out a little way from the central point of the cross where they are painted red within a white border. Traces of green pigment are also apparent in places, but these are probably not part of the cross.

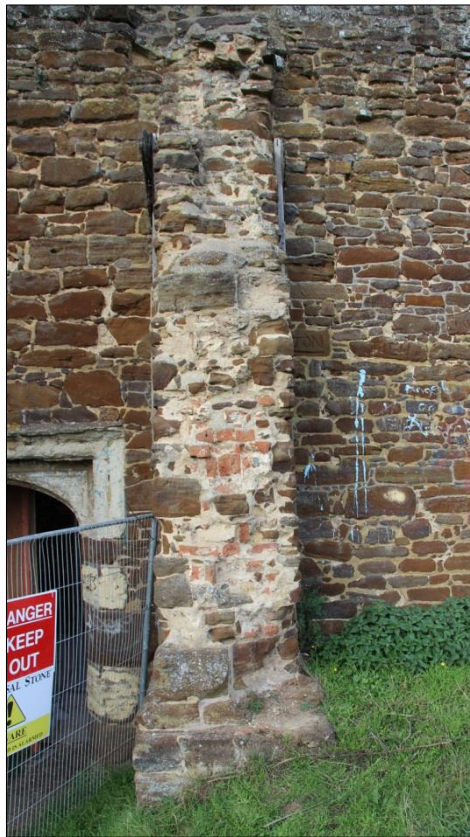
The ground has built up around the church with the result that the plinth is largely obscured and the south door is at a considerably lower level than the ground to either side. Excavations along the southern wall revealed modern cement repairs to the plinth, which was exposed to a depth of 350mm below the offset (Section 5 below). Post-medieval repairs to the buttresses were also revealed during the Watching Brief (Plate 8). The core of the buttress to the east of the south door was exposed, revealing hand-made red bricks with stone inclusions and Spanish. The bricks measure approximately 10-11cm wide by 6-7cm deep with a maximum length of 14cm. They are similar to those in the chancel arch, which have horizontal skintlings and measure 23 x 22 x 7cm and are likely to be 19th century. No bricks were present in the core of other buttresses, although not all were exposed.

Plate 8: Buttress detail showing brick pieces in the infill

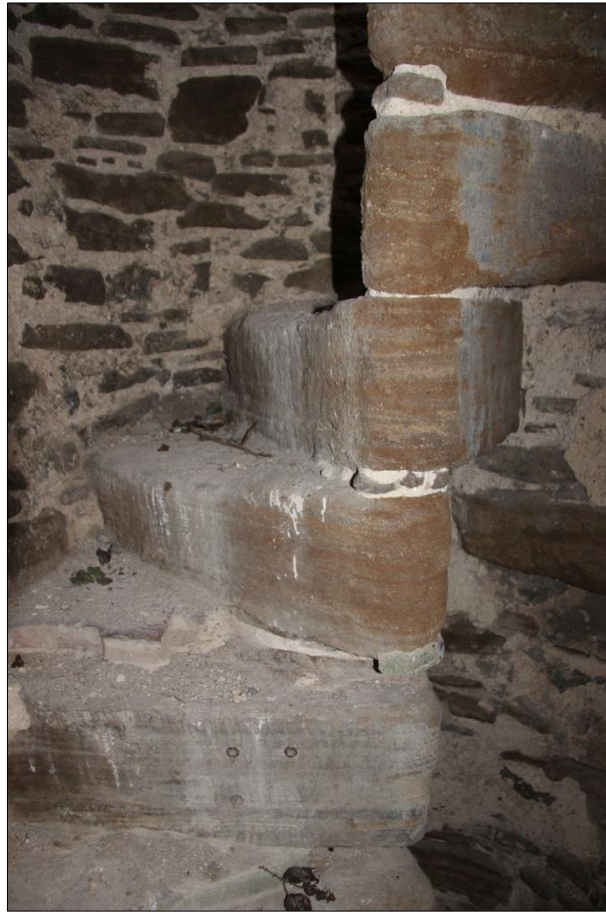
The stairs are also of ironstone and most of the treads are original (Plate 19-20). They are not rebated, nor do they have nosings and are built using around a newel rather than a shaft. Between some of the treads is a smaller stone, in other instances they are simply separated by a 2-3cm bed of mortar. Some of the treads have been replaced or added to, but these later additions are very narrow and poorly built. A concrete coating has been applied to some of the steps and further 20th century work may be indicated in the loss of the door, the tiled roof over the stair and what appear to be dislodged stones. This is most evident in the diagonal stones at the top of the stair, which would appear to have been the threshold for the original tower door except for the fact that they are not flush with the tower wall and there are three more steps beyond.

Plate 19: Detail of the treads

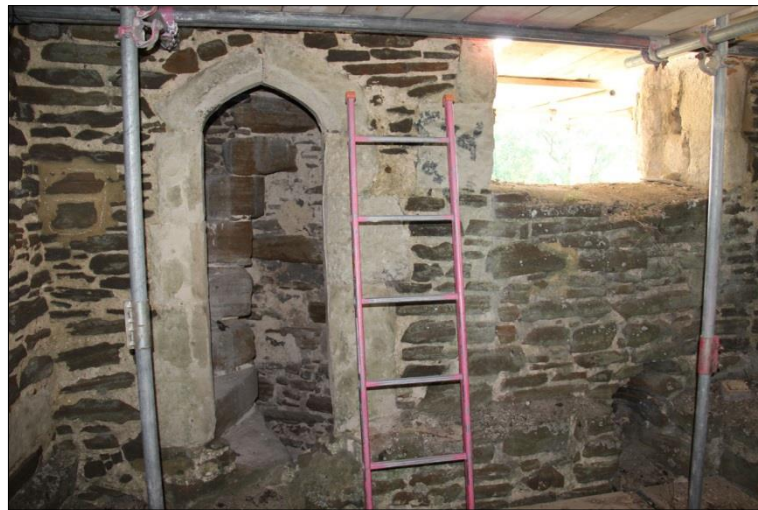
The original floor level in the bellchamber was indicated by the large putlog holes in the north and south walls (Figure 16; Plate 23). Another putlog hole, measuring 20 x 26cm was located to the right of the window and opposing putlog holes some 29cm high were observed at the eastern end of the north and south walls of the bell chamber. The tracery to the 2-light trefoiled windows in the bell chamber had only survived in the north window. The Totternhoe clunch was badly eroded, but sufficient remained to enable some reconstruction to take place (Figure 16; Plate 25-25).

Plate 23: Bell chamber, south wall

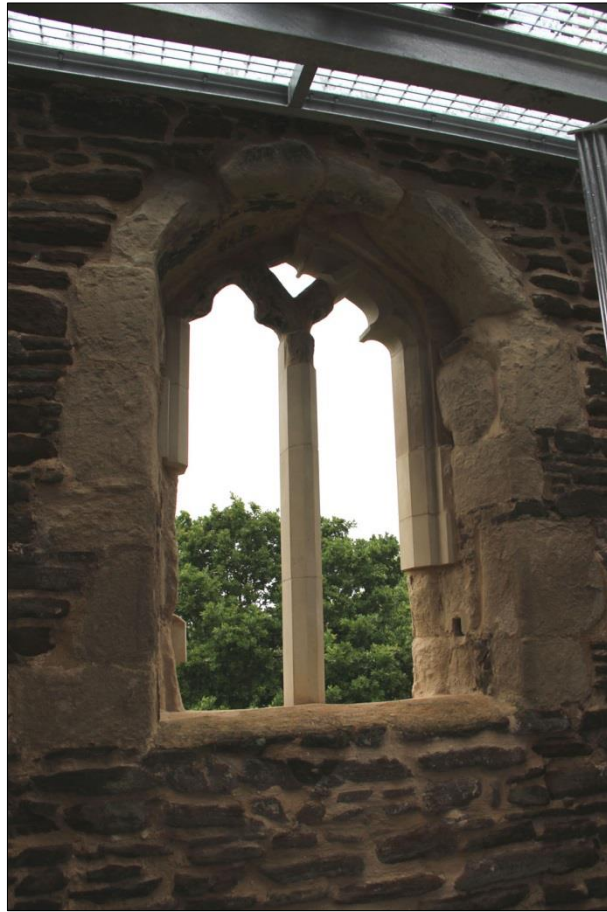
Plate 25: North window tracery restored

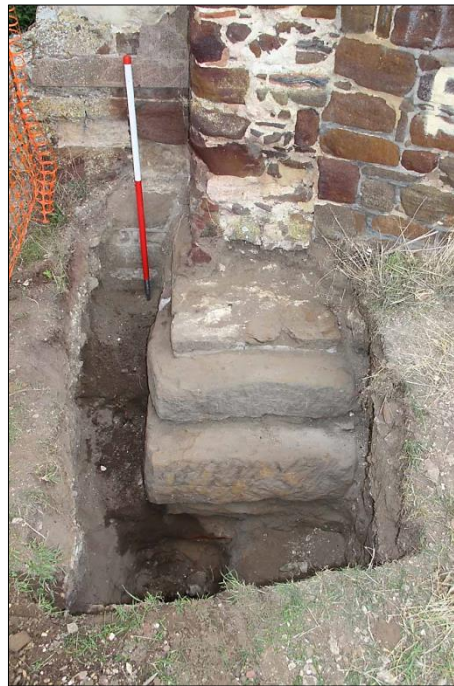
Plate 26: Test pit A: butters footings (104), looking N (1m scale)

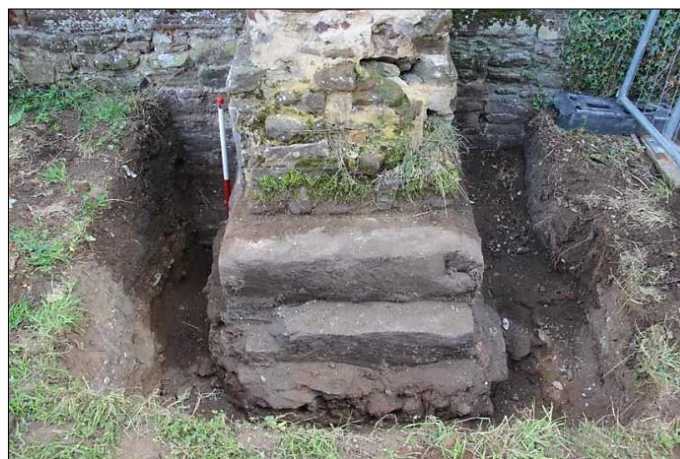
Plate 28: Test pit B: butters footings (104), looking S (1m scale)

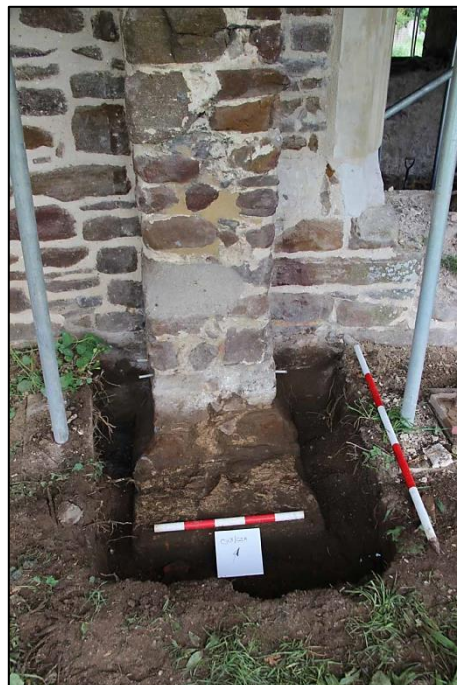
Plate 30: Test pit C: butress footings (104), looking N (0.5m and 1m scale)
