## Historic Building Recording

The Norman King Public House

Church Street

Dunstable

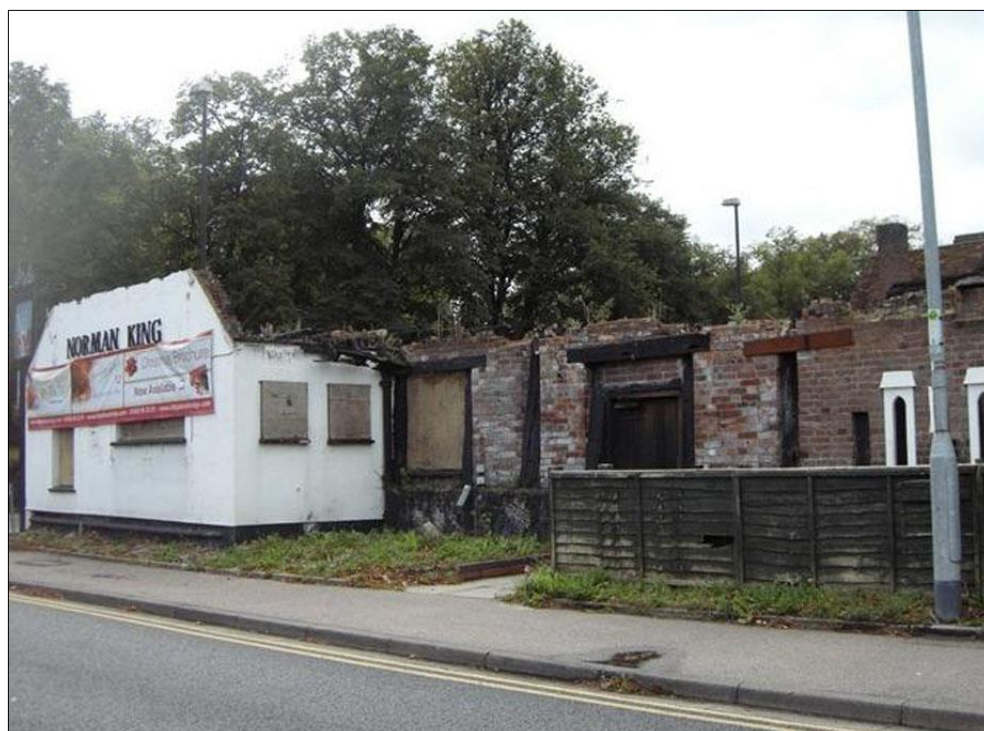
**Figure 15:** The southeast corner of the Norman King after the fire  
(Courtesy of [www.closedpubs.co.uk](http://www.closedpubs.co.uk))

The east end and the west wall of the structure are brick built (Fig. 15) the brickwork in the east wall being early 20<sup>th</sup> century. The west wall was exposed above the wallplate and is built of Fletton bricks that appear to be later 20<sup>th</sup> century.

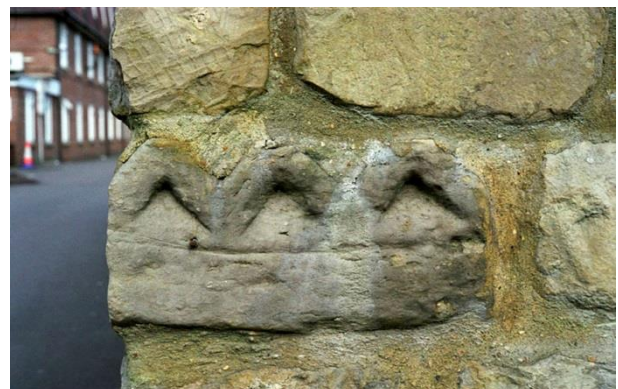
**Plate 6:** Detail of the re-used moulded stone

The stonework in the south elevation is painted internally, but photographs of the exterior show moulded stone having been re-used (Plate 6) alongside worked and unworked stone of various sizes and in various degrees of degradation. Some of the stones bear bolster marks, and others chisel marks though most have no tool marks whatsoever. Amongst the stone blocks are occasional tiles and bricks, all set in what appears to be lime mortar (Plate 7). The stonework to the west of the door, where a moulded stone fragment survives, appears to be 20th century. The available photographs appear to show the wall to the east of the door to be of at least two phases (Figs 17-19). The basal courses are rather distinct in both colour and structural form, and may be all that survives of a medieval wall. The stonework above is post-medieval but re-using medieval and later stone fragments. Later repairs and repointing are also evident in the photograph, and the wall was clearly breached to install the window.

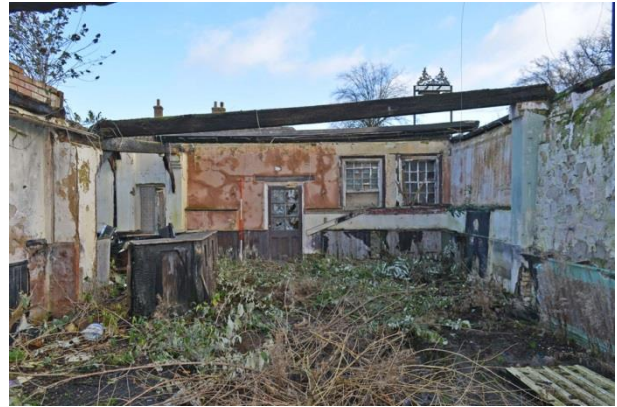
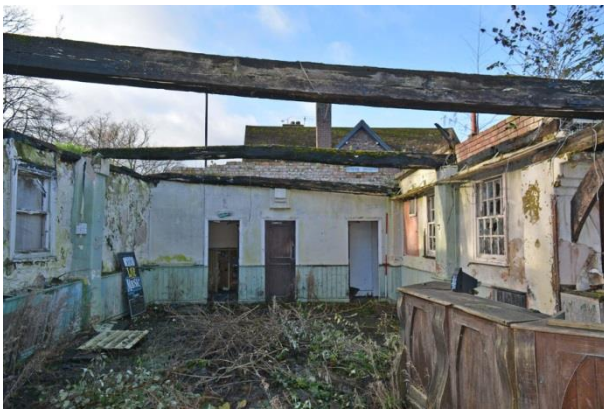
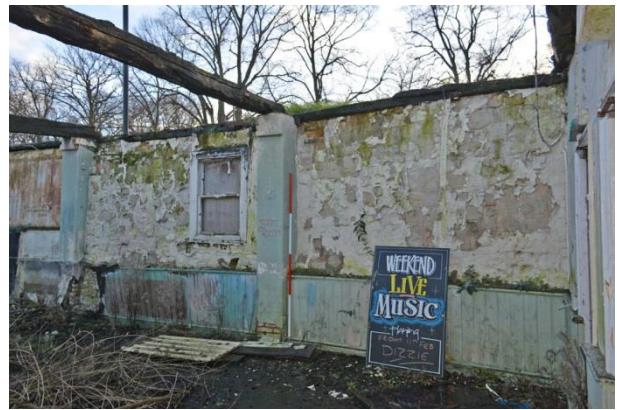
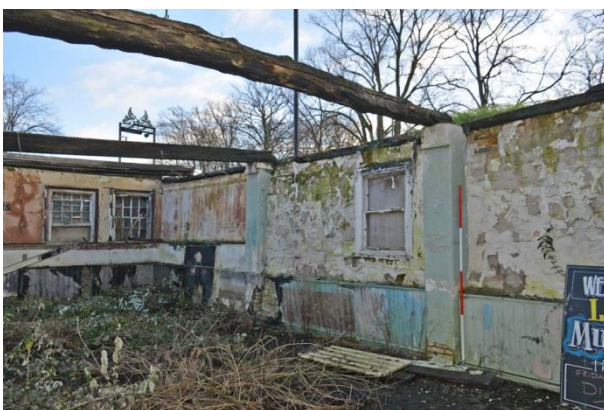
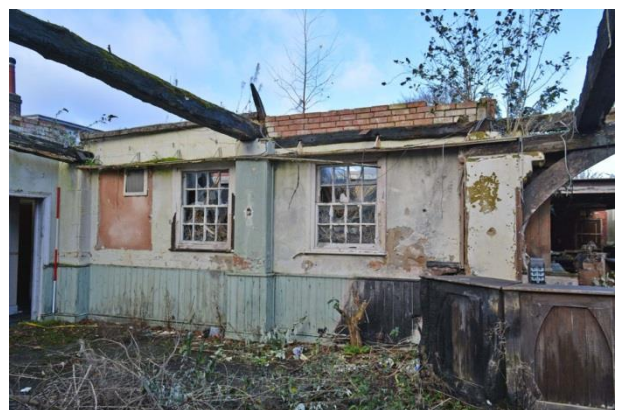
Internally little of the historic building fabric survives other than two north-south aligned binding beams and the wall plates (Plates 8-12). The eastern beam is supported by brick built pillars at either end, as is the east-west aligned beam above the bar (Plates 11-13). The present north wall has late 20<sup>th</sup> century Fletton brickwork above the wallplate (Plate 12) and either early 20<sup>th</sup> or possibly 19<sup>th</sup> century brickwork below. However, only a small area of the latter was exposed during the survey making identification difficult. A post medieval iron tie was observed at the western end of the northern wallplate.

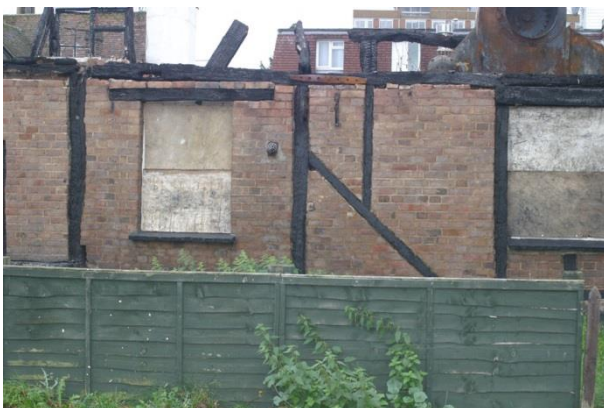
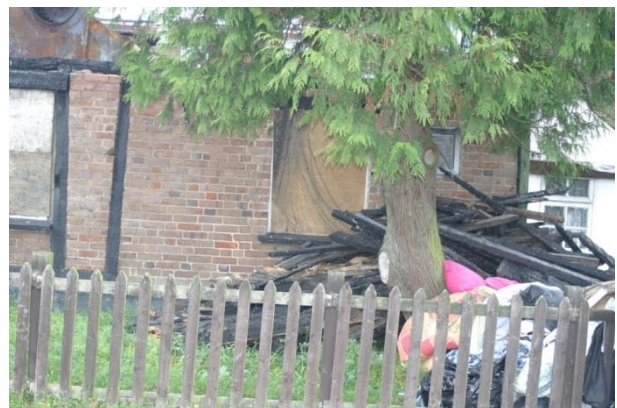
The timberwork in the southern part of the wall is fairly substantial with the posts to north and south of a reproduction plank and batten door measuring 24 and 26cm wide respectively (Plate 14). Both posts are re-used; the southern one has redundant stave holes and appears to have been cut to lean. Because the timberwork leans inwards, the lower part of the studs to the north of the door can only be seen on the outside and the upper part on the inside, where the internal bracing is also exposed along with the wooden pegs and redundant mortices (Plates 15-16 & 24). The wall itself is 27cm thick and is breached by 4 lancet windows, which are clearly a later insertion (Plate 15-16). The timberwork at this end of the range has internal bracing, which would suggest a date of c.1500, whereas that to the north of it is likely to be of 18<sup>th</sup> century date (Plates 17-18).

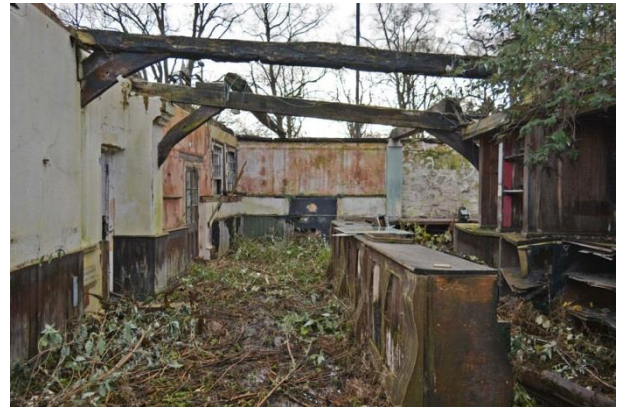
Plate 20: View northwards from Room G3

To either side of the main entrance in G3, the bar area, are two east-west aligned beams. Both are braced and the southern one is supported on brick pillars (Plate 20). This is a modern insertion, but the northern one appears to have a modern brace on an earlier post and beam. To the north of this is a substantial timber post with a redundant mortice for a brace (Plate 21). Both the brace and beam have been replaced by steelwork. Fletton brickwork is evident in the west wall of G3 and is indicative of late 20<sup>th</sup> century work (Plate 22).
