KDK ARCHAEOLOGY LTD

## Archaeological Observation and Recording Report

Church of St Mary the Virgin  
Stotfold  
Bedfordshire

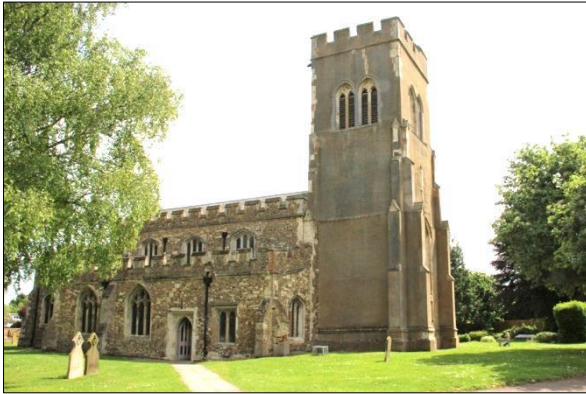
Plate 1: Initial survey, north elevation and tower (1)

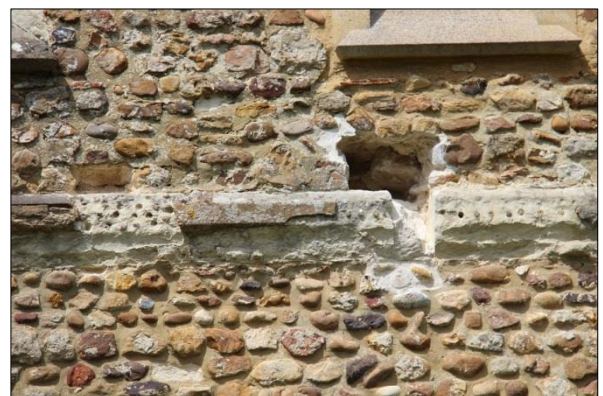
A great many of the stone mouldings around the building had suffered serious degradation, whether due to environmental erosion or due to inadvisable past repairs. Among the most severely affected areas were the string courses of the north and south aisles and the south porch. These were missing in sections and, in some instances, had been entirely replaced cement render, which in turn had failed. Holes had been artificially made in the deteriorated stone behind in order to key the cement render mouldings, however this had failed to prolong the life of the repairs (Plate 12).

Plate 12: Initial survey, south aisle string course (28)

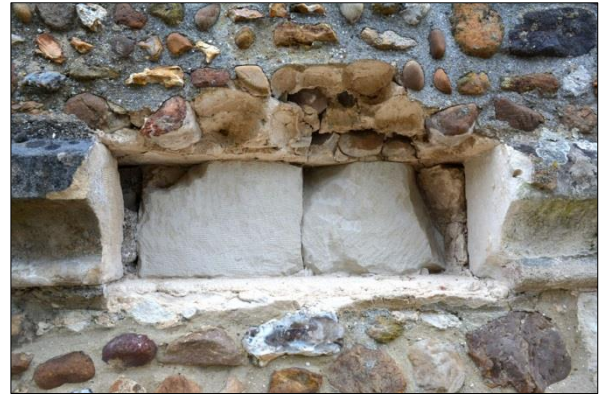
**Plate 14:** Watching brief, exposed clunch in north aisle string course (39)

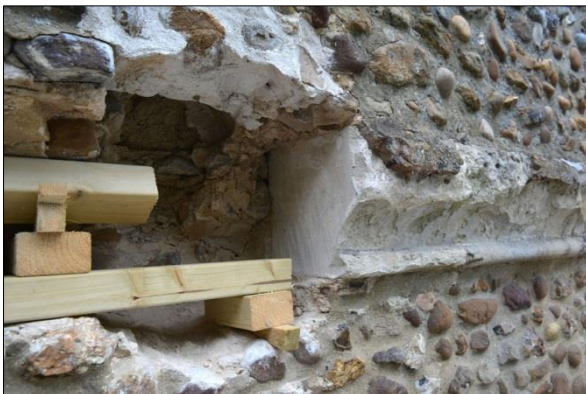
**Plate 15:** Watching brief, exposed clunch in north aisle string course (36)

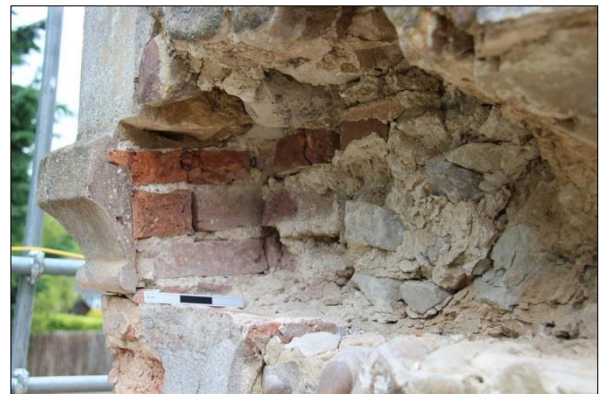
**Plate 16:** Watching brief, exposed brick in north aisle string course (47)

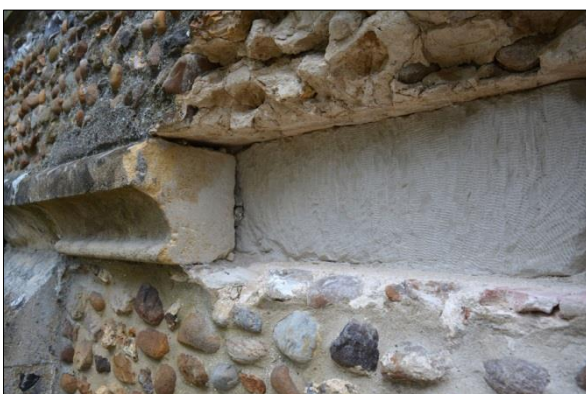
**Plate 17:** Watching brief, Lincolnshire limestone in north aisle string course (37)

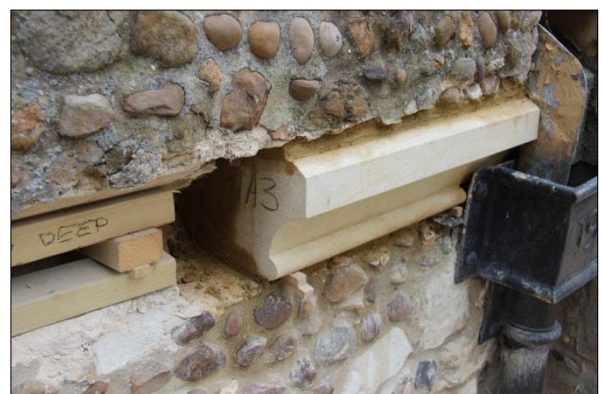
**Plate 18:** Watching brief, new Clipsham stone in north aisle string course (46)

The use of Clipsham stone to make the repairs during this project has proven to be a worthwhile choice, in contrast to the past use of unidentified, coarse Lincolnshire limestone in the string courses. Clipsham has a similar appearance to the original clunch but is more resilient. The final result is pleasing and makes immeasurable improvement to the exterior of the building. The new quoins, string courses, window surrounds and parapets are sympathetic to the aesthetic of the church and are a welcome alternative to cement repairs that existed previously.

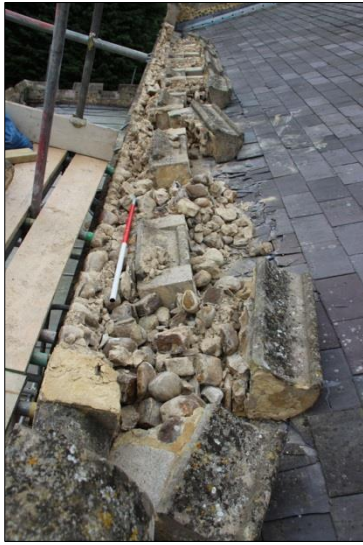
The subsequent site visit was made following the collapse of the north nave parapet wall onto the nave roof (Plate 19). It had been 23cm (9 inches) in width and had consisted of cobbles set in lime mortar with limestone copings. Inspection was made of works to the south aisle and porch. The west parapet wall of the south aisle, constructed of brick with cement render (Plate 20), was removed down to the string course, revealing a 19cm high course of clunch behind beneath a brick wall in roughly consolidated cement mortar. The red bricks were poorly puddled with stone inclusions and measured 21 x 10 x 6cm. They likely dated to the early 19<sup>th</sup> century and had been reused (Plate 21). Further east along the south aisle, the parapet wall was not removed but the string course was repaired using the same methods used for the north aisle. The removal of sections of the string course as well as much of the cement render revealed that its past treatment had evidently been similar to its counterpart on the north aisle. Sections had been repaired with a cement moulding adhered to roughly dressed clunch stone, or had been wholly replaced with red brick and cement (Plates 22 and 23).

**Plate 19:** Watching brief, collapsed north nave parapet (48)

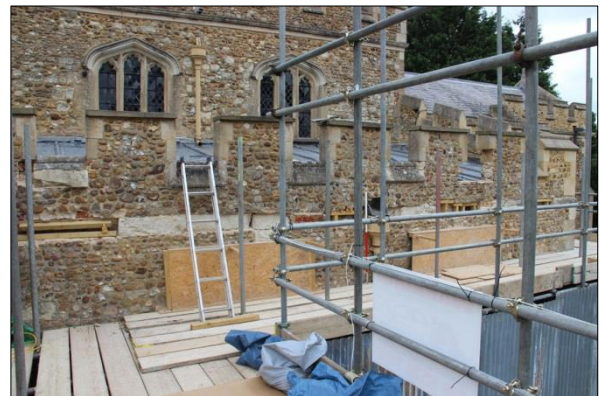
**Plate 22:** Watching brief, south aisle string course (56)

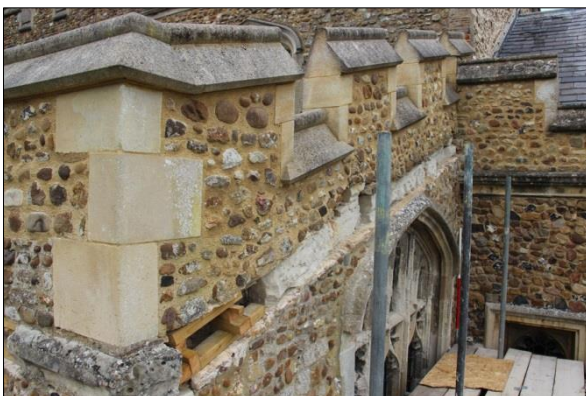
**Plate 23:** Watching brief, south aisle string course (57)

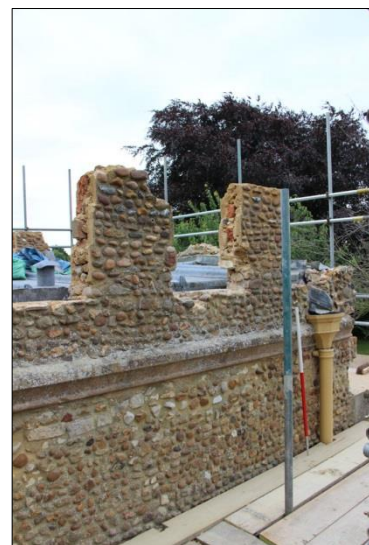
The parapet wall of the south porch was stripped of its coping stones so that past cement repairs could be removed. Once the cement was removed from the sides of the battlements, it was clear that they predominantly consisted of brick infill, although they were cobbled on the exterior (Plate 24). Removal of material from the southeast corner above the string course showed a cement core in the wall and also highlighted that much of the lead flashing to the roof had been wrongly installed. In addition, handmade nails dating to the 18<sup>th</sup> century had caused rust-jacking to the clunch quoins, no doubt aided by the ingress of moisture from the poorly installed lead flashing. Removal of the quoins also showed that parts of the string course contained brick, as also seen on the north and south aisles. It was also observed from the scaffolding that the roll-top moulding on the southeast corner did not align properly with the corners of the quoins above, in contrast to that of the southwest corner, which was in alignment (Plate 26).

**Plate 24:** Watching brief, south porch stripped parapet wall (51)

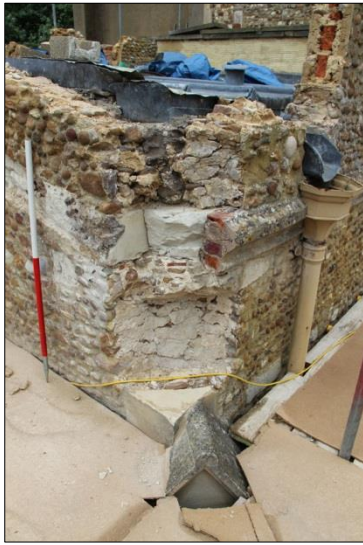
**Plate 25:** Watching brief, southeast corner of south porch (55)

Replacement of the limestone quoins to the corners of the south porch was required, following damage caused by rust-jacking. This is a process whereby the rusting of iron fixings between stone pieces causes the metal to expand, subsequently cracking the stone around them. In this case, it was most likely caused by the ingress of water from poorly installed lead flashing on the porch roof. This caused some 18<sup>th</sup> century handmade nails to rust, and the limestone to blow. Below these quoins, it was observed that the roll-top moulding above the buttress on the southeast corner of the porch was out of alignment with the quoins. The reason for this is unknown but it could reasonably be assumed to be a mason's error.

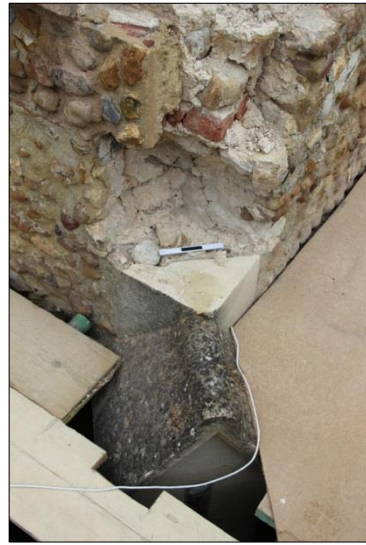
**Plate 26:** Watching brief, southwest corner of south porch (53)

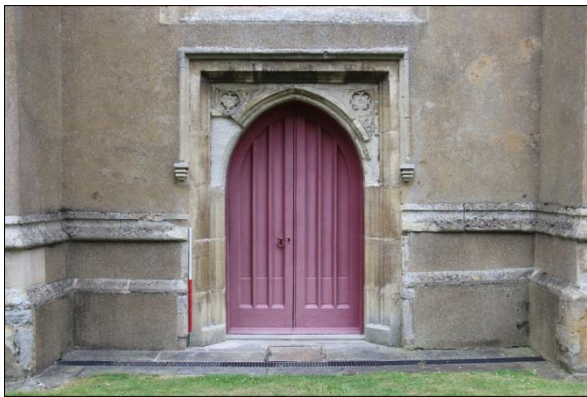
**Plate 27:** Watching brief, mouldings removed from west doorway (58)

Sections of mouldings were also removed from the arch around the west door of the church, in preparation for later replacement (Plate 27).

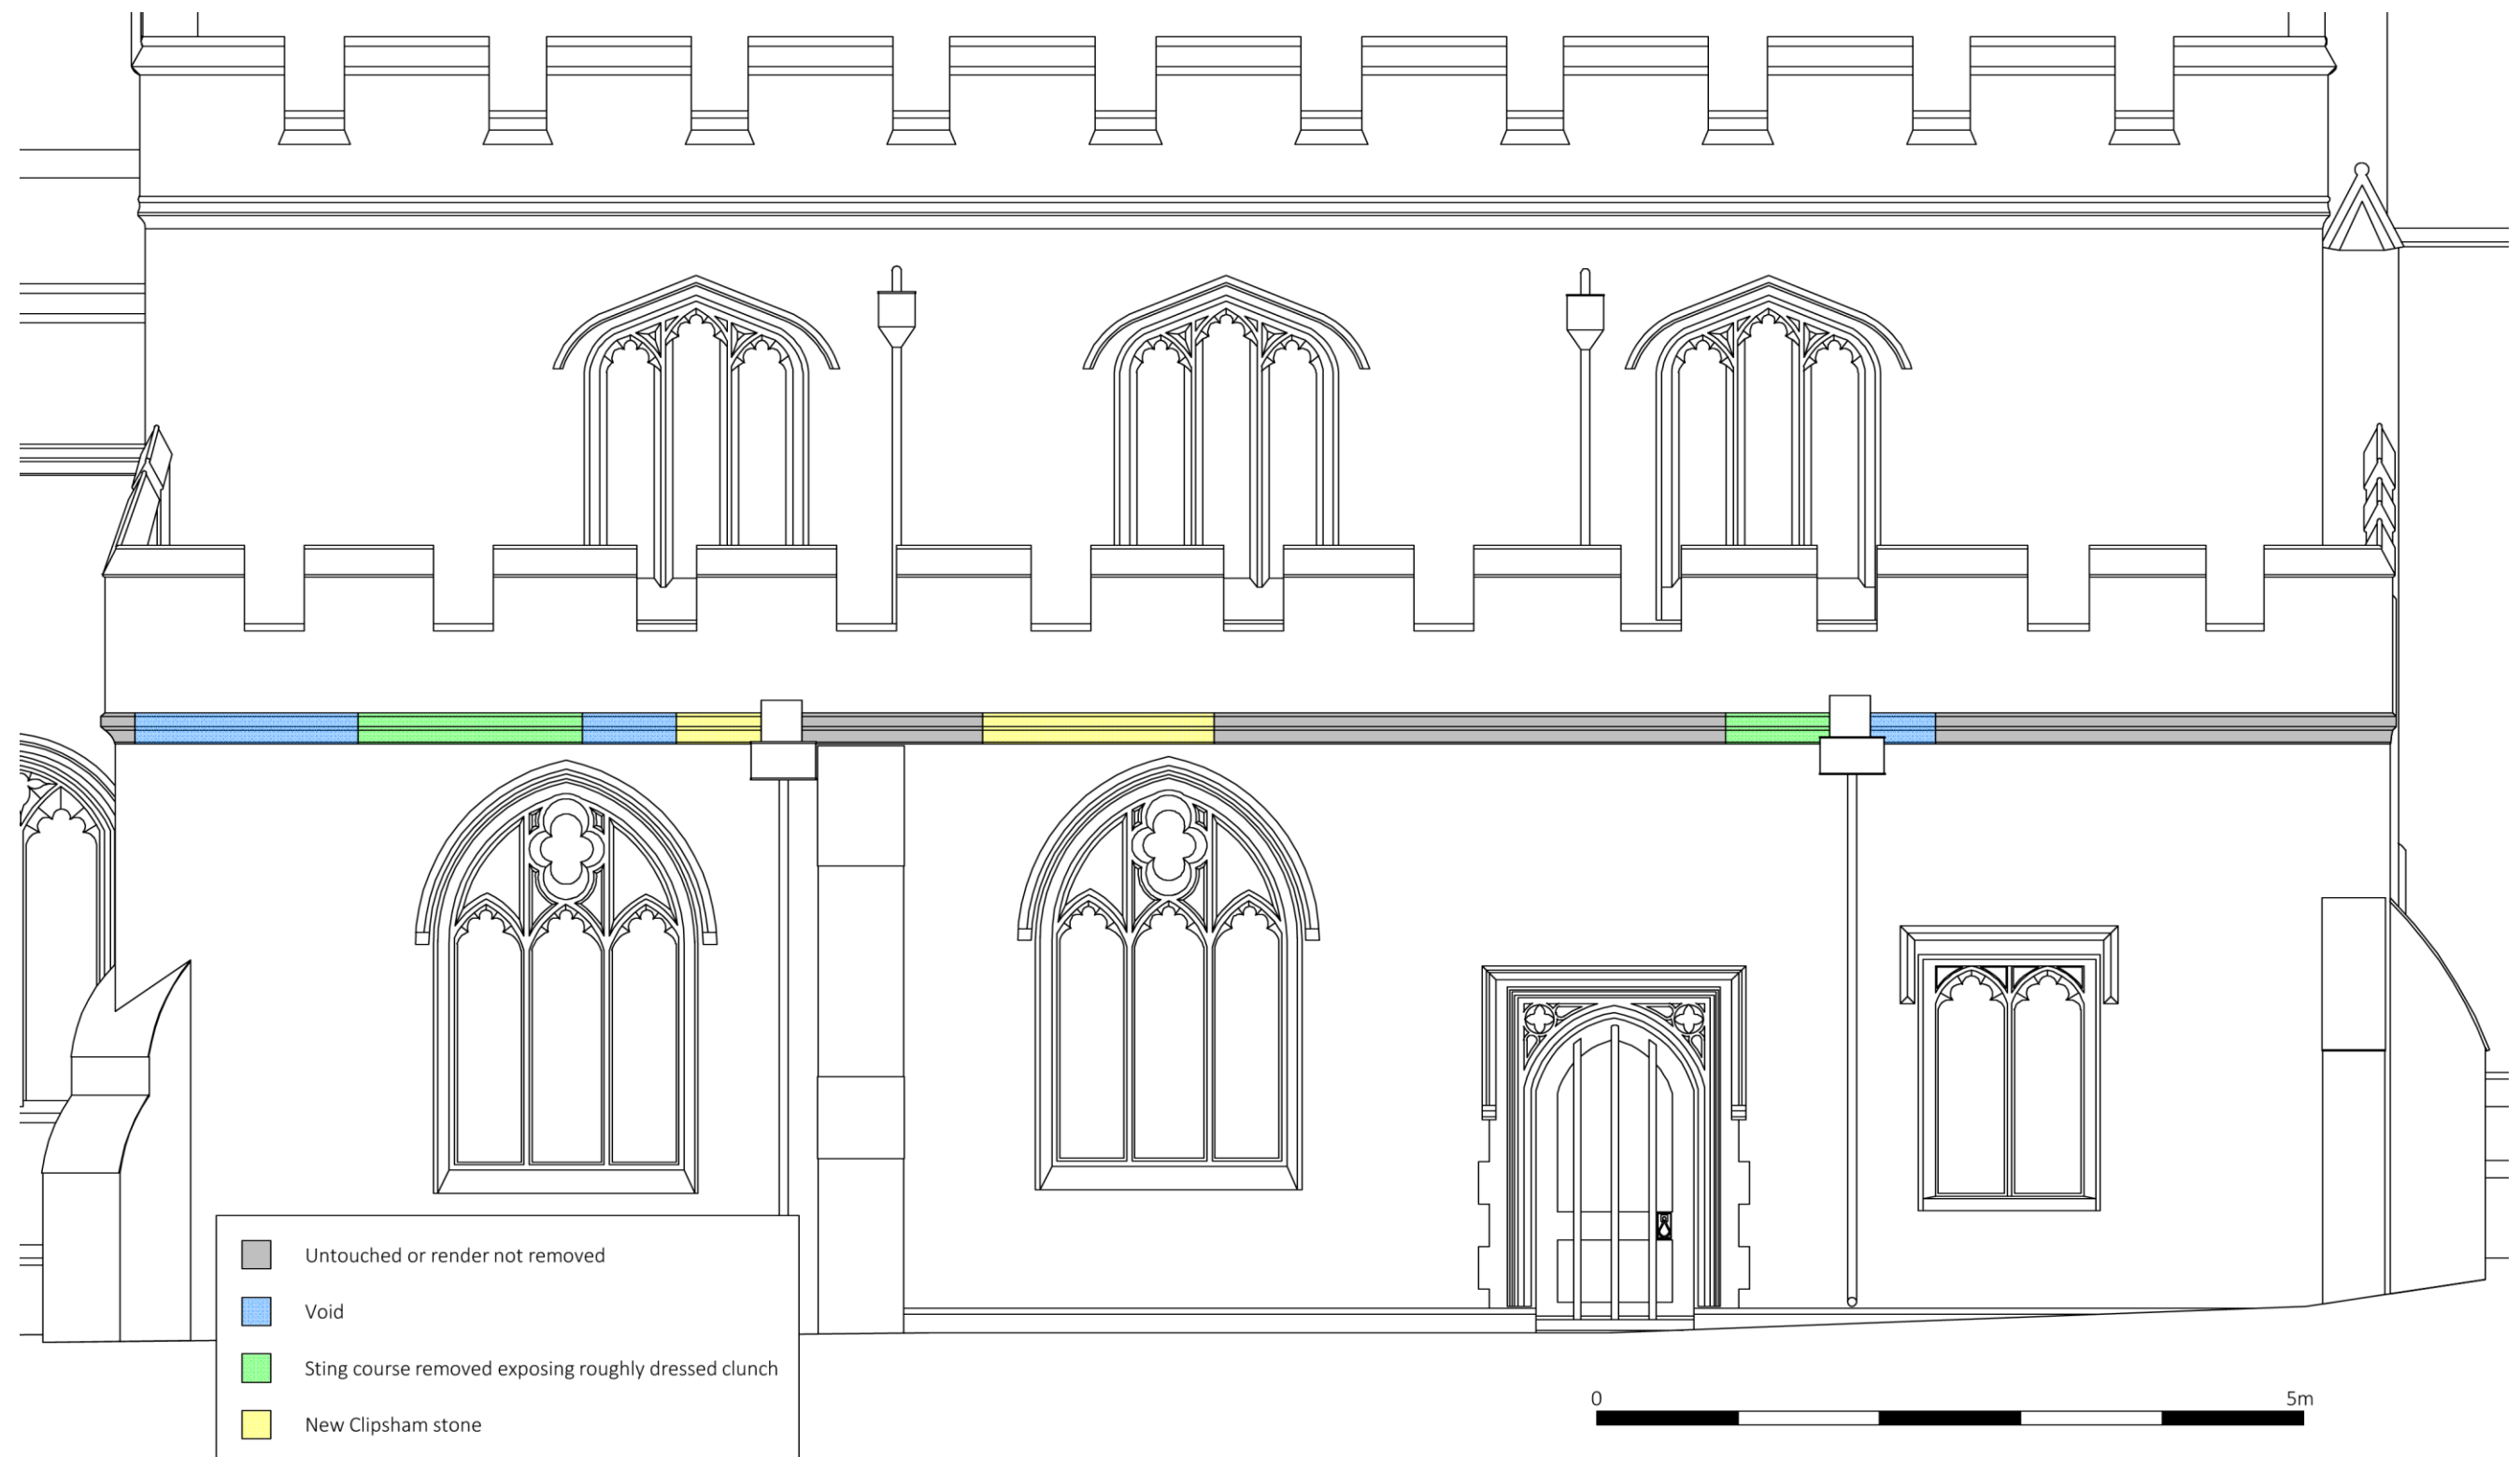
Figure 7: North aisle string course during watching brief (scale 1:50)

Following the erection of scaffolding a site visit was made to inspect exposed historic fabric in the string course of the north aisle. The removal of sections of the string course revealed that the mouldings were composed of a range of materials and had been repaired in a number of different ways. In general, large pieces of the original clunch still survived behind the front mouldings, roughly dressed and bearing the marks made by claw chisels (Plate 14). Some clunch still survived in the string course moulding, revealed by the removal of cement render. These pieces had been degraded and their mouldings subsequently reformed with cement (Plate 15). The same technique had evidently been applied in other areas, except that the original clunch was replaced with red brick in lime mortar and covered with a cement moulding, particularly at the east corner of the north aisle string course (Plate 16). Other pieces of the string course were revealed in profile to be distinct from the original clunch stone, in some instances they were composed of an unidentified but coarse and shelly limestone (Plate 17), and in other instances appeared to be examples of Lincolnshire limestone, possibly Weldon or Ancaster. New sections of the string course were installed using Clipsham stone (Plate 18), from the Lincolnshire Limestone Formation, which is commonly used for restoration work where other limestone has failed or significantly deteriorated (Hunt 2015). Figure 8 shows the restoration work to the north aisle string course.
