Heritage Asset Appraisal

The Dolphin Inn
Leighton Road
Stoke Hammond
Buckinghamshire

December 2017

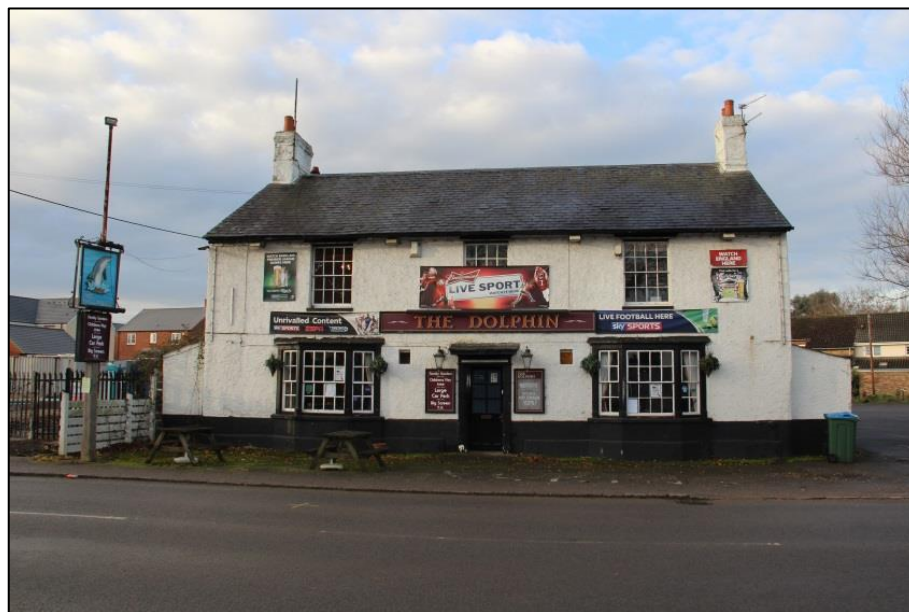
Plate 1: Shot 1. East elevation

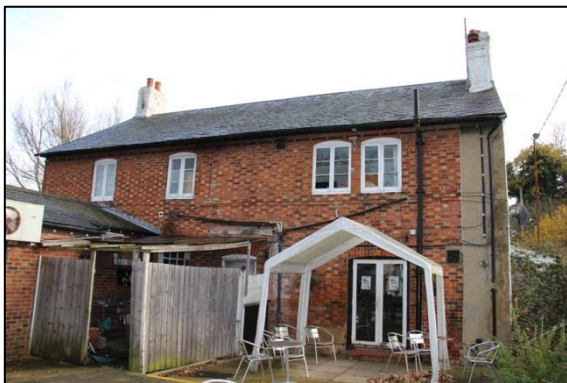
Project No: 337/SHD	Project: The Dolphin Inn, Stoke Hammond	Elevation: West
<p>* Brick 21.5x6.5x10.5cm. Some horizontal skintlings. Flemish bond. Lime mortar repointed in cement. Glazed headers</p>		
Recorder: KK	Survey Date: 16.11.17

Plate 6: Shot 8. West elevation

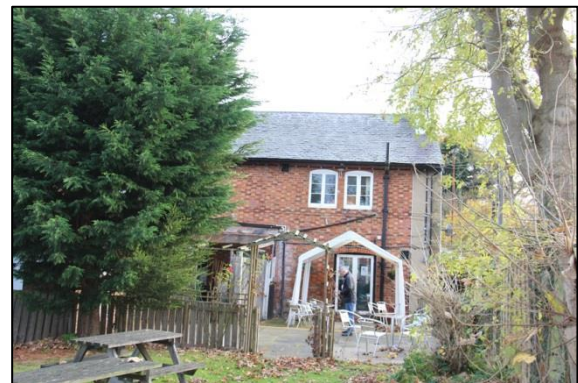
Plate 7: Shot 7. West elevation

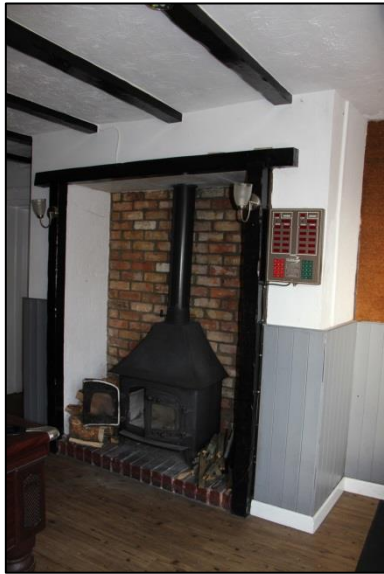
A smaller bar (Room G3), which gives access to the cellar in the modern extension beyond, lies to the north of the entrance lobby. This has a fireplace with a wood burning stove set within a timber framed recess in the north wall. The timber frame and the ceiling beams are modern additions.

Plate 22: Shot 23. G3 fireplace detail

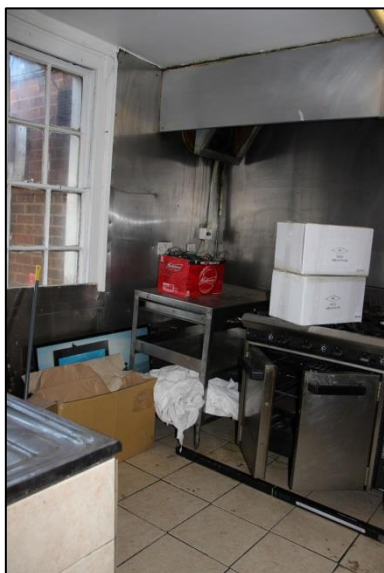
To the rear of the building is a kitchen (G4), the walls of which have been entirely covered in stainless steel. This is accessed by a narrow passage (G5) that also provides access to the first floor living quarters.

Plate 24: Shot 24. G4 Kitchen, northwest corner

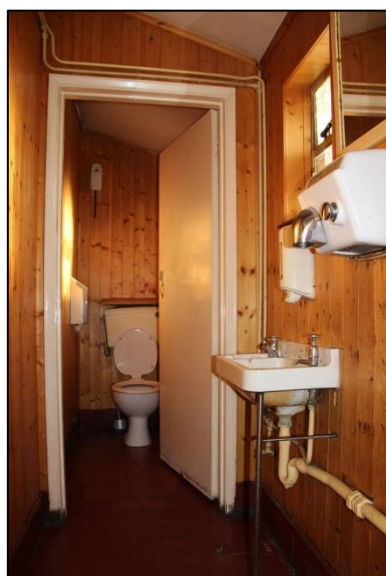
Project No: 337/SHD	Project: The Dolphin Inn, Stoke Hammond	Room no: Ladies WC
Location: Ground floor		Function: ladies toilet
Wall form & decor: Wooden panelled walls		
Ceiling / roof structure: Painted plasterboard		
Windows: Crittall type top venting windows one in each compartment		
Doors: Flush door to bar and another between the WC and the wash room. A door opening between the entrance and washroom has a moulded doorframe.		
Floor: Quarry tiled. Modern wood floor in the entrance area to the west		
Fireplace: None		
Staircase: None		
Other architectural details: 3 separate spaces, entrance, wash room and WC. Damp in west corner		
Recorder: KK		Survey Date: 17.11.17

Plate 29: Shot 16. Ladies WC, looking east

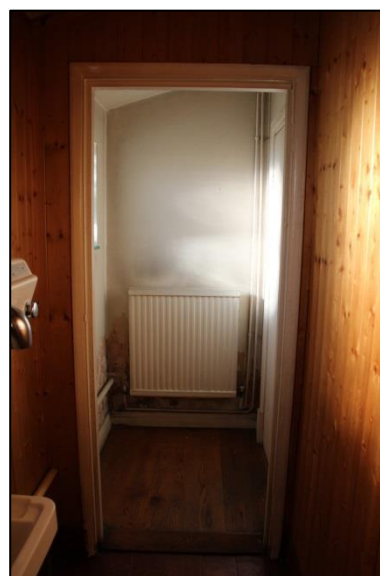
Plate 30: Shot 17. Ladies WC, view to entrance

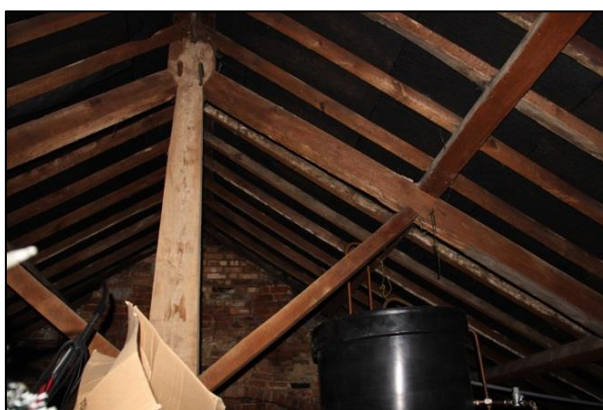
Potentially the oldest surviving feature in the building is in the roof space. The roof is supported by two substantial king post trusses supporting two trenched purlins on either side. The rafters appear to be machine cut, but the trusses are earlier and, given the dearth of architectural features pre-dating the mid 19th century, may have been re-used.

Plate 58: Shot 56. King posts in loft, looking south

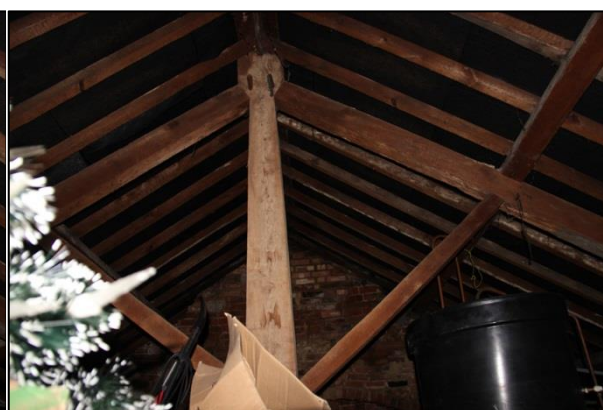
Plate 59: Shot 57. King posts in loft, looking south

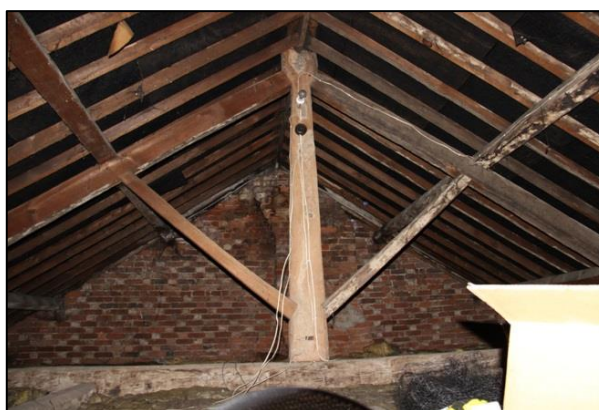
Plate 60: Shot 58. King posts in loft, looking north
