KDK ARCHAEOLOGY LTD

Historic Building Watching Brief

St Michael and All Angels' Church
High Street
Shefford
Bedfordshire

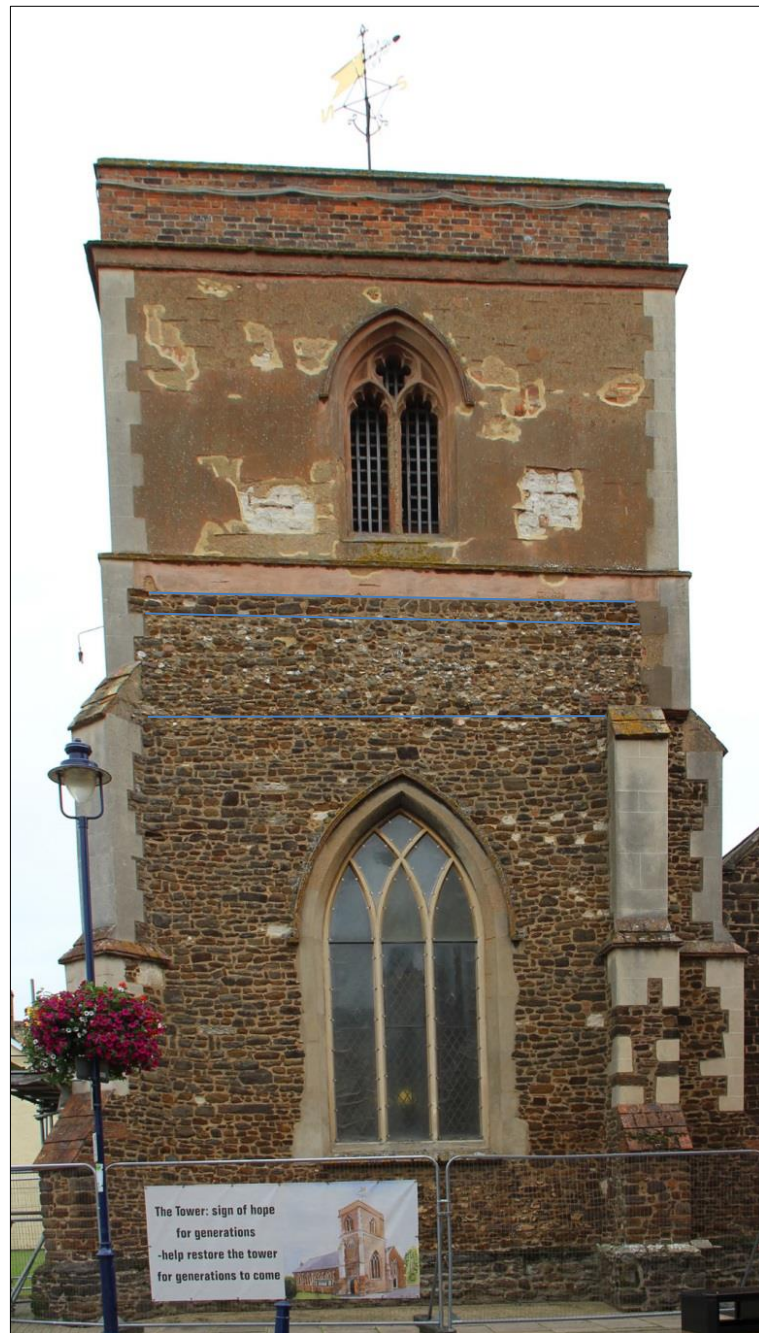
Plate 6: West face of the tower

The brick built parapet at the top of the tower is not rendered. The bricks measure 22 x 10 x 6.5cm (8½ x 4 x 2½ inches), and are the same as in the exposed part of the west wall, which appear to have the most diverse fabric including tiles laid flat against the original clunch as well as fairly substantial brickwork at the southern end.

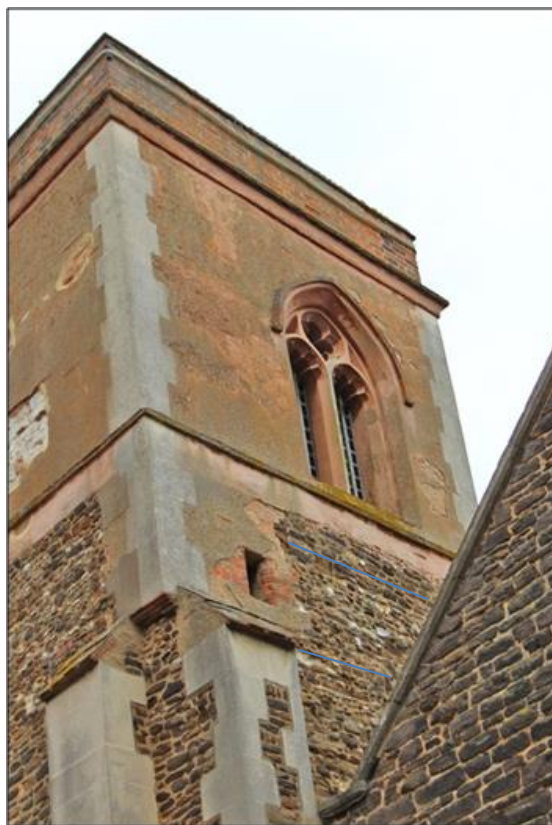
Plate 7: Repairs to the southwest corner

Within the upper lift in the south elevation are two circular arrangements of stone, which are unlikely to be putlog holes as they are not aligned correctly for that. There is also a small brick built opening that has been rendered at the western end of the south elevation, no doubt to light the staircase within (Plate 7).

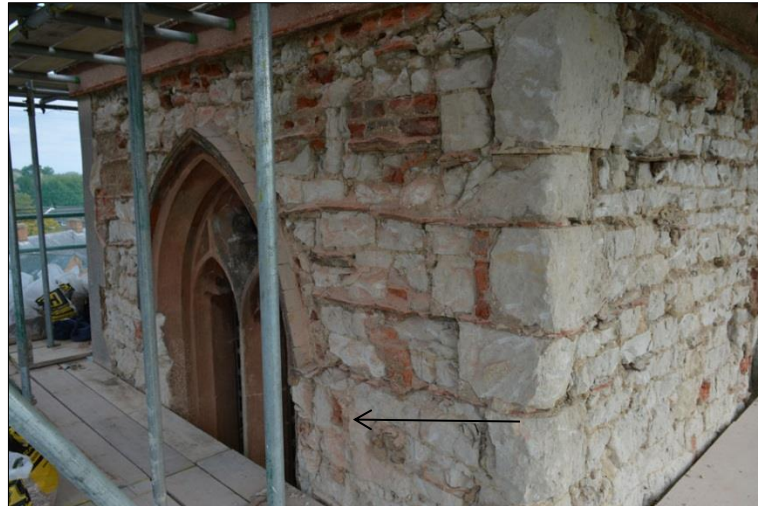
Plate 8: North and west elevations, upper level putlog hole indicated by arrow

Later brick repair work was evident to the east and the west of the window (Plate 8). The bricks to the east, where a piece of ironstone had also been inserted, had horizontal skintlings and were possibly re-used 19th century bricks. The western bricks were still partially covered in mortar and less clear, but not is not unreasonable to assume that they are of the same date.

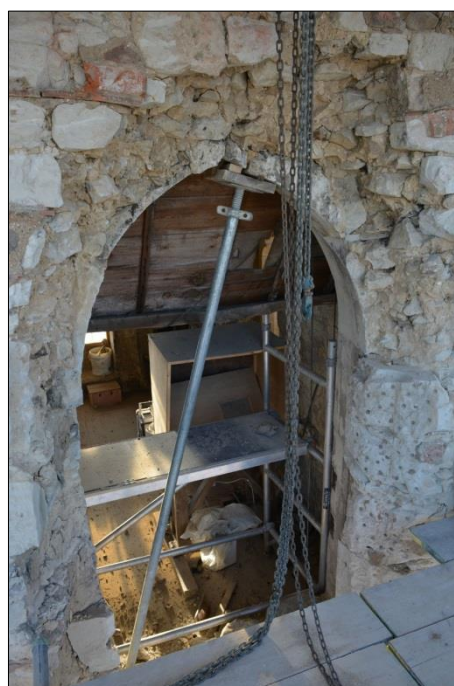
Plate 10: North window opening

When the window had been removed, the clunchwork inside the opening was revealed showing large key holes in the ashlar stonework in the jambs and chalk rubble in hard, stony mortar making up the wall above the window (Plate 10). Similar work had apparently been evident in the east window when the tracery had been removed.

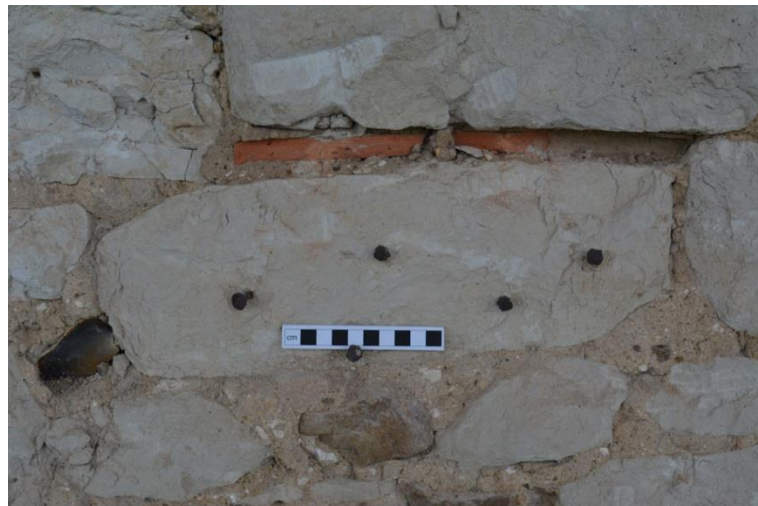
Plate 13: Detail of tile insert above and nails inside clunch piece

This elevation is also largely of ashlar clunch with the same use of tiles and iron nails as in the north wall. It also has a similar arrangement of building material below the upper string course as the north wall (Plates 11-12). Some of the nails intended to act as a key for the render survived (Plate 13), as did a large, apparently handmade masonry nail holding the tiles to the surviving clunch in the string course.

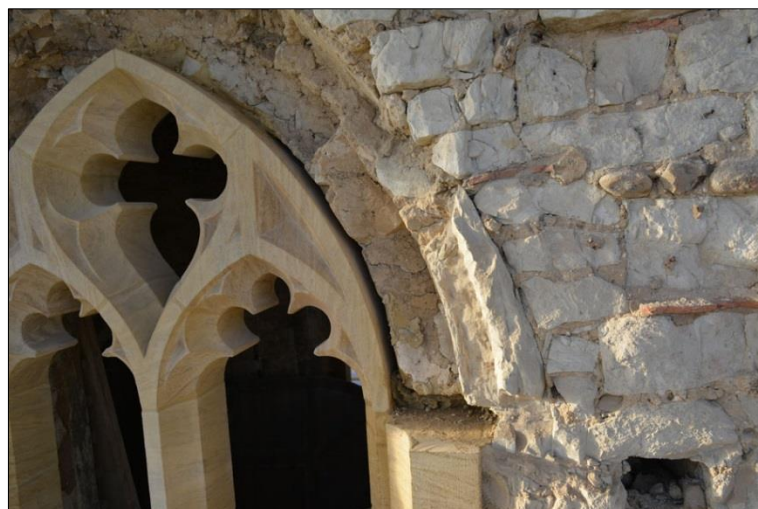
Plate 14: East window: remains of clunch hood mould and put log hole

Putlog holes could be seen on either side of the window (Plate 14). The one to the north, which measured 16cm wide by 14cm high was devoid of filling, but the southern one, which measured 17cm in width by 21cm in height was filled with brick and flint. Three further holes, probably associated with the floor joists, were noted in the first course of ashlar clunch between the flint walling and the lower string course. One was filled with stone and the others with brick.

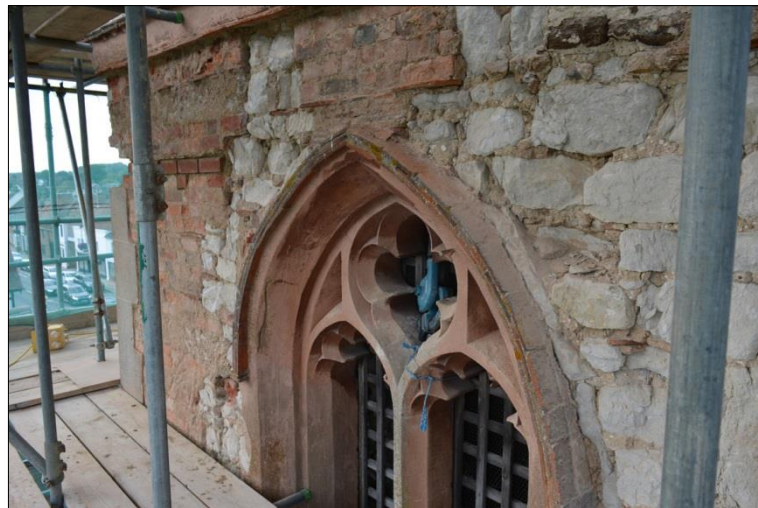
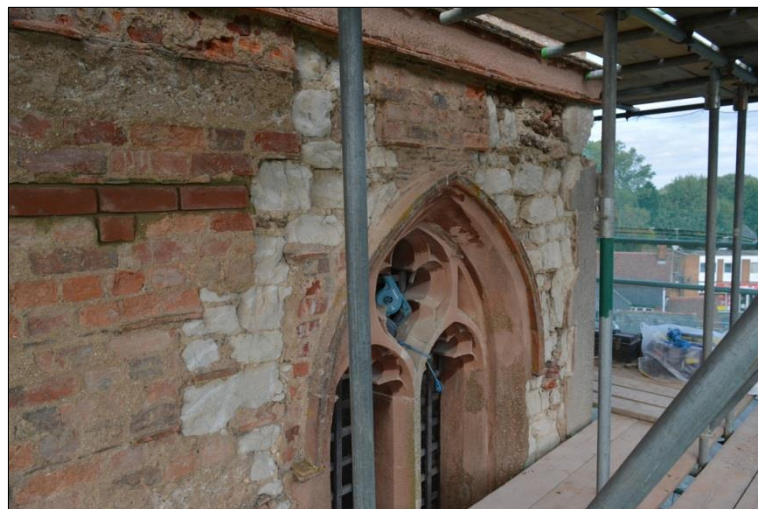
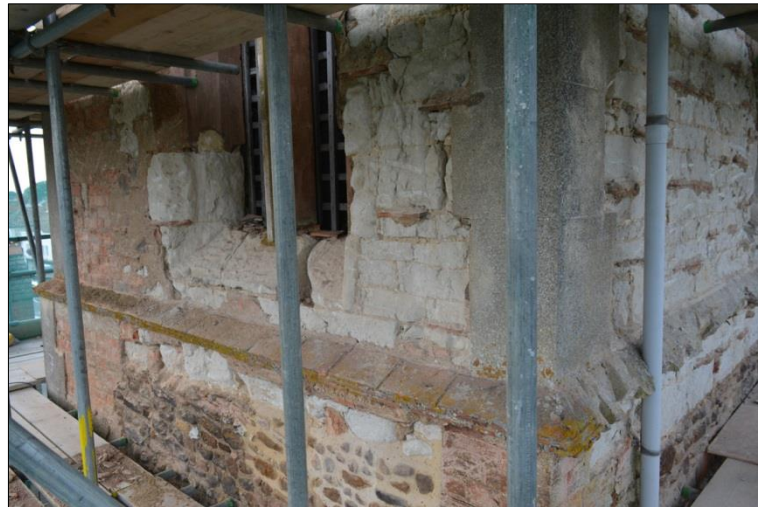
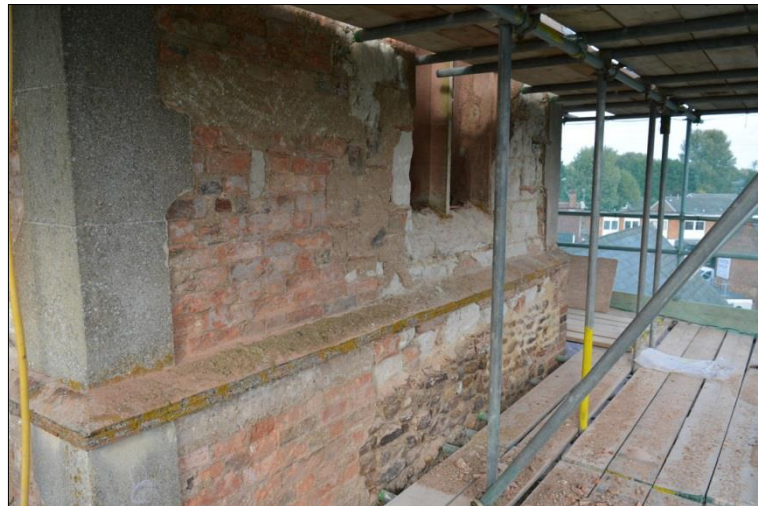
Whereas most of this elevation is similar to the north and east elevations, the western corner has been rebuilt in brick in a variation of English Garden bond to accommodate a new staircase (Plates 15-18). The bricks are poor quality, with horizontal skintlings and are set in cement mortar. Despite the presence of the skintlings, the walling appears to be late 19th or early 20th century as the mortar is cement based and later repairs have taken place using blocks and tiles. The wall above the window has also been patched in brick although these are of a better quality than those in the wall. The bricks measure 22 x 11 x 7cm (8¾ x 4¼ x 2¾ inches).

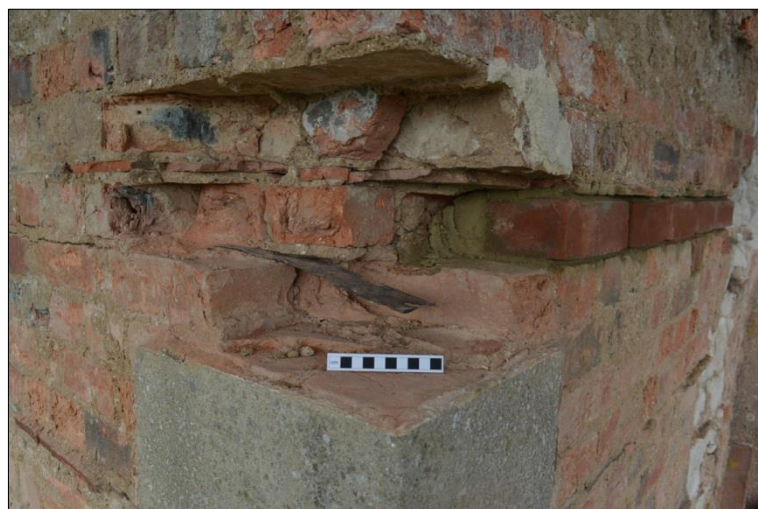
Plate 19: South elevation: iron work within southwest corner

Iron stone repair work, with some brick and tile set within it, was evident at the eastern end of the elevation, directly below the upper string course. An iron strap was also observed within the brickwork in the southwest corner (Plate 19).

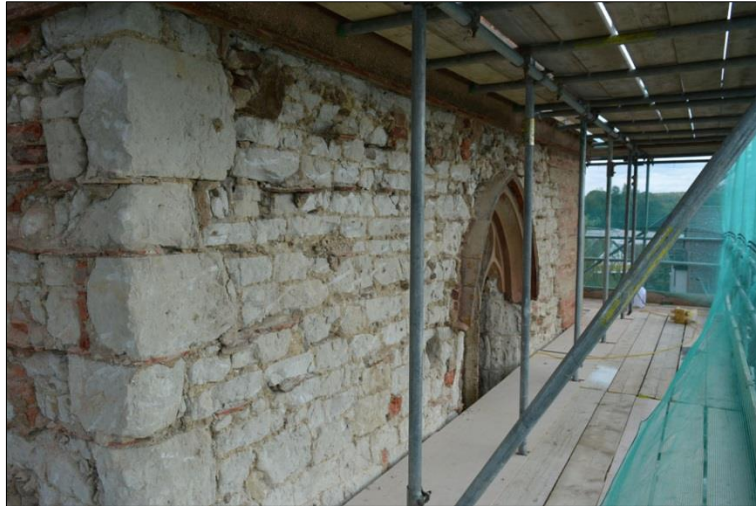
Plate 20: West elevation: upper level from the north

The brick work for the staircase extends half way along the southern section of the wall, beyond which the original clunch survives, albeit with tile inserts as in the other elevations and a section of iron stone repair at the northern end (Plate 20).

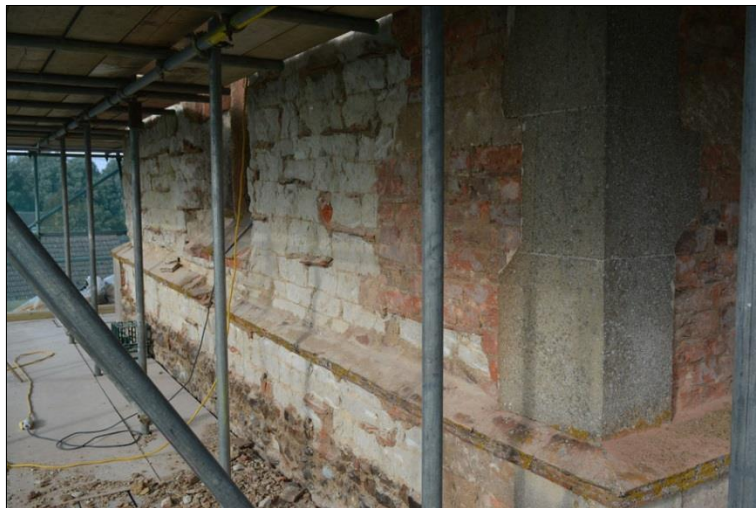
Plate 21: West elevation: lower level from the south

The putlog holes on either side of the window measure 17 x 20cm to the north and 15cm x 23cm to the south. The northern one has no infill, but that to the south is filled with brick and flint. Five further holes, probably associated with the floor joists, were noted in the first course of ashlar clunch between the flint walling and the lower string course (Plate 21). One is filled with stone and the others with brick.
