KDK ARCHAEOLOGY LTD

Historic Building Recording

Maltby's Farmhouse
40 Mill Lane
Wingrave
Buckinghamshire

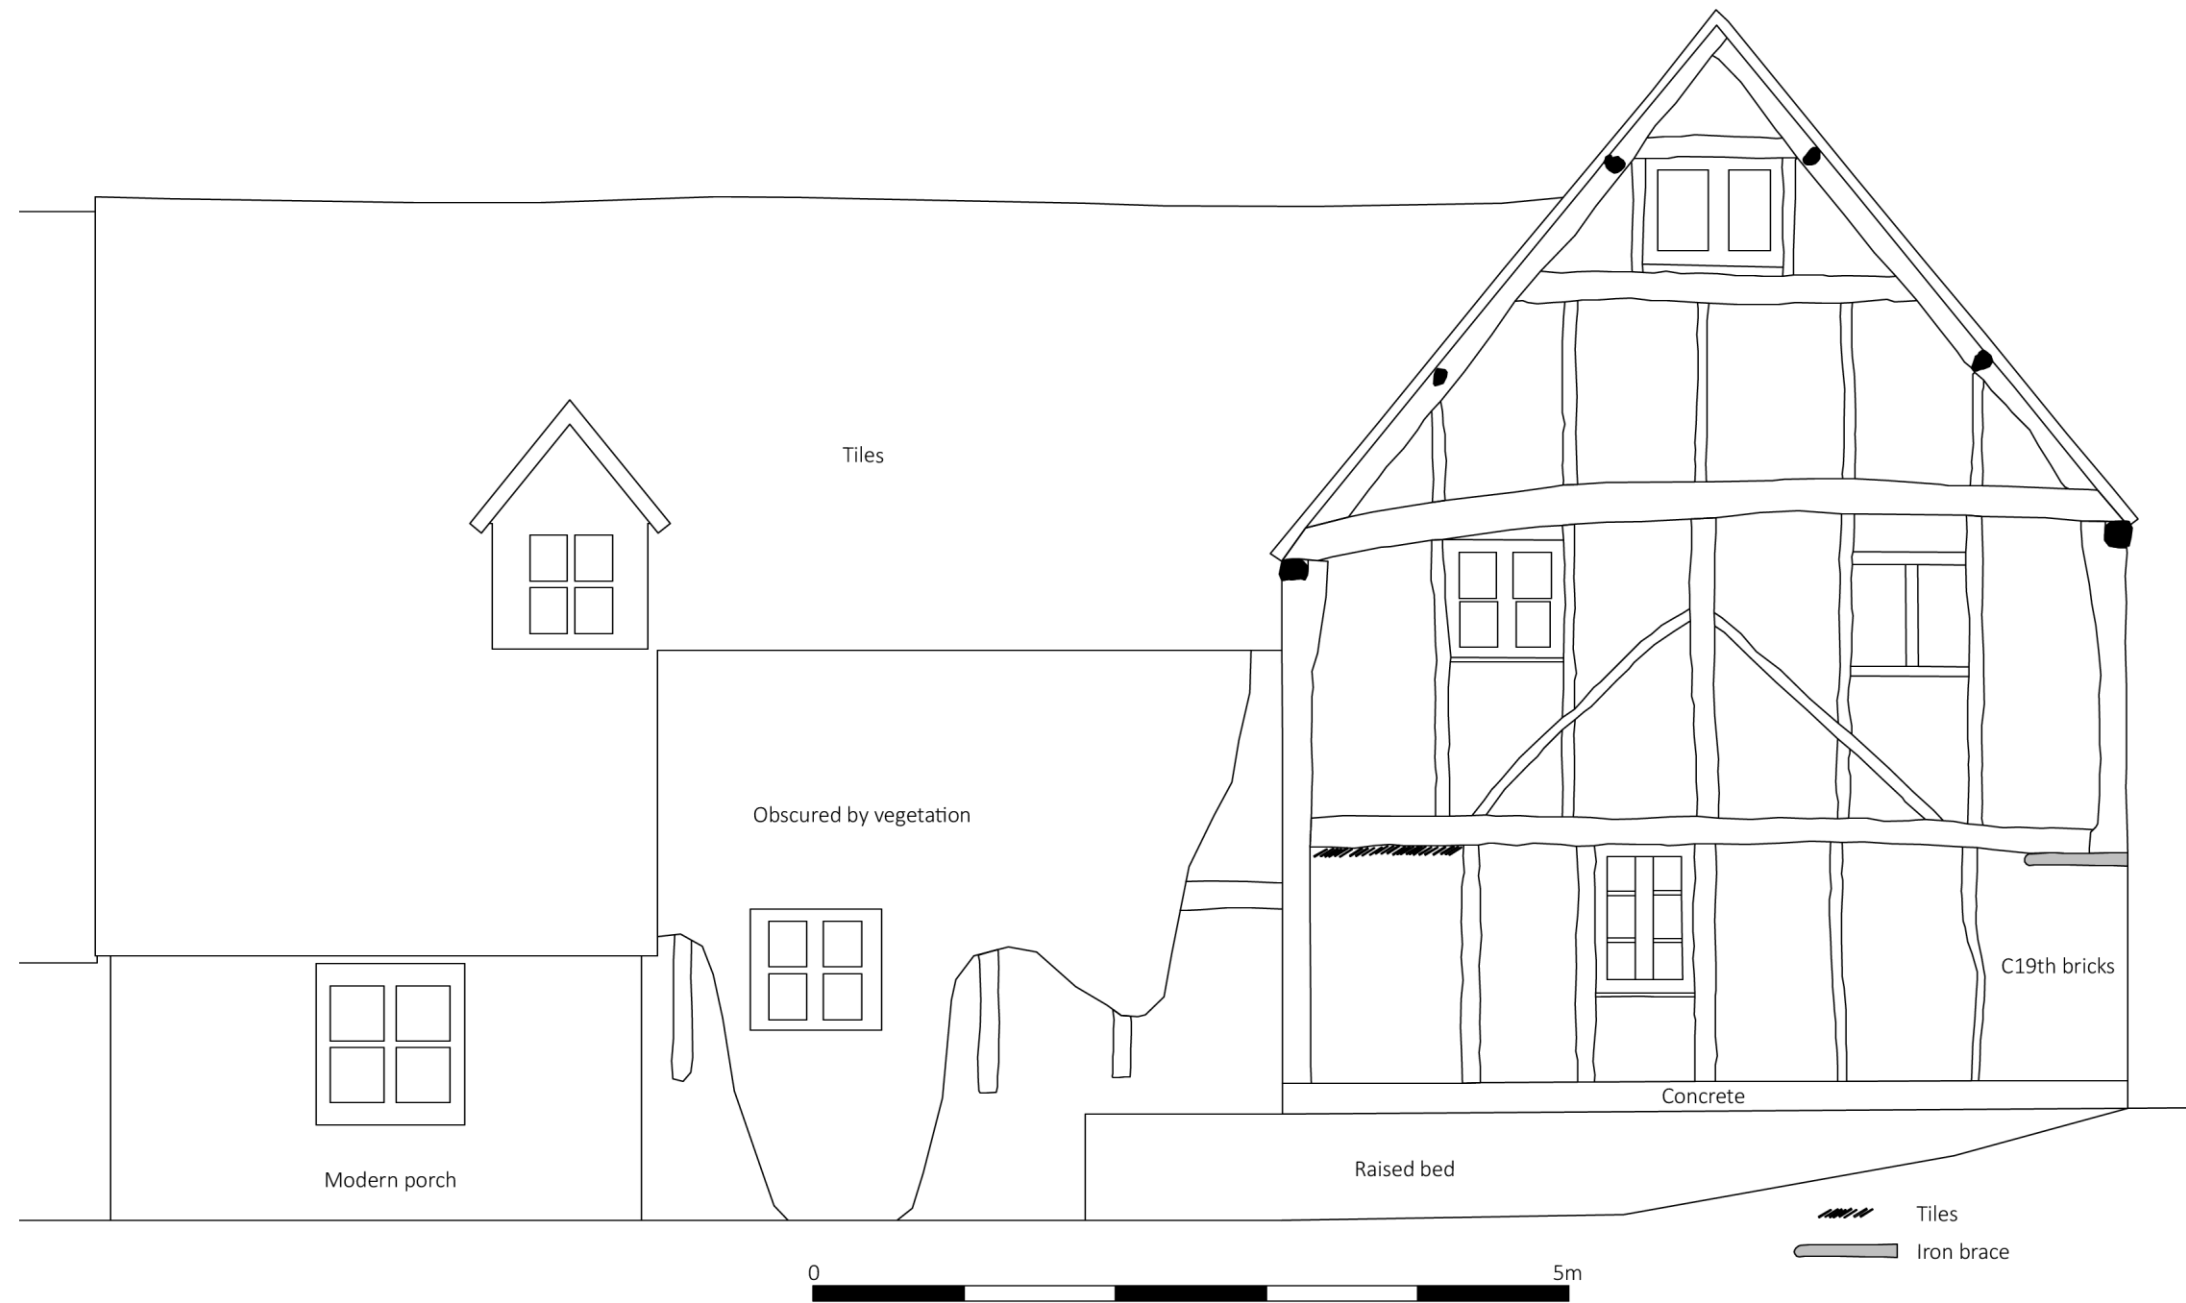
Figure 5: North elevation (scale 1:50)

4.2 *North Elevation* (Fig. 5, Plates 1 – 7)

The north gable of the west range shows the original timber frame, fully exposed and with brick infill. The timbers are entirely hand-worked, confirming a pre-industrial date. The frame consists of two studs either side of a central post to each storey, with five studs above the tie beam. The first floor has two diagonal braces either side of the central post. The ground floor and first floor each has a modern casement window placed between existing studs. Also on the first floor level is evidence for an earlier window in the form of a lintel, sill and mullion. There is a third window at the top of the elevation set between two collar beams. The red brick infill is generally in stretcher bond but is occasionally irregular. The pointing appeared to be a dense lime mortar. The bricks measure 22 x 9.5 x 5.5cm (8¾ x 3¾ x 2¼ inches), with 1cm (⅜ inch) joints. A section of wall at the western corner of the ground floor has been rebuilt in Flemish bond, most likely in the 19th century, using imperial red bricks measuring 22.5 x 11 x 6.5cm (9 x 4¼ x 2½ inches) with 8mm (¼ inch) joints. These bricks also replaced the principal post in this corner and are braced with an iron strap placed just below the mid-rail and the sloping jowl post, which has been cut at mid-rail level. The panel at the eastern end of the ground floor section has a layer of diagonally overlapping tiles just below the mid-rail.

The north elevation of the east range is mostly obscured by ivy, however some exposed hand-worked timber is visible. There are three studs that appear to be cut 0.85m above ground level. A mid-rail is also visible at the western edge. There is a single modern casement window. The bricks are similar in size and composition to the generally seen in the west range.

The original timber frame is entirely exposed in the north elevation and is well preserved, with the exception of the sloping jowl post at the western corner, the lower half of which has been cut away. The brick in-fill is unlikely to be an original feature as the walls would have been initially filled with wattle and daub. Some changes have taken place in the north elevation, for example the first floor window on the right hand side has been long since blocked and two windows have been added to the ground and first floors, the attic window at the top of the elevation is unlikely to be an original feature. The brick replacement to the ground floor corner of the house looks to be 19th century in date and resulted in the removal of the bottom half of the principal post. This phase of brickwork is also present in the west elevation and extends along the north bay, terminating at the modern front porch.

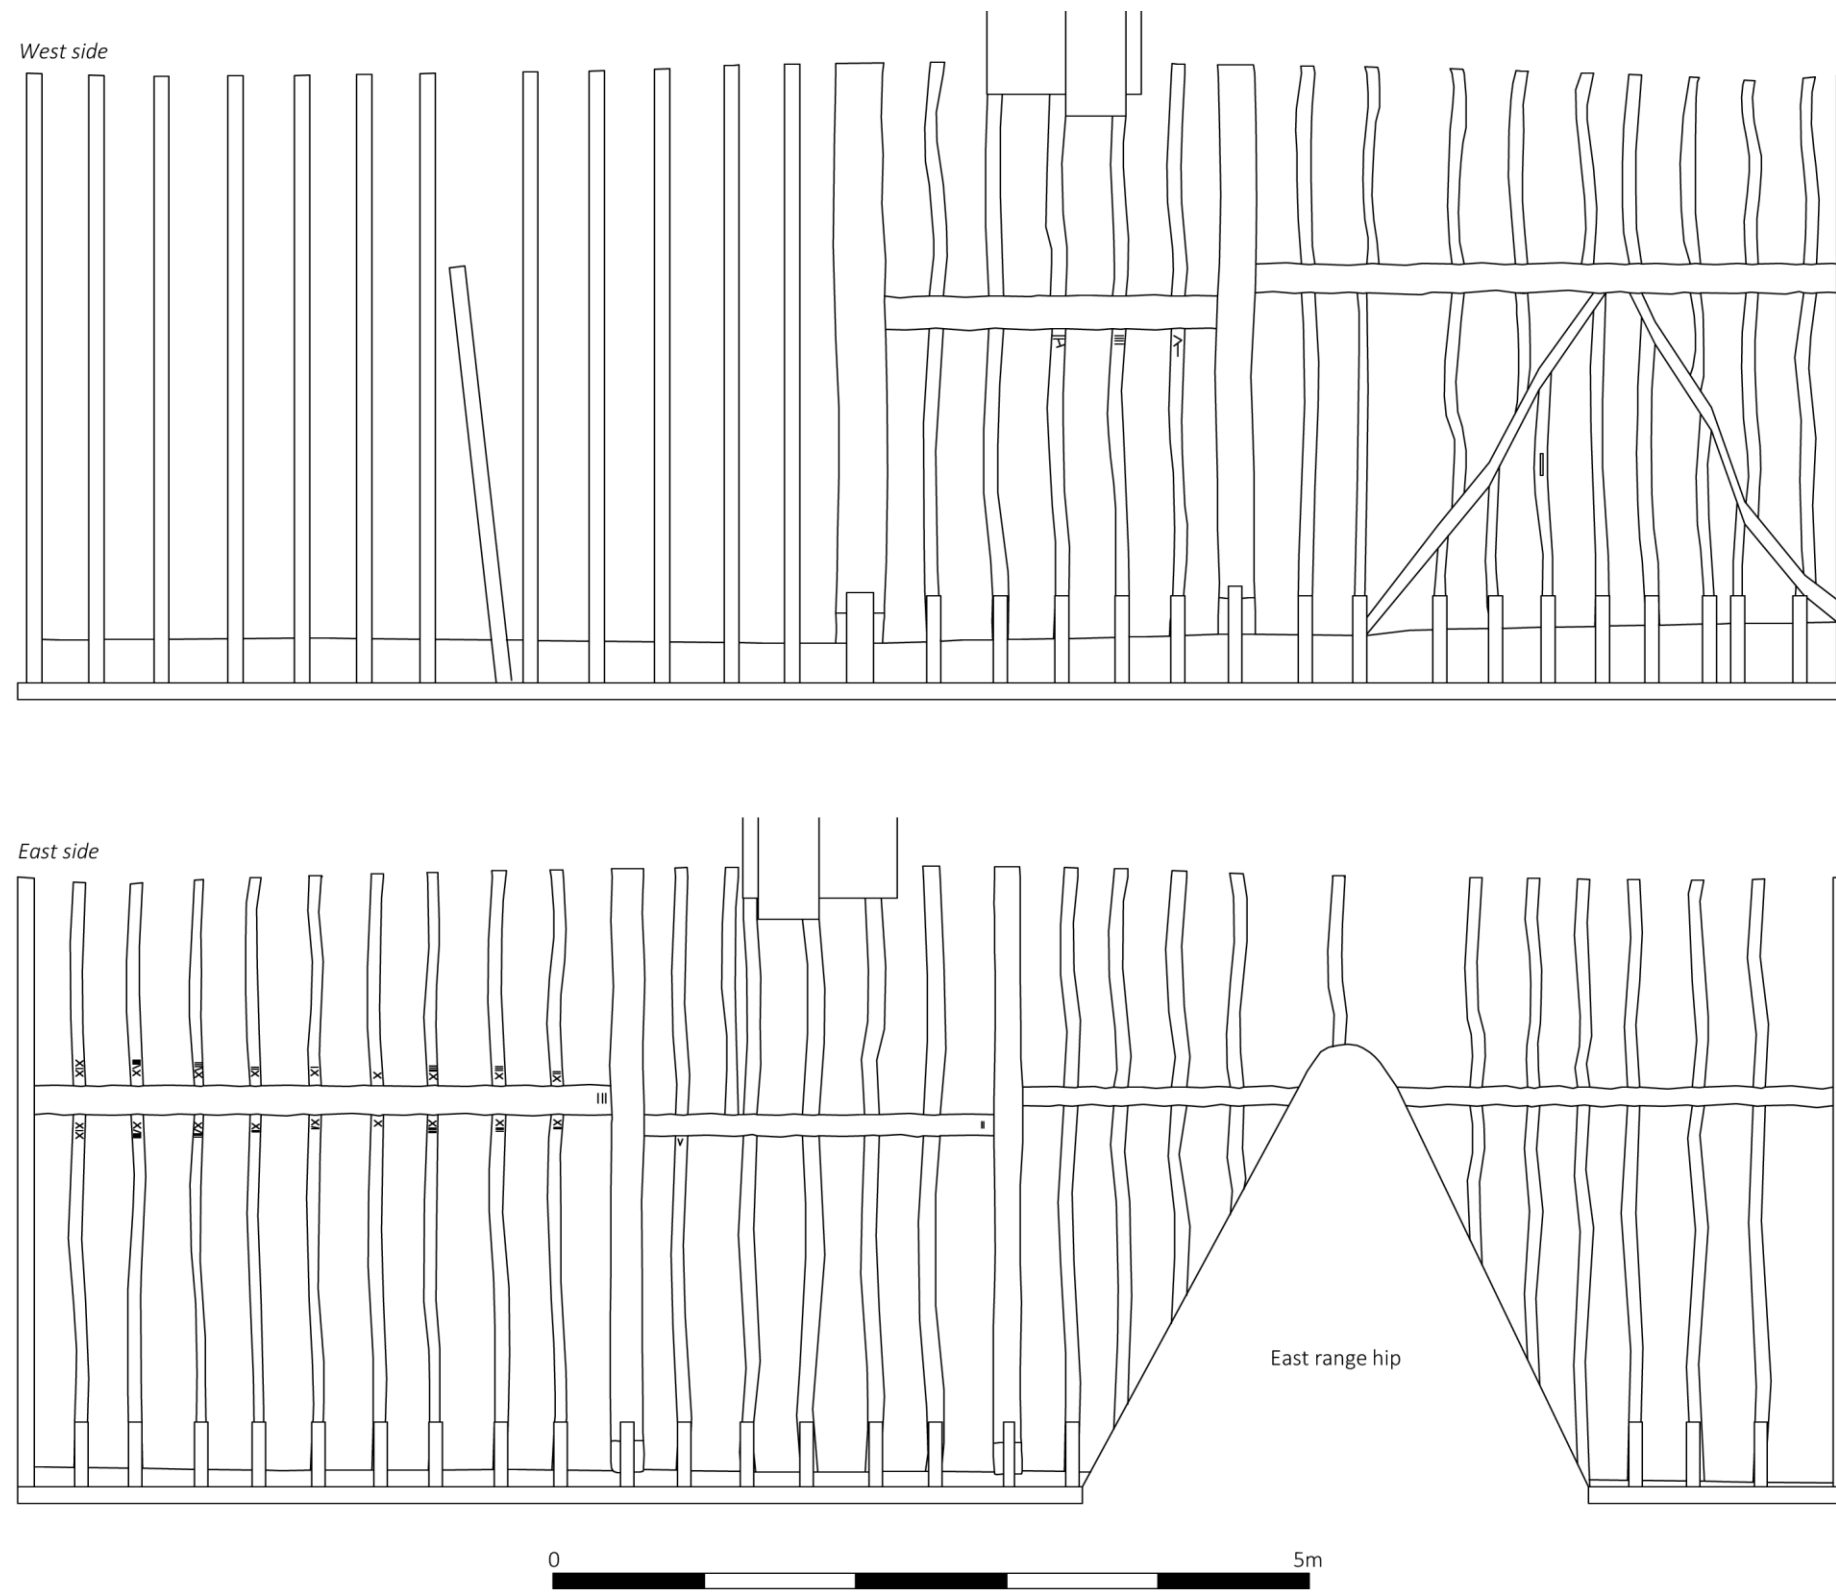
Figure 6: West range roof (1:50)

The exposed roof of the west range is primarily built of hand-worked timber. The general roof structure consists of three bays with staggered butt purlins, the rafters being tenoned into the purlins. Butt purlins were a method of providing longitudinal support in order to prevent racking, but were less common than full length purlins. They were first used in southern and eastern England in the late 16th century (Brown 1986:75). The earliest butt purlins were aligned, with the staggered form being a slightly later variation first seen in Surrey in the 1570s, they were introduced to Kent and Hampshire marginally later (Wild & Moir 2013:53). Although there is no way to definitively establish precisely when staggered butt purlins were introduced to Buckinghamshire, it was likely at approximately the same time.

The truss timbers are the most substantial in the roof elevations and vary in width from 18cm (7 inches) to 30cm (12 inches). The common rafters are positioned in two rows and are seated into the purlins. The common rafters are of a lesser scantling and generally measure between 6cm and 12cm in width (2¾ – 4¾ inches). They are mostly spaced 20cm to 30cm (8 – 12 inches) apart, although some voids are as wide as 80cm (31½ inches). The exception to this is the northern section of the west side of the roof, which consists of full length machine-cut rafters with no visible purlin, measuring 9cm (4 inches) wide. These are an entirely modern

replacement. The lower rafters on each side of the west range have been lengthened with machine cut wooden pieces in order to meet the eaves and extend past the point of the wall plate. This may date to the installation of a tiled roof, as it is likely that the property was originally thatched. The southern bay has diagonal bracing beneath the purlin on the west side, which is not present in the rest of the west range.

A number of mortice and tenon joints are visible on both sides of the west range roof, which mostly connect the rafters with the purlins. Centrally located or slightly off-centre tenons with unrefined shoulders are primarily used to connect the common rafters with the purlins (Plate 10), although on the east side the roof there is at least one instance of a central tenon with a spurred face shoulder (Plate 19). The common rafters also exhibit barefaced soffit tenons, though mostly on the west side of the roof. There is a relatively unusual joint that connects the central butt purlin to the south truss rafter on the west side of the roof, which consists of a central tenon with spurred shoulders (Plate 11). This form is a reversal of a diminished haunch tenon but is a less than perfect design, possibly indicative of a rural carpenter trying to improve upon well-established methods (Hewett 1980:282-283). Many of the roof timbers display carpenters' assembly marks that take the form of Roman numerals, albeit with slight variations. For example, the rafters on the east side of the roof over the southern bay, both above and below the purlin, appear to be numbered for the purpose of matching the top and bottom rafters although the method and the logic behind the numerical sequence are unclear. Also to the east side of the roof, the central and southern purlins are numbered 'II' and 'III' respectively. No 'I' could be seen on the northern rail.

The roof of the west range shows at least three clear phases of timberwork. The main part of the roof structure is of hand-worked timbers with the rafters tenoned into staggered butt purlins, suggesting that these timbers are original. Many of the rafters and purlins exhibit carpenter's assembly marks in Roman numerals, mostly on the east side of the roof, the purpose of which were to match corresponding upper and lower rafters as well as to number the purlins. The timbers with carpenters' marks may represent a programme of repairs by a single craftsman. This is followed by relatively modern repairs, which include the section of full-length rafters in the north bay on the west side. At some stage the eaves have been lowered using small timber pieces to bridge the gap between the short original rafters, which rest on the wall plate, and the new gutter fascia board. The joints between the rafters and purlins consist of a range of mortice and tenon joints. These are primarily central or off-centre tenons used to connect the common rafters to the purlins, but there are some joints with barefaced soffit tenons or with spurred shoulders. At least one of the joints between the butt purlins and the principal rafters on the west side of the roof is a central tenon with spurred shoulders. This was not entirely successful and has become slightly disengaged from its housing.

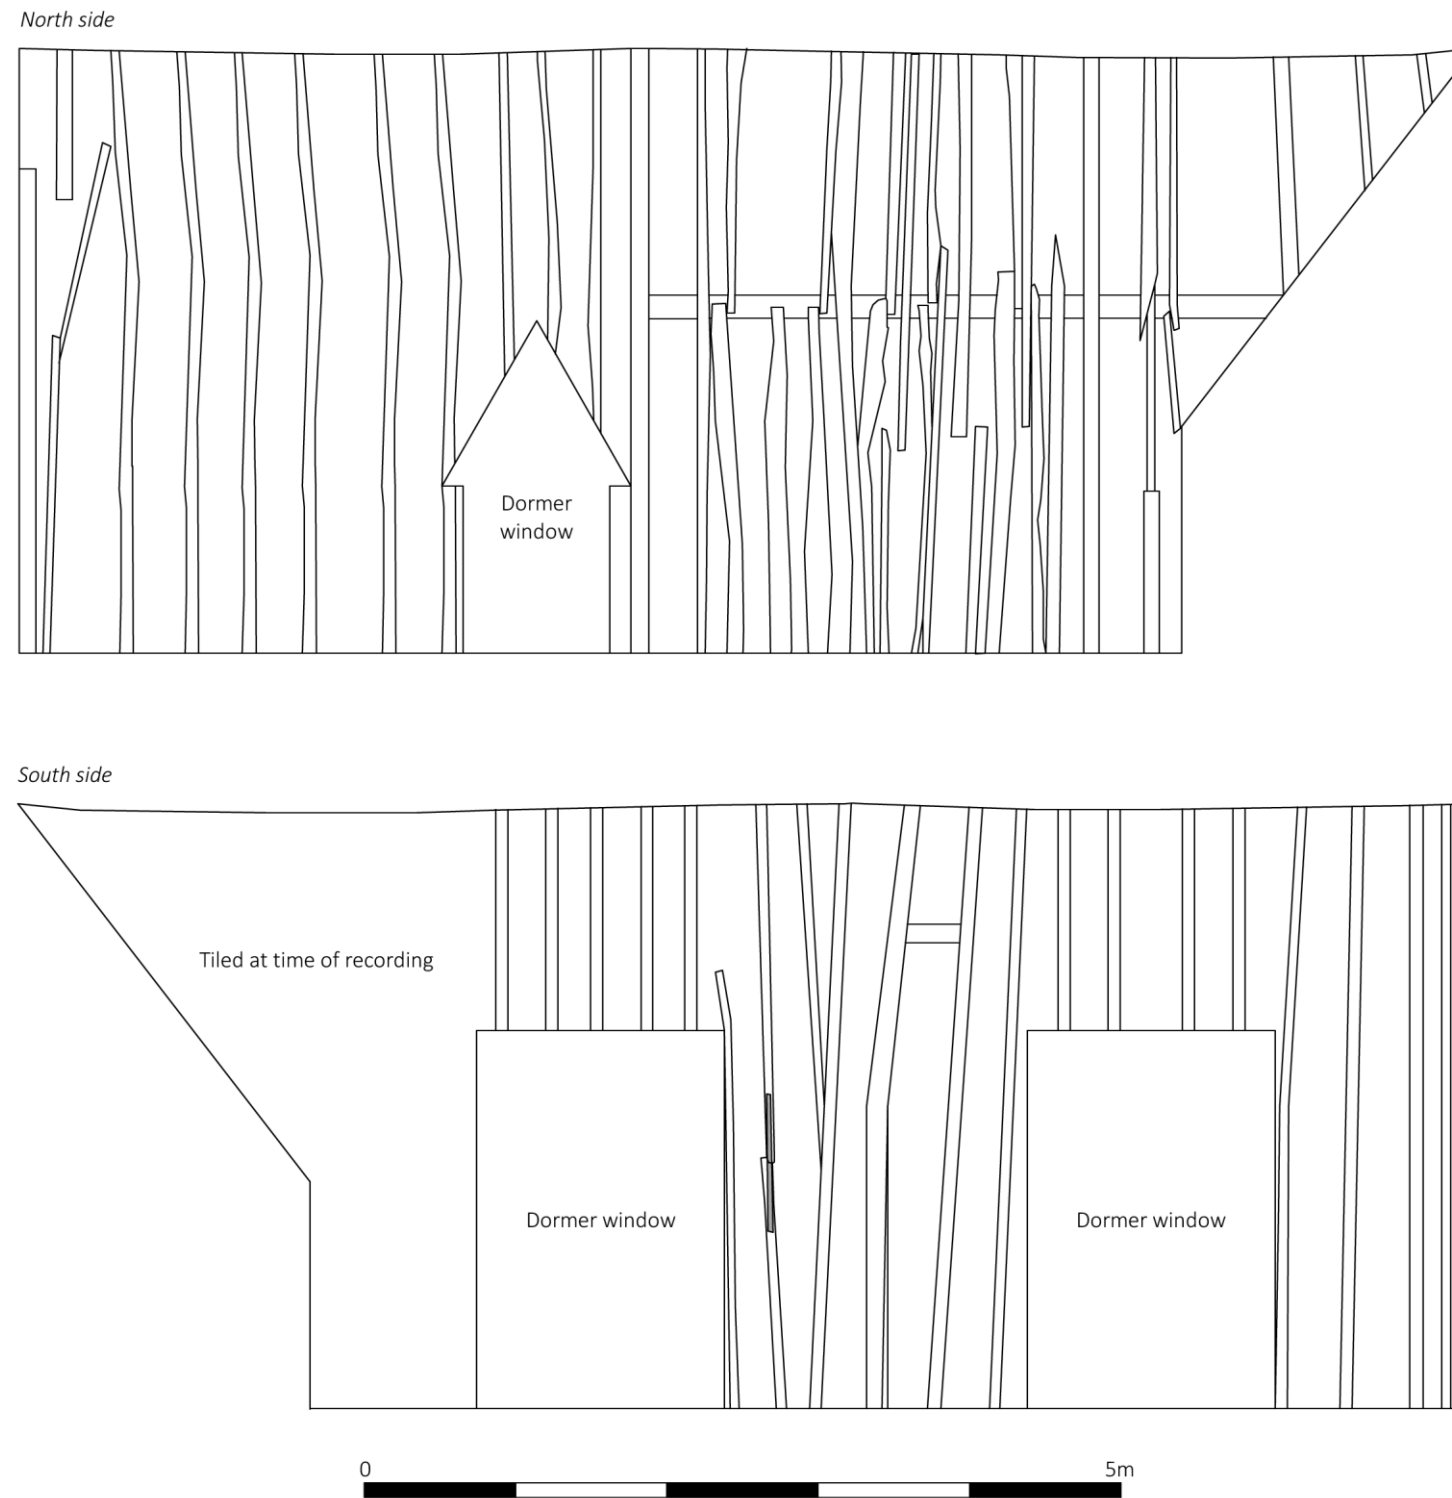
Figure 7: East range roof (1:50)

The east range roof consists of two bays, and although the rafters were exposed, modern insulation obscured the internal structure. The section on the north side to the west of the modern dormer window appears to have a single purlin, which has greatly deteriorated. The timbers in the roof of the east range are in considerably poorer condition than those of the west range. Most are hand-worked, although there are some machine-cut replacements, particularly to the south side. The section of the north side roof between the dormer window and the west range is in particularly poor condition and very few full length rafters remain. Many have been replaced with reused timbers largely unfit for purpose, requiring later bracing with further short pieces of timber in order to bridge gaps. To the south side of the roof are two dormer windows and to the north side is a single gabled dormer. No carpenters' marks or joints of interest are visible in the east range.

The roof over the east range has undergone a great many changes, particularly on the north side, which appears to have been repaired on an ad hoc basis in the past, rather than in any single event. The rafters have been replaced with reused timber of lower quality and then patched together and braced at a later date with more modern pieces of timber.

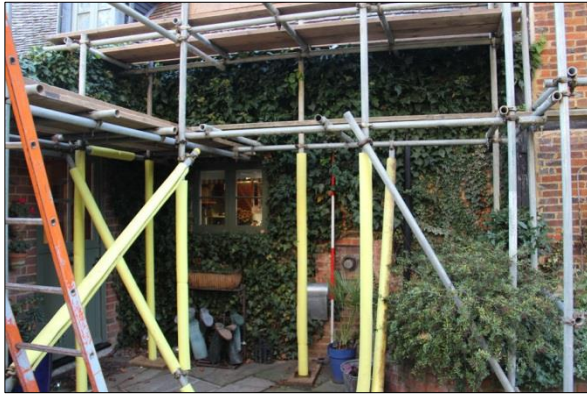
Plate 7: North elevation, east range (3)

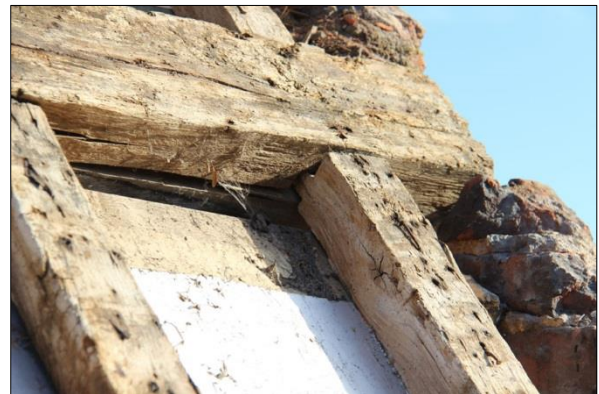
Plate 10: West range roof, west side: off-centre tenon joint between purlin and common rafter

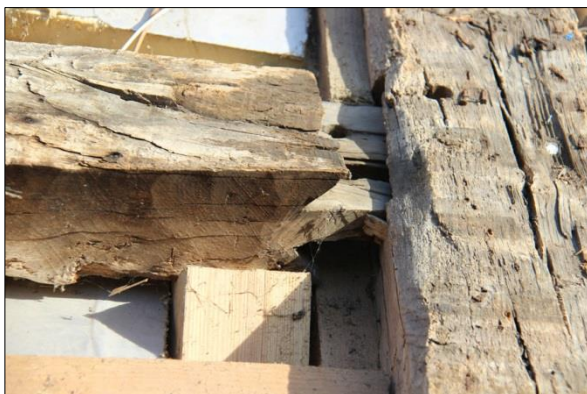
Plate 11: West range roof, west side: central tenon with spurred shoulders between purlin and principal rafter (31)

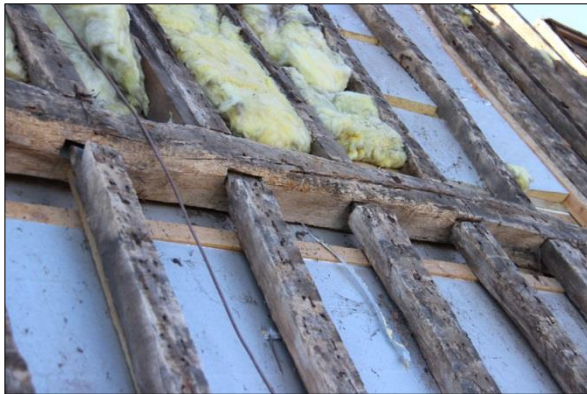
Plate 19: West range roof, east side: central tenon joints, one with a spurred face shoulder to the left, between purlin and common rafters (36)
