## Archaeological Observation and Recording Report

St Margaret's Church

King's Lynn

Report number	422/KLM/2.2	Event number	ENF145563
Consultation reference	CNF48499	Event/Accession no	NWHCM:2018.350
OS reference	TF 61772 19806	OASIS reference	kdkarcha1-334722
Local Planning Authority	n/a	Faculty reference	2017-009561

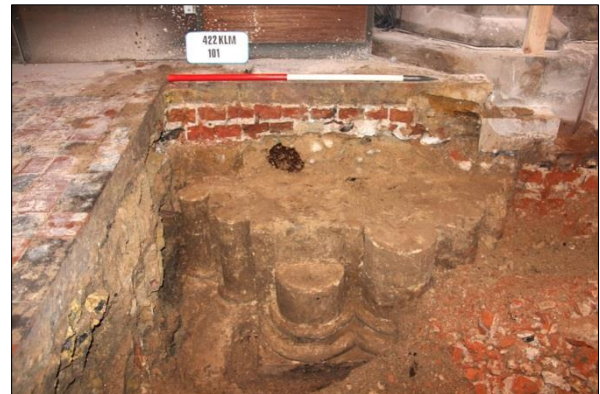
In the northwest corner of the excavation was a large stone feature [104] that appeared to be the base of one of the earlier tower piers. It was constructed of limestone pieces with a degraded stone rubble and mortar core. The moulded rolls were Romanesque in style, each with two engaged shaft mouldings on each side. The mouldings on the base consisted of a small and large plain torus above a square plinth (Plate 23). The design is identical to the Romanesque piers visible elsewhere in the church, including the adjacent pier to the south and those that still survive at the base of the southwest tower. Visual inspection suggested that the stone was an oolitic limestone from the Lincolnshire Limestone group, possibly from the King's Cliffe quarry. Despite being quarried in Northamptonshire, this stone is often also found in Norfolk and adjoining counties, as are other examples of the Lincolnshire Limestone Formation (HE 2017a).

**Plate 23:** South facing section of brickwork [102] and original pier [104], view north

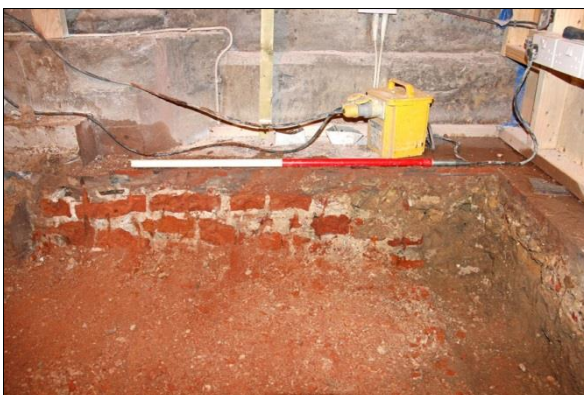
The lower brick surface [107] appeared to terminate at the eastern end of the trench and gave way to a mid-brownish grey deposit (109), which stratigraphically post-dated [107] in section. The deposit was similar in composition and consistency to (105) and (106), though with less silt, suggesting another backfill used to make up the floor level. However, (109) did not yield any finds and it is not possible to know how far the deposit extends (Plate 24).

**Plate 24:** South facing section of brickwork [107], view north

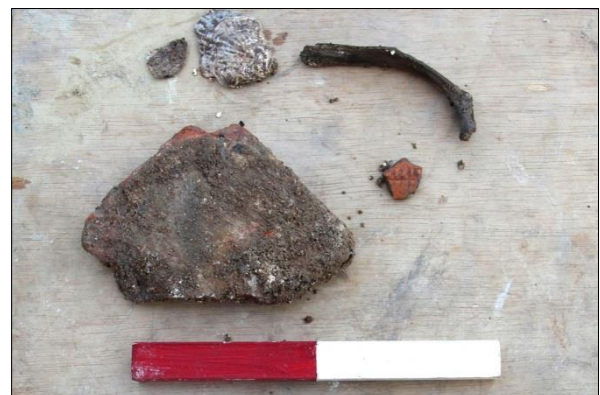
Immediately around the base of [104] was a dark silty deposit (105) containing animal bone, oyster shell, ceramic building material (CBM) and a small sherd of glazed pottery. None of the finds were retained but they appeared to be of late medieval or early post-medieval date, possibly contemporary with the late 15<sup>th</sup> century reworking of the church. The material may have been deposited to build up the ground level around the redundant pier. There was a deposit (106) in the southwest corner of the trench that appeared similar to (104) that contained animal bone, CBM and a clay pipe, which would suggest a post-medieval date. Abutting these layers and covering much of the base of the trench was a red brick surface [107] measuring at least 1.93m by 1.92m. The bricks appeared to be post-medieval in date and may have been part of earlier steps leading from the north aisle to the raised level beneath the northwest tower.

**Plate 25:** Finds uncovered in deposit (105), including oyster shell, animal bone, pot and CBM (clockwise from top), 20cm scale

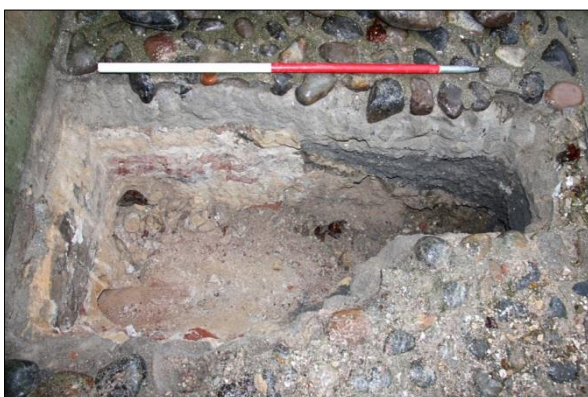
A service trench was excavated immediately to the north of the northwest porch to connect foul drainage from the porch to existing drains. The trench initially measured 1.5m long by 0.3m wide, but was widened to 0.5m at the south end on a subsequent site visit. It was 0.9m deep at the north end and 0.65m deep at the south end. The top surface was of cobbles in cement and was less than 5cm deep, below this was a layer of concrete between 0.22m and 0.3m deep. Below the concrete was a foundation [201] consisting of limestone and patches of red brick and CBM in lime mortar, although there was a layer of tarmac above at the north end. The stones of [201] were offset by 0.2m towards the north, where there was a layer of silty soil (202), which partially covered the limestone but lay below the layer of tarmac. The foundation [201] abutted the wall of the north porch and may be part of the original spreadwork. No finds apart from CBM were recovered from the service trench (Plate 28). The limestone of [201] was identical to that found in the North Porch wall, most likely also King's Cliffe Stone.

**Plate 28:** Service trench to the north of the porch including stone and brick foundation [201], view west

The stone and brick feature [201] uncovered in the external service trench to the north of the porch is likely to be part of the foundations of the north porch. The bricks were not complete and therefore it was not possible to give an accurate date on site. The stone matched that of the 15<sup>th</sup> century north porch but contained bricks that may have been medieval or post-medieval. Although the 19<sup>th</sup> century Shambles was located above [201] and abutted the porch, this looks to have been an entirely brick structure, unlikely to have had a stone foundation.

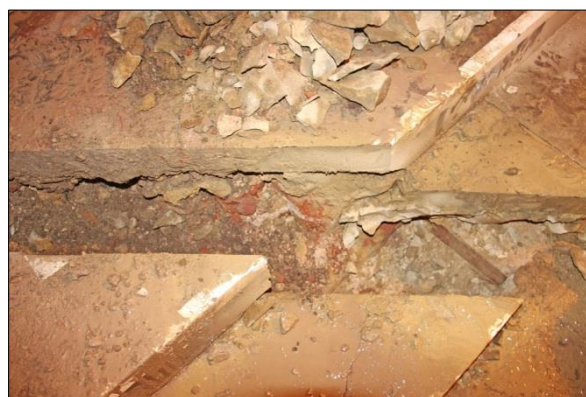
A 0.1m wide service trench was cut into the stone steps along the east side of the north porch. Beneath the steps was a layer of rubble containing CBM and stone fragments. Bricks had been used as a base for the steps (Plate 29). Tiles were also cut away above two caskets containing the ashes of two priests, one Eric Samuel Turnbull who died in 1995 aged 77 years, and the other Justin Bray Banbury who died in 1965 aged 28 years (Plates 30 and 31). The remains were then moved before the project continued. The latter was also commemorated in the screen between the north porch and tower.

**Plate 29:** Trench cut into steps in the north porch, view southeast

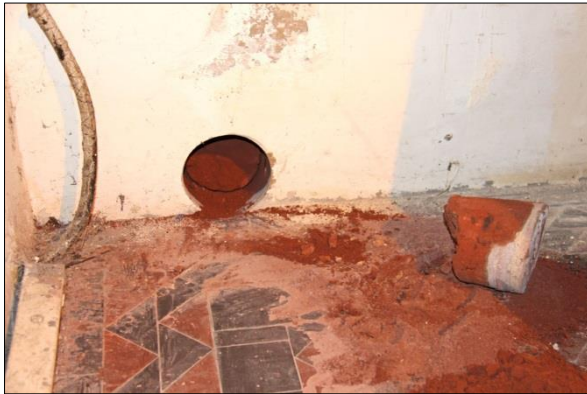
A 0.3m diameter hole was cut in the north wall of the porch at floor level, in order to connect interior foul drainage to the exterior service trench. The cut hole produced a core of solid limestone from the wall with no unexpected material (Plate 32). This was in contrast to the centre of pier [104], which had a rubble core and demonstrates the change in construction methods throughout the medieval period.

**Plate 32:** Hole for drainage in north wall of porch, view north

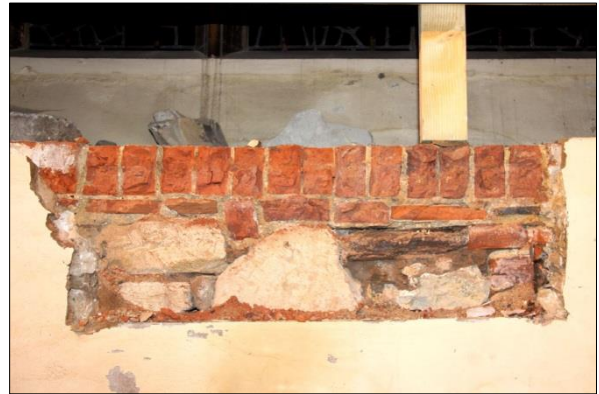
A small section of plaster was removed from the west wall of the north porch, just below the west window, which revealed stone and brickwork making up the sill, the topmost course being a row of on-edge header bricks of an unknown, but possibly post-medieval, date in lime mortar (Plate 33).

**Plate 33:** Brickwork beneath plaster in the west wall of the porch, view west

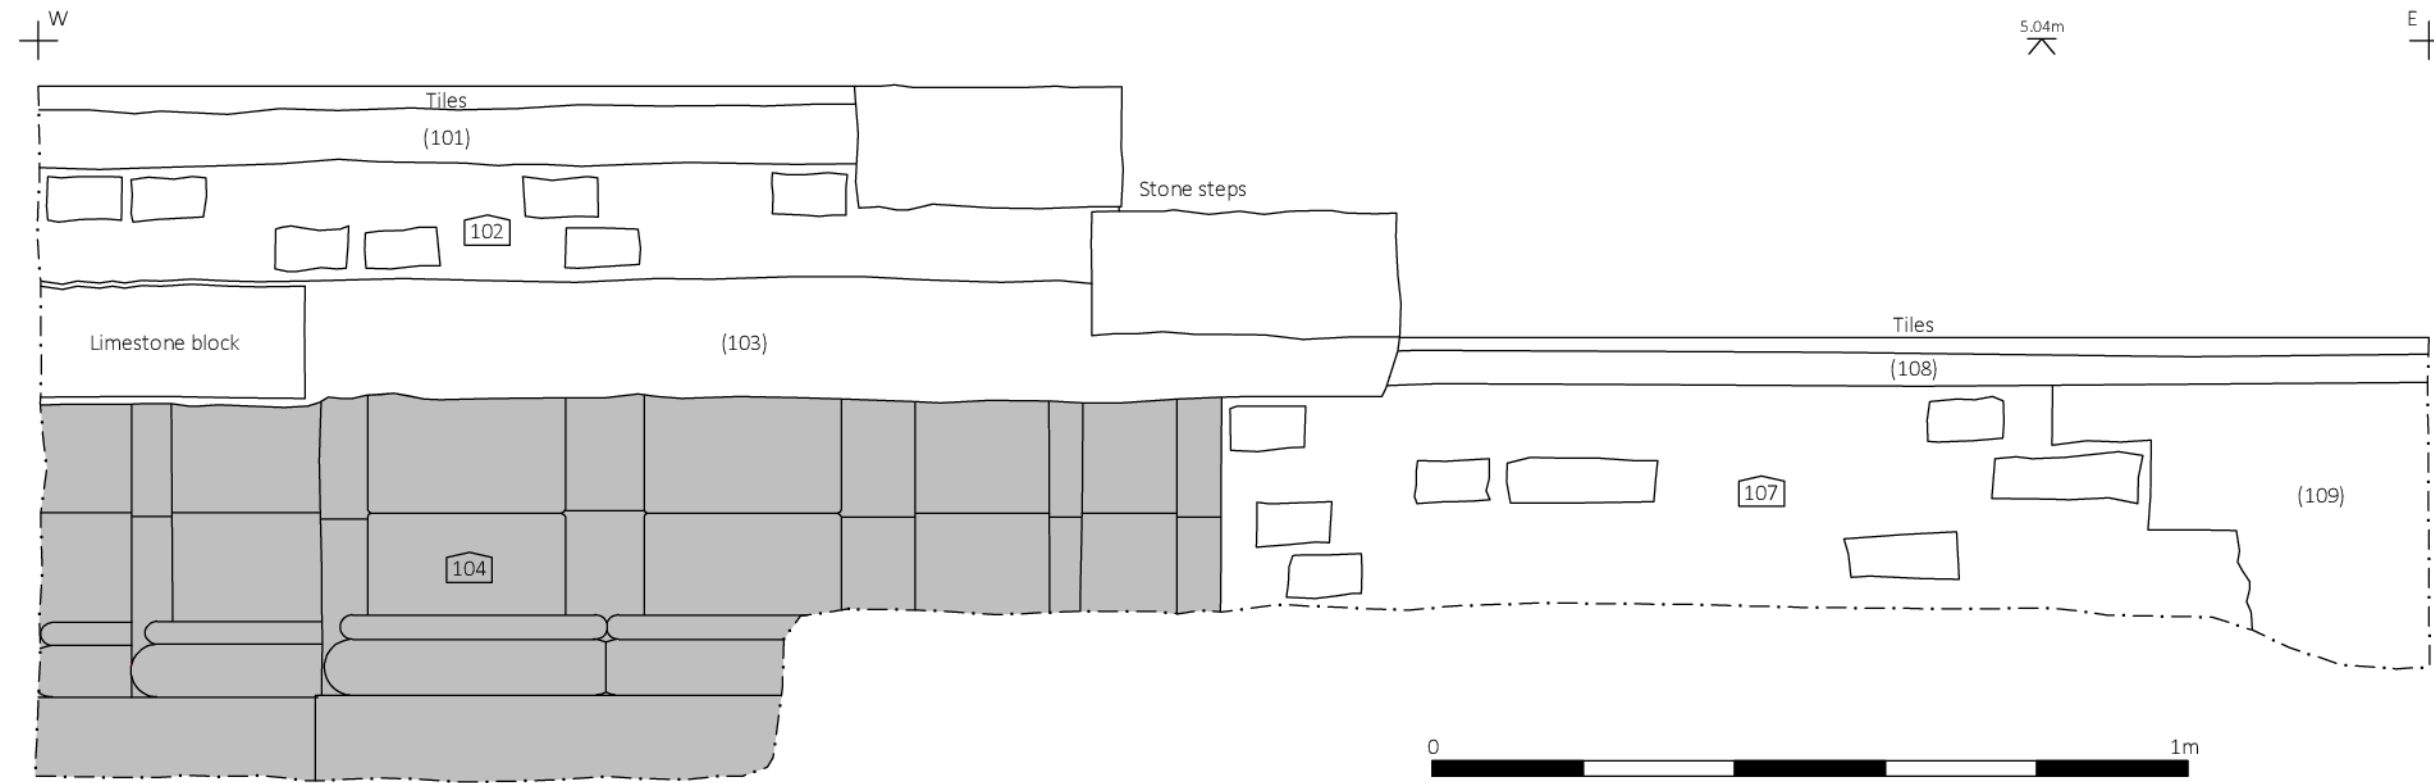
Figure 7: South facing section of wheelchair lift excavation, including original pier base [104], (scale 1:10)

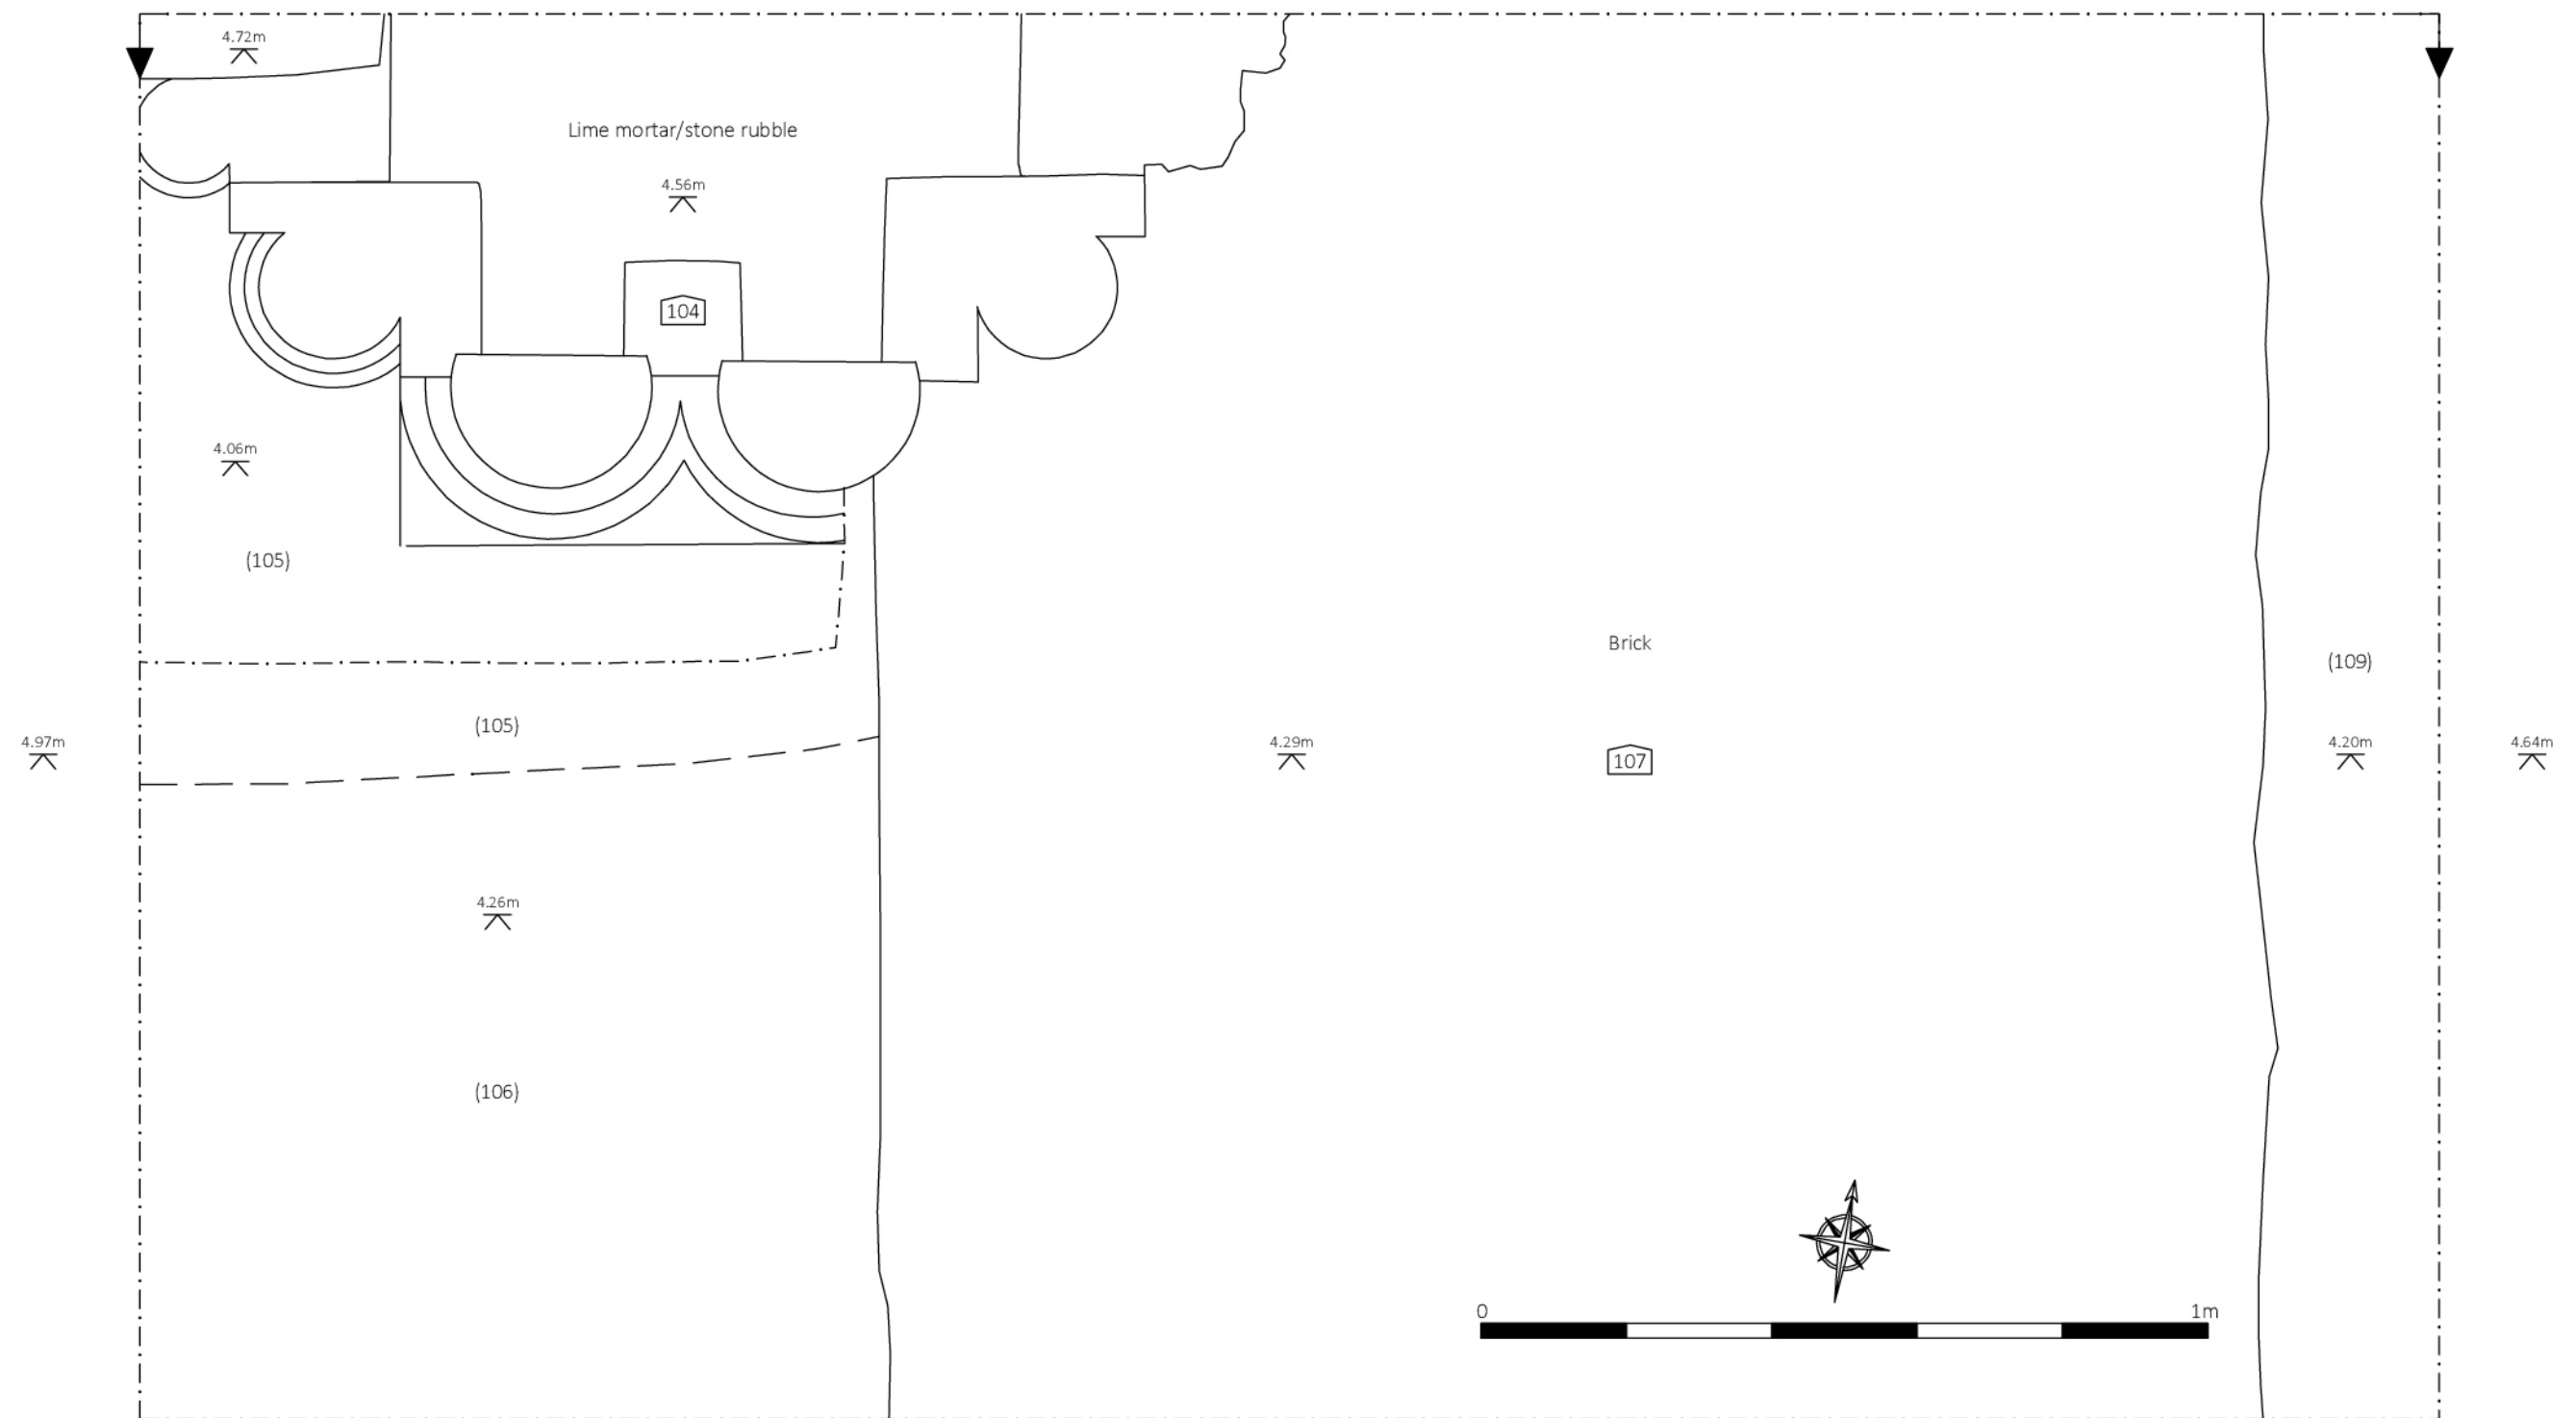
Figure 8: Plan of wheelchair lift excavation, including original pier base [104], (scale 1:10)

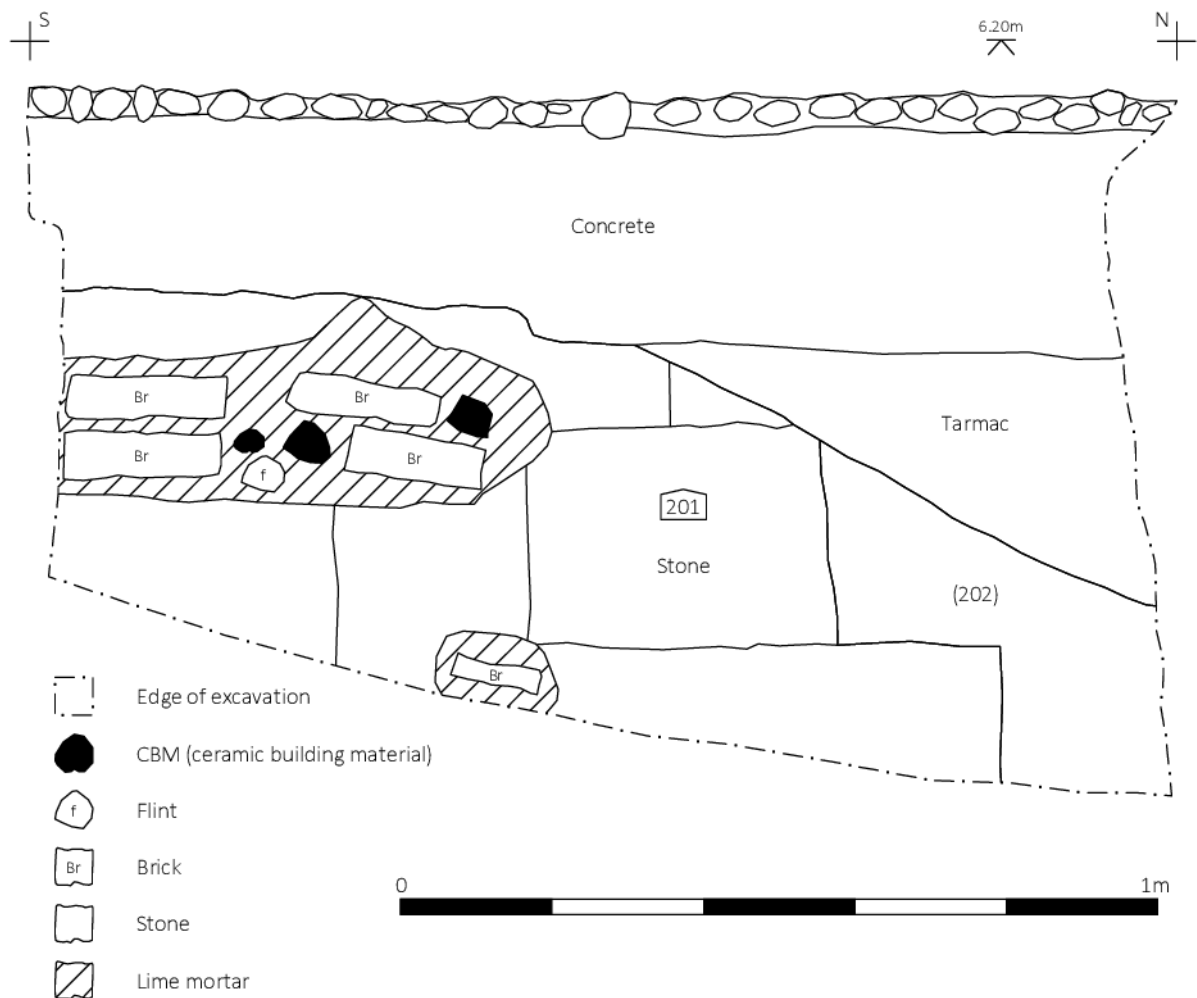
Figure 10: East facing section of service trench (scale 1:10)

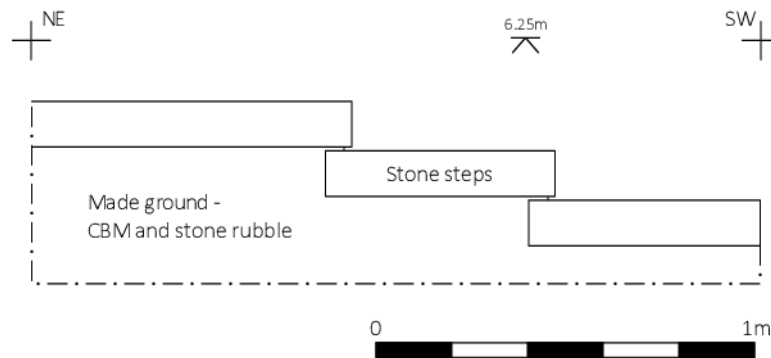
Figure 12: Northwest facing of the trench through the steps inside the north porch (scale 1:20)
