KDK ARCHAEOLOGY LTD

Historic Building Recording

Wheathampstead Place
Station Road
Wheathampstead
Hertfordshire

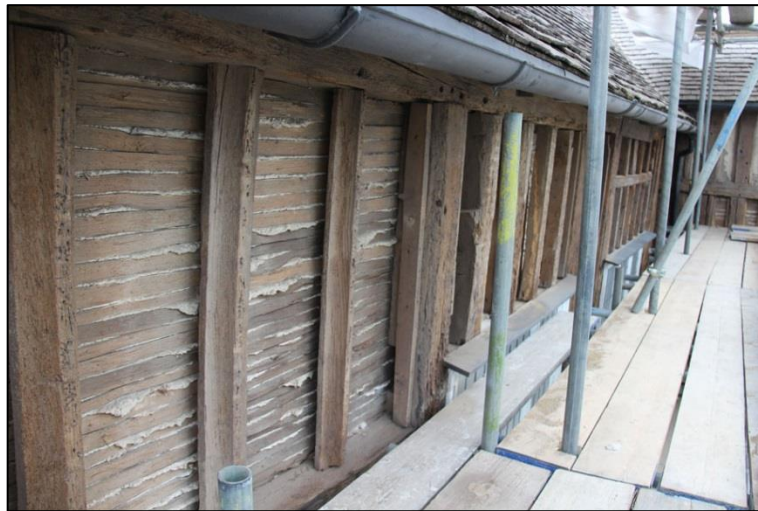
The west elevation of the main range has been built of robust timbers (one of the posts being 42cm wide) with external bracing and a mullioned window at the northern end (Plate 1). A bridle butted joint is located above the second and third mullions from the north. Hertfordshire staves for wattle and daub, consisting of three round, one rectangular, then two round and one rectangular recess, survive in the wallplate soffit (Plate 2). This would suggest that the window was installed at a later date, presumably when the fireplace was built and the first floor added. The wattle and daub was later replaced by lath and plaster, except towards the southern end of the range where there lath and plaster is absent and only panelling from within the room can be seen (Plate 3). A cross brace over the northern window was clearly added once the window was no longer in use.

Plate 1: Upper floor with mullioned window to the left

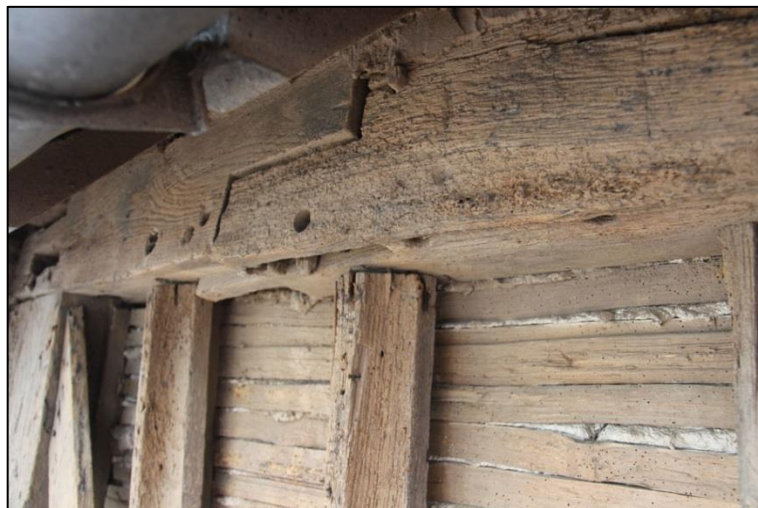
Plate 2: Bridle butted scarf joint and Hertfordshire staves

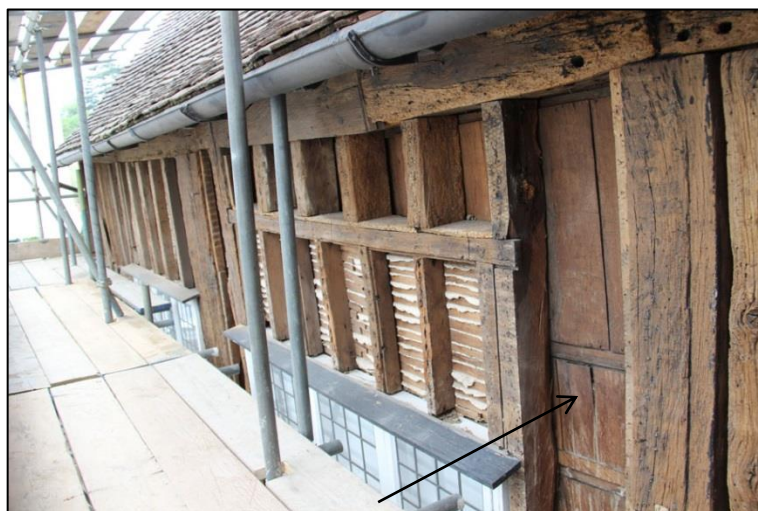
Plate 3: Upper floor from the south showing internal panelling to the right

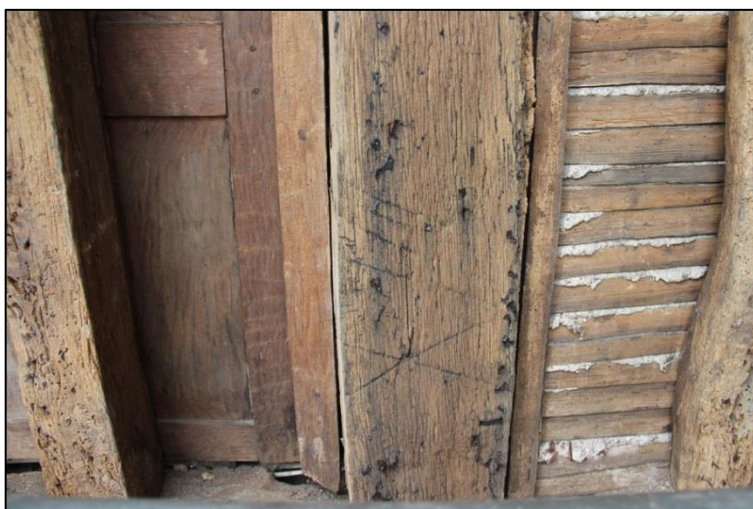
Very few carpenter's marks were observed in this elevation, the only exception being at the southern end where four straight and a series of lines forming a circle have been incised into the brace and the post (Plate 5).

Plate 5: Carpenter's mark on a first floor post

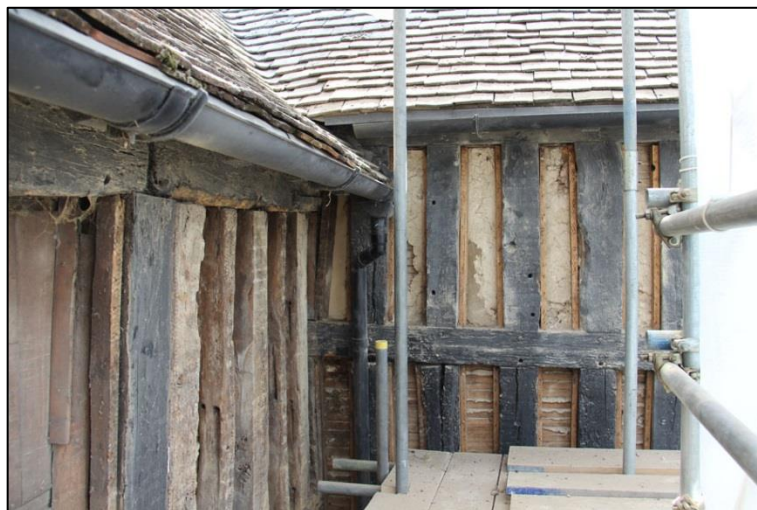
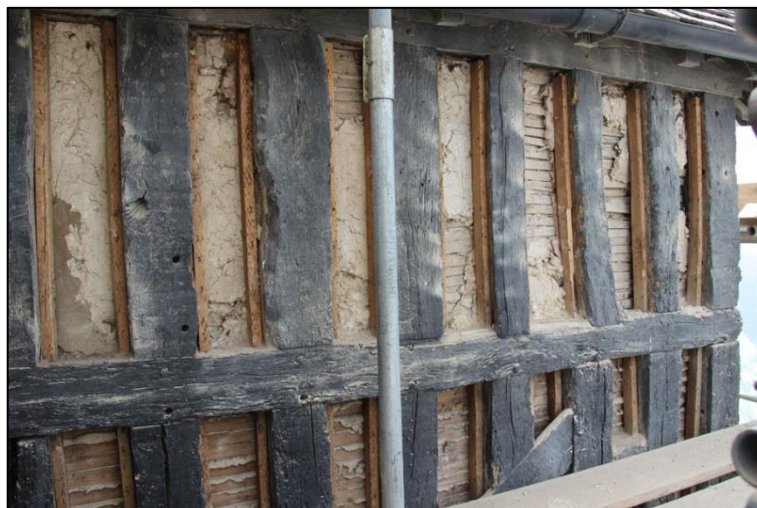
The cross wing has seen several episodes of rebuilding. It was clearly heightened, as is evident in the addition of an entire series of studs above the original wall plate in the north elevation (Plates 6 & 7). Further evidence can be seen in the south elevation where the tops of the jowlposts have been cut and reinstated above the original wallplate (Plates 8 & 9). The northern jowlpost in the west elevation remains unaltered, but its counterpart to the south has been replaced by a straight corner post. Indeed, the posts adjacent to this in the south elevation, like the corner post, extend as far as the heightened roof and must all have been inserted when the roof was raised. Within this section of timberwork at the western end of the south elevation, is a timber mullioned window that houses a more recent single light casement window at its eastern end (Plates 10 & 11). The central mullion is square section and the iron rod to the north of it survives. The principal posts to either side of this mullioned window have mortices which appear to have been for a large window, which could either suggest that the mullioned window is a later insertion or that the posts have been reused, as is the case with a post to the east of the southern chimney stack.

Plate 6: Cross wing north elevation

Plate 7: Cross wing north elevation

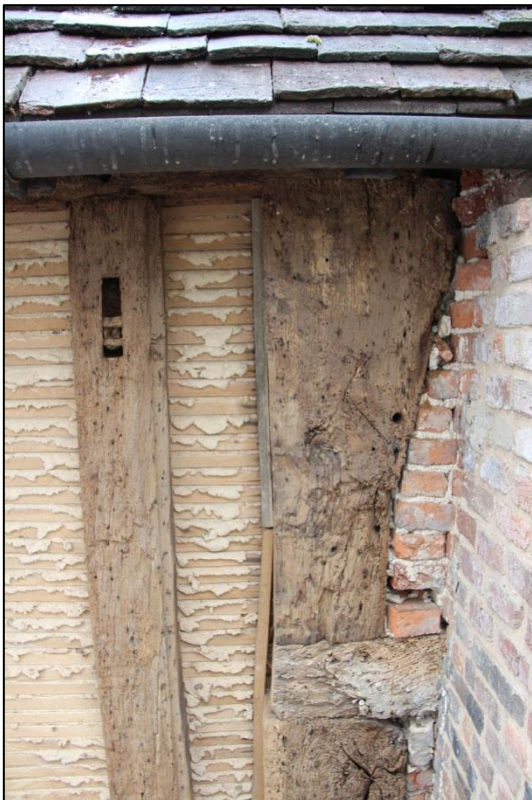
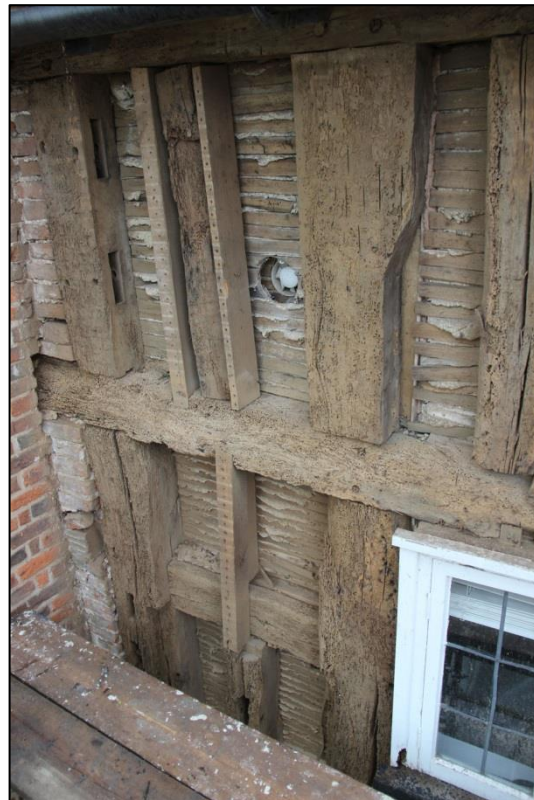
Plates 8 & 9: South elevation; cut and re-instated jowlposts to the west and east of chimney stack

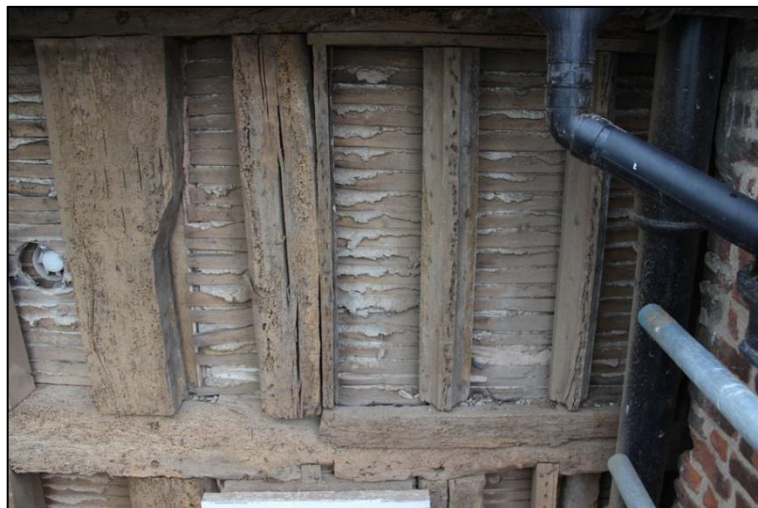
Another mullioned window was revealed in the timberwork between the two chimney stacks in the south elevation. It clearly pre-dates the construction of the eastern stack as the eastern end of the window is blocked by the stack (Plate 12).

Plate 12: Eastern window in the south elevation

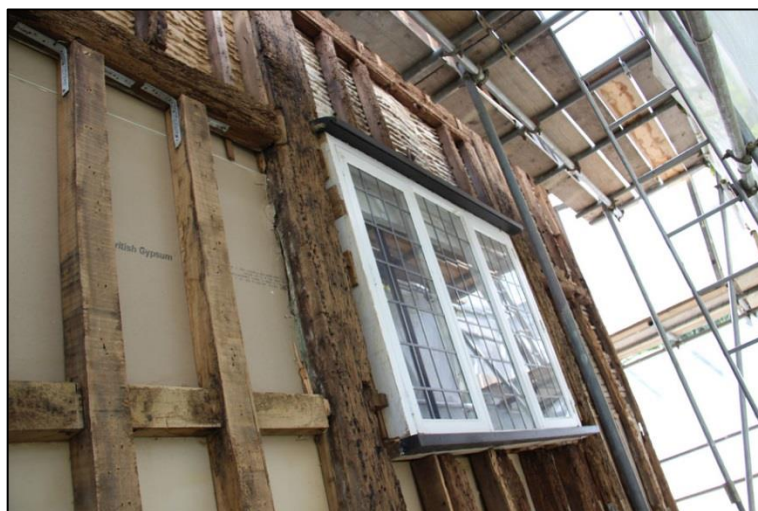
The west elevation has a single light timber casement at the top of the elevation, below which is evidence for another timber mullioned window truncated by a more modern replacement (Plate 13).

Plate 13: Fenestration at first floor level in the west wall of the cross wing

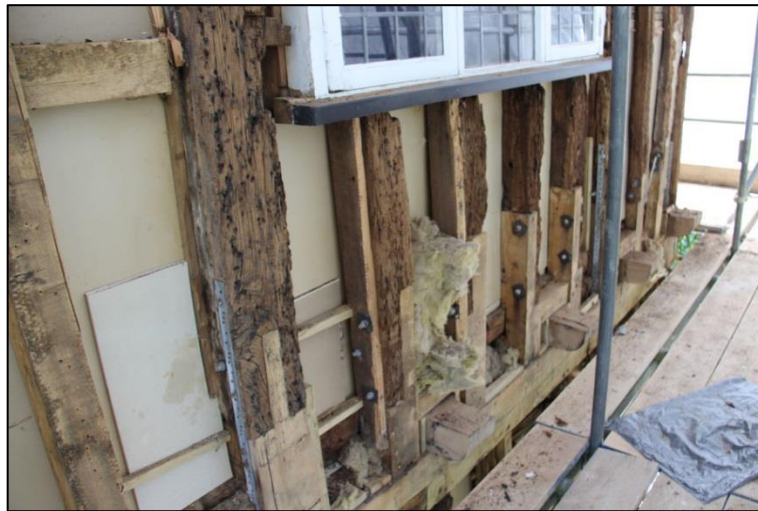
More recent alterations, many dating from 2001, are clearly evident at lower levels where entire studs and the floor joists have been replaced (Plate 14). There is modern studwork at the eastern end of the south elevation (Plate 15) with brick and breeze block to the west of it, and a section of the north wall has been replaced with breeze block. A new wall had been built in front of the original brick supporting dwarf wall and the gap filled with sand (Plate 16).

Plate 14: Modern repairs in the west elevation

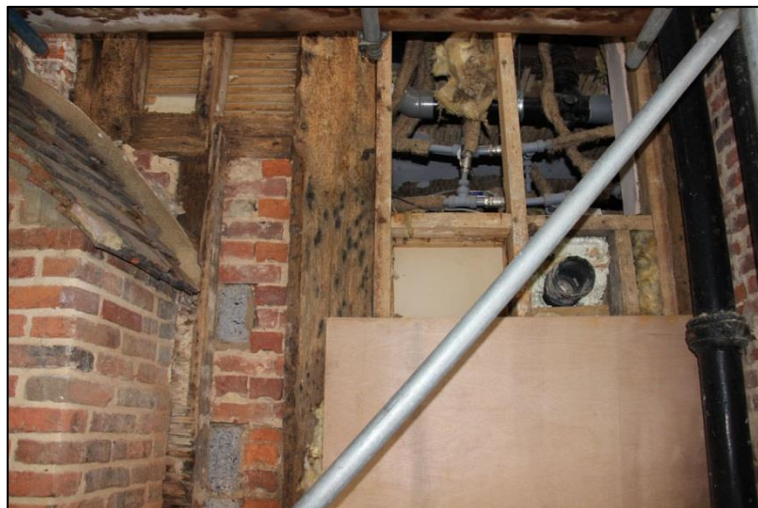
Plate 15: Modern studwork in the south elevation

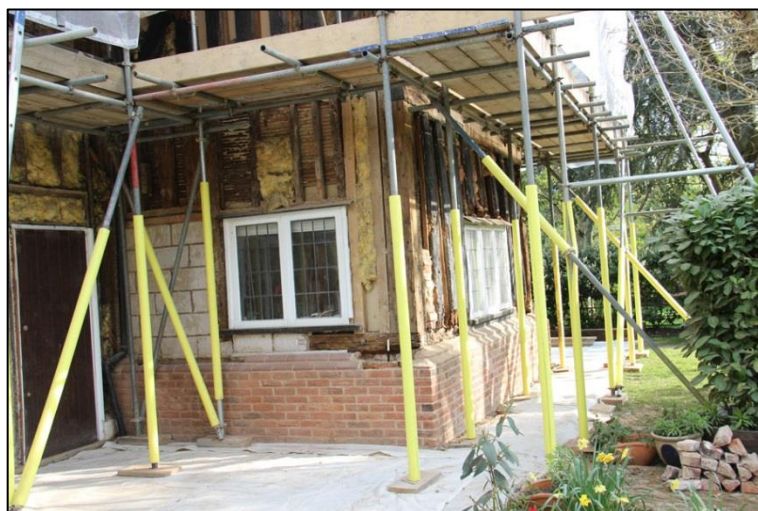
Plate 16: Breeze block in the north elevation of the cross wing

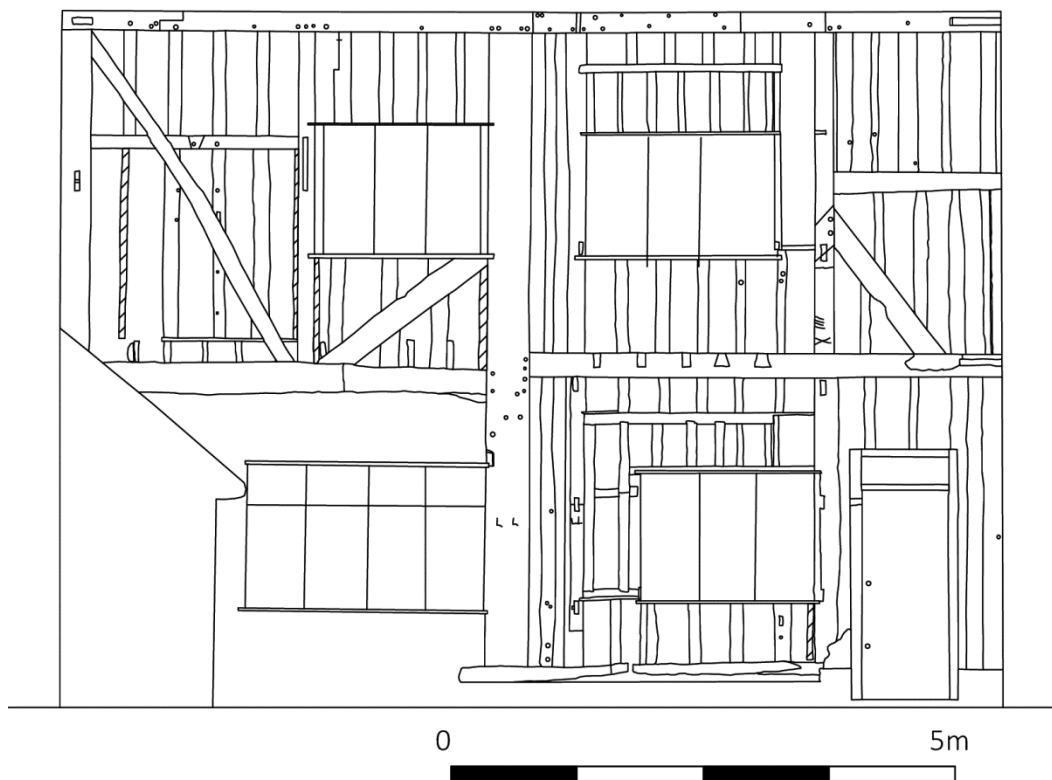
Figure 3: Main range west elevation (scale 1:75)

The remedial works consist of the fumigation of the entire structure to eliminate wood-boring insects, the replacement of cement rendering with lime rendering on the south and west elevations, the removal of modern decorative timberwork and the replacement of rainwater goods. (Fig. 3)

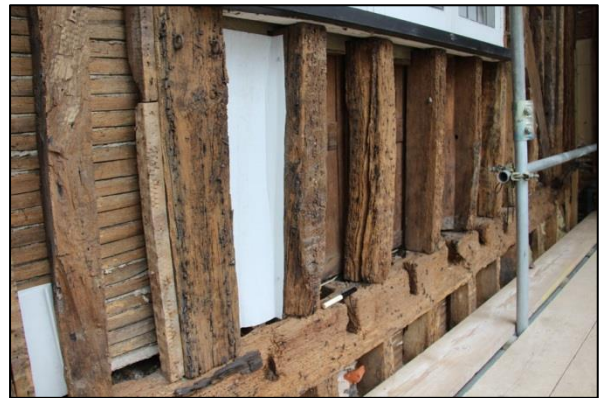
Plate 31: Midrail with redundant seatings for window

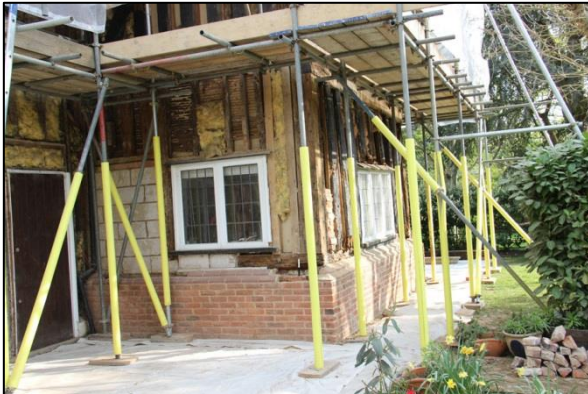
Plate 45: Ground floor with modern brick plinth

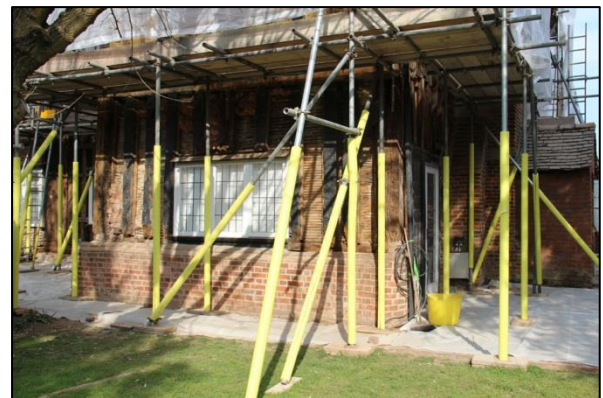
Plate 73: Ground floor with the modern brick plinth
