Historic Building Watching Brief

The Hayloft
Chiltern Way Academy
Church Lane
Wendover
Buckinghamshire

<i>Author</i>	Karin Kaye MA MCIfA and Chris Martin-Taylor BSc	<i>Version</i>	445/WCL/2.1	<i>Date</i>	20.07.2020
---------------	--	----------------	-------------	-------------	------------

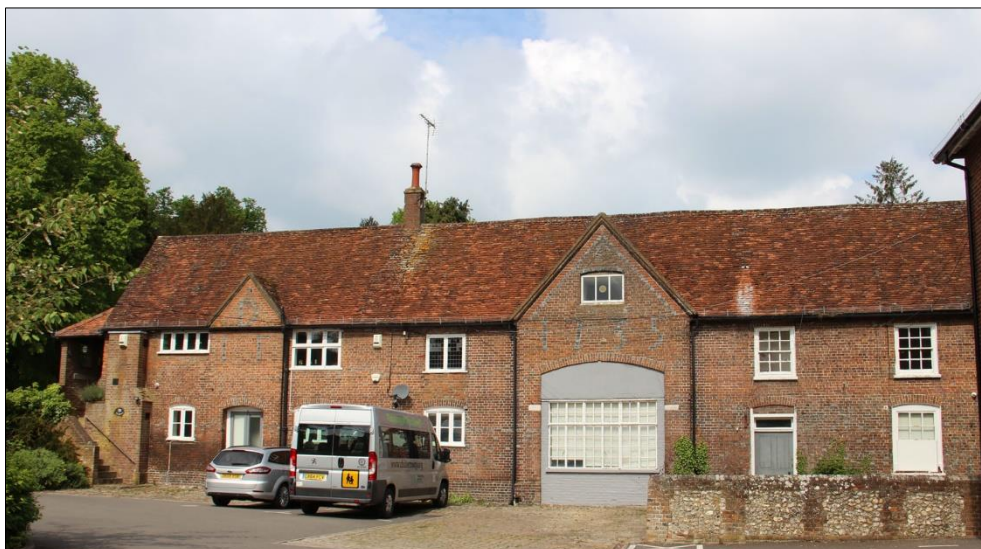
The Hayloft, which is also known as the Stable Block, was constructed c.1735 (Plate 1). The lower floor is currently being used as classrooms with staff accommodation above (Cullen 2018:10).

Plate 1: Main elevation with the date over the former carriageway (Shot 37)

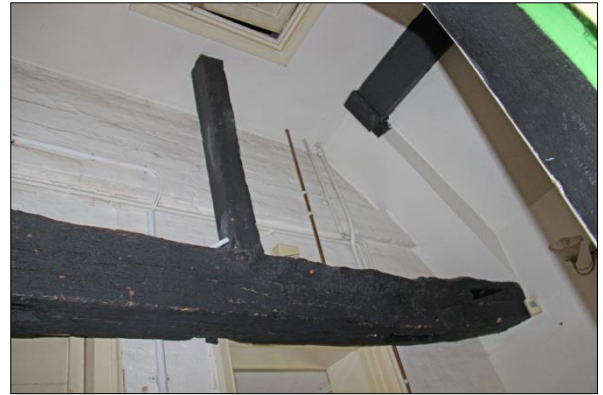
Plate 8: Truss 1, facing northwest (2)

Truss 1, which is located immediately inside the west wall of the Hayloft, has a king post on a tie beam that is 24cm high x 21cm deep and a 10cm² post (Plates 7 – 8). There is a large mortice at the northern end measuring 31 x 7cm, and two large mortices for posts in the soffit measuring 30 x 7cm to the north and 23 x 6cm to the south (Plate 9).

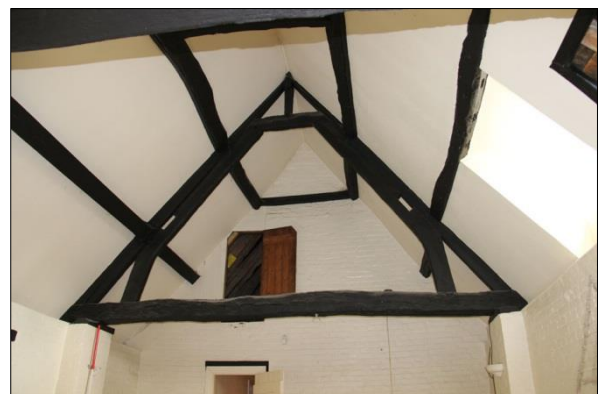
Plate 24: Truss 4, facing east (24)

Truss 4 has no mortices in the fascia, but does have two in the soffit measuring 23 x 5cm (Plates 24 – 26). Figure 4 shows Truss 4 but its structure is representative of Trusses 3, 4 and 5.

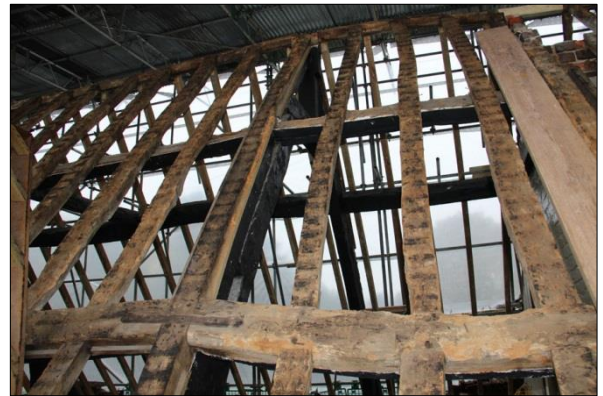
Plate 52: South roof, Truss 4 (104)

Some timbers are modern machine-cut replacements, notably all the rafters in Bay 3 have been replaced, as well as some sporadically replaced rafters in Bays 1 and 2. The replacement rafters are of a far lesser scantling and are no more than 5cm (2 inches) in thickness. A board was placed over the lower purlin in Bay 3, obscuring the original timber, the purpose likely to provide a level base with which to secure the new rafters (Plates 47 – 48). Some historic repairs are evident in Bay 5 with additional rafters measuring 10 – 12 cm added (Plates 53 – 55). The purlins to either side of Trusses 2, 4 and 5 are braced with iron straps (Plates 41, 52 and 56).

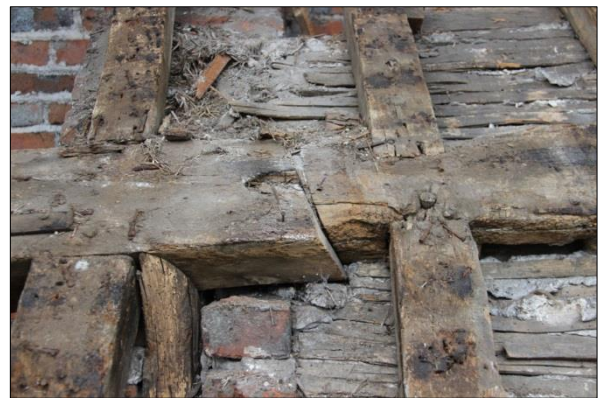
Plate 64: South roof, Bay 7 scarf joint (120)

The only scarf joints that are apparent on the south side are simple splayed joints.

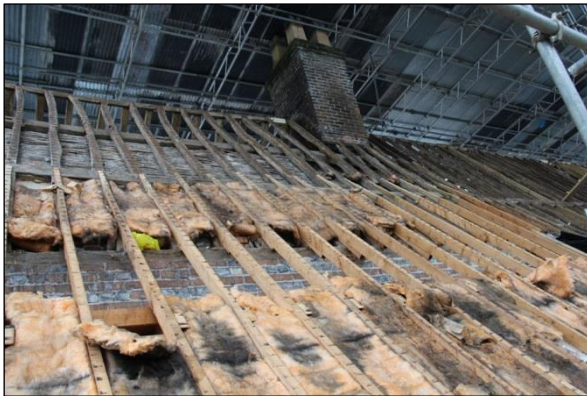
Plate 97: North roof, Bay 7 (82)

The majority of the rafters on the north side of the roof are modern replacements of the same type found to the south, particularly at the west end (Plates 73 – 80). The exception is most of the rafters in Bay 5 and all of those in Bays 6 and 7, which are still hand cut (Plates 81 – 100). The principal rafters remain unchanged however. The lower purlins were also replaced in Bays 1, 2, 3 and 4 but the upper purlins are still original. More carpenter's marks are present on the original lower purlins on the north side. The marks in Bay 5, though still Roman numerals, are of a distinctly different type than those on the other side of Truss 5 in Bays 6 and 7. Those in Bay 5 are considerably larger, covering the entire width of the purlin, this may represent a different craftsman (Plates 83, 85 and 95). Truss 5 has another iron strap brace (Plates 86 – 87). A modern catslide roof is present at the east end, with modern 5cm (2 inch) rafters that attach to the original hand cut rafters in Bay 7, overlapping them at a shallower angle (Plates 97 – 100). They are placed 32cm (1 foot) apart.
