## Historic Building Recording

11 Fishpool Street  
St Albans  
Hertfordshire

<i>Author</i>	Karin Kaye MA MCifA	<i>Version</i>	448/SAF/2.1	<i>Date</i>	10.05.2019
<i>Editor</i>	Ellen Shlasko PhD	<i>Version</i>	448/SAF/2.1	<i>Date</i>	10.05.2019
<i>Revision</i>		<i>Version</i>		<i>Date</i>

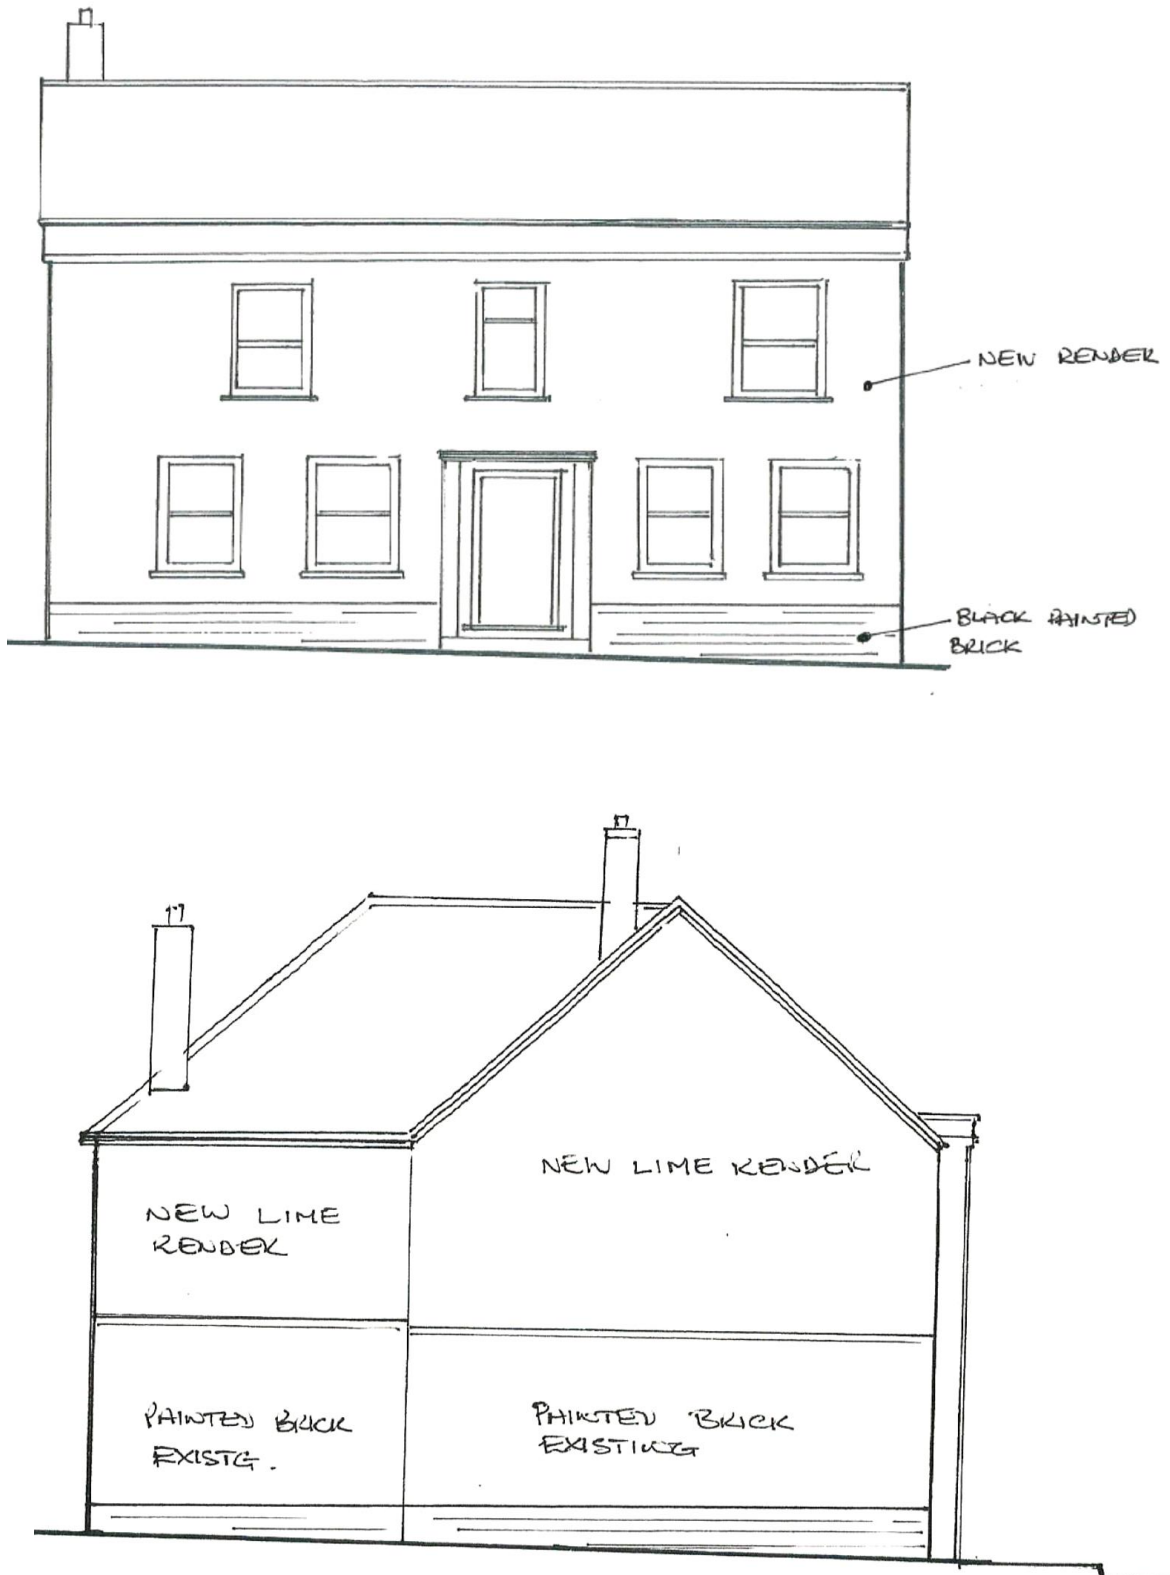
Figure 3: Remedial works– front elevation (top) and flank (east) elevation (bottom) (not to scale)

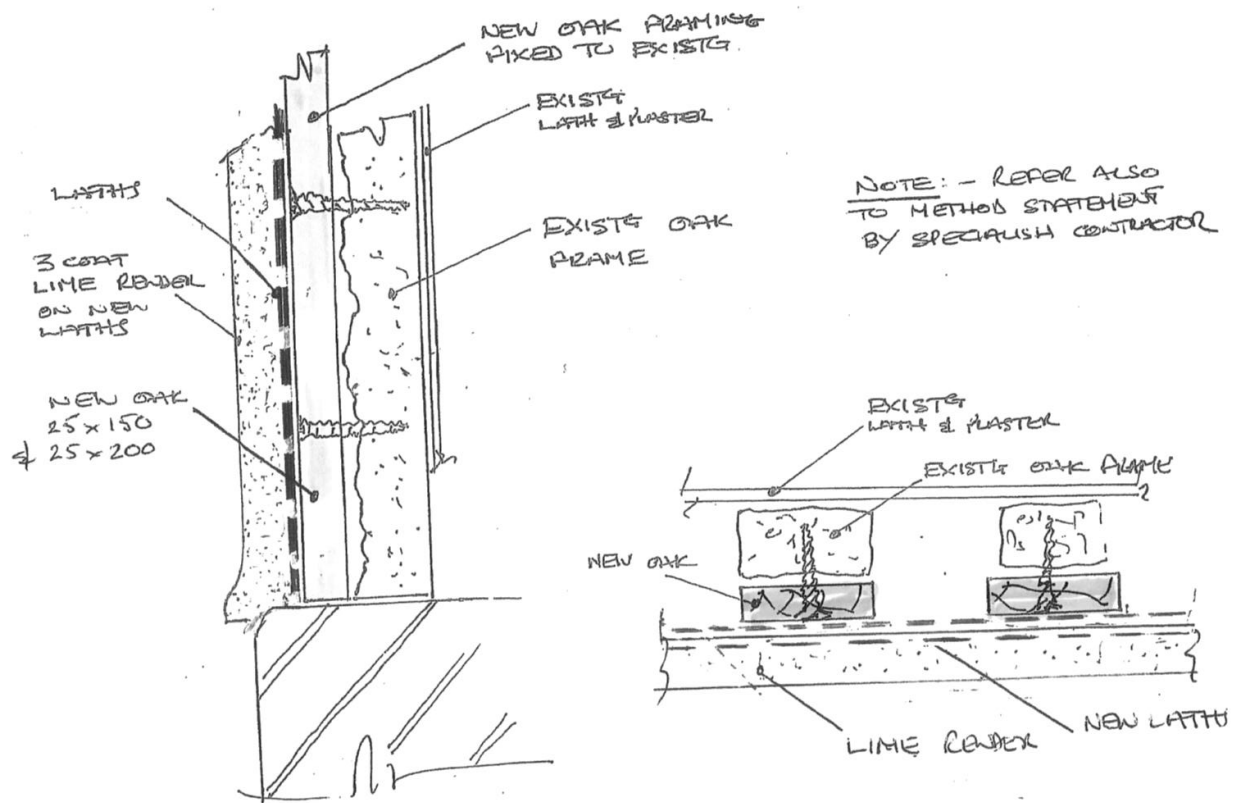
Figure 4: Sketch details of repair work (not to scale)

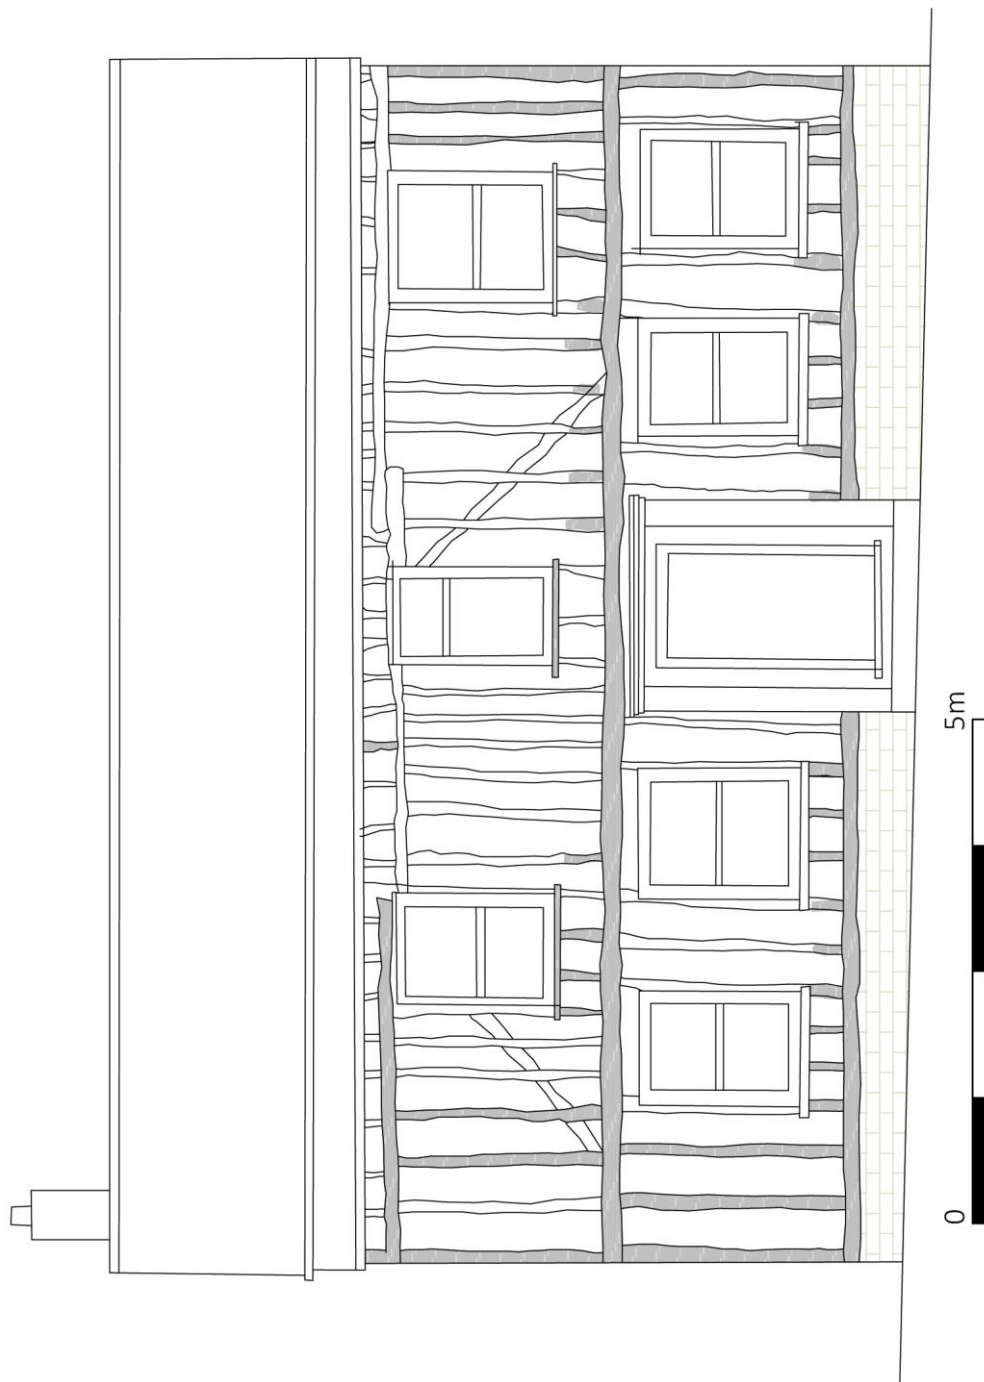
**Figure 11:** North elevation showing decayed timbers (scale 1:75)

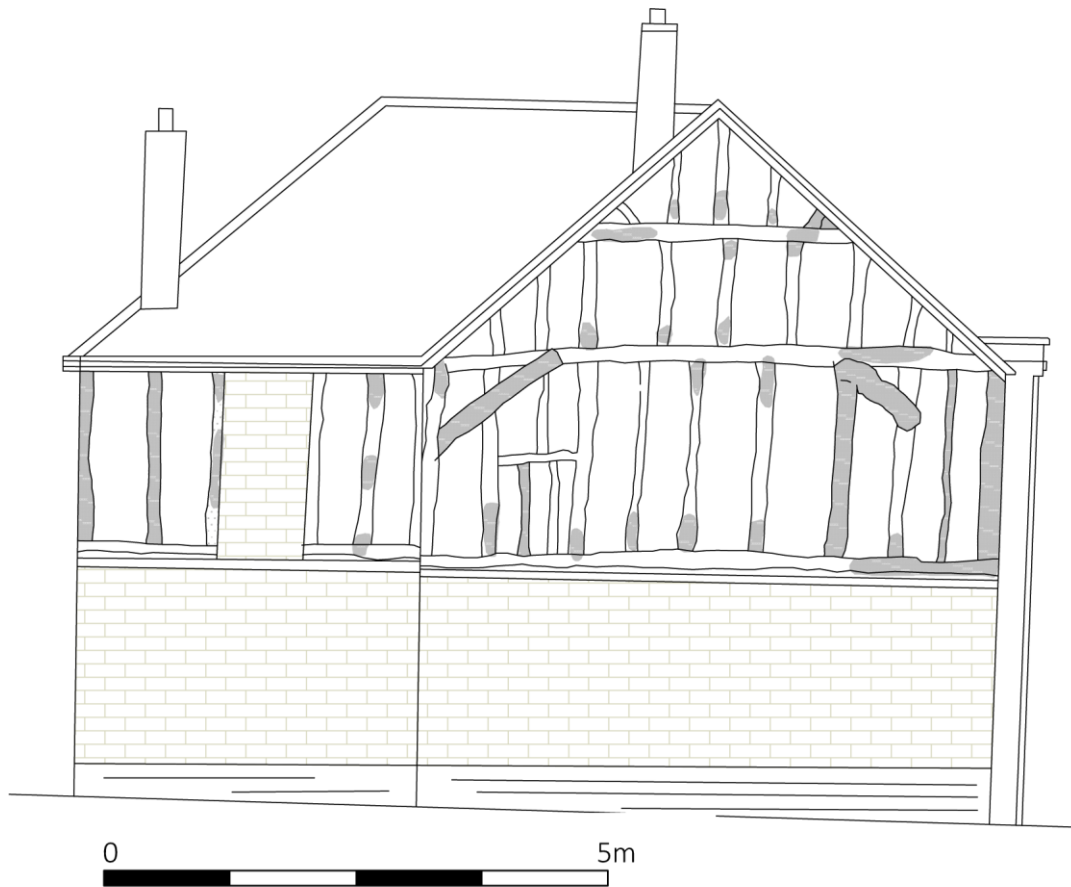
**Figure 12:** East elevation showing decayed timbers (scale 1:75)

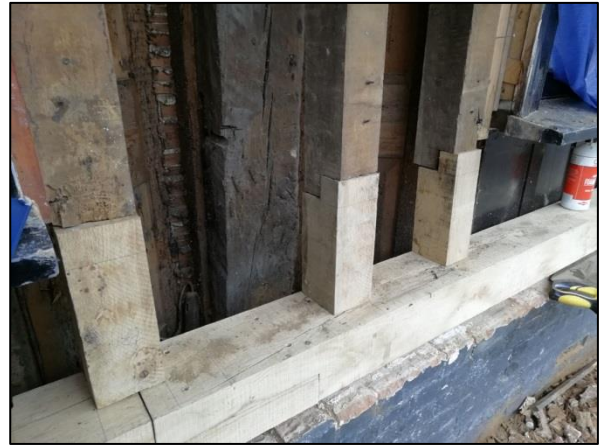
**Plate 17:** North wall: repairs to studs

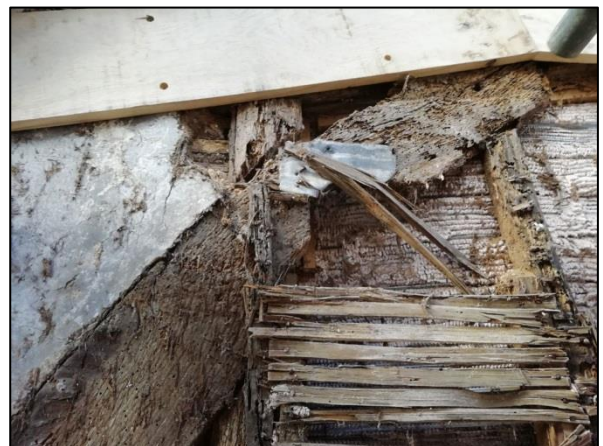
**Plate 35:** East wall: decayed brace & stud with laths to front and modern plasterwork to rear

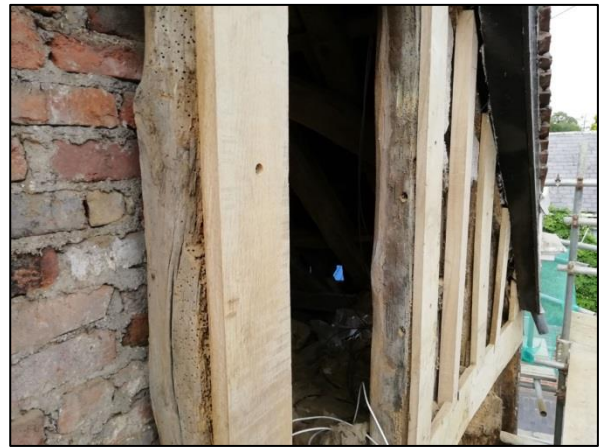
**Plate 43:** East wall: new studs in front of the original

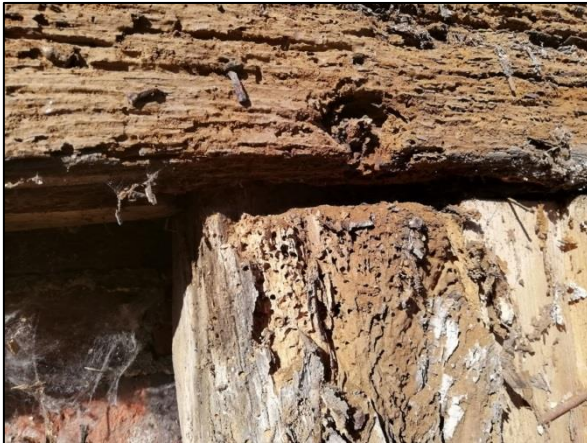
The presence of death watch beetle and other wood boring insects as well as damp, caused such extensive timber decay to many of the structural timbers as well as the minor studs that immediate remedial work was called for. The inappropriate cement based render caused further issues in that the mathematical tiles could not be saved. A strategy was agreed with the SADC Conservation Department whereby:

**Plate 46:** Detail of decay to post and beam

- The severely decayed timbers would be repaired or replaced with new air dried oak timbers
- A new timber frame made of air dried oak studs measuring 25mm thick and the width of the existing, which varies between 140mm to 220mm, would be added to the external face of the existing timbers. In the event, the 25mm thick studs were used almost exclusively on the east elevation and a few added to strengthen original studs on the north elevation.
- New traditional oak laths would be fixed to the new frame using stainless steel shank nails
- Three coats of lime render with horsehair or similar would then be applied

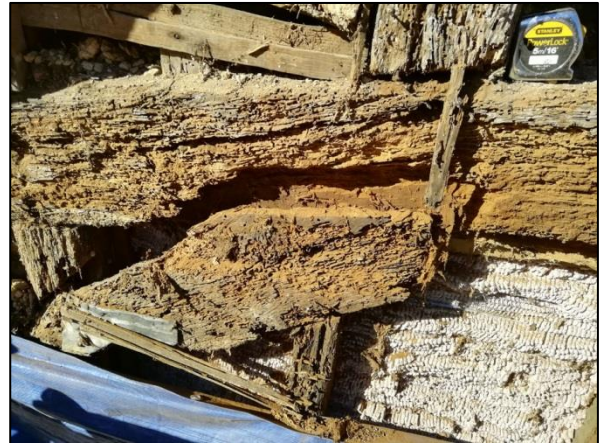
**Plate 47:** Detail of decay to beam and brace

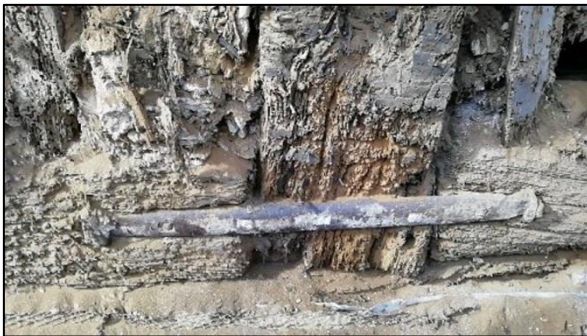
**Plate 48:** Iron tie holding decayed post and beams

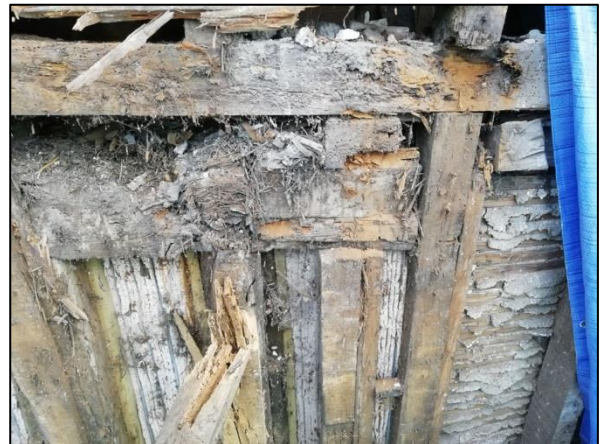
**Plate 49:** Decay to 18<sup>th</sup> century frame

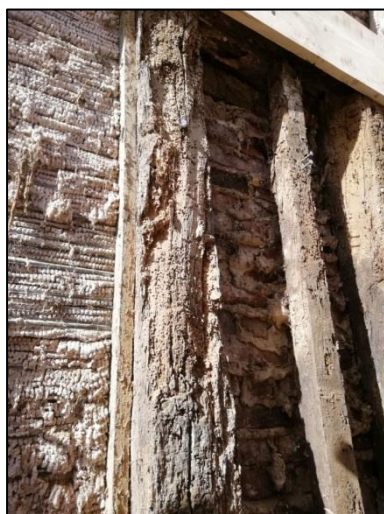
**Plate 50:** Decayed stud with modern plasterwork to the left

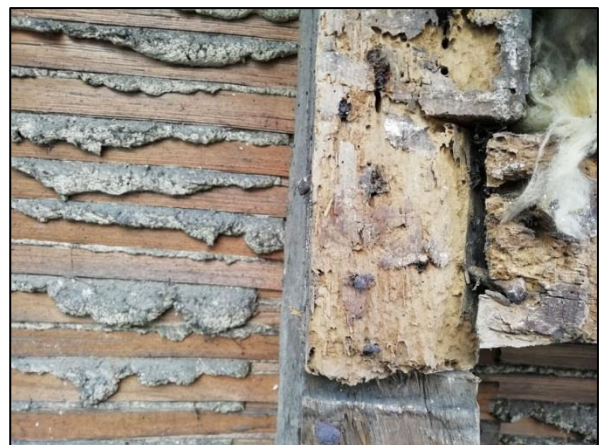
**Plate 51:** Decayed post with lath & plaster behind

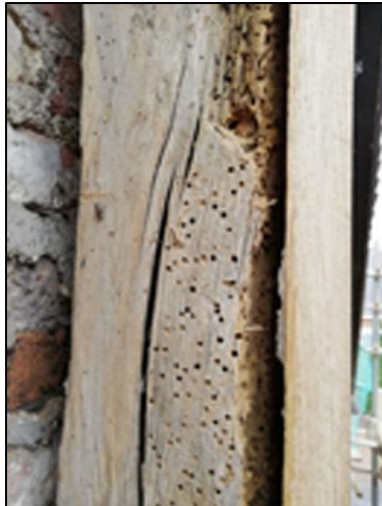
Plate 54: New stud in front of original, infested stud
