KDK ARCHAEOLOGY LTD

Historic Building Recording

New Farm
2 St Mary's Road
East Claydon
Buckinghamshire

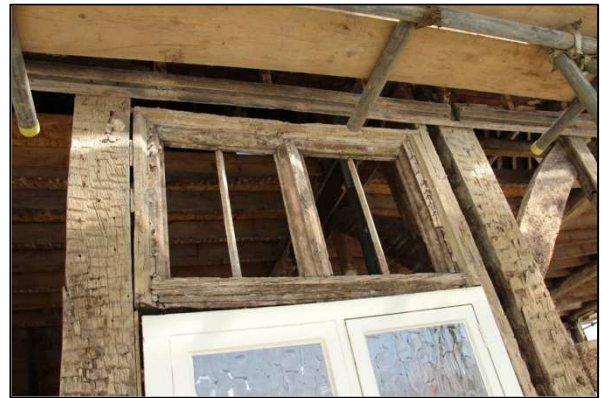
Plate 10: South elevation: timber mullioned window in panel 6

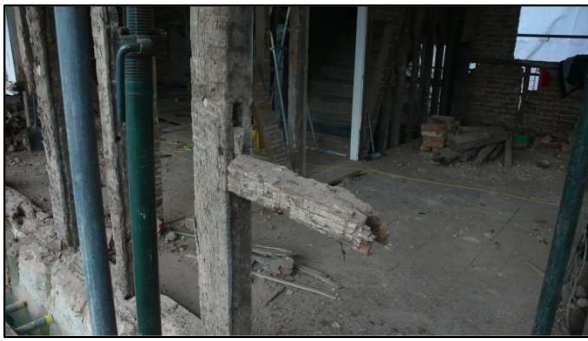
Plate 19: South elevation: detail of decayed rail

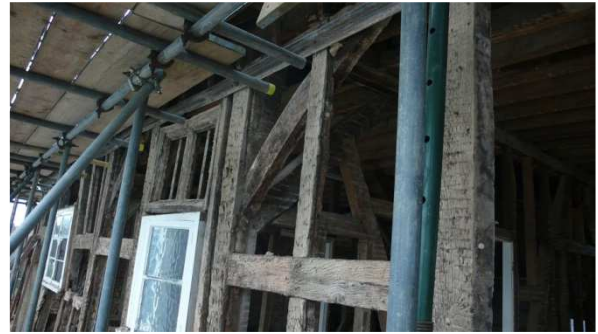
Plate 20: South elevation: stud in panel 8 without V groove

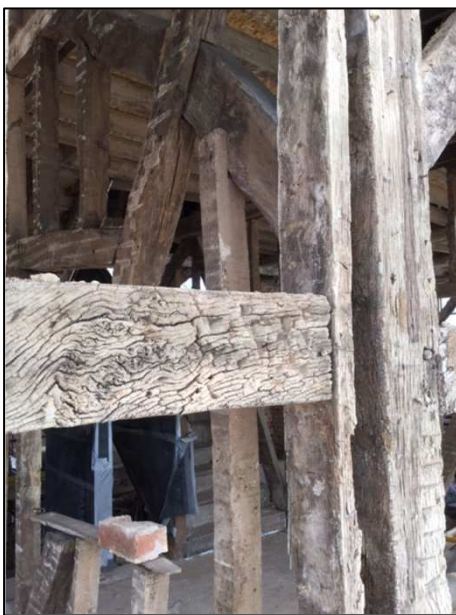
Plate 27: South elevation: eastern side of former window

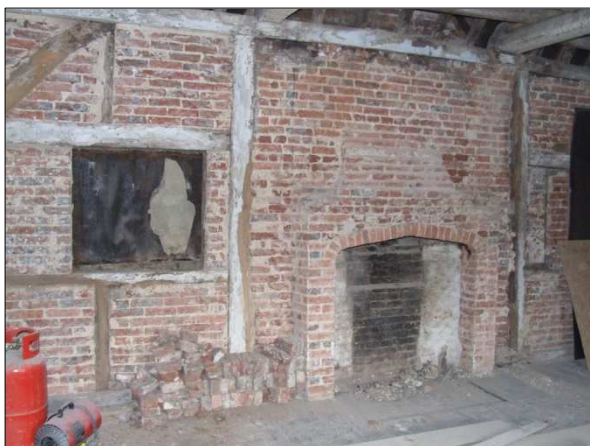
Plate 39: Blocked mullion window to the left of the fireplace

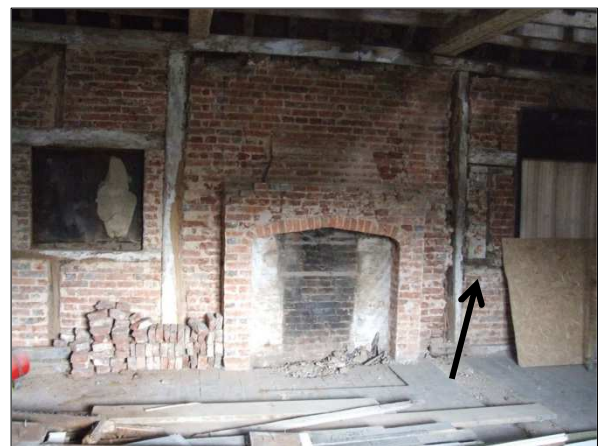
Plate 40: Remains of locked mullion window to the east of the fireplace
