KDK ARCHAEOLOGY LTD

**Historic Building Recording,
Historic Building Watching Brief &
Archaeological Watching Brief**

Abdale House/Northside
32-34 Warrengate Road
North Mymms
Hertfordshire

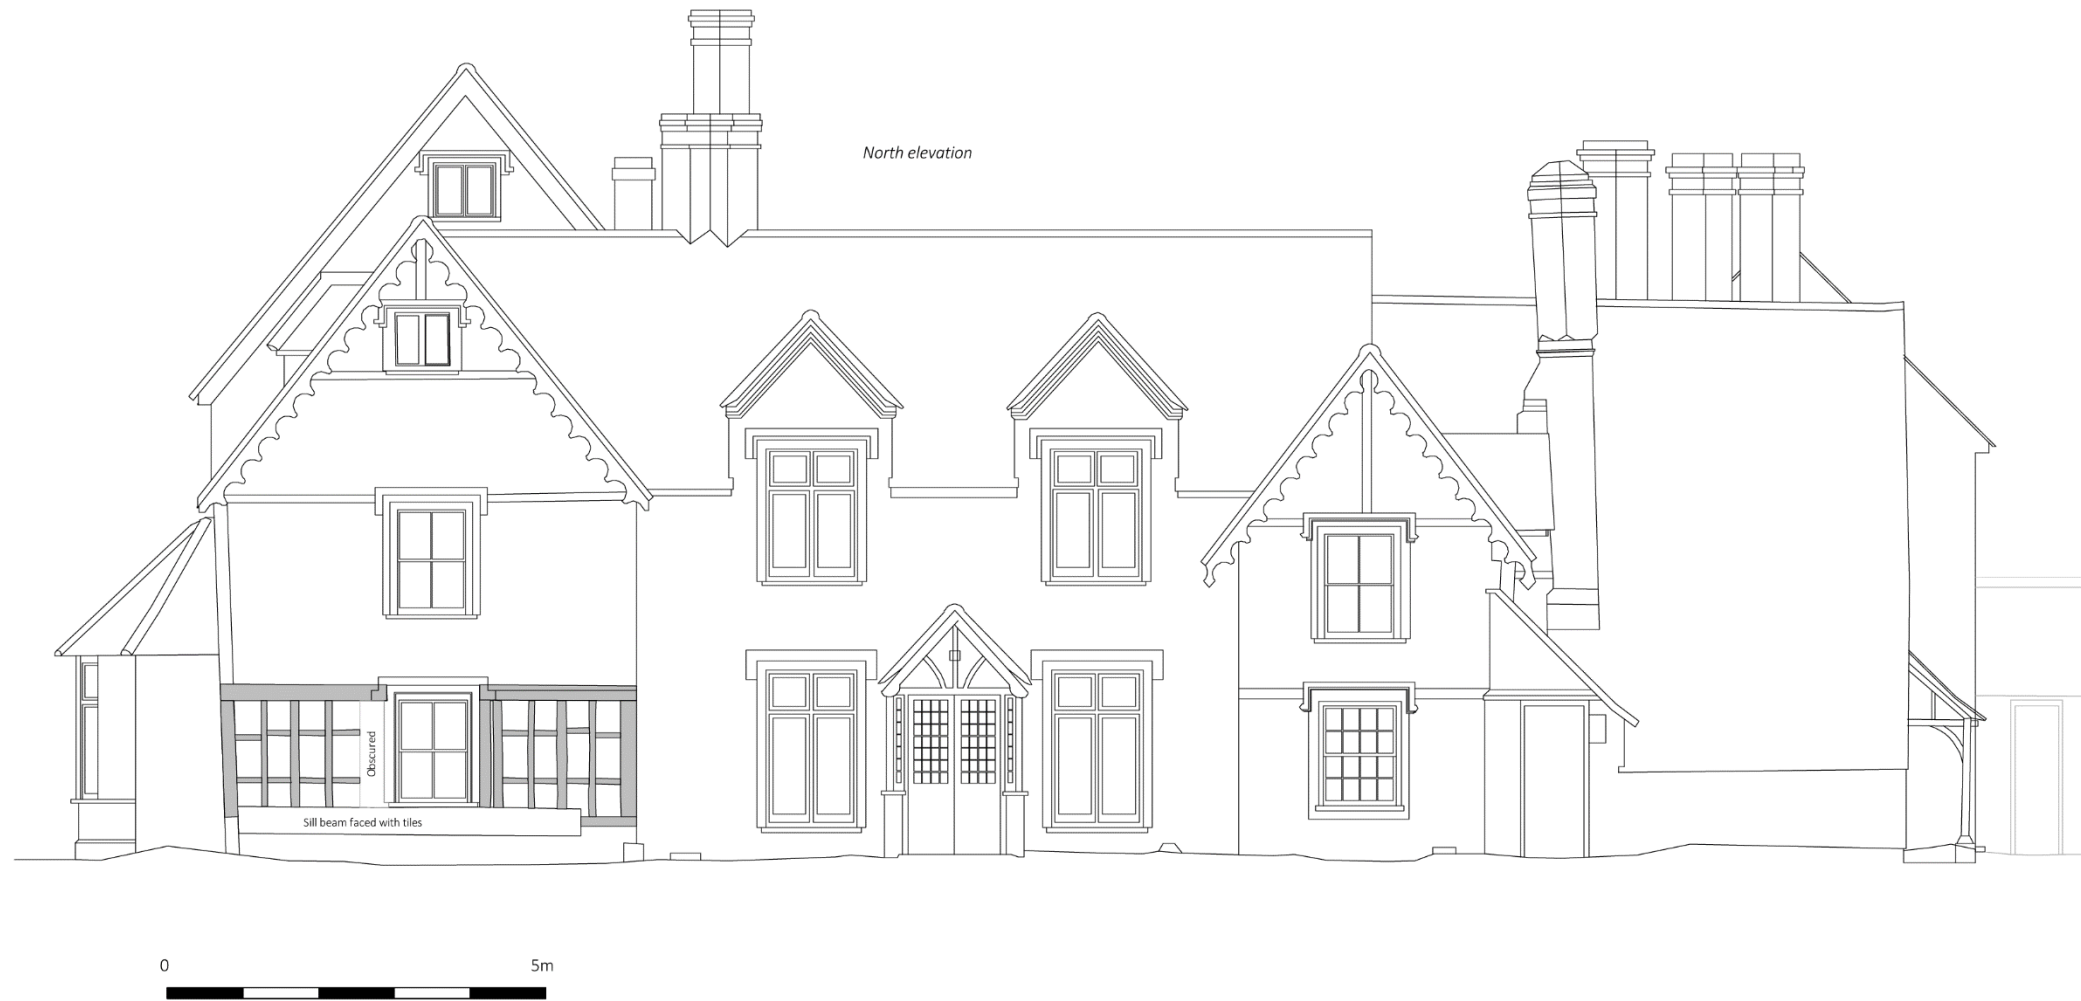
Figure 5: North elevation showing the timberwork exposed during the building works (scale 1:100)

- 4.6 Close studding was revealed in the east wall with tension braces in the north, south and east walls at first floor level (Room F4; Photos 143-154). The studs in the latter are mostly later replacements and bonding timbers are prevalent throughout. Although the reworking of the south wall appears to be a single phase of 18th century date, the north and west walls have been extensively re-worked, with only a few original studs surviving to the west of the window in the north wall. The west wall was largely rebuilt in the 19th century when the fireplace was installed. The remains of a 4-centred arch survive behind a later fireplace in the room below, (G2; Photos 44-57), which also has a spinal beam with lamb's tongue chamfer stops, a feature commonly used between 1560 and 1650. The room was extended to the south in the 19th century to house a canted bay window and French doors. The roof over the east crosswing (Fig.15 ; R6 & R7; Photos 254-255, 257-260) is probably the original and has 8 cm wide pegged rafters on 35-45cm centres. Some carpenter's marks are still visible, as are some widely spaced saw marks, which could have been either the result of being cut in a saw pit or an early mill.

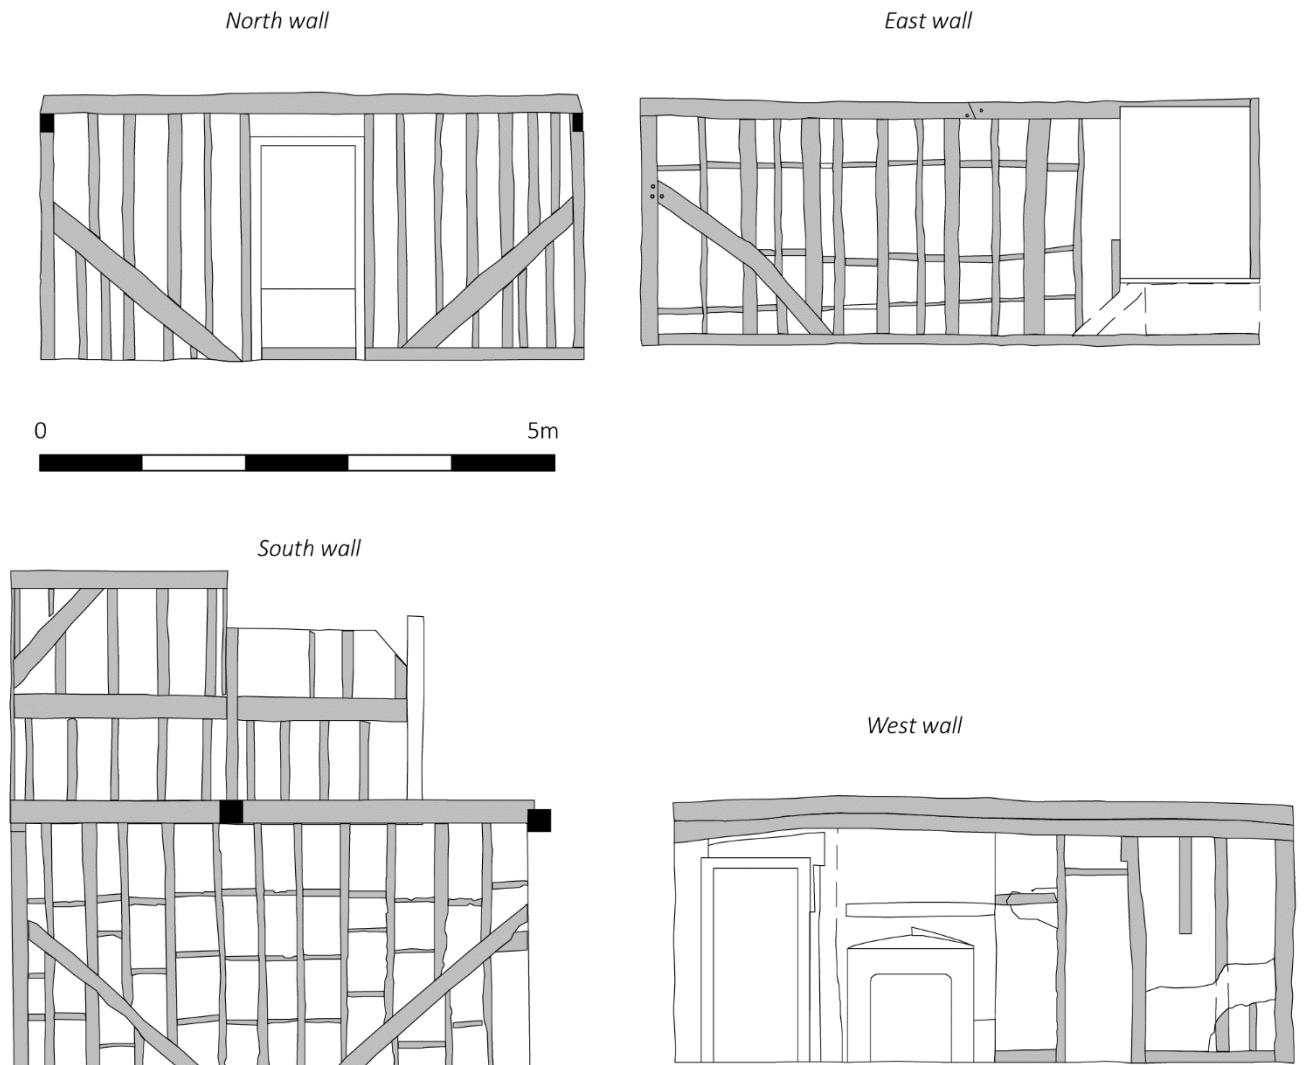
Figure 19: Room F4 timberwork (scale 1:75)

Additional notes: Room F4 was fully exposed and also visible from the room below (G2). The walls have curved tension braces 17-22cm wide. The studs in the east wall are closely set at 40cm centres but the studs are alternately 16 and 7cm wide. The bricks in between are 23x10x5cm. The mortar is actually hard render. The same can be seen in the south wall where render has replaced the mortar. The studs here are mostly later replacements and binding timbers are prevalent. This appears to be late 18th century reworking of the wall. The north wall is largely obscured by debris. Only the braces and the central part to the left of the window before the brace are original. Earlier replacements are 13cm wide on 40cm centres. Modern studs are more prevalent to the right of the window. The west wall has been largely rebuilt, probably in the 19th century when the fireplace was installed. The bricks in between the studs also appear to be 19th century. The ceiling joists are also later replacements although the floor boards above are wide.

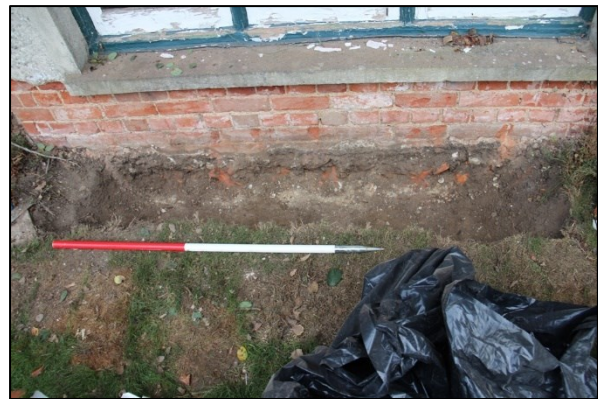
Plate 5: Brick footing beneath G4

Another French drain was excavated along the east and south elevations as far as the western end of Room G4 (Plates 3-5). The drain, which was hand dug around the scaffolding posts, was c.0.30m wide and 0.30m deep. The east elevation as well as the south wall of G3 had been underpinned with concrete foundations (Plate 4) but the late 19th century brick foundations for G4 had not been altered.

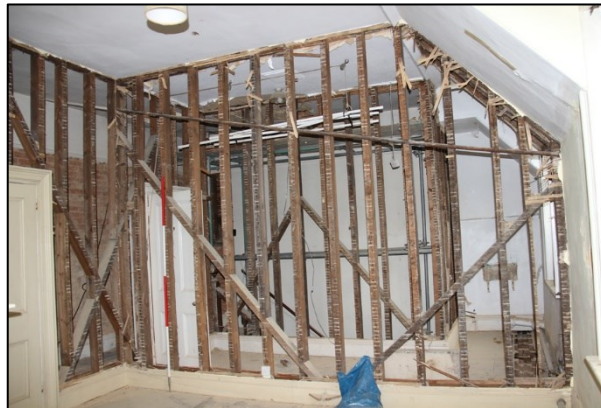
- 4.7 The central section of the original medieval house (Rooms G1; Photos 24-43, F1-3; Photos 121-142) was heavily rebuilt in the late 19th century. The original north wall was demolished and a brick wall constructed approximately 1m further northwards, the ceiling of G1 was entirely rebuilt and has two rows of scissor bracing between the newer joists. The first floor was re-configured with new stud partition walls using machine cut timbers with primary bracing were installed to form Rooms F2 and F3 off the landing (F1). The roof was entirely replaced over this part of the house; the rafters are clearly machine cut 2 x 4" with a ridge board and a single purlin to the south (Photos 235-237) It has a square, 4 stack chimney at the eastern end of the roof, built of red brick and cement with evidence of later repairs. As part of the rebuilding, the hall was given a new staircase and fireplace, although a medieval arch was retained above the opening to the west wing.

Photo F10: F1-3: 19th century partitioning

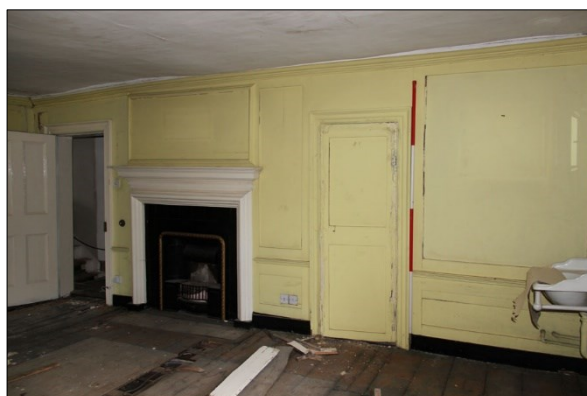
Photo F23: F4: west wall, door to right blocked with brick

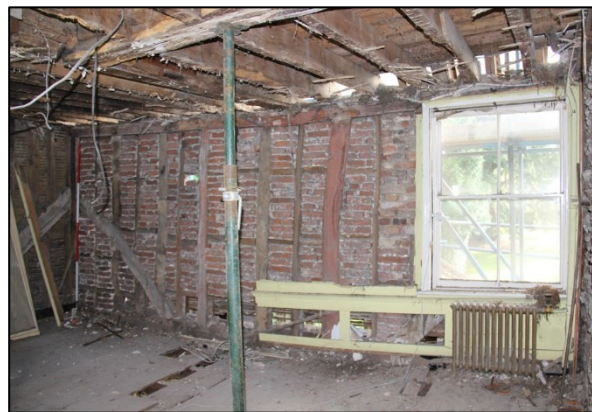
Photo F30: F4: east wall stripped

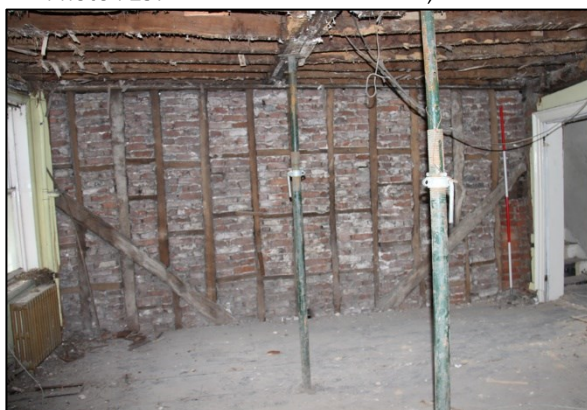
Photo F31: F4: south wall stripped

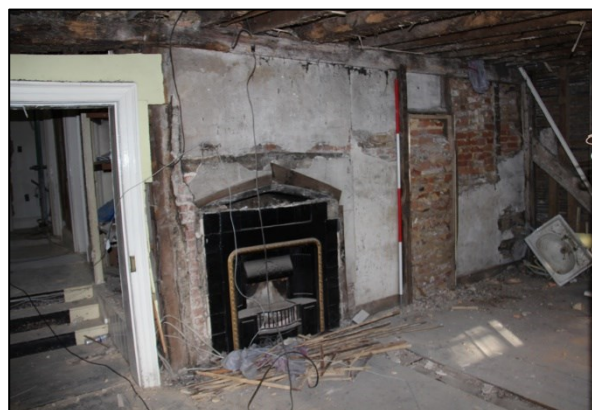
Photo F32: F4: west wall stripped

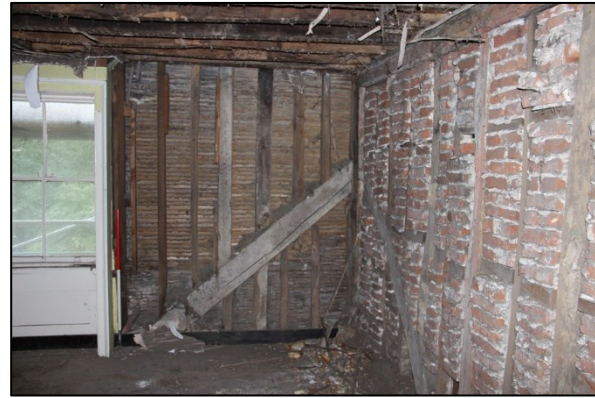
Photo F34: F4: east end of north wall stripped
