KDK ARCHAEOLOGY LTD

Historic Building Recording

Minsden Chapel

Scheduled Monument 1003543

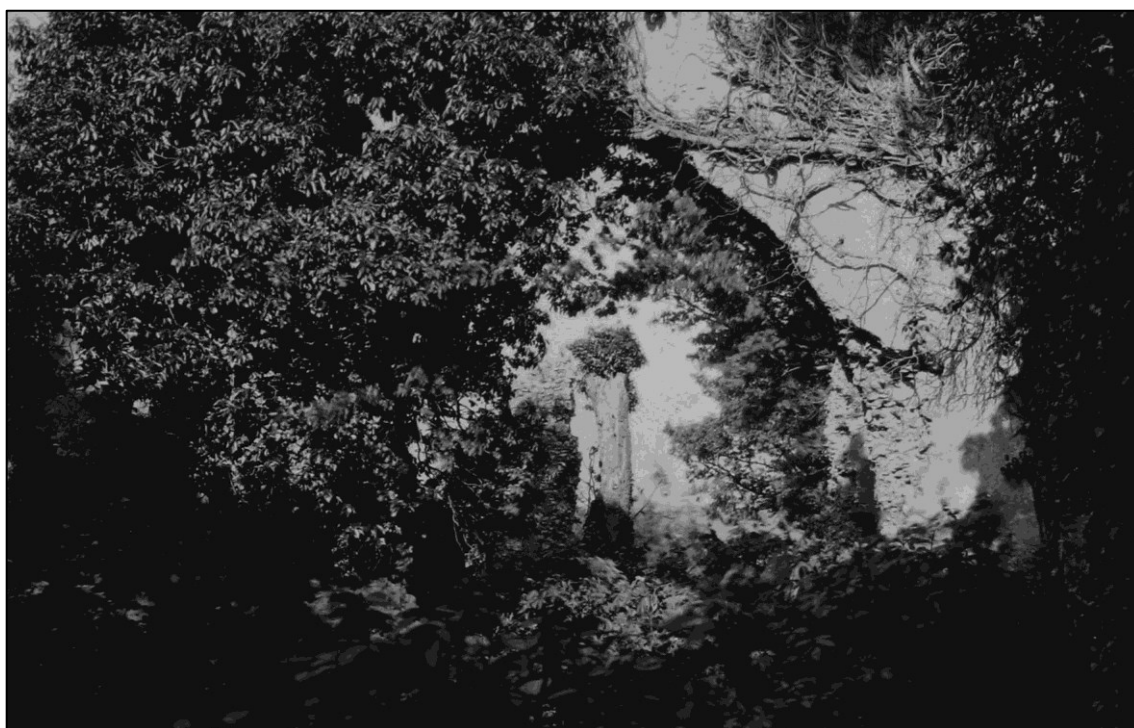
By 1909 a great deal of damage had occurred and the ruins had become heavily overgrown, but the chancel arch and some of the east window was still standing (Fig. 7). Two photographs taken in 1922 show the deterioration was advanced, but by the chancel arch was still intact in 2001 even if the east window had by then disappeared (Figs. 9 & 10).

Figure 7: Chancel arch 1909 (HALS DE/1042/8/75a)

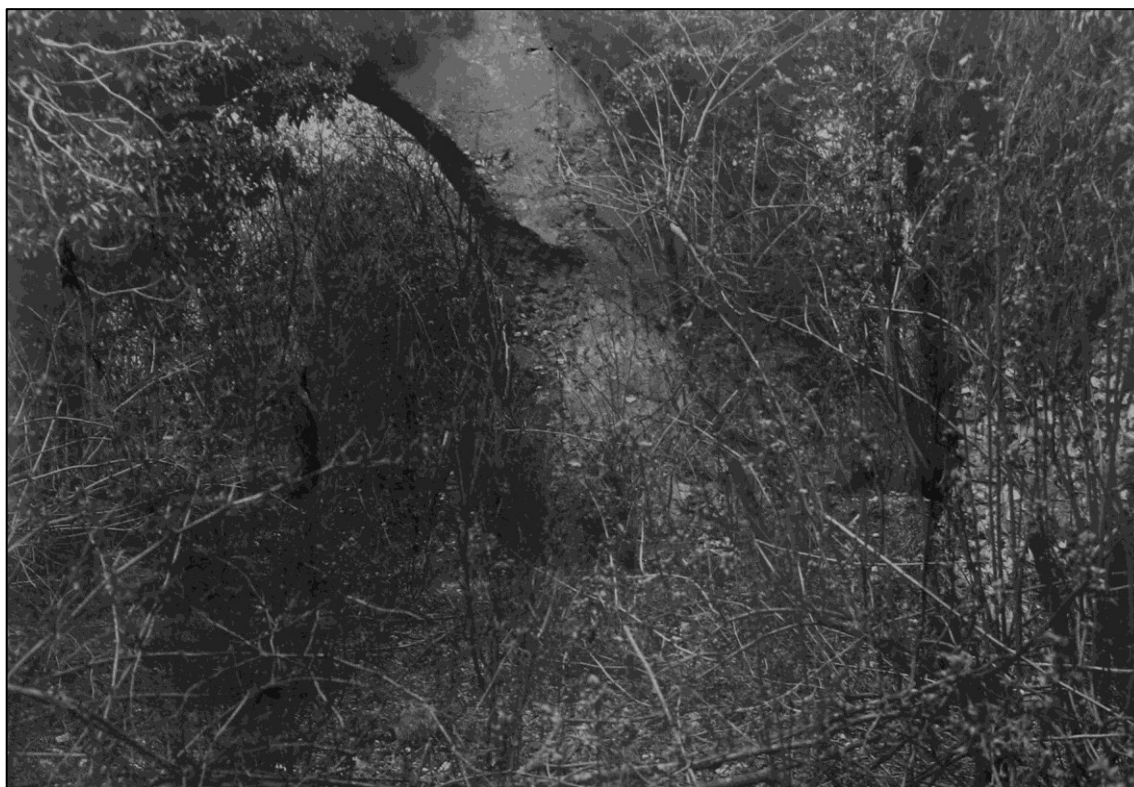
Figure 8: Chancel arch 1922 (HALS DE/1042/8/76b)

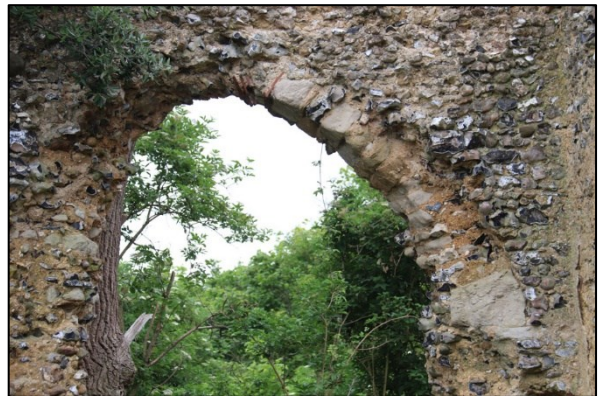
Plate 13: Voussoirs in the south wall (18)

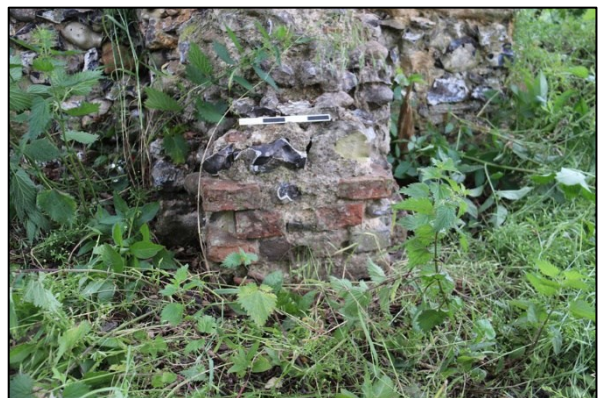
Roof tiles have also been used as walling material, to line some of the putlog holes and at the top of the window arch in the south wall between the voussoirs. These are largely isolated pieces, but the base of the buttress to the east of the south window has several courses of tiles. The base of the neighbouring buttress to the east is of floor tiles measuring 13 x 11 x 5cm and 10 x 10 x 5cm. Some roof tile is also present at the back of the buttress and also on the buttress at the east end of the nave. Whereas the tile within the walling is likely to have been spolia, that within the buttress is clearly later repair.

Plate 22: Floor tiles in southern buttress (32)

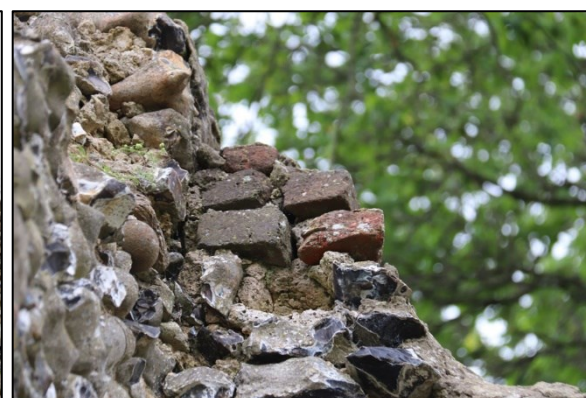
Brick has also been used within the structure; as a repair to the door opening in the north wall, and to construct a belfry in the southeast corner of the nave. The bricks within the door opening are c.13 x 10 x 6cm although some are only 5cm high and others are bullnosed. They are poorly puddled reds, with a few stone inclusions but no spanish and appear to be 18th century. The mortar is hard and cement based, which would suggest that the bricks have been re-used. The bricks used for the belfry could only be studied in detail through the camera lens and photograph. They are also handmade reds, with no apparent inclusions and appear to be c.5cm high. There is a narrow arched opening 4 courses high and roughly 29cm wide more clearly evident from within the church. The bricks are handmade reds and the return wall to the left of the opening is bullnosed. Bricks have also been used in later repairs to the south wall.

Plate 26: Brick repair work on south wall (66)

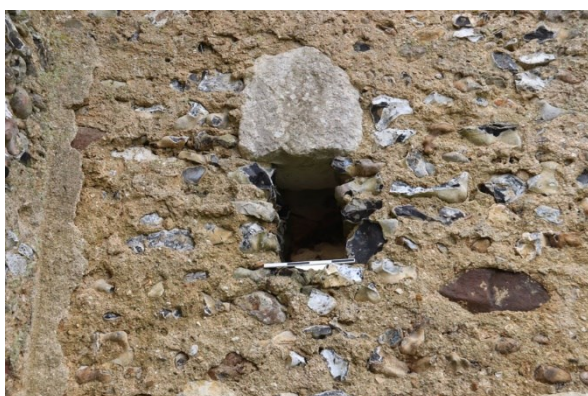
The putlog holes on the internal face of the west wall are the most distinctive. Those at lower level have been damaged, but the southern one is intact and has clunch sides and Barnack lintel. This mixture of material to line or frame the hole is typical, as can be seen in the table below. Often the lintel on the external face is different to that on the internal aspect, and it would appear that whatever was easiest to hand was put to use. This would include spolia, such as the large moulded clunch piece in the internal face of the west wall and a similarly moulded piece of puddingstone on the outer face of the same wall.

Plate 27: Moulded clunch lintel on interior of west wall (53)

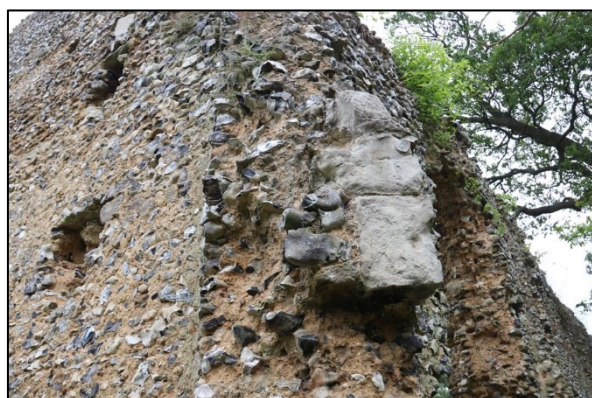
Close inspection of the buttresses suggest that they were originally built at the same time as the rest of the chapel but that many if not all were repaired at a later date. Although Buckler’s illustration shows the diagonal buttresses at the eastern end of the chapel as being completely faced with ashlar clunch, the evidence from the southwestern diagonal buttress suggests otherwise. The surviving clunch blocks are on the same plane as the adjacent flints, which would suggest the quoins were ashlar and a section of flintwork was left exposed in the centre, as at St Mary’s Baldock.

Plate 29: Clunch and flint on southwestern diagonal buttress (22)

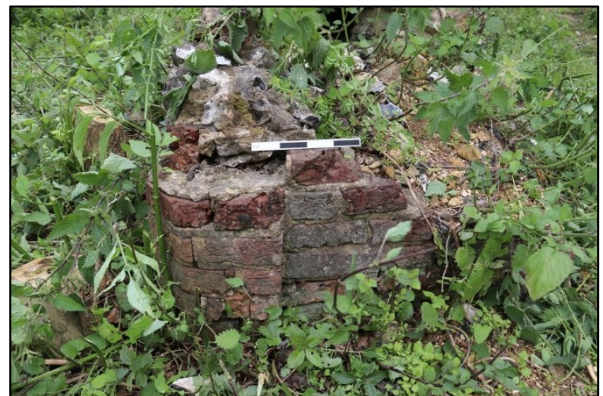
Shot 48: Brick base to door opening

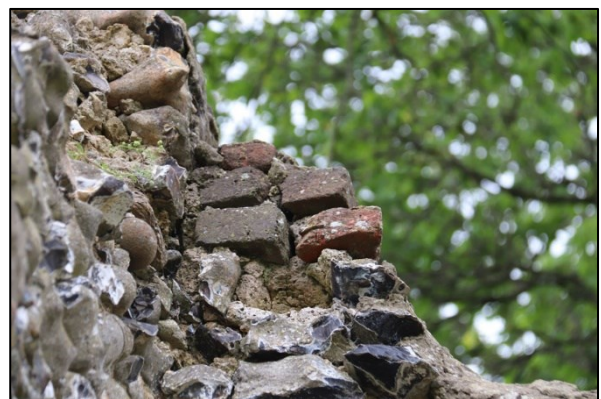
Shot 66: Brick repairs at the top of the freestanding section of south wall
