## Historic Building Watching Brief

Minsden Chapel

Langley

Scheduled Monument 1003543

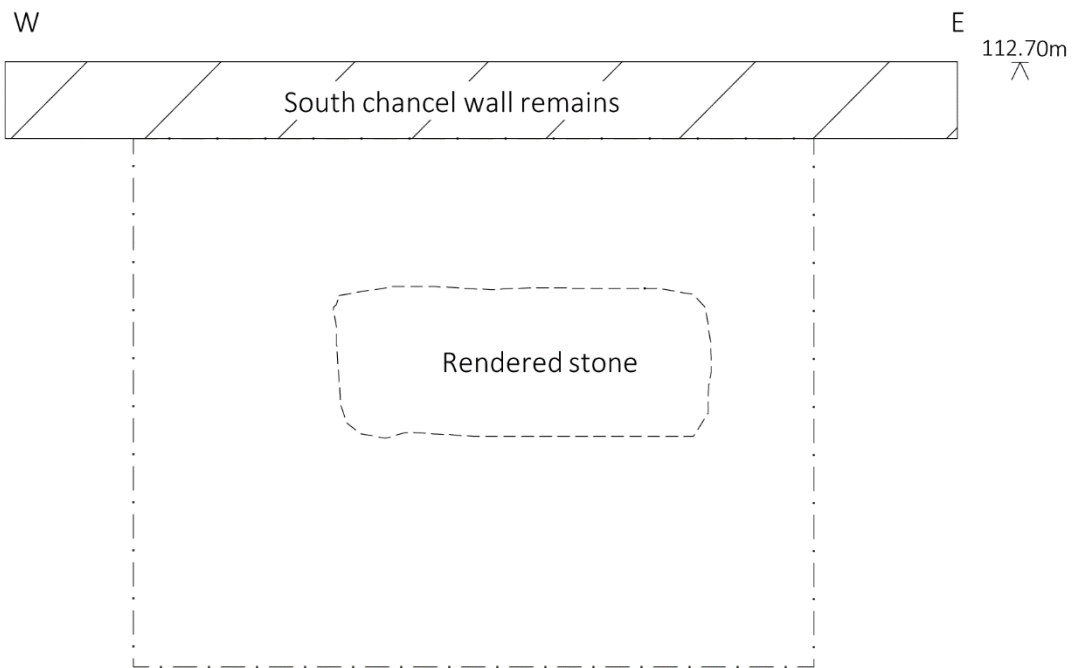
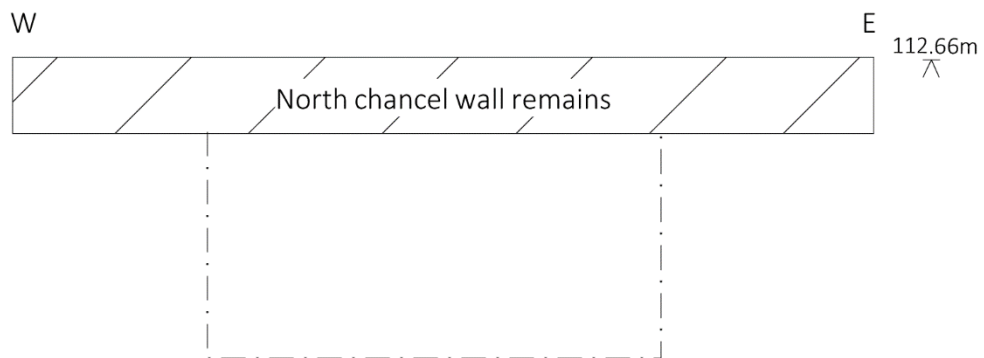
**Figure 5:** Chancel test pit sections (scale 1:10)

A slot measuring 0.90m x 0.40m was excavated to a depth of 0.80m from the top of the wall along the outside of the chancel wall to ascertain the depth of the foundations (Fig. 5; Plates 19-20). The fill was made up of building debris consisting of flint, roof tiles and brick fragments. The foundations consisted of the same mix of building materials as elsewhere, including some fragments of rendered stone approximately 0.30 from the base of the pit. The rendered area was 20cm high and covered only the stones, which were c. 0.50m long, which could suggest that these have been re-used. However, it is also possible that this indicates the original ground level.

A small slot measuring 0.60m x 0.30m was excavated inside the north chancel wall in order to determine whether any evidence of flooring had survived. There was no evidence for such at a depth of 0.40m from the top of the chancel wall and the test pit was abandoned (Fig. 5).

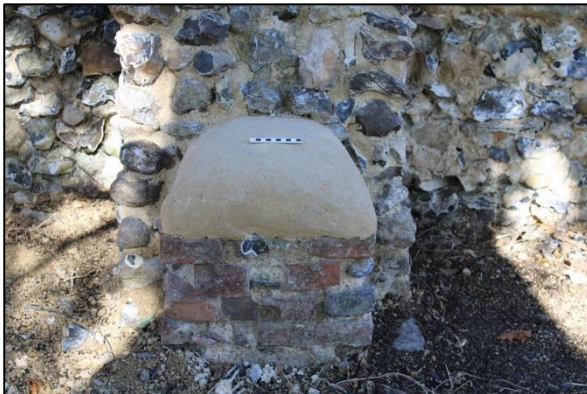
**Plate 21:** Detail of south chancel/nave buttress repair

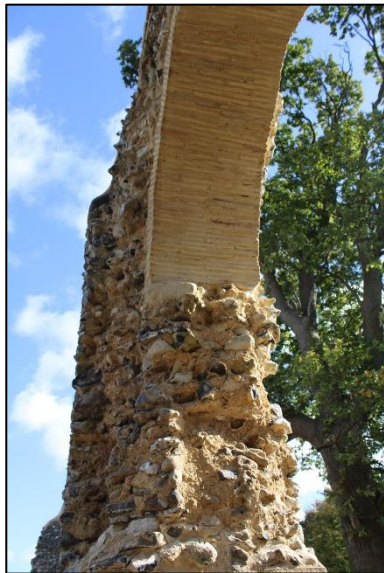
**Plate 33:** Detail of brick arch repair from the east

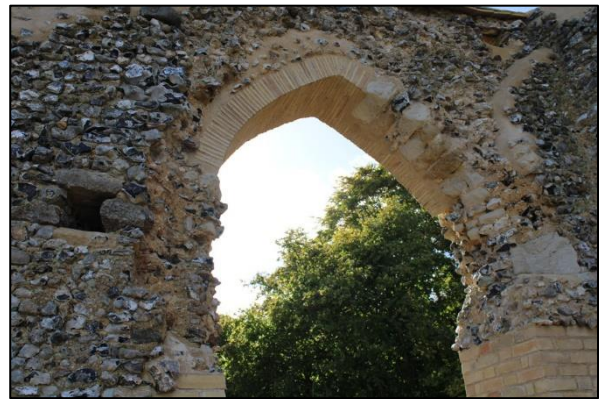
**Plate 34:** Detail of brick arch repair from the north

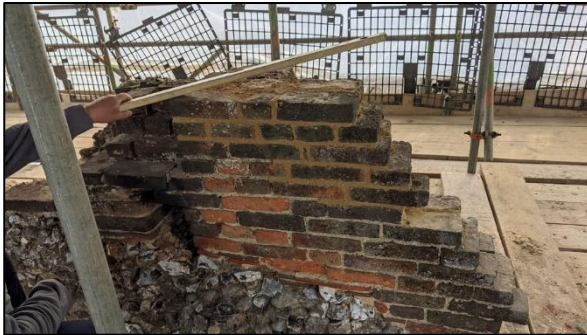
- The condition survey of 2021 had identified the bellcote as an exposed location that would require repair and repointing.
- With scaffold in place in spring 2022 a closer inspection could be undertaken. The historic lime mortar had eroded to such an extent that the top courses of brickwork on the bellcote were found to be largely held by gravity.

**Plate 1:** Bellcote under repair, looking east

- The repairs required that the brickwork be re-built to replicate the existing arrangement. Before proceeding, the bricks were carefully marked with chalk, so that they could easily be put back in the same position.

- Approximately 3 upper courses of the most exposed brickwork and the courses stepping down were partially dismantled to reach a sound base. These were re-bedded with the agreed lime mortar mix.

- A protective layer of lime mortar hard-capping, which was installed over all wall heads was also applied over the repaired brickwork bellcote to give it an additional protection from the elements. The hard-capping lime mortar was the approved mix with added horsehair.

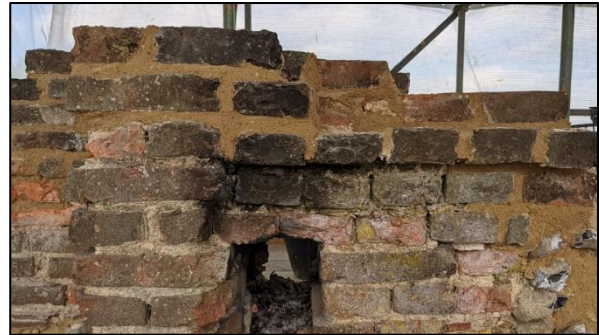
**Plate 2:** Detail of upper courses, looking west

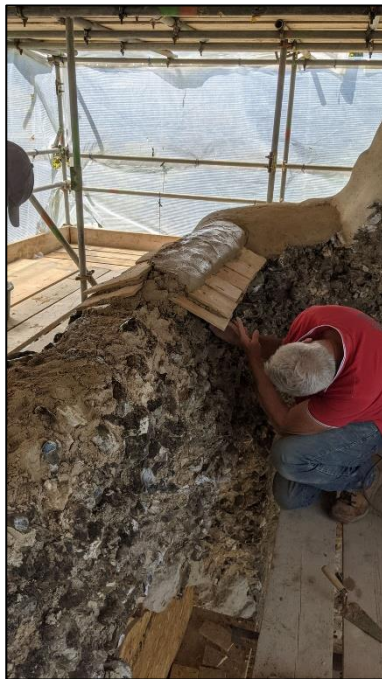
- The wall heads across the ruin were identified as exposed locations in the 2021 condition survey, which allowed water to saturate the core of the walls. The repair strategy was to help protect the wall core from water ingress and help shed rainfall away.
- The head of the south wall was relatively flat, which posed the risk of small pockets of water forming in time, if only hard-capping was installed.

**Plate 10:** South nave wall under repair

- The approach for this repair was to integrate a tile drip edge with the hard-capping to help shed water away from the immediate face of the walls and from its head.

- The repair commenced with removing any previous cementitious hard-capping across the ruin with hand tools only.
- The area was inspected and the loose flintwork was partially dismantled under supervision of an ecologist to reach a sound core, approximately 3-4 courses or 400mm. Much of this was already loose due to long-term weathering of the exposed wall head. All flint was cleaned and set aside for re-use. Any vegetation was carefully removed or treated prior to removal, so as not to weaken the masonry.

- A drip edge was provided consisting of two courses of buff clay tiles to help shed the water away from the top faces of the wall and improve run-off over the relatively flat wall head.

- The camber to the hard-capping also ensures water quickly shed away. No flintwork was included across the top of the hard-capping to avoid creating any water traps.

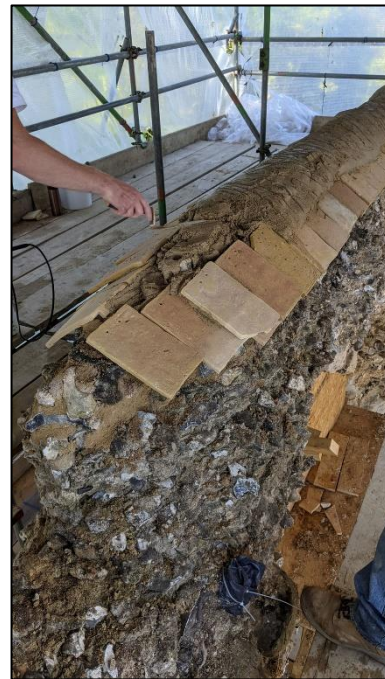
**Plate 11:** South nave wall under repair

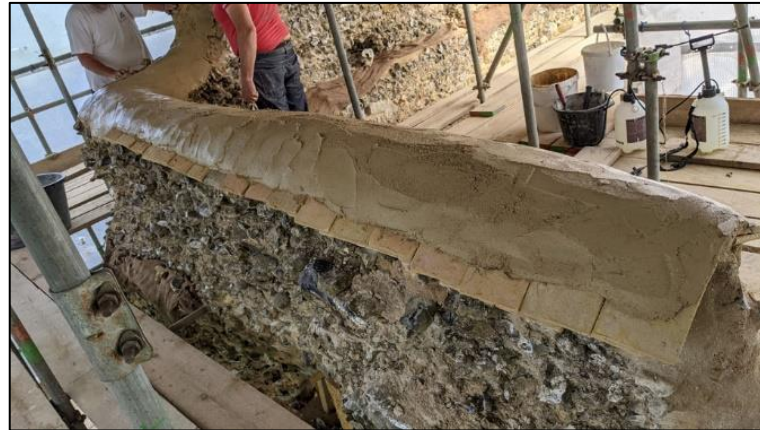
**Plate 12:** Completed repairs to south nave wall

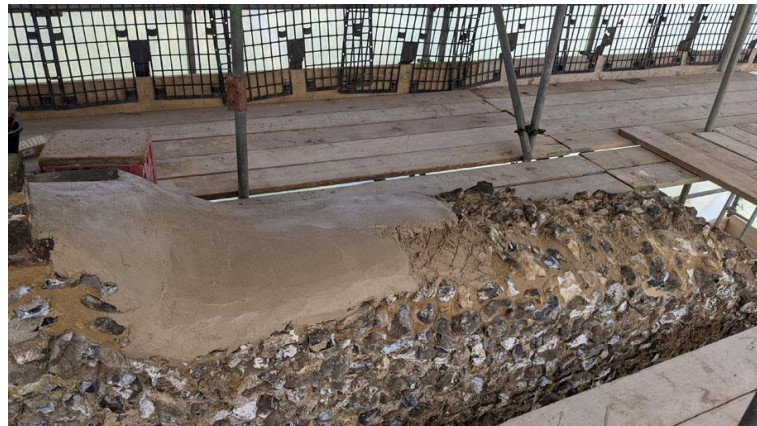
**Plate 13:** Example of hard capping in progress

- The approach, philosophy and installation of hard-capping to the rest of the walls at the ruin follow the same principles as detailed in Section 4.8 above without the inclusion of a drip edge due to the uneven geometry.

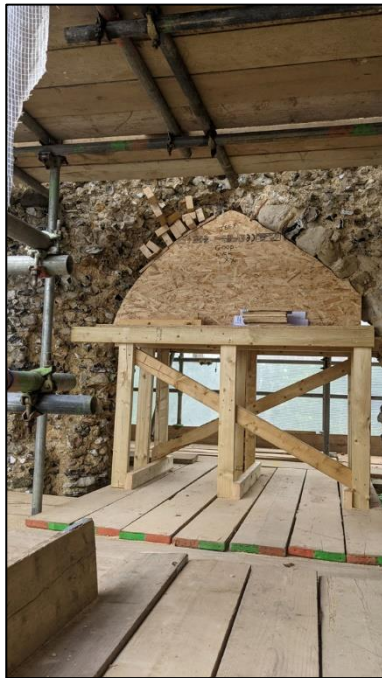
- Minsden Chapel was added to Historic England's Heritage at Risk Register in 2009 following the collapse of the chancel arch in 2008 and due to the deteriorated state of its remaining arches in the south wall. The dilapidated condition of these remaining arches was the focus of the conservation works to ensure these are preserved in time.
- The works to the arches consisted of several strands of repairs:
  - o tile arch repair to reinstate the curvature where historic voussoirs were missing to the west arch.

- Tile arch repair:
  - o The most significant structural element is the south nave window, close to the west gable. Part of the stone arch, with its voussoirs, survived to the west side of the window, whilst to the east side the arch had been lost leaving the rubble core of the wall above 'self-arching' over. At low level both reveals to the windows had been lost leaving undercut areas with unsupported rubble masonry above.

**Plate 14:** Arched opening under repair

- o Rebuilding the undercut areas below the springing points of both arches in buff brickwork
- o Flint and mortar repair to the head of the east arch
- o Reinstating the base of the wall with flintwork and hard-capping between the brick rebuilding to the west arch

- o With scaffolding in place, temporary support was provided to the arch prior to commencing any repairs. Tile arch repairs would replicate the existing curve of the arch, which had been formed through erosion of material and was therefore unsymmetrical. Some of the underside of the rubble core needed to be gradually and carefully removed to allow for the tiles to be inserted and a full arch to be formed that would stabilize the opening.

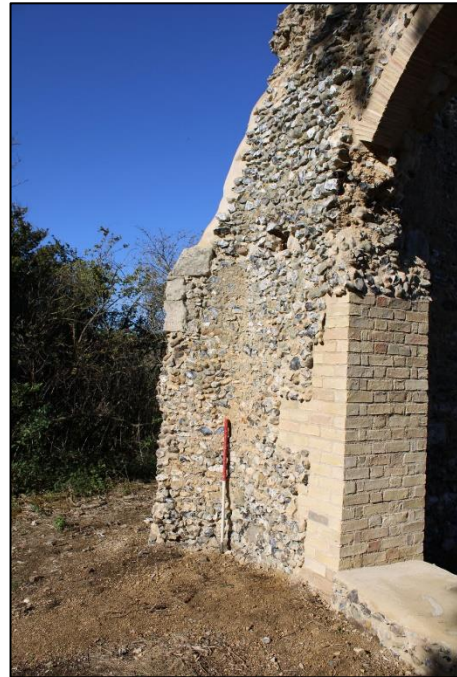
**Plate 15:** Brickwork and base within completed opening

- Reinstating the base of the wall with flintwork and hard-capping between the brick rebuilding to the west arch.
  - o To protect the base of the built arch opening and better define the historic window opening, flint collected from the site was used to build the opening approximately 3-4 courses and hard-capping lime mortar mix was applied for protection over.

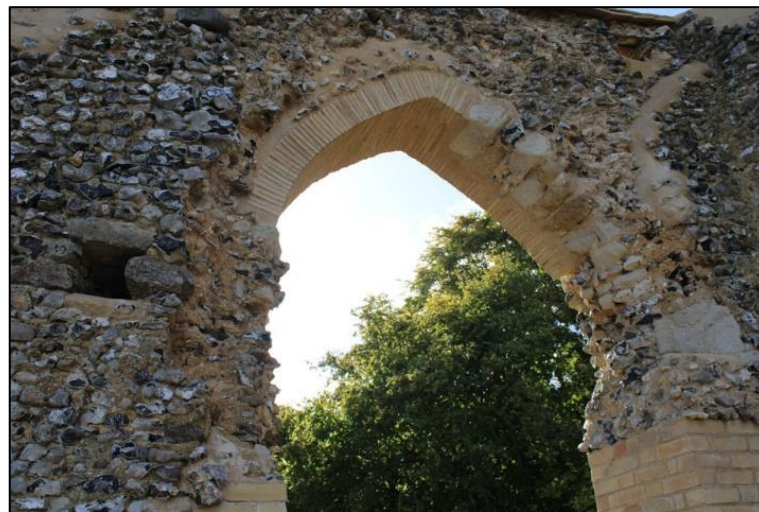
**Plate 16:** Completed arch

- Flint and mortar repair to the head of the east arch
  - o Loose flintwork was carefully dismantled and a lime mortar mix with reinstated flints was installed to stabilize the arch head.

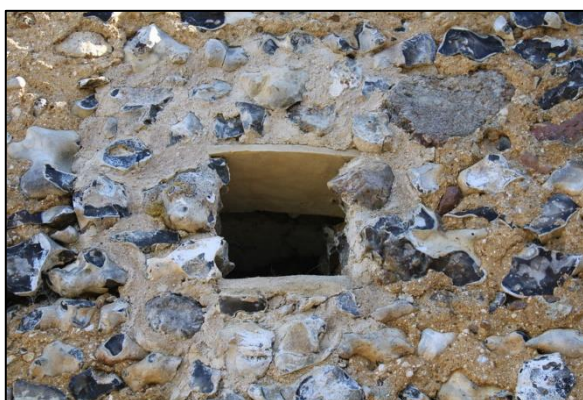
- Putlog holes at low level were subject to natural erosion and damage through human intervention. The principal was to repair the low-level putlog holes to protect them, but in a technique that ensured they remain legible as having been putlog holes.
- The exact scope of putlog holes to be repair was identified with scaffold in place when closer inspection was possible.
- Putlog holes that had lost their lintel had a new buff clay tile reinstated as a lintel, both to protect the opening and to signify that this repair type was part of the 2022 conservation campaign.
- Putlog holes with eroded edges had some of the loose flintwork gently dismantled under the supervision of an ecologist. Any flints were cleaned and set aside for re-use. The putlog edges were stabilized with rebuilt flint and the approved lime mortar mix.

**Plate 17:** Example of a repaired putlog hole

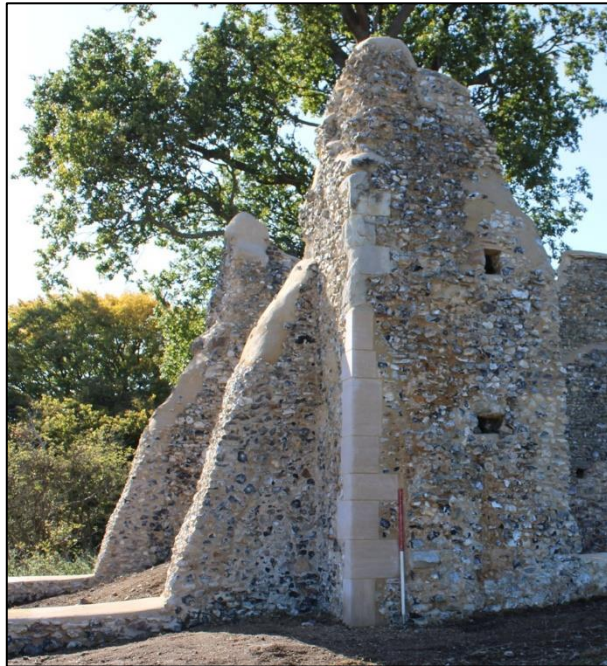
- The northeast and southeast corner of the nave had a few clunch quoin stones remaining at high level but there were empty pockets of where lower-level quoins had been removed and sold at local markets.
- New Clipsham Cream stone was used to reinstate the missing quoins and offer protection to these exposed corners of the nave walls at the ruin. Some flintwork rebuild was needed around the quoin stones to stabilize the area and prevent pockets of water forming.

**Plate 18:** Replacement quoins in north nave wall

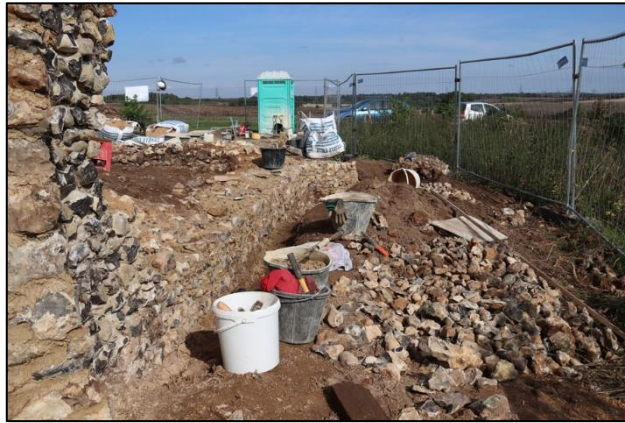
**Plate 19:** East chancel wall being rebuilt

- The area was inspected and the loose flintwork was partially dismantled under supervision of an ecologist to reach a sound core. Any previous cementitious hard-capping was removed with hand tools only.

- The reinstatement of flintwork that had been lost in time consisted of re-using flints collected from site and the approved lime mortar to elevate the height of the existing walls approximately 300-350mm above ground level. This extended across the three chancel low walls – north, east and south, and also the northeast and southeast chancel buttress.

- Once the reinstatement was complete, a layer of hard-capping to the approved lime mortar mix with horsehair was applied across the top of the low walls to provide improved protection against rainwater ingress to the core of the stonework.

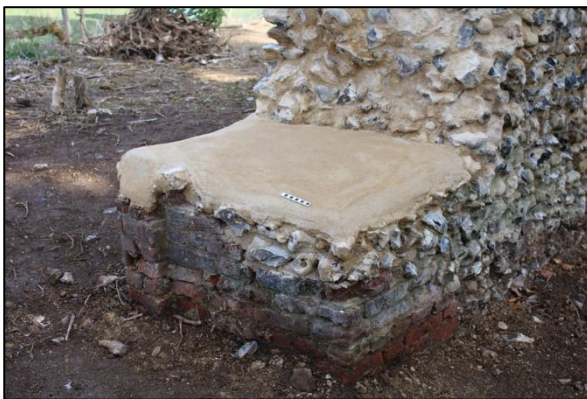
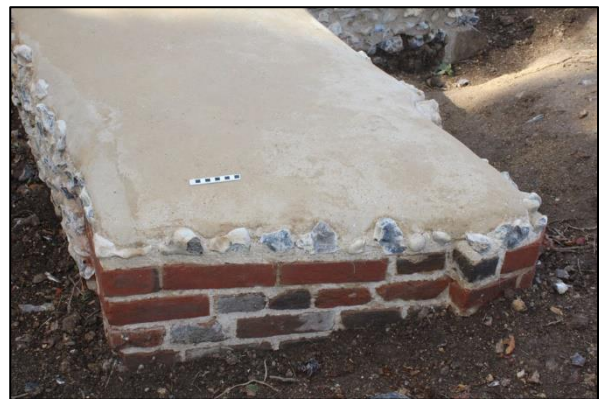
**Plate 20:** Door opening repaired

**Plate 21:** Door opening repaired

- The area was inspected and the loose flintwork was partially dismantled under supervision of an ecologist to reach a sound core. Any previous cementitious hard-capping was removed with hand tools only.

- The newly discovered brick door reveal was better defined with red brick making the historic door opening clearly legible with both reveals now readily visible on site.

- Once the reinstatement was complete, a layer of hard-capping to the approved lime mortar mix with horsehair was applied across the top of the low walls to provide improved protection against rainwater ingress to the core of the stonework.
