**Historic building recording
at an outbuilding at The Old Vicarage
Husborne Crawley, Bedfordshire
Level 2
February 2022**

Report No. 22/021

THE OLD VICARAGE, HUSBORNE CRAWLEY

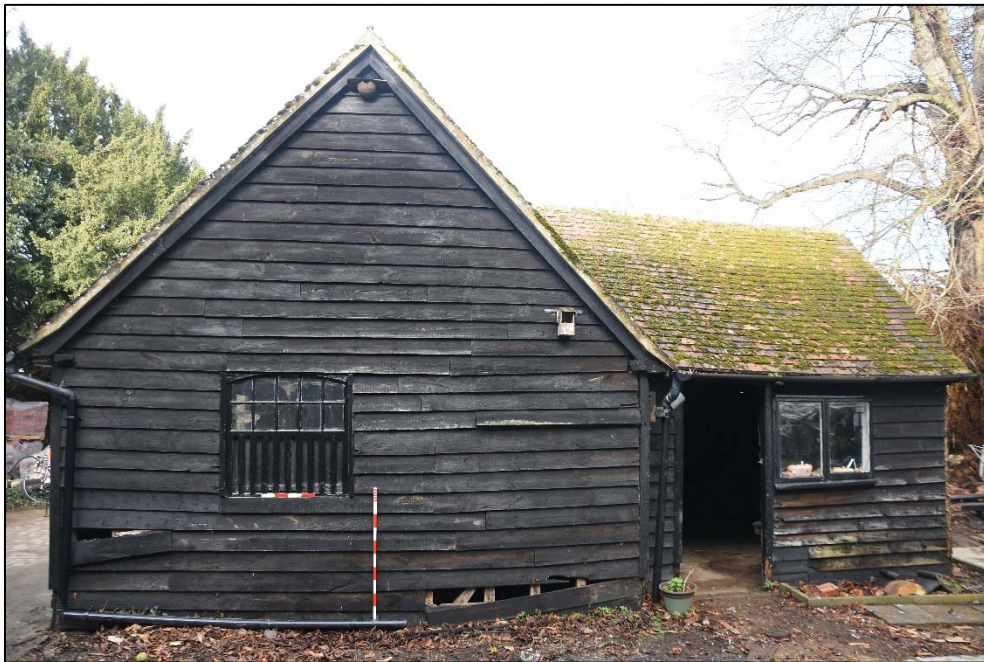
Fig 6

As mentioned above the east end mirrors its western counterpart with weather-boarding and an off-centre window (Fig 6). Some of the weather-boarding has failed and exposes part of the internal timber-frame including some studwork. The weather-boarding is softwood and several pieces show mechanical saw marks. To the gable the wall-plates sit proud of the weather-boarding.

East elevation of the outbuilding with north range extension, looking north-west

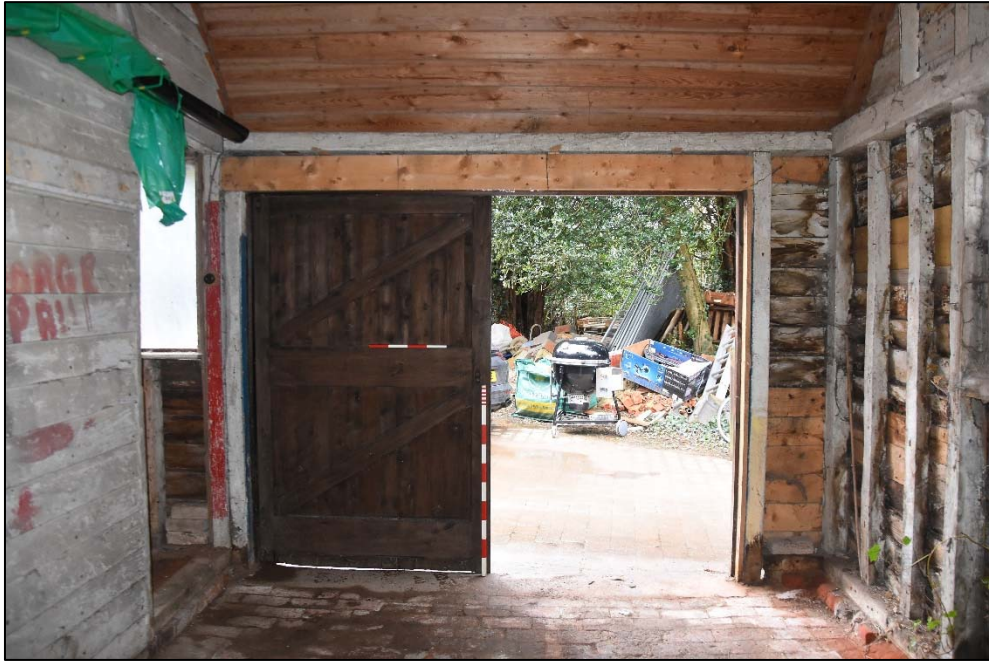
The doors are ledged and braced to the rear and are modern (Fig 9). They are framed by two historic studs and a wall-plate. However, a modern lintel has been inserted which cuts the eastern stud at the top. The wall-plate retains empty mortises for studwork, either indicating a previous use, or that these wide double doors are a later insertion. The doors take up most of the wall, but a slender area of the weather-boarding can be seen to the west.

South wall of Store A, showing double doors, looking south Fig 9

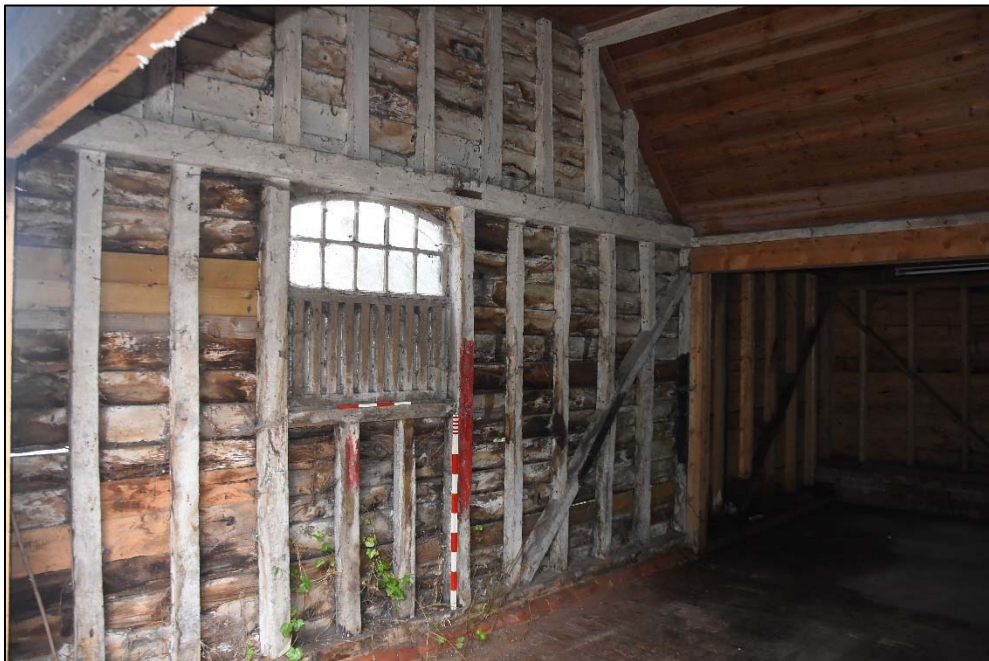
The west wall comprises studwork above a course of worn red bricks (Fig 10). There are eight studs, two outer posts, and a downward brace to the north. The wall-plate has an empty mortise but no corresponding bridging joist, and there is no evidence of a matching mortise on the opposite wall. The window is as described externally and interrupts two studs below (Fig 11). Above the wall-plate several studs rise to the roof. Two of these support purlins which simply rest atop these studs, there is one in each pitch. The rest of the roof is not visible as it has been boarded with modern softwood boards.

West wall of Store A, showing studwork, looking north-west Fig 10

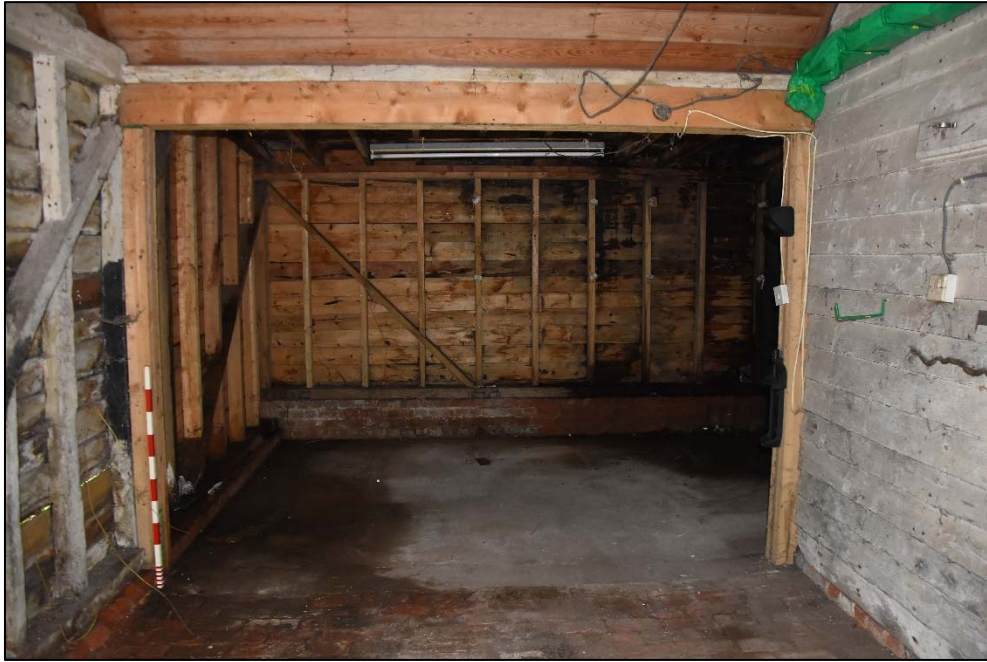
To the north this wall has been affected by the addition of the flat-roof extension to create Store E (Fig 13). The studwork has been removed and all that remains is a modern softwood frame and a wide, open aperture.

North wall of Store A which has been altered with the addition of Store E further to the north, looking north-west Fig 13

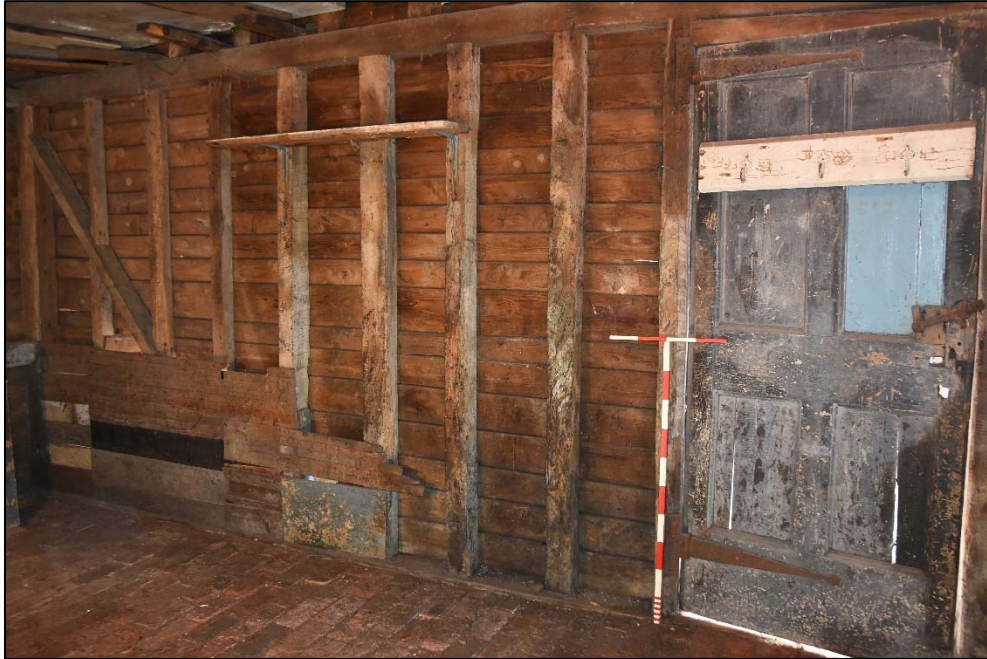
This boarding continues onto the east wall to a height of c0.75m and seems to comprise various quality timber (Fig 20). Here it perhaps covers an area of lost studwork seen within the adjacent store. Otherwise, the east wall comprises studwork and a downward brace descending from the north. The studwork rises from a sole-plate flush with the brick floor. To the south a six-panelled door gives access

East wall of Store B, looking north-east Fig 20

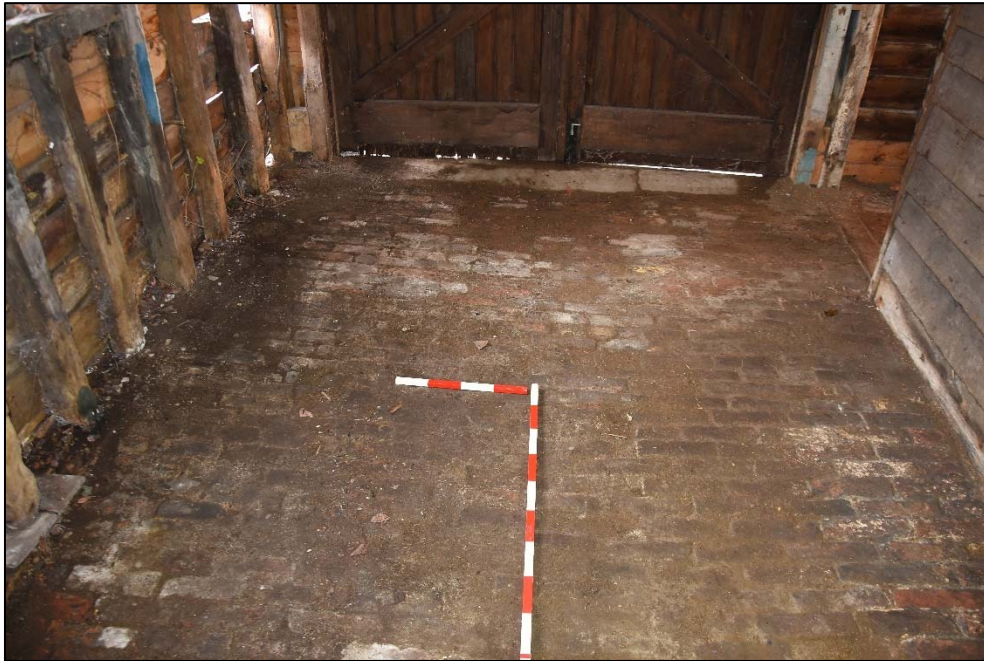
The furthest eastern store also retains a brick floor with bricks laid on end measuring 21.5 - 22.5cm by 6cm (8½ - 8¾inches by 2½inches), there is noticeable damage to the floor towards the southern end (Fig 22). The walls all comprise timber studwork and there is weather-boarding to the west. The space is entered from the south via a second set of wide double doors, and from Store B to the west. There is a loft over the northern part of the room.

Brick floor in Store C, looking south Fig 22

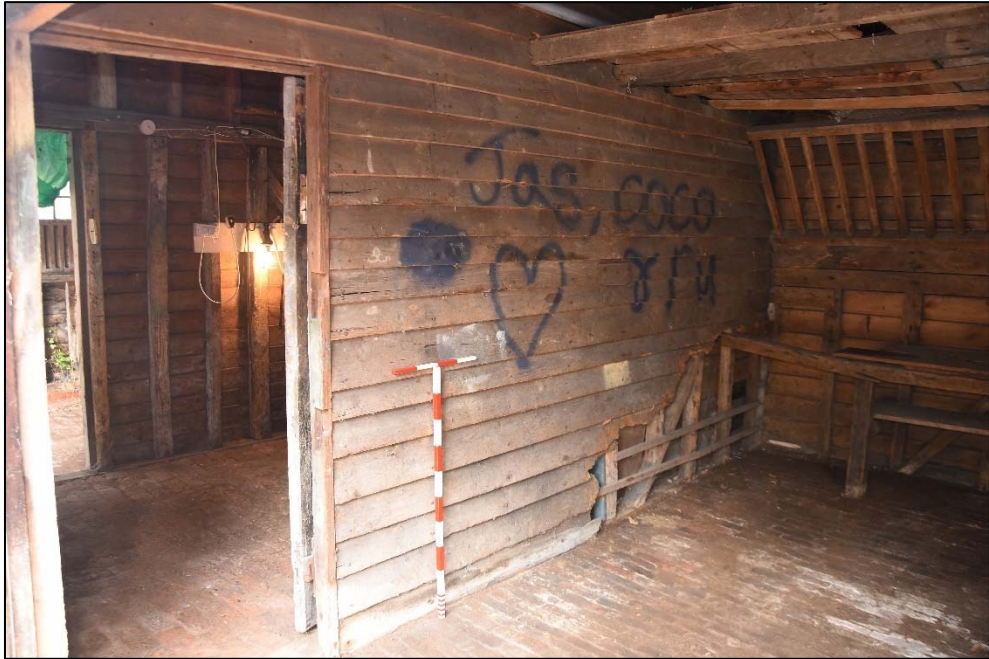
The west wall is weather-boarded and has suffered damage to the north-west where the underlying studwork is visible (Fig 25). Four studs and the corner post are exposed, with a downward brace. The door to Store B has a wrought-iron handle to this face. The weather-boarding extends above to the closed partition.

West wall of Store C, looking north Fig 25

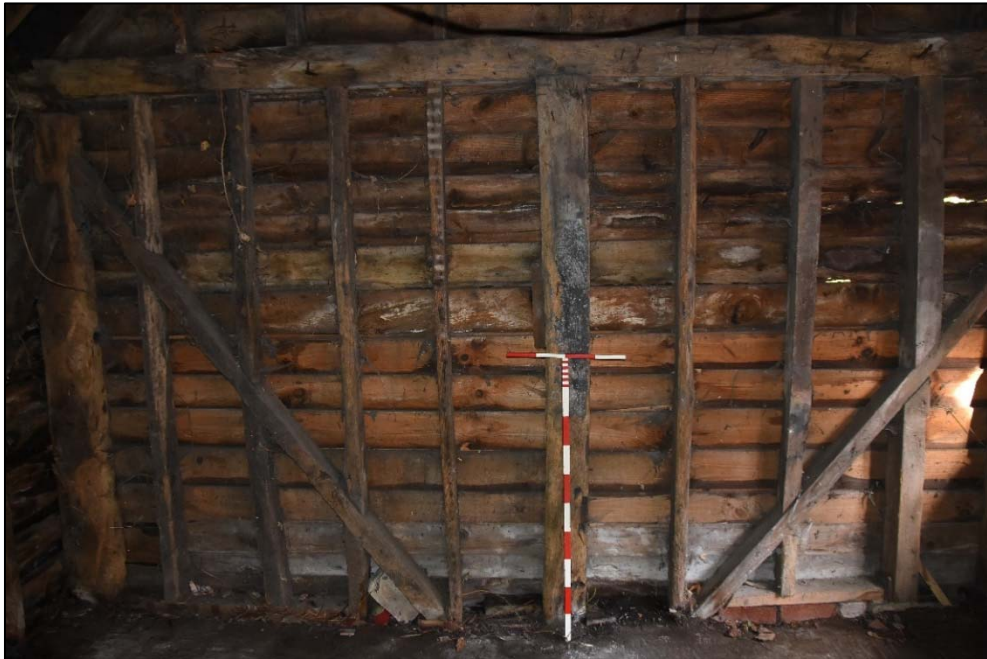
To the north there are eight studs with a more robust central post (Fig 35). The studs vary in scantling and are cut by two diagonal braces descending from the corner posts. There is no sole-plate but a single course of bricks to the north replace this, some studs descend directly onto the concrete, and a modern insertion to the east

perhaps attempts to rectify this. Above the tie-beam there are seven studs all slender which rise to the rafters.

Timber studwork to the north wall of Store D, looking north-west Fig 35
