Building recording and archaeological inspection at Church Farmhouse 10 Church Street, Empingham Rutland, October 2013

Planning reference: APP/2012/0934

Report No. 14/24

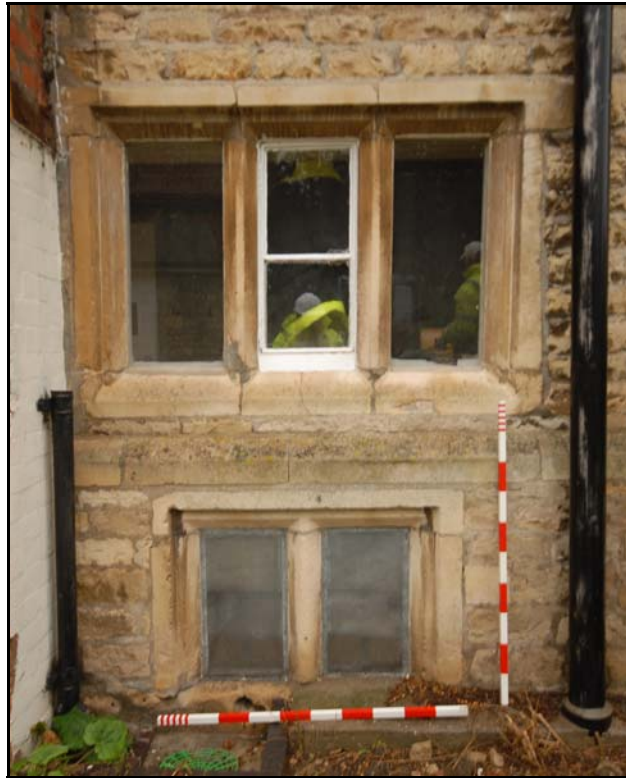
Fig 4

The cottage is constructed in coursed roughly dressed limestone with limestone quoins. The roof is tile and the chimney stacks red brick (Fig 5). The windows, with the exception of those on the north rear wing, are wooden casements. Those on the north wing at ground and basement level are limestone chamfered mullioned windows, the kitchen having three lights and the basement two lights (Fig 4). It would appear that some of the stone work of the kitchen window has been replaced. Access to the north wing is through a ledged plank door set in a plain opening and accessed via two steps, the entrance formally had a modern porch which was removed as part of the works, prior to the survey (Fig 6).

Stone mullioned windows

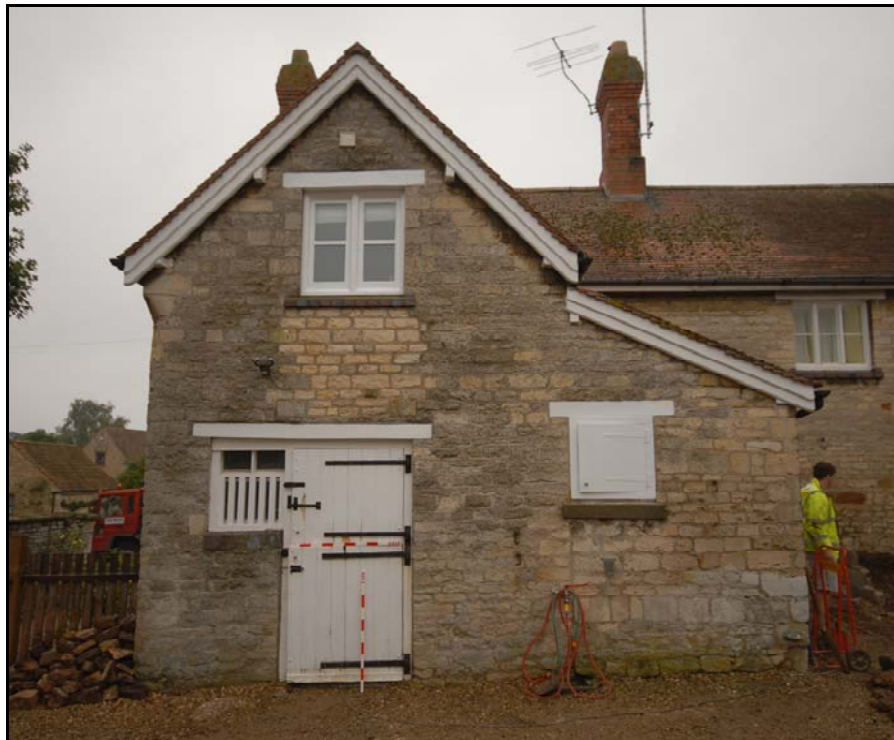
Fig 5

The southern wing appears to be a later, 19th century, addition to the property and originally served as a stable at ground floor with a hay loft over as evidenced by the newer stone work below the first floor window converting it from a door to a window (Fig 5). The ground floor still retained its split stable door with a vertical sliding vented window to its side (Fig 5).

South wing showing stable door and blocked hayloft access

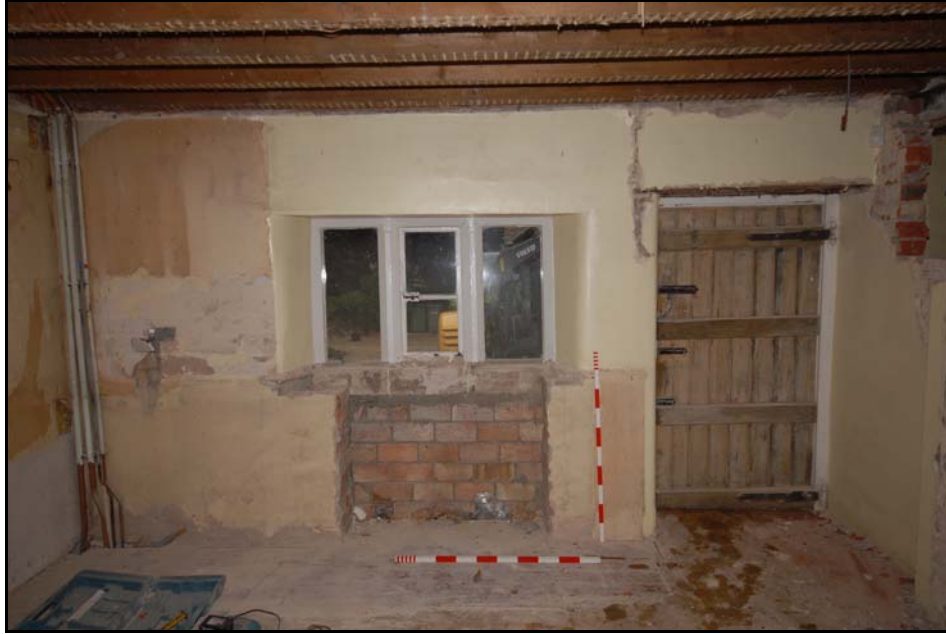
At the time of the survey the interior of the kitchen had been removed, exposing plastered brick dividing walls and the back (north) wall in un-coursed limestone rubble. The southern wall was still plastered, however, red brick could be seen internally, below the stone mullioned window reveal. This brickwork partially blocks the mullion window in the cellar below (Fig 6).

Kitchen interior Fig 6

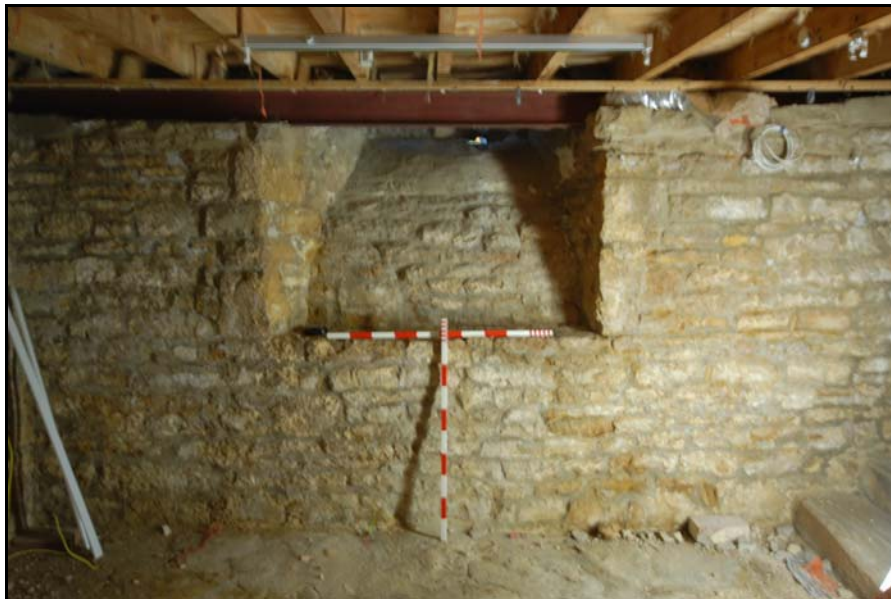
The walls of the cellar are unpainted roughly coursed limestone rubble, with a light well on the south wall. The ceiling of the cellar is supported on modern RSJ beams, the joists and the floor boards of the room above are sawn pine, this work has removed any traces of the original or an earlier ceiling (Fig 7).

The cellar Fig 7

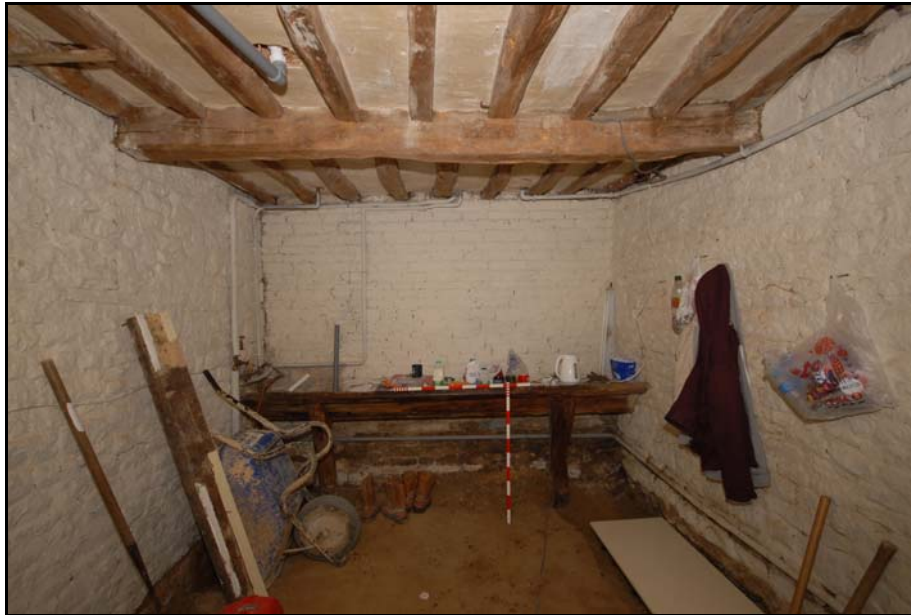
Only the single ground floor room of the south wing was recorded as this is the only part that is to be altered. The single room had white washed stone walls to the north, east and south, the west wall dividing the former stable from the house was white washed red brick., the floor was beaten earth, the ceiling had the beam and joists exposed with lath and plaster infill. The room retained its wooden manger along the west wall (Fig 8).

Interior of the south wing Fig 8

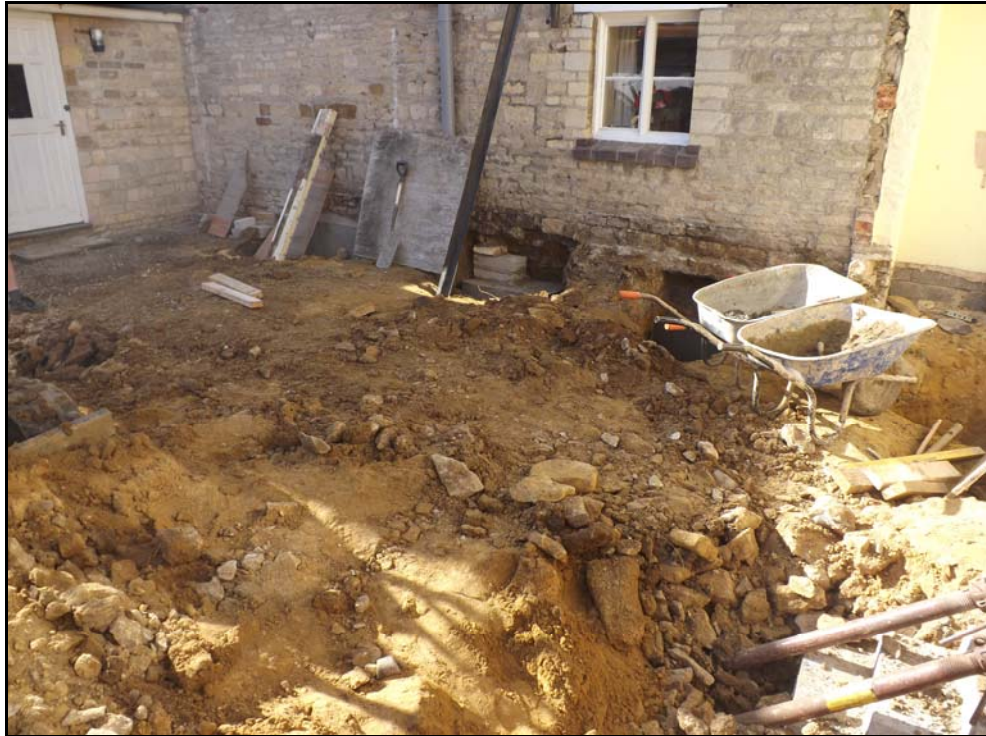
An archaeological inspection was carried out during the ground works for the new extension on the rear of the house. Natural sandy clays were exposed below the made ground of the modern raised terraced garden area (Fig 9). No archaeological features or artefacts were observed.

Watching brief area, during the underpinning works Fig 9

The removal of the terraced garden area and subsequent ground reduction did reveal that the rear wall of the house was built straight onto the natural without footings, so as part of the works this wall was underpinned.
