**Archaeological Building Recording and Archaeological
Observation, Investigation, Recording and Analysis
At The Oak Inn, Easton on the Hill
Northamptonshire**

Report No. 14/42

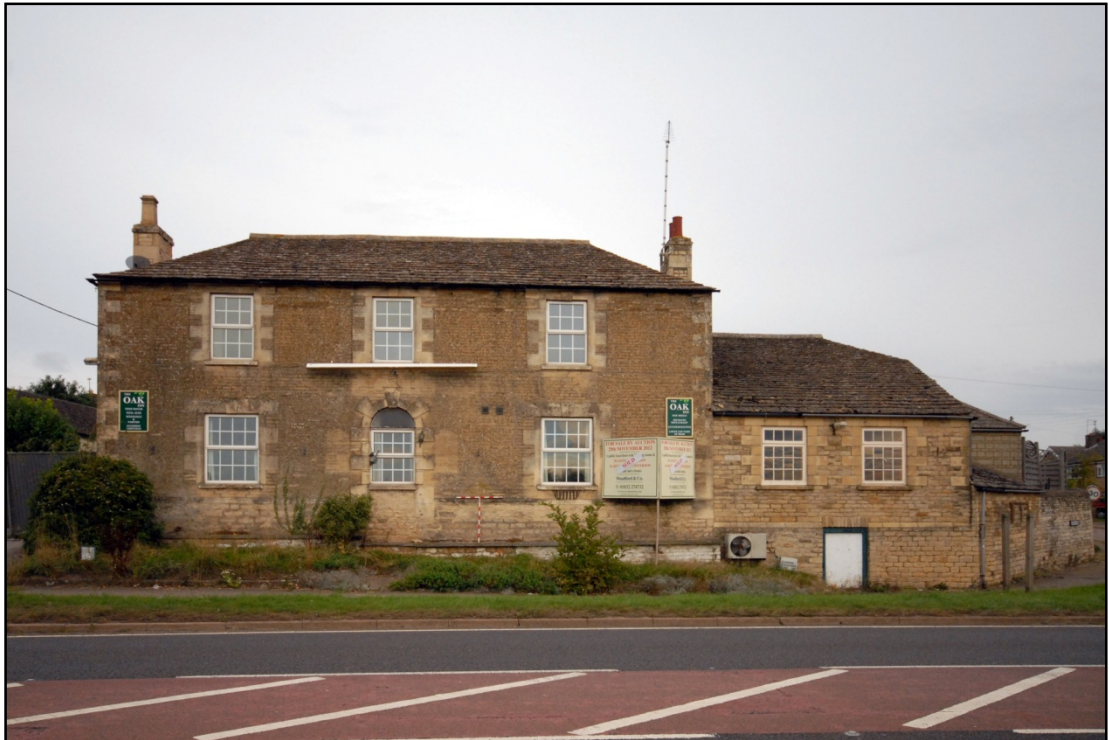
The building fronts onto Stamford Road, presenting a two storey, three bay elevation of coursed limestone with ashlar quoins (Fig 10). These materials are sourced locally and are typical of contemporary architecture in the region. A central doorway raised above ground level, formerly with steps leading up, has been blocked and a modern window inserted (Fig 12). The door opening is arched with ashlar surround. A fanlight, formerly over the door, was retained. The ground and first floor windows all have ashlar surrounds with flat arches and keystones. Modern double-glazed replacements have been fitted into the original window openings. The roof is of Collyweston slate and is hipped at the east and west ends (Figs 8 & 10). A pair of chimneys at the east and west ends of the building are flush with the gable walls (Figs 8 & 10). They are constructed in the same style as the main structure with ashlar quoins. Rainwater goods are of cast iron and polyurethane.

The south elevation from Stamford Road Fig 10

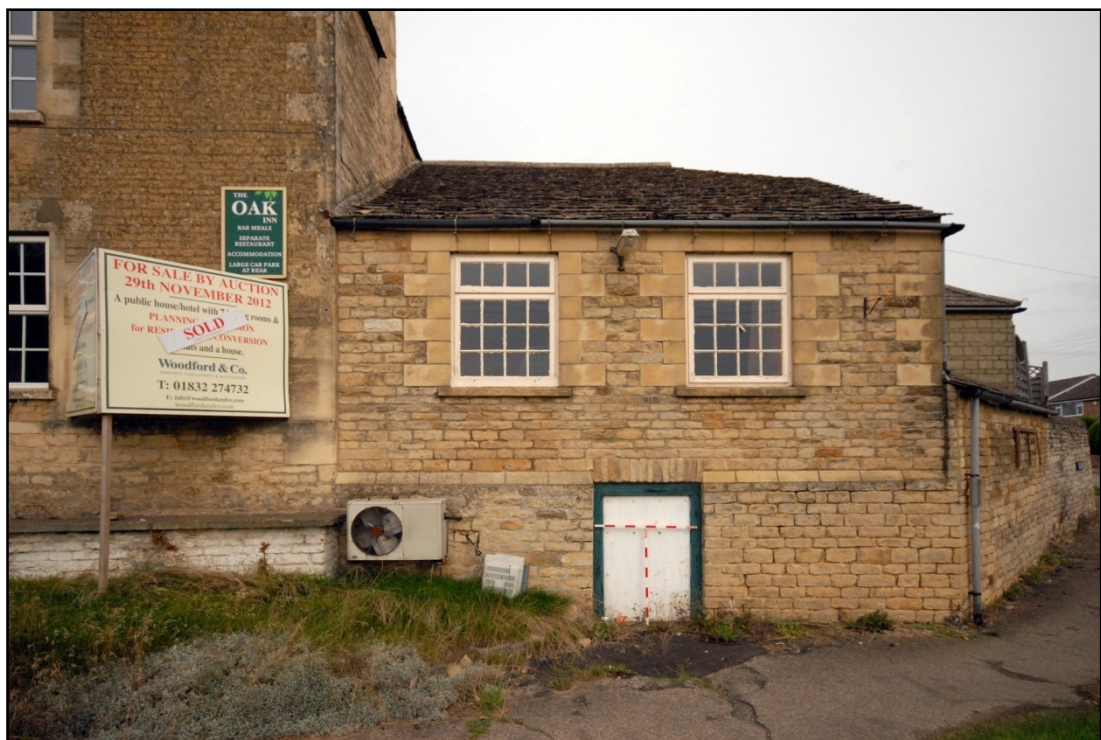
The main building has been extended eastwards along the Stamford Road (Figs 9 & 11). The lower portion of the extension is of an earlier construction than the upper (Fig 8). A door, c1.5m high leads into the cellar. The top of this door is level with the change in build (Fig 11). The 1886 and 1900 Ordnance Survey maps (Figs 6 & 7) show structures in this

area which are on a different layout to those currently present. It is probable that the lower portion of the extension is a remnant of these earlier structures. A course of chamfered limestone blocks separates the two phases. The modern portion of the elevation is constructed of larger, coursed limestone than that below. A pair of steel-framed windows are present at ground floor level looking south from the kitchen. The openings for these windows are dressed to resemble the older style of surround in the main structure.

The modern extension with change in phase, level with the top of the cellar door Fig 11

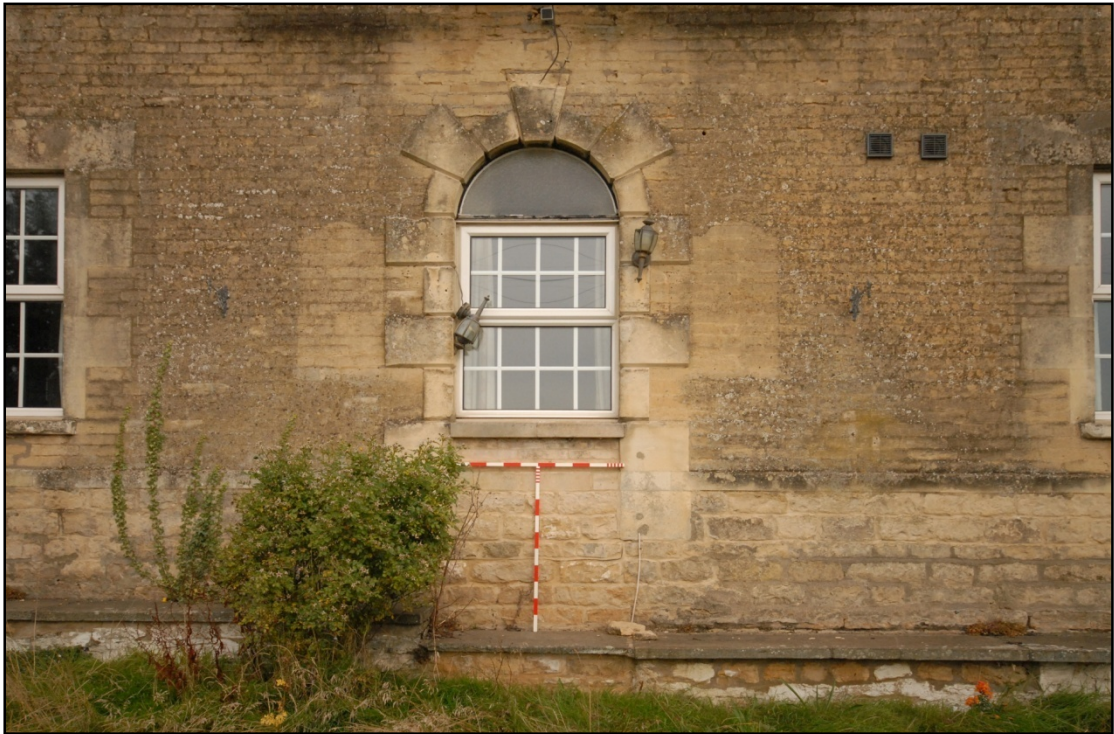
Detail of the blocked door with replacement window and fanlight over Fig 12

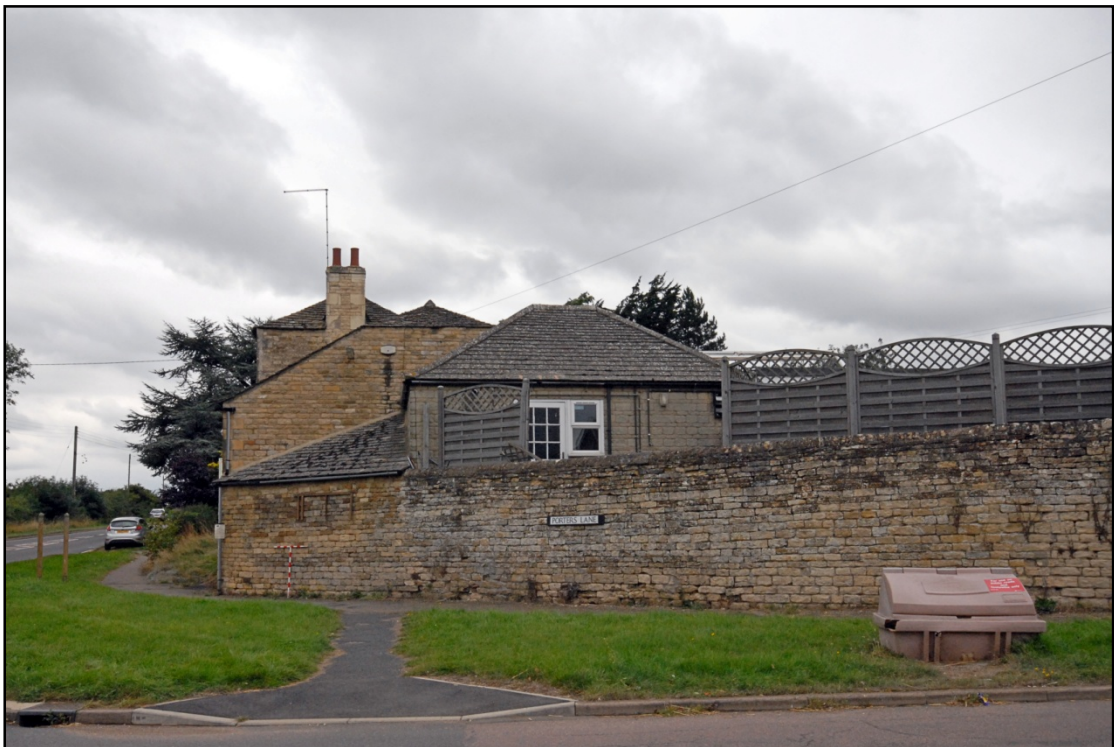
Viewed from the east, The Oak Inn presents a cascading roof line from the main structure down to the smaller extensions (Figs 8 & 13). A stone retaining wall picks up the ground floor level of the Inn and carries it around the corner of Porters Lane.

The east elevation from Porters Lane Fig 13

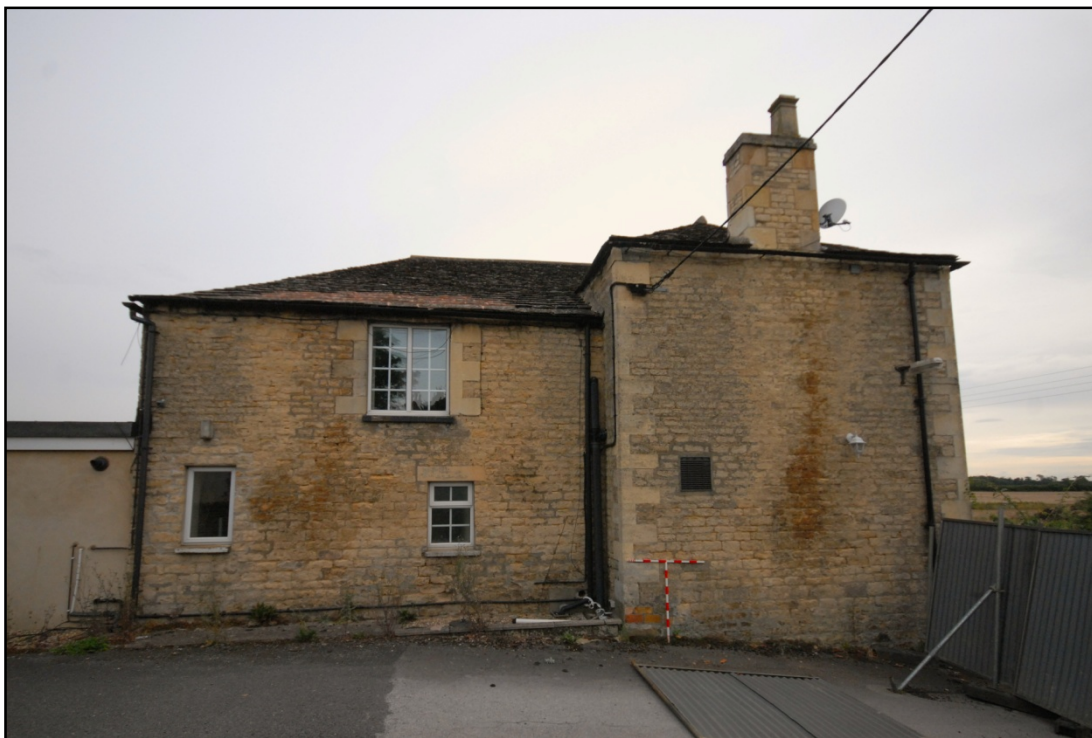
To the west of the Inn, an incline provides access from Stamford Road to the rear car park (Fig 14). The western elevation is plain with no windows (Fig 8). A square vent with iron mesh provides ventilation to Store 2. The elevation steps back 0.7m to continue north. Two small windows without dressings are at ground floor level looking out of Bedroom 4 and En-suite 4. At first floor level, a modern replacement window with original surround looks out from the Landing. A chimney once protruded from the roof, to the right of the first floor window. This chimney linked to the fireplace in Bedroom 4. A patch of slightly different roof tiles mark its former location. The roof here is also of collyweston slate, hipped to the north. A modern extension continues the elevation around the rear to the car park.

The west elevation, looking east Fig 14

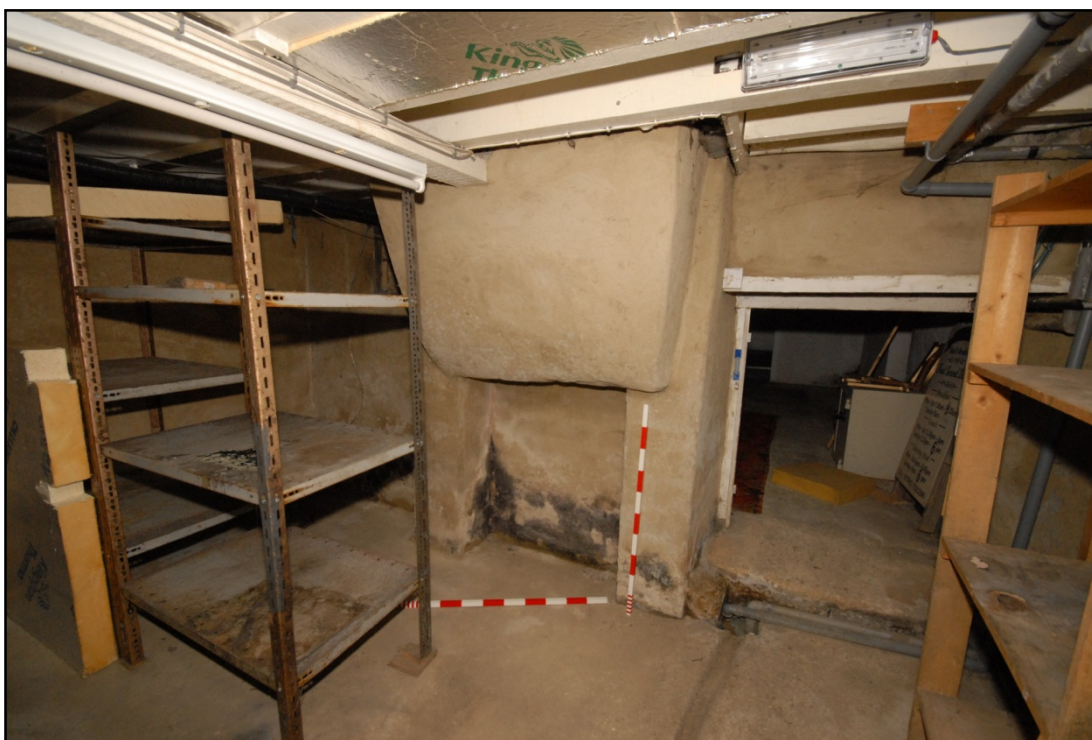
The Cellar, Room C1, the blocked fireplace, looking north-east Fig 19

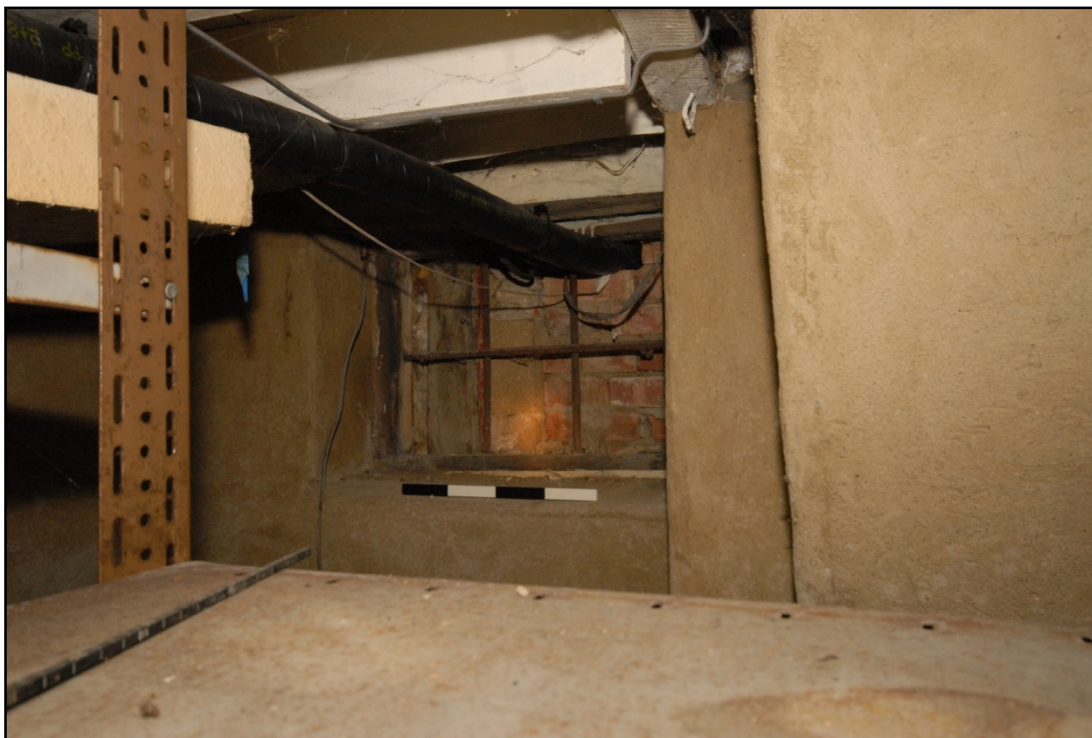
The blocked window in room C1 previously acted as a light well before the construction of room C2. The 25" Ordnance Survey map of 1886 shows a structure to the east of the main building which would have prevented the light well from functioning. This indicates that the structure was built after the main building. It is therefore probable that the eastern half of the cellar, room C2, was created contemporary with that structure. As previously noted, when viewed externally, the south wall of room C2 is of an earlier construction than that seen at ground floor level. With the creation of the kitchen and bar, a new stair was inserted to the east of room C2 to provide internal access between ground floor and cellar (Fig 23).

The Cellar, Room C1, the blocked window, looking east Fig 20

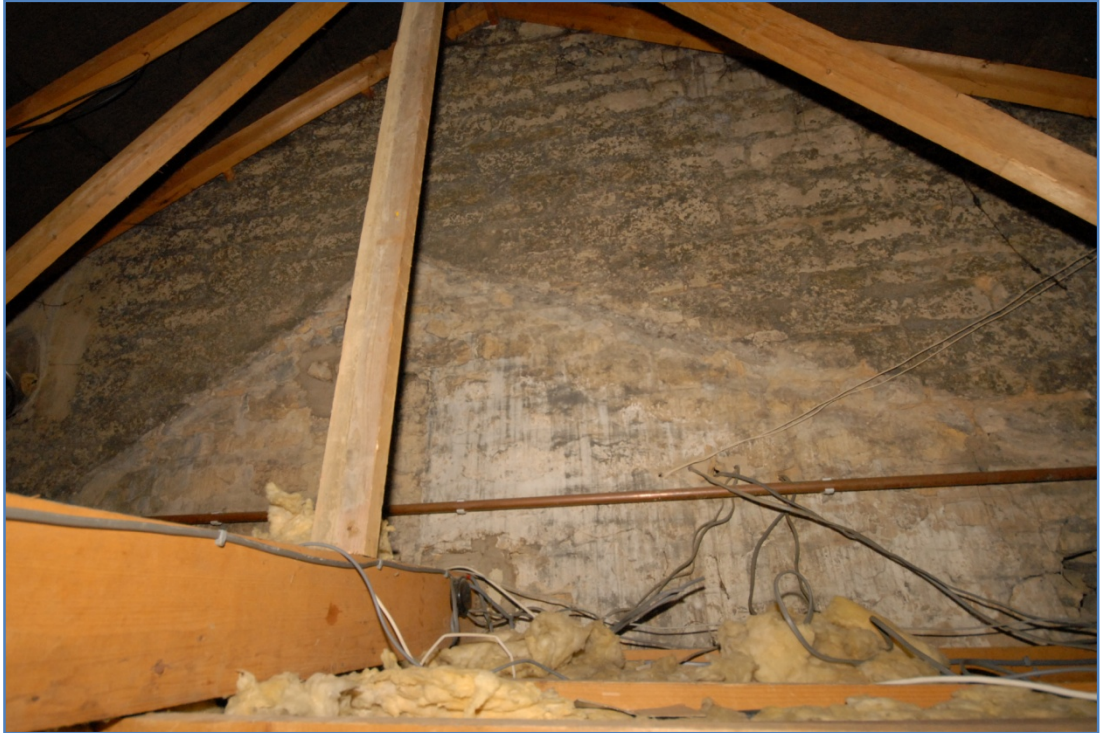
The scar of a former gable visible in the roof space over the Bar Fig 28

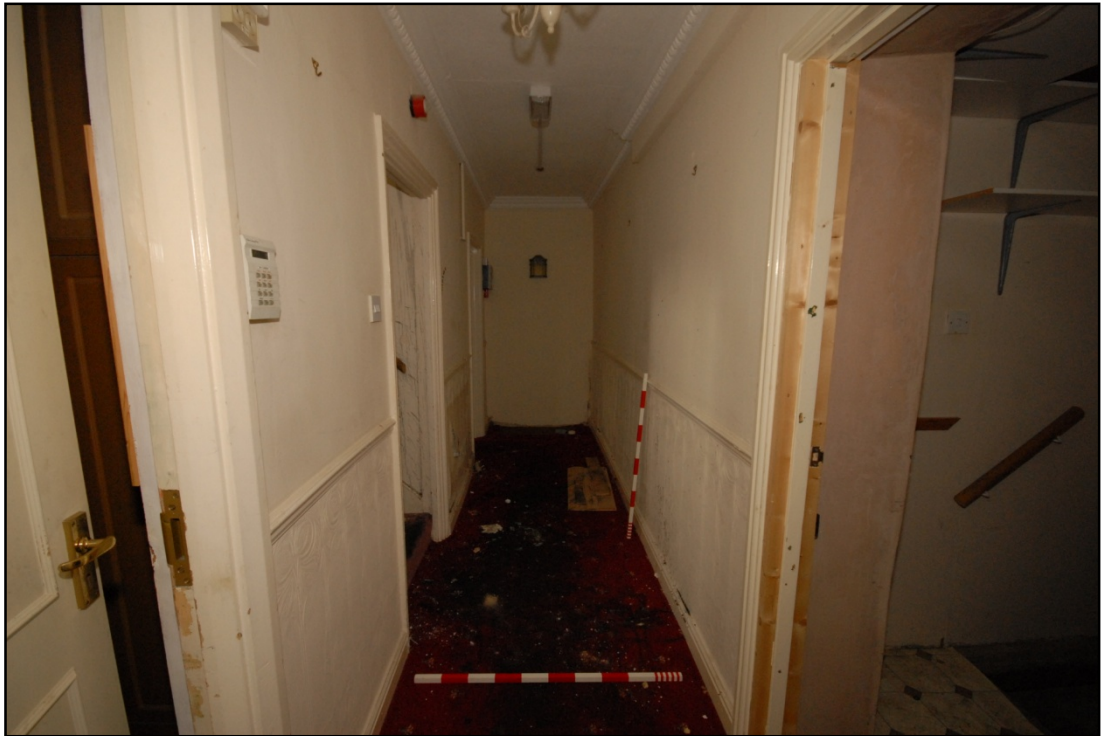
Corridor 3 with blocked door at the north end Fig 40

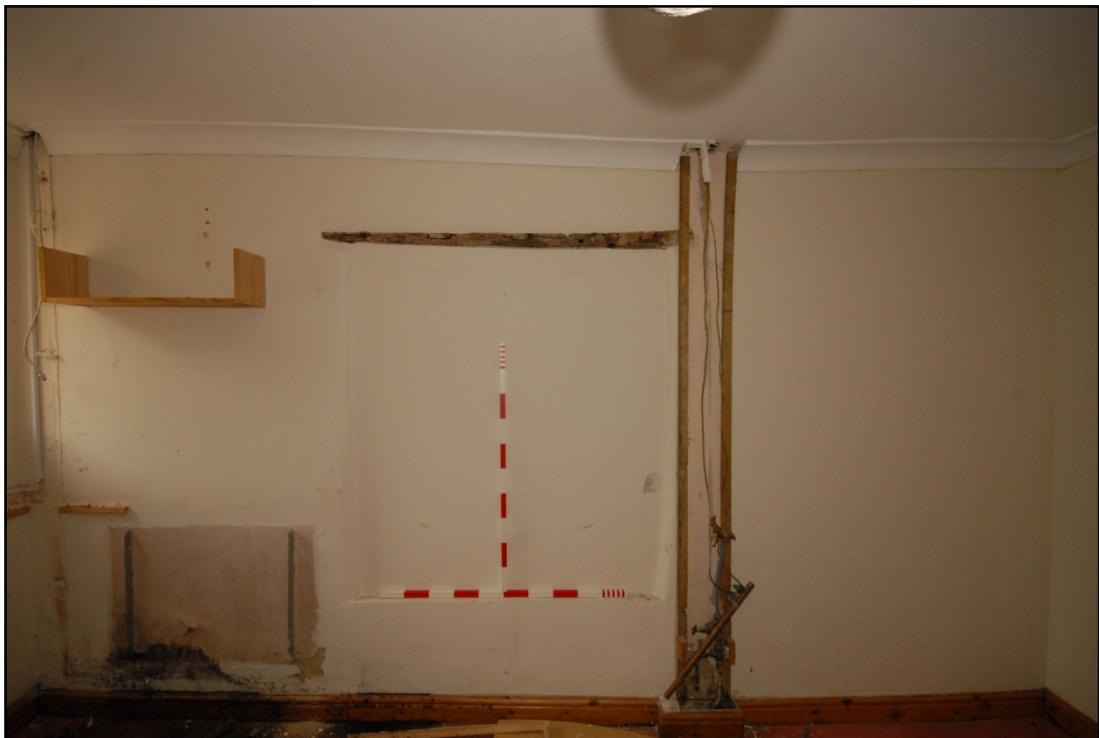
Bedroom 4, the blocked window, looking north Fig 43

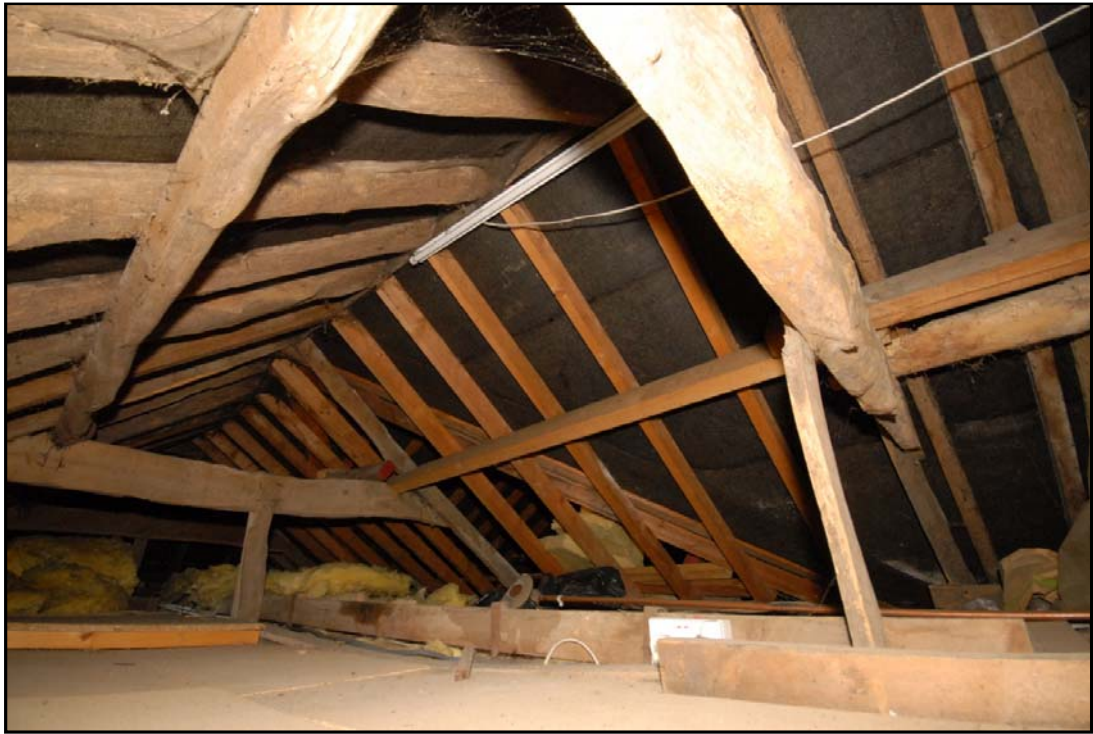
The roof structure shows signs of alterations to its structure. Each collar beam has a defunct purlin trench further outward from the existing purlins. Several of the rafters have been replaced or newer rafters have been added beside the earlier rafters for additional support. The rafters on the south side of the roof pitch are generally of an earlier date than those on the north side. The roof lends weight to the idea that the northern part of the building is of a slightly later date than the main building since it appears to have been modified to accommodate the southern structure.

The Attic, looking north-west from Bedroom 7 (note the difference in timbers on either side of the ridge) Fig 60

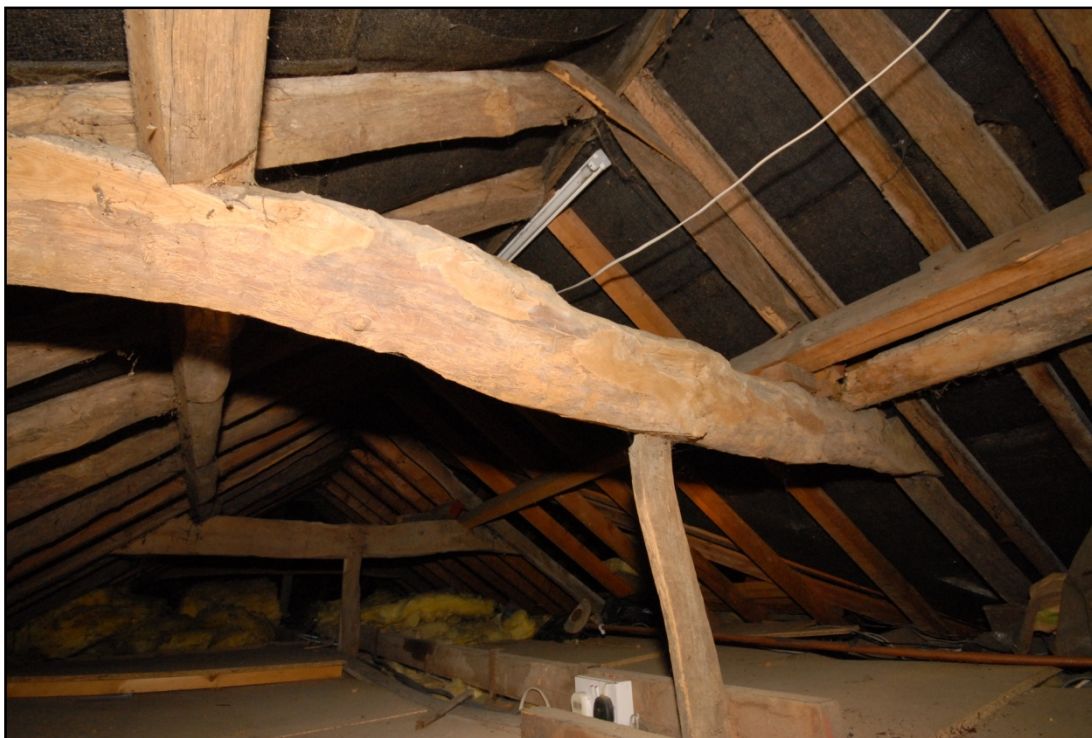
Detail of the collar beams and clasped purlins Fig 62

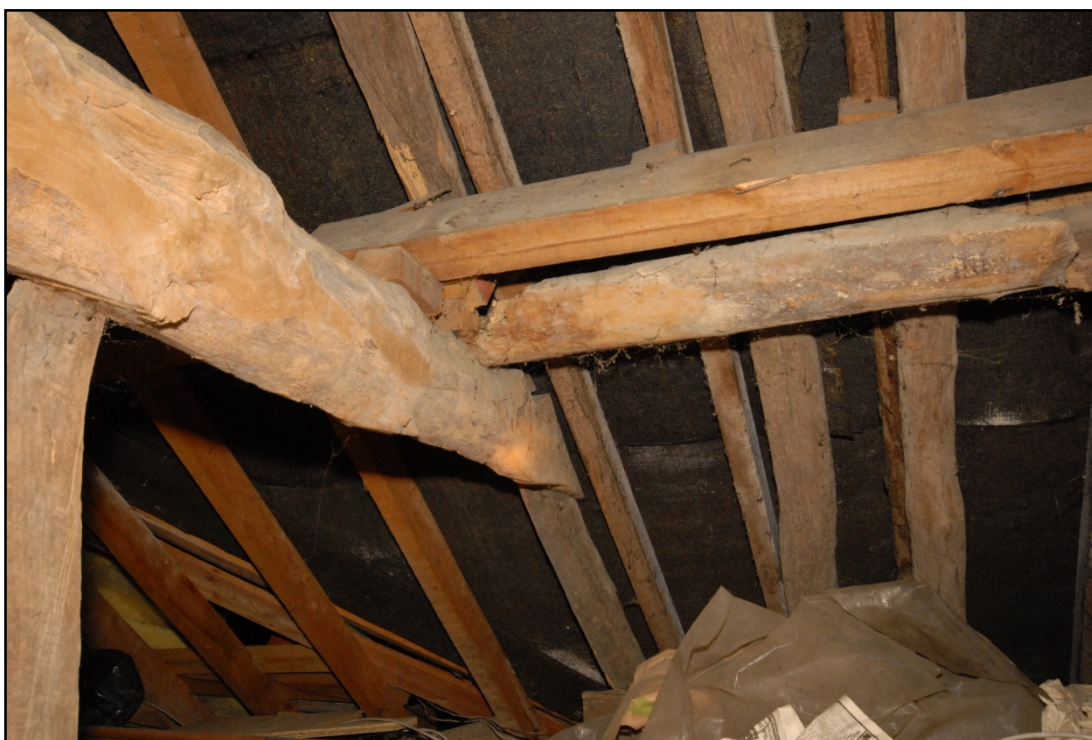
Detail of the clasped purlins and collar beams (note the differences in timbers) Fig 63

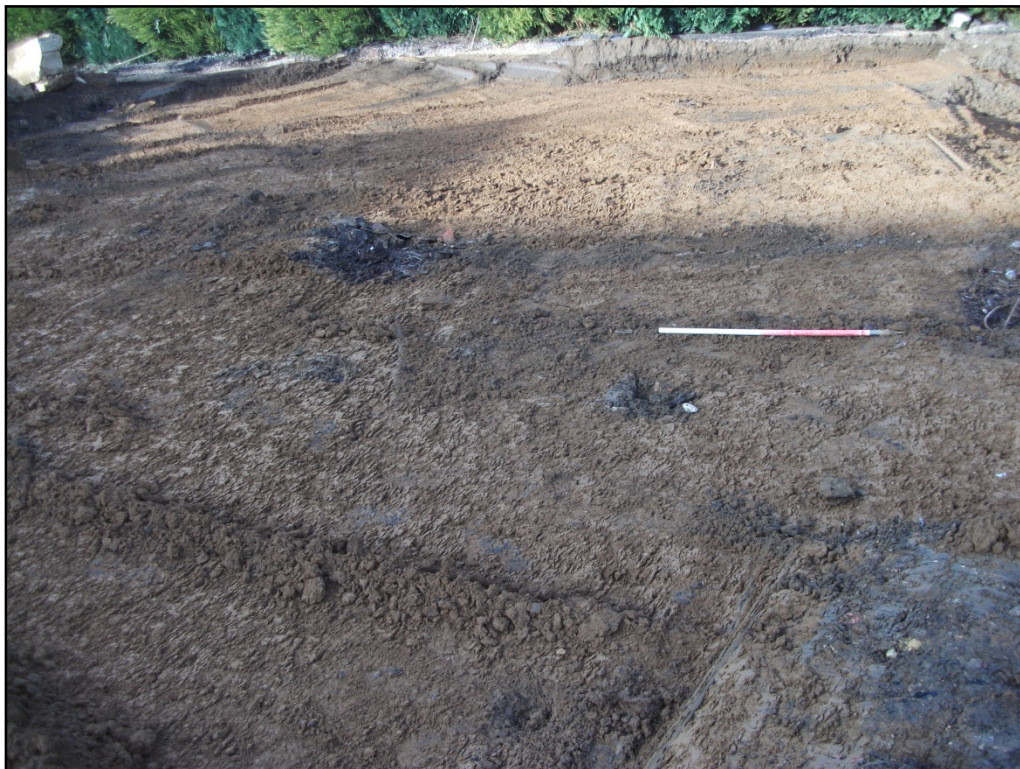
Two lines of modern postholes, some retaining the remains of wooden posts, were observed (Figs 2 and 65). These were likely the remains of a modern garden fence which divided the rear garden from the house. Scattered modern rubbish pits containing pieces of asbestos sheeting and bicycle and pushchair parts were also observed. Pieces of ceramic roof tile and glass bottles could be seen within the topsoil and subsoil.

The Watching Brief area, looking north, showing postholes Fig 65
