**Historic Building Recording
at Edgcote Lodge Farm, Edgcote
Northamptonshire
February 2014**

Report No. 14/56

NGR: SP 51400 46700

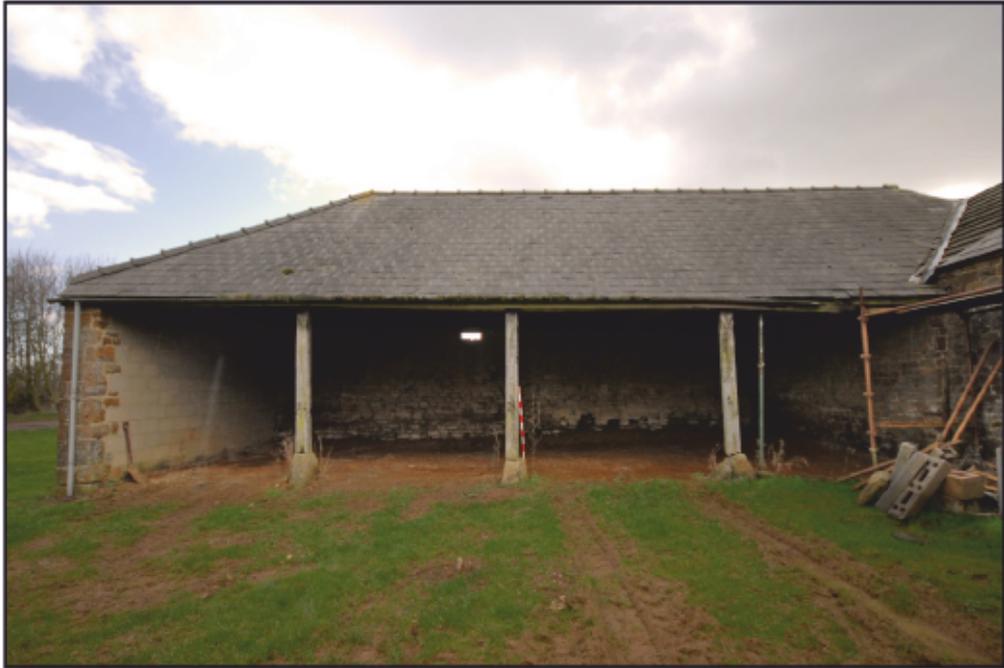
The north facing elevation is open fronted with three timber posts, chamfered at the tops and bottoms, on concrete supports carrying the roof over (Figs 8 & 15). These timbers are the original timbers for the building unlike the modern replacements seen in Building 1.

Building 2, the north-west elevation Fig 15

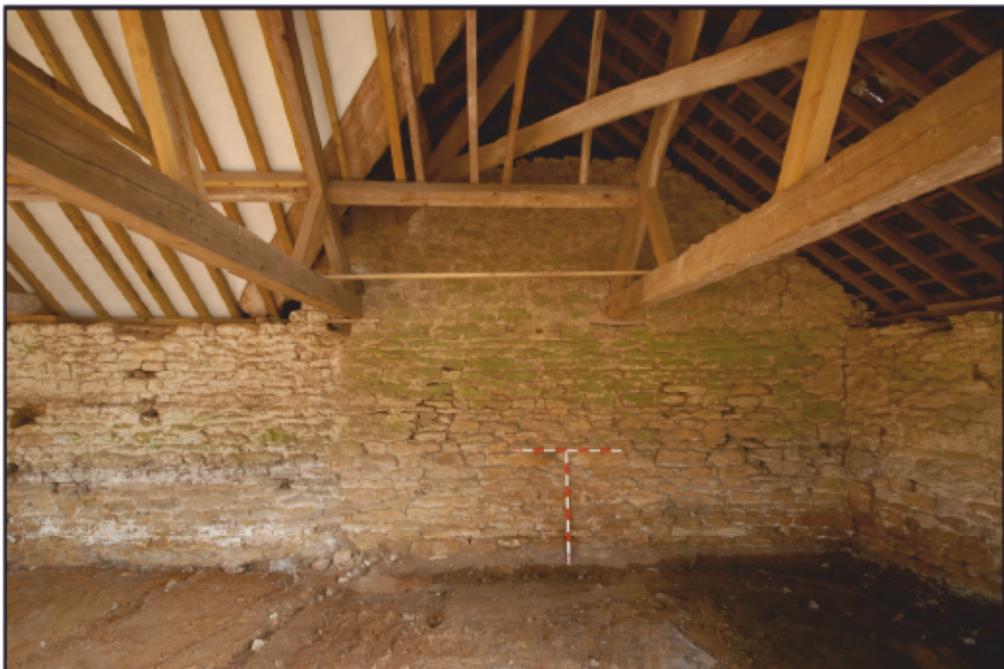
A pair of timber partitions originally separated the middle of the building from the south and northern ends (Fig 7). Evidence for this could be seen on the trusses above, in the form of defunct lap joints and patches of discolouration as well as on the wall which bore remnants of the whitewash that was present only in the segregated area (Figs 21, 22 & 26).

Building 1, interior, the end gable of Building 2 with line of former partition visible to the left Fig 21

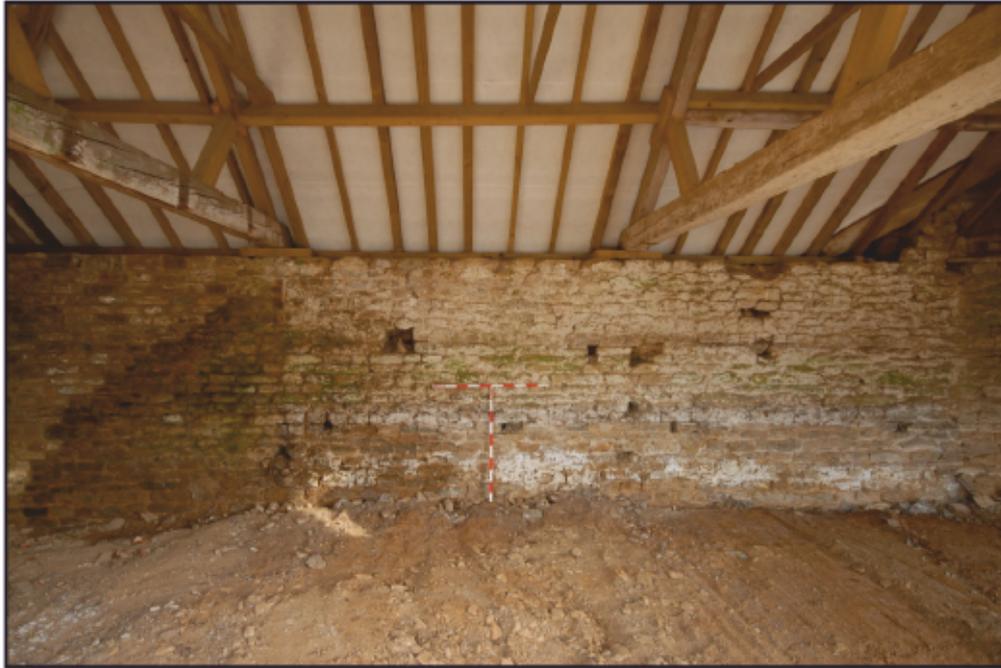
Building 1, the back wall showing the modern repair to the left and the line of a former partition Fig 22

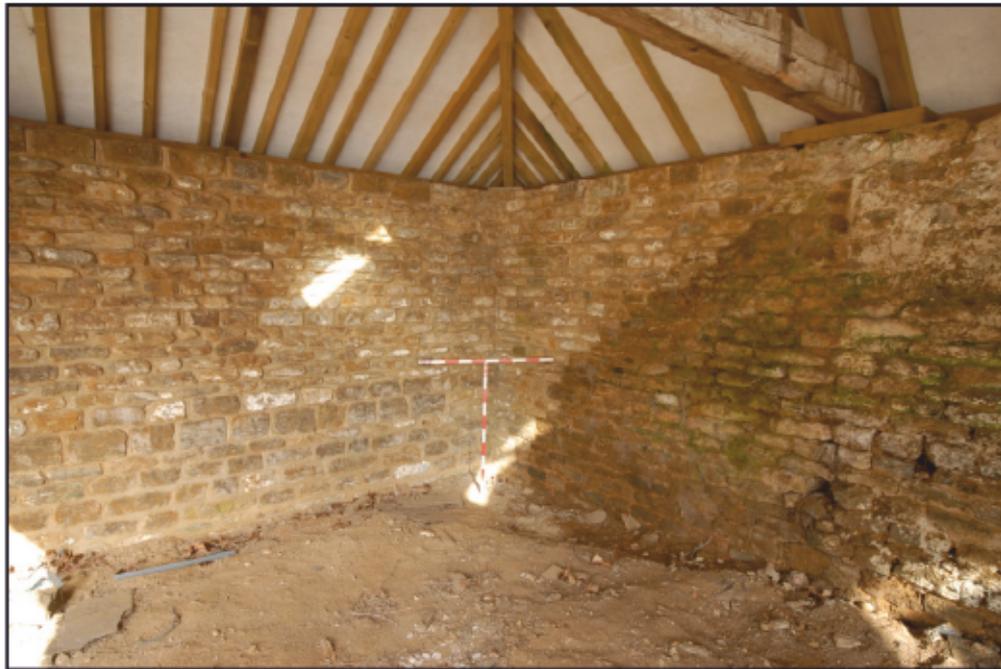
Measuring c5m x 14m Building 1 is a single storey structure, aligned north-west, south-east and open fronted to the west (Fig 7). It has a floor plan of c62sqm. The building was originally almost twice as long but the northern extent of the building collapsed in recent times and was made good to its current footprint. The building was re-roofed in the early 2000s and roof lights were added. The historic fabric of the building is of coursed sand and ironstone rubble with a pale, sandy mortar (Fig 32). The new north elevation and repair to the east elevation are also of coursed rubble with mortar infill (Fig 23).

Building 1, the north corner, showing the join between the modern repair and historic fabric Fig 23

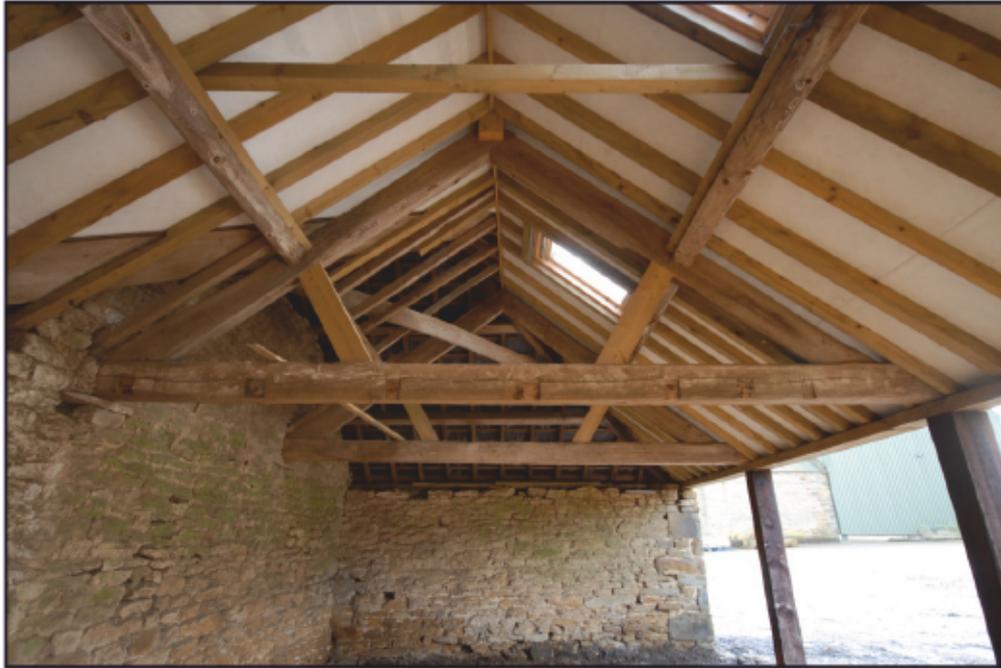
The roof which is hipped at both ends, is largely a modern rebuild incorporating original timbers in the bottom and upper chords of the trusses (Figs 9, 24 & 25). Of particular interest is the survival of matching pairs of carpenters' marks on several of these original timbers (Figs 27-30).

Building 1, detail of the roof structure, showing original timbers with modern bracing and rafters, looking south-east Fig 24

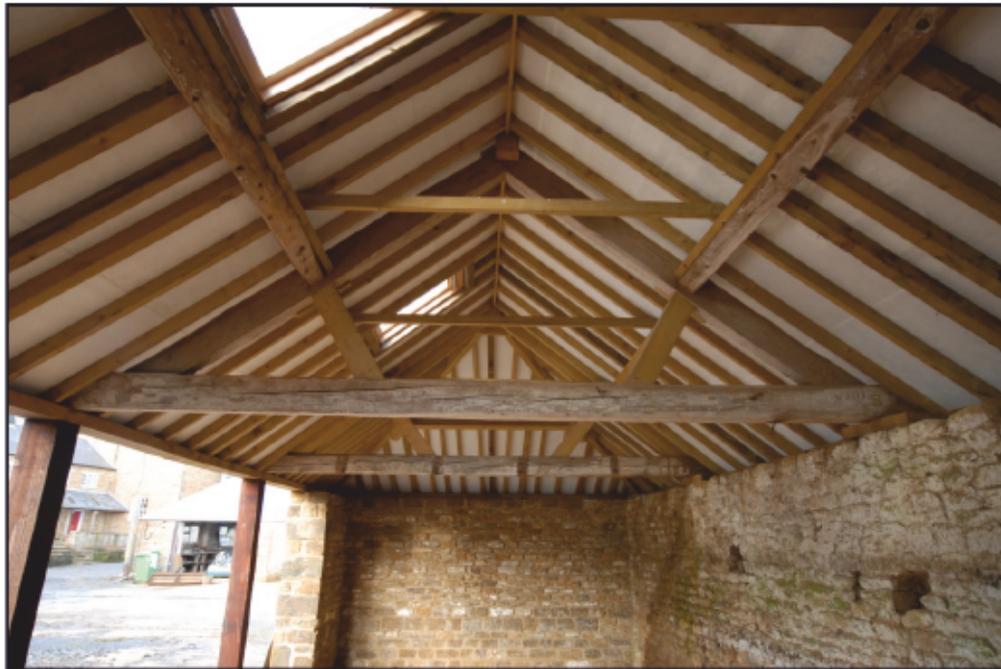
Building 1, detail of the roof structure showing historic and modern timbers Fig 25

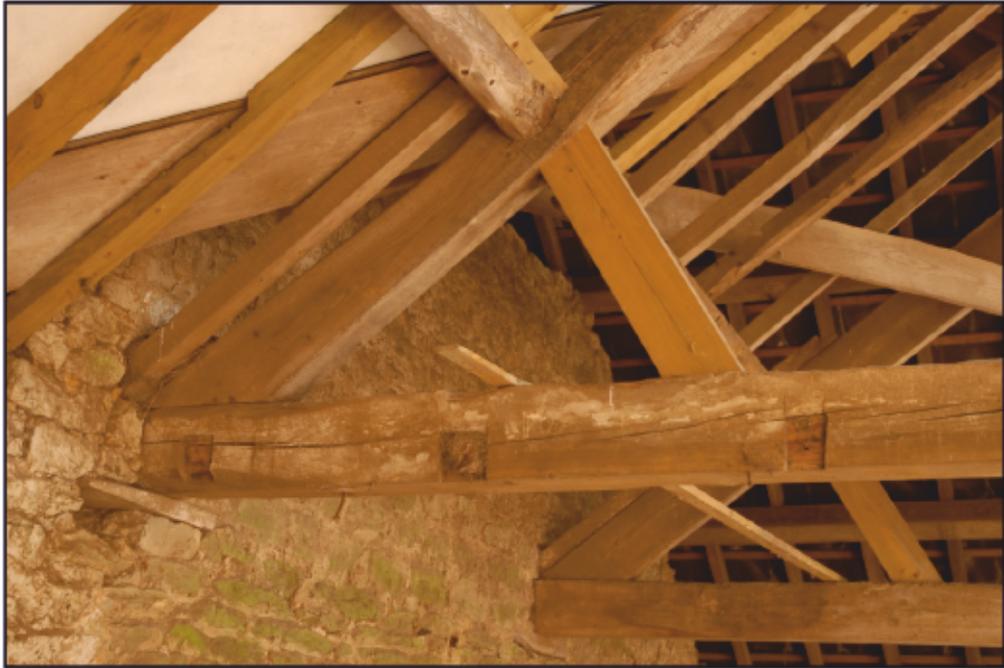
Building 1, detail of truss showing defunct joints of former timber partition

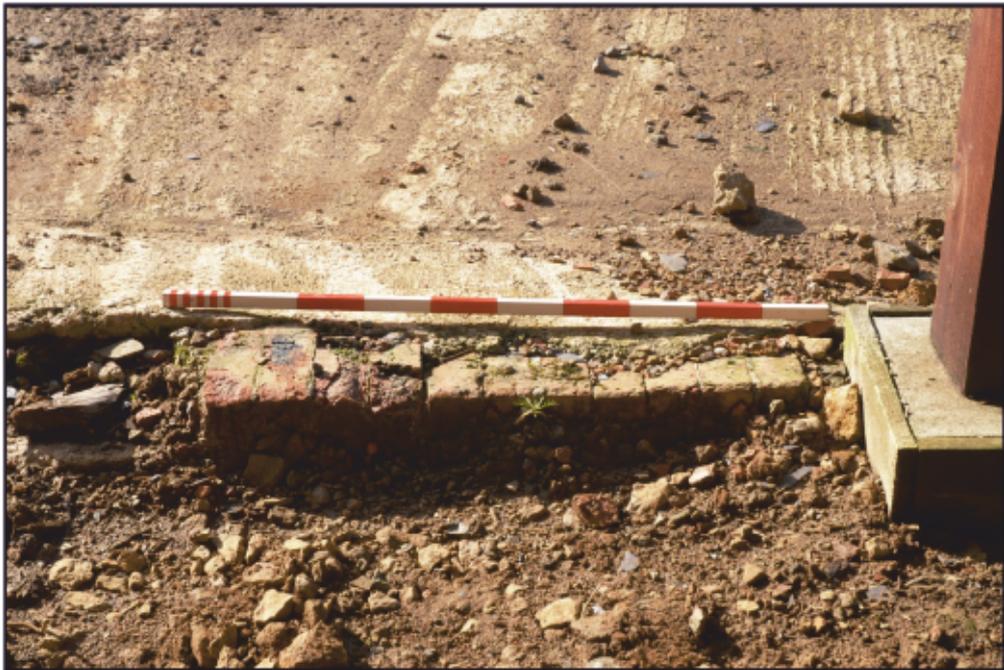
The posts supporting the open fronted, west elevation are all modern timbers replacing the original supports (Figs 7 & 8). A few surviving patches of bricks on edge indicate that the floor was originally bound by a long strip of these bricks, running the full length of the elevation, separating the yard surface from the interior of the structure (Figs 7 & 31). A manger, formerly against the east wall had been removed by the time of this survey (Fig 7).

Building 1, surviving remnant of brick edging on the south-west elevation Fig 31

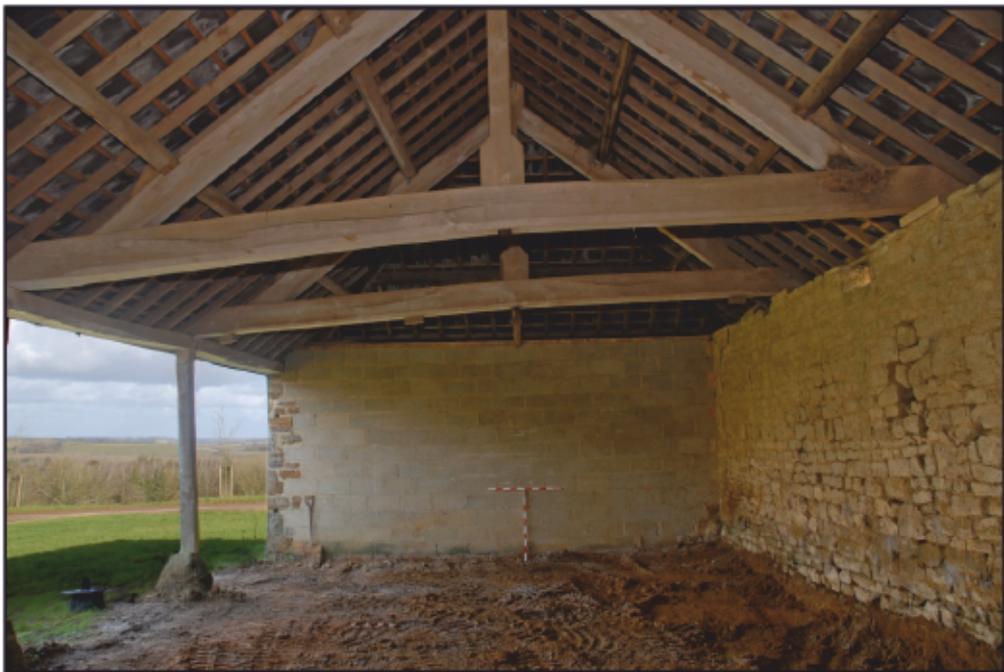
Building 2, interior, looking north-east, showing the breeze block re-facing of the north-east wall Fig 34

Building 2 appears to have been re-roofed in the mid-late 19th century with a machine sawn pine structure carrying welsh slate. This roof structure has been well incorporated into the modern roof of Building 1. The south-east interior elevation has been re-faced with breeze block.

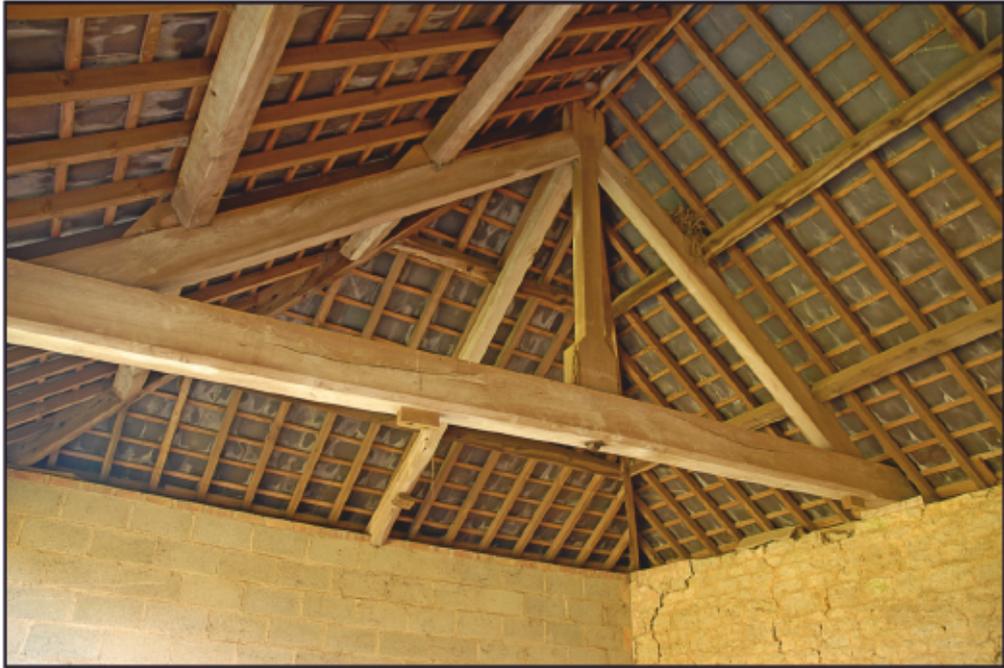
The roof is of welsh slate, hipped at the east, carried on classic king post trusses with iron ties centrally (Figs 9 & 37). The timbers in the trusses are machine sawn pine, chamfered along the edges. Carpenters' marks were present on two of the truss timbers (Figs 38 & 39). The construction of the trusses is likely of a post-1850s date, more recent than those seen in Building 1, indicating a re-roofing of the structure in the mid-late 19th century. Curved tiles cover the edges of the roof along the ridge and hip. Lead flashing is present where the roof meets that of Building 1.

Building 2, detail of the roof structure Fig 37
