Archaeological Survey of the North Retaining Wall at St Matthew's Church, Church Hill Walsall, West Midlands

Report No. 14/67

**Archaeological Survey of the North Retaining Wall
at St Matthew's Church, Church Hill
Walsall, West Midlands
February 2014**

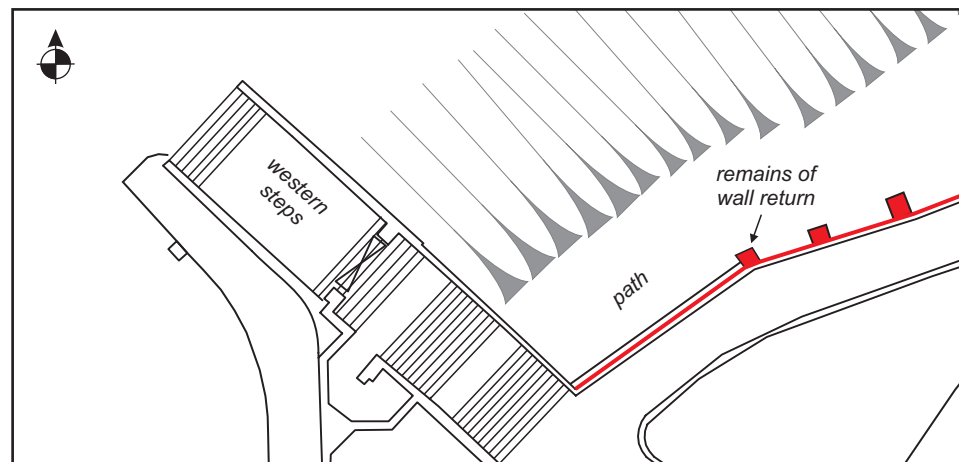
From the western steps, the wall is aligned north-east, south-west. This stretch of wall continues for c8m where the remains of a former property boundary mark the change to a shallower alignment (Fig 23). This wall was formerly the back of the structure which survived until at least 1954, replacing or incorporating an earlier building shown as Rodger-Tea Traders on historic photographs (Figs 5 & 7). The jutting brickwork which protrudes at an angle to the wall is the remains of the eastern wall of this building which formerly stretched to Peal Street (Fig 7). The brickwork of the bottom half of the retaining wall is in English Garden bond with rows of headers separating three rows of stretchers (Fig 23). The lower portion of the wall rises to c1.3m where it is capped with concrete slabs and the wall steps back c0.1m to continue rising to the full height. The upper part of the wall is largely in stretcher bond with a row of headers at its base and occasional headers throughout the main fabric (Fig 23).

The western extent of the retaining wall, showing phases of construction and repairs Fig 23

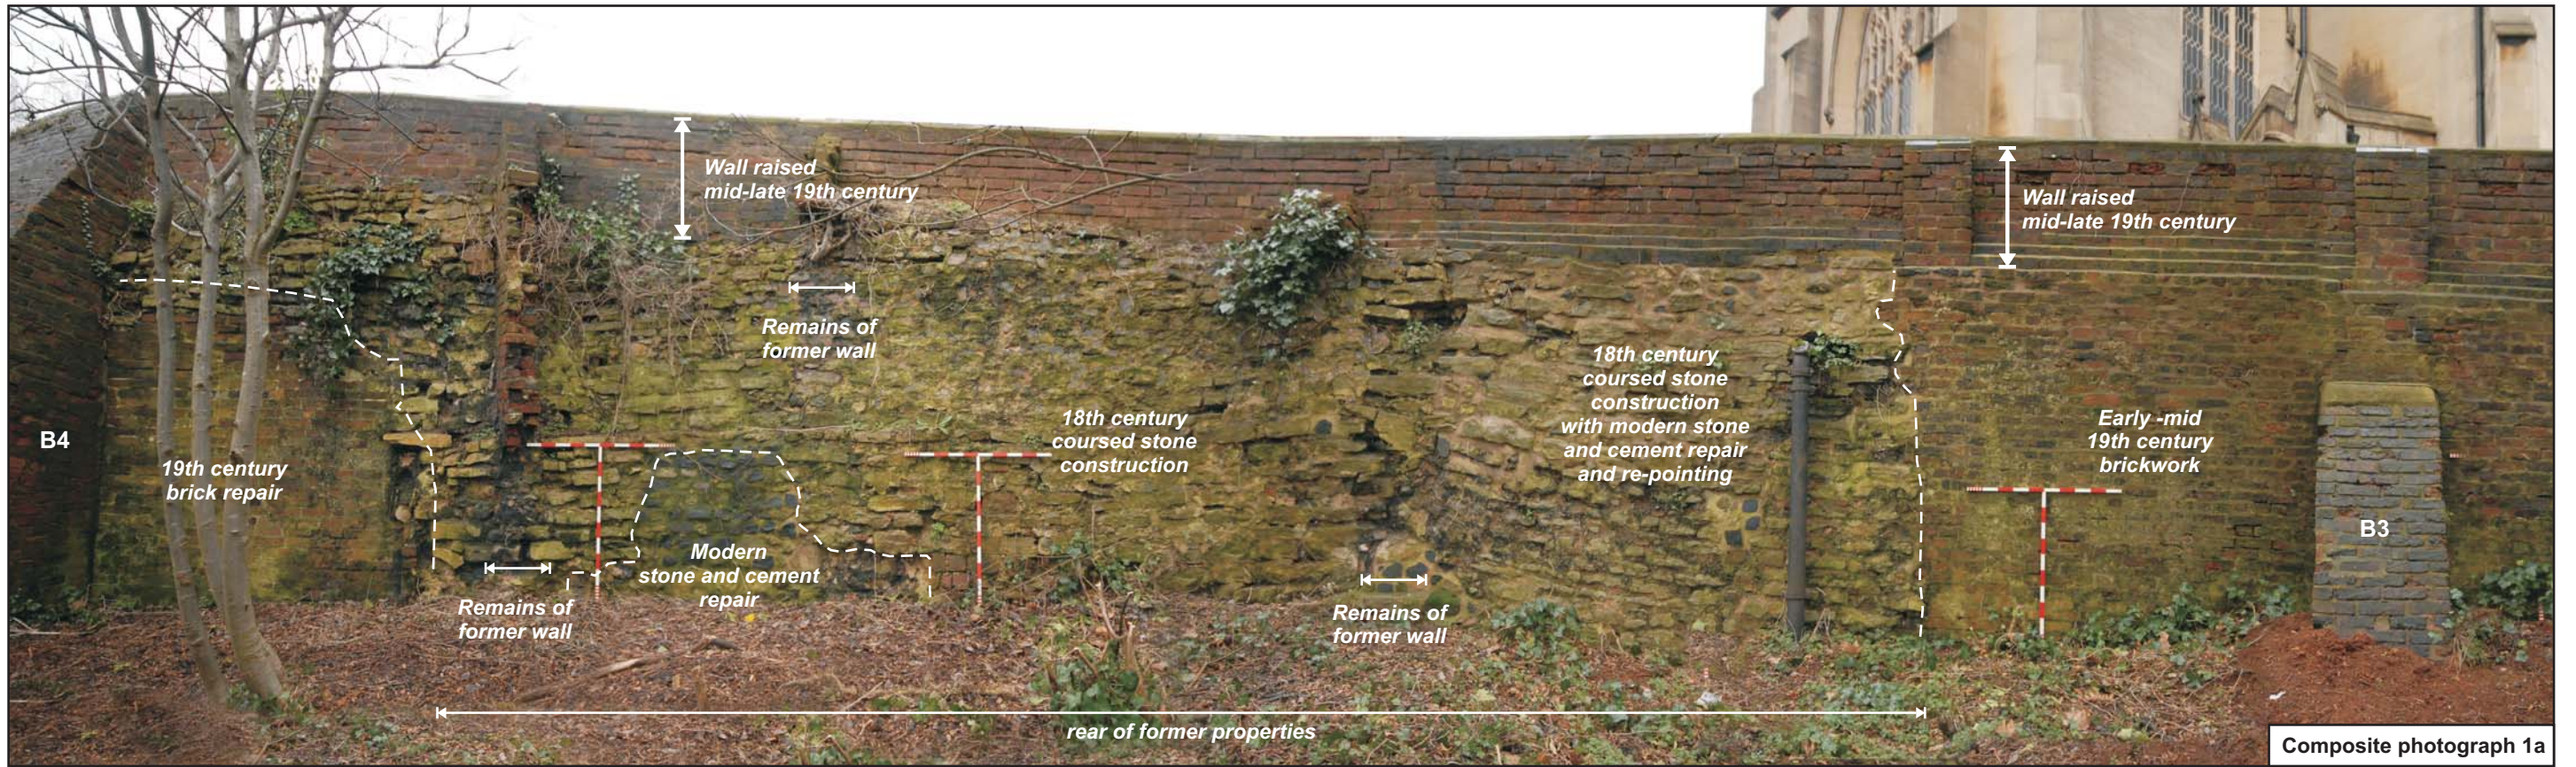
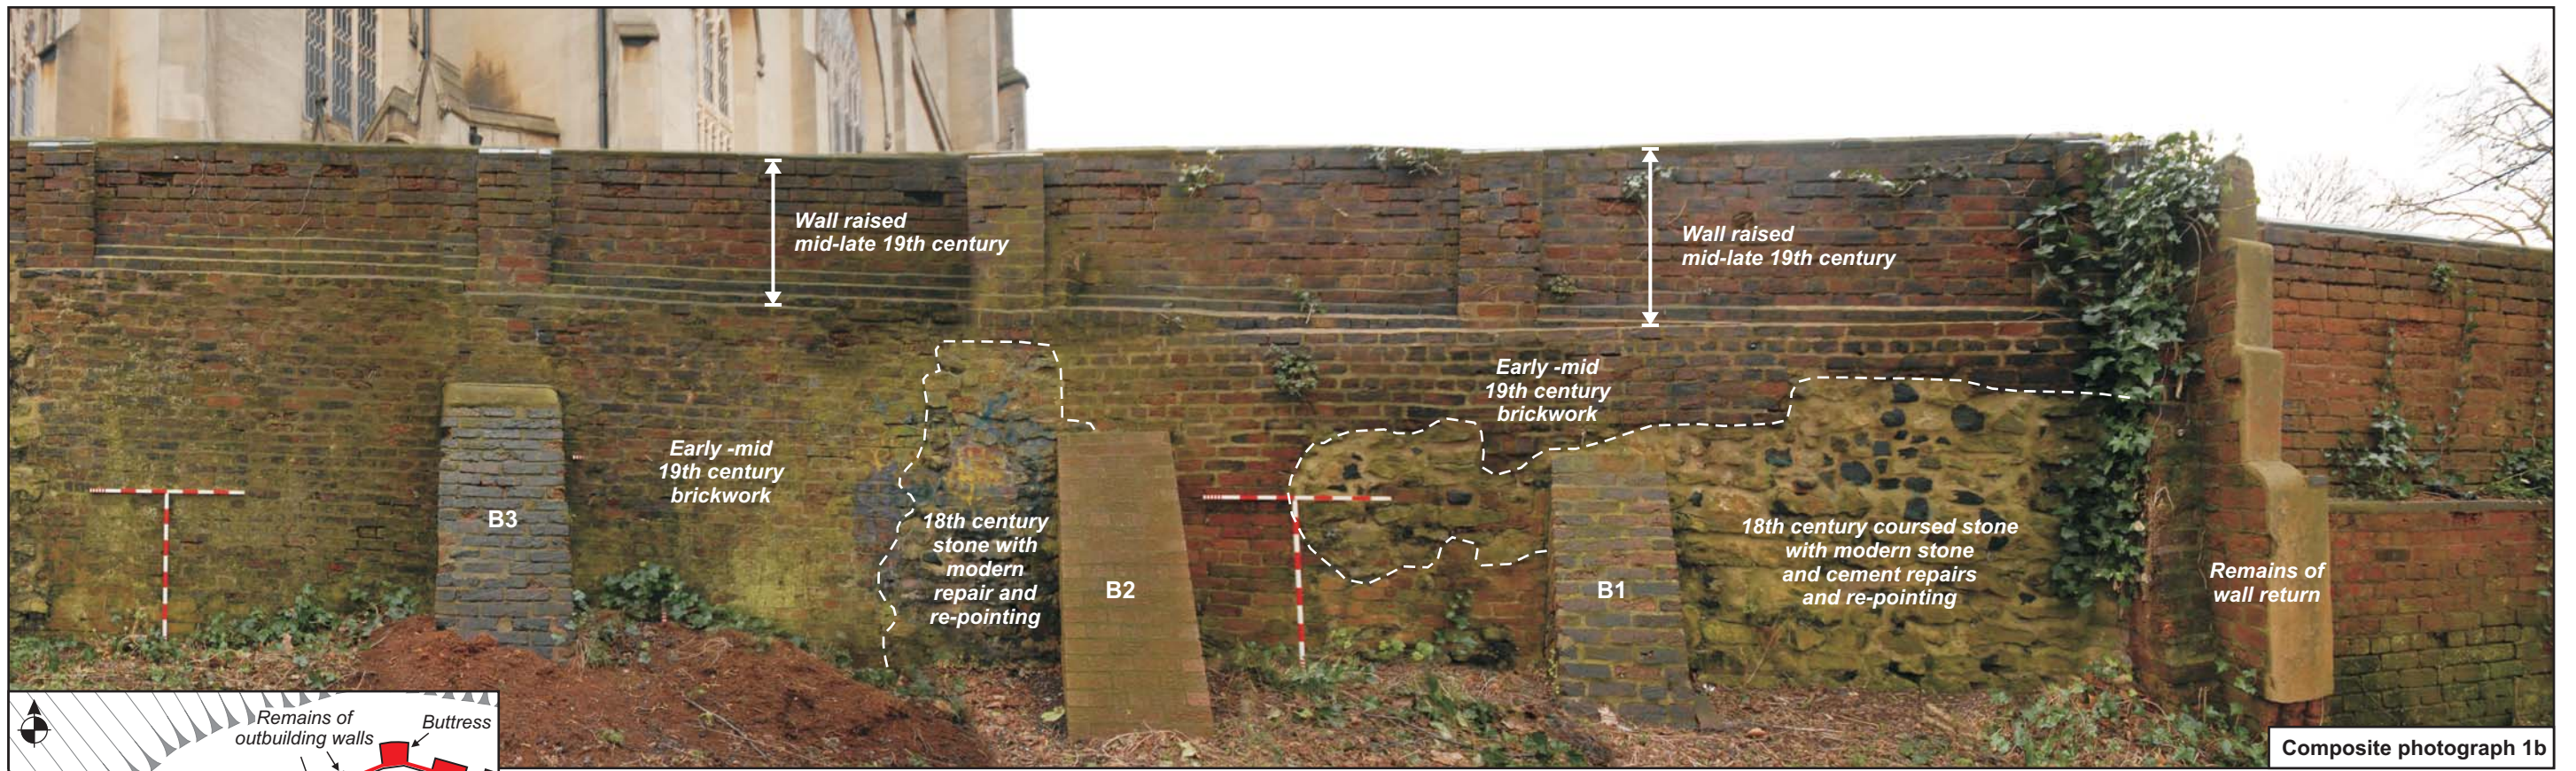
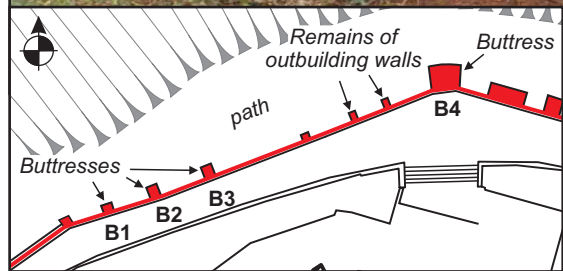
The retaining wall across this stretch is of irregularly-coursed, roughly-shaped rubble, representing the earliest phase of construction surviving largely due to being preserved at the back of properties. It has been partly rebuilt in handmade brick where it meets buttress B4. Subsidence has caused structural damage to part of the wall, resulting in the rubble courses sinking and pulling apart (Figs 24 & 34).

Composite photograph 1, showing phases of construction and repairs Fig 24

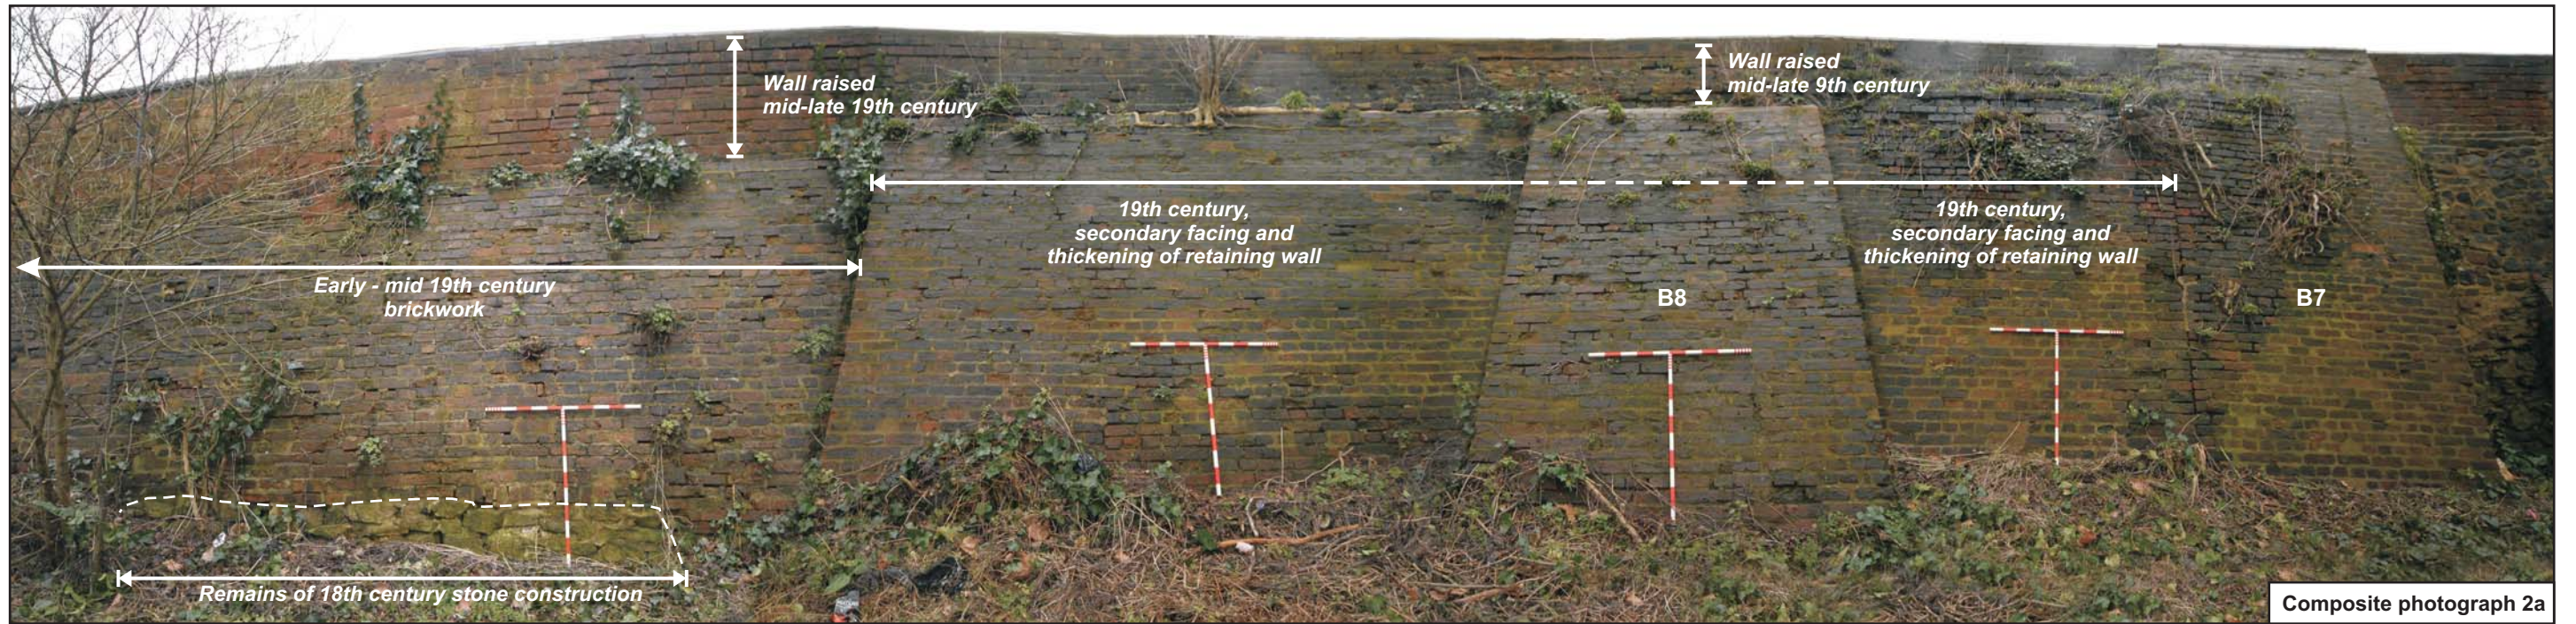
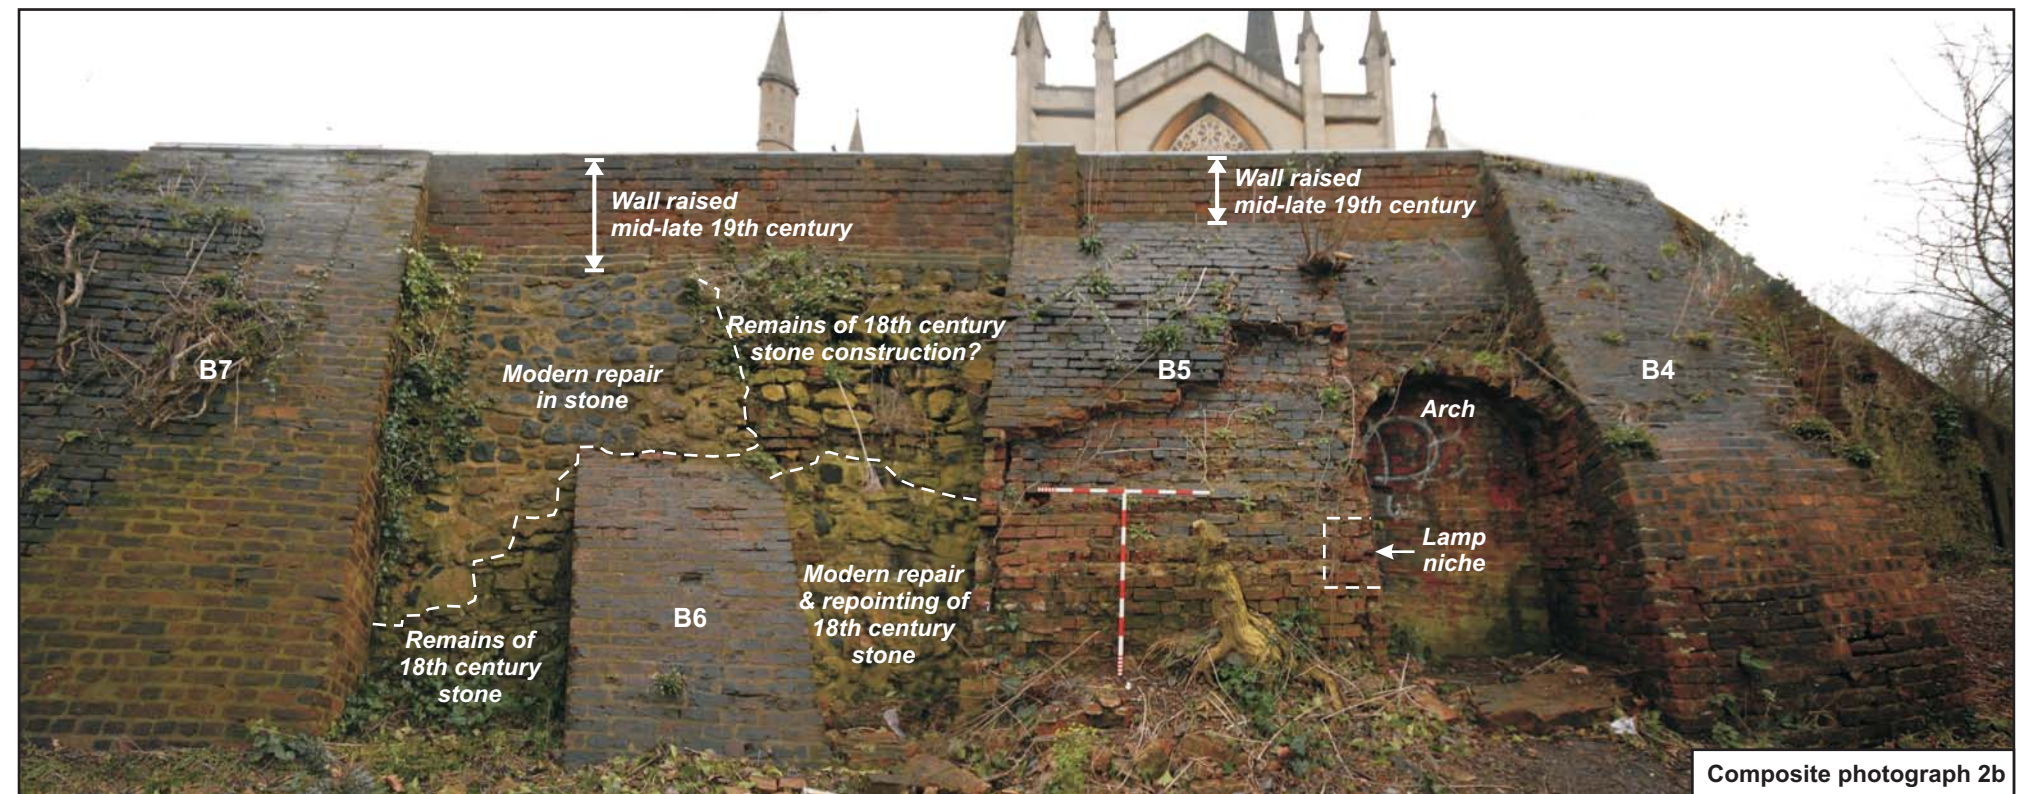
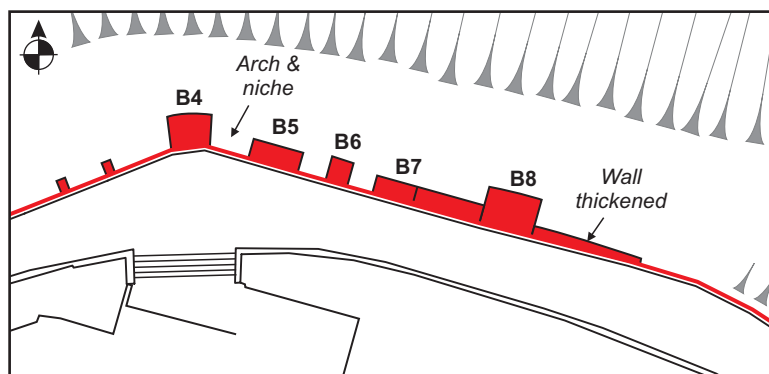
Buttress B5 is constructed of handmade, reddish-purple bricks showing skintling marks with pink lime mortar between (Fig 25). The outer face of the buttress is primarily in stretcher bond but where this has fallen away, the brickwork beneath is in English bond with alternating courses of headers and stretchers (Fig 42). English bond is largely associated with the medieval period and fell out of fashion in early 17th century but was revived in the 19th century for structural purposes. Though the inner cores of the other large buttresses are not visible, it is likely that they were constructed with a core of brick in English bond for strength and faced with an outer layer in stretcher or garden wall bond. B5 was found to be in poor condition with the north face having slipped away from the core. The damage to the brickwork was caused primarily by the growth of a tree at the base of the buttress which forced the bricks apart and began a process of gradual deterioration. A smaller buttress supporting the upper wall level is built into the top left corner of B5 (Fig 25).

An area of coursed rubble, c3.5m in width, is bound between buttresses B5 and B7 (Figs 25 & 43). It has been partly rebuilt or repaired in the upper left corner with new stone and cement re-pointing. As elsewhere, this area of rubble represents the earliest phase of construction and likely survives behind the buttresses to either side.

Composite photograph 2, showing phases of construction and repairs Fig 25

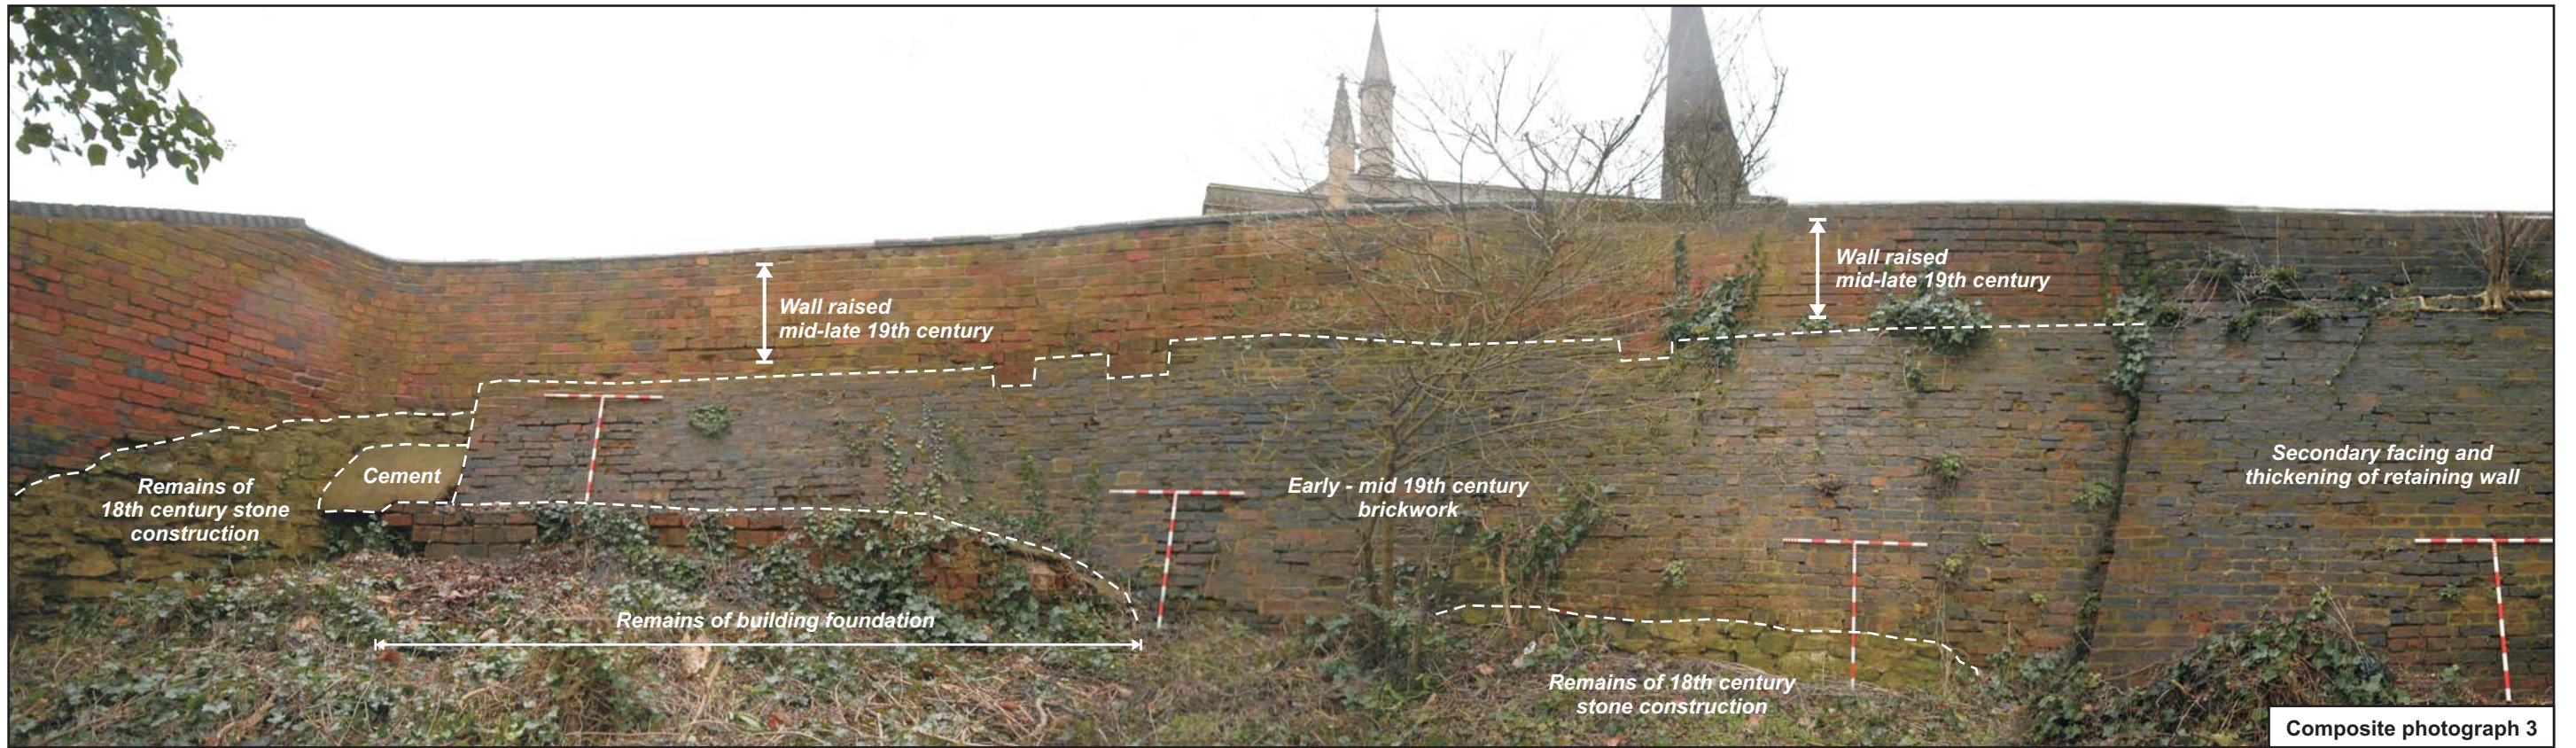
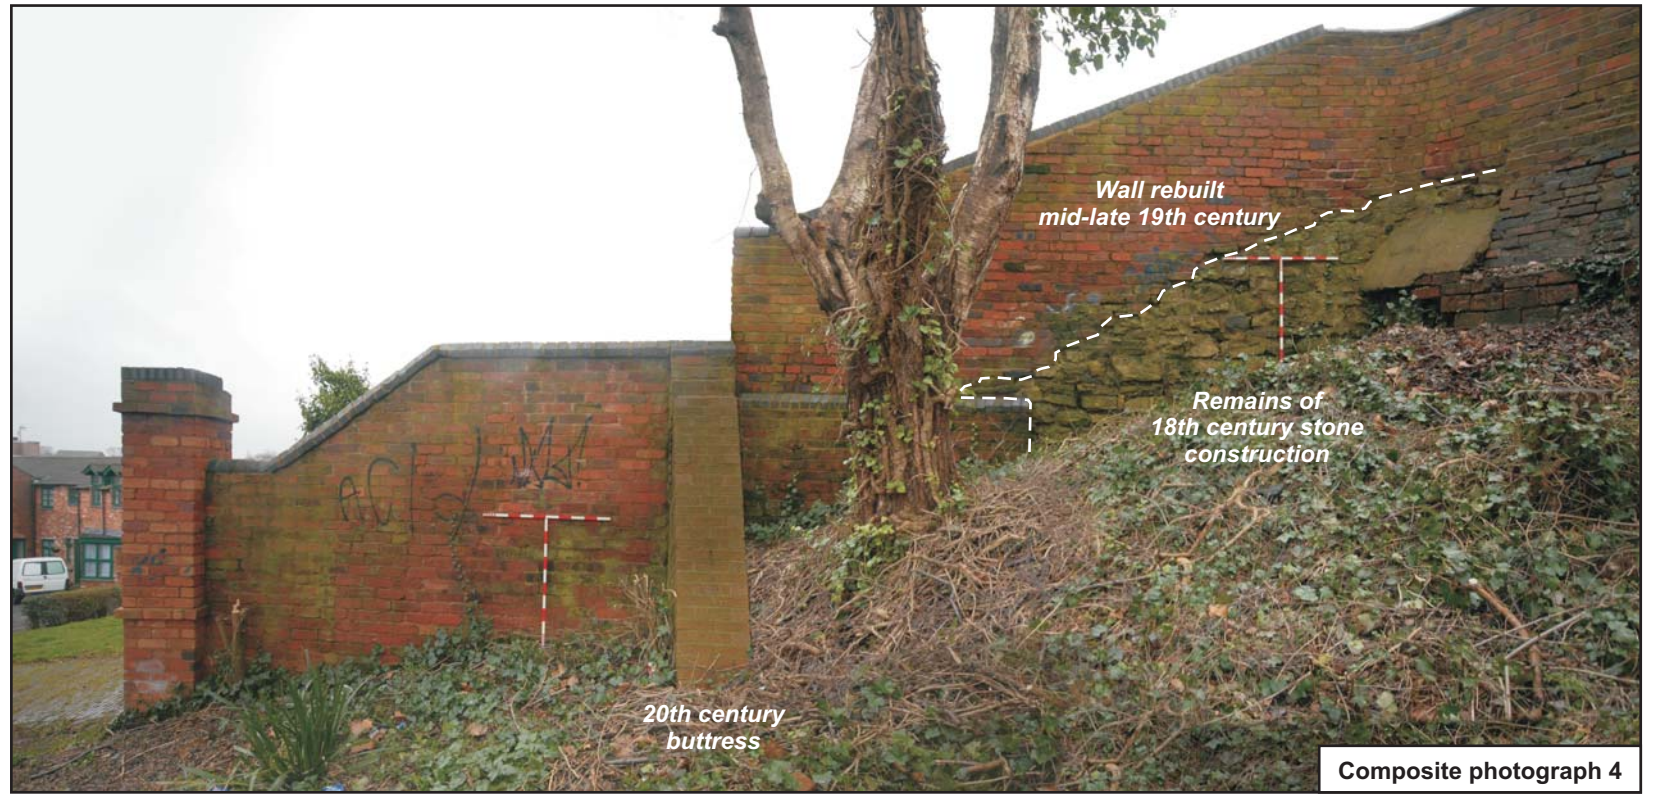
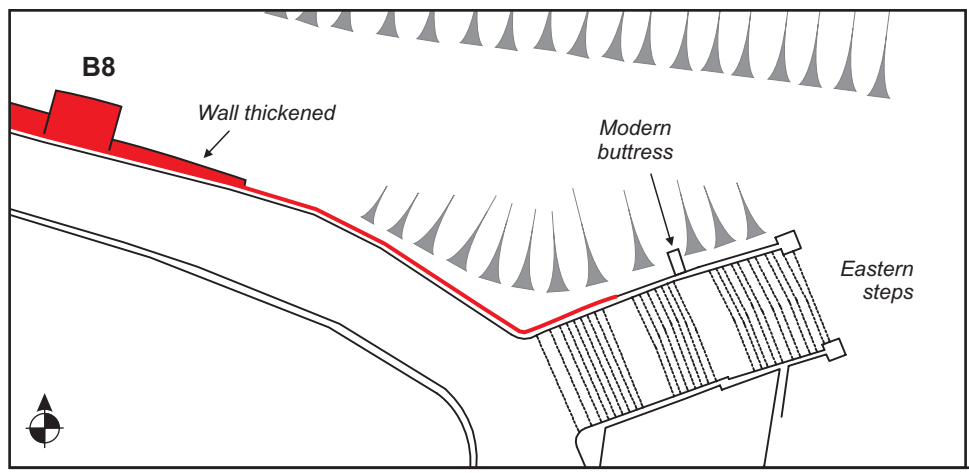
Where it meets the eastern steps, the retaining wall curves around and continues around them (Figs 26 & 49). The upper portion of the retaining wall becomes the primary fabric of the wall and changes to header bond around the curve, then changes back to stretcher bond as it straightens (Fig 26). At the base of the steps and wall there survive several courses of the earlier, coursed rubble construction (Figs 48 & 49). A modern brick buttress provides additional support to the brickwork at the side of the steps (Fig 26).

The foundations of a structure which formerly stood in the angle between the steps and retaining wall partly survive, largely hidden by vegetation (Fig 26).

Composite photographs 3 and 4, showing phases of construction and repairs Fig 26

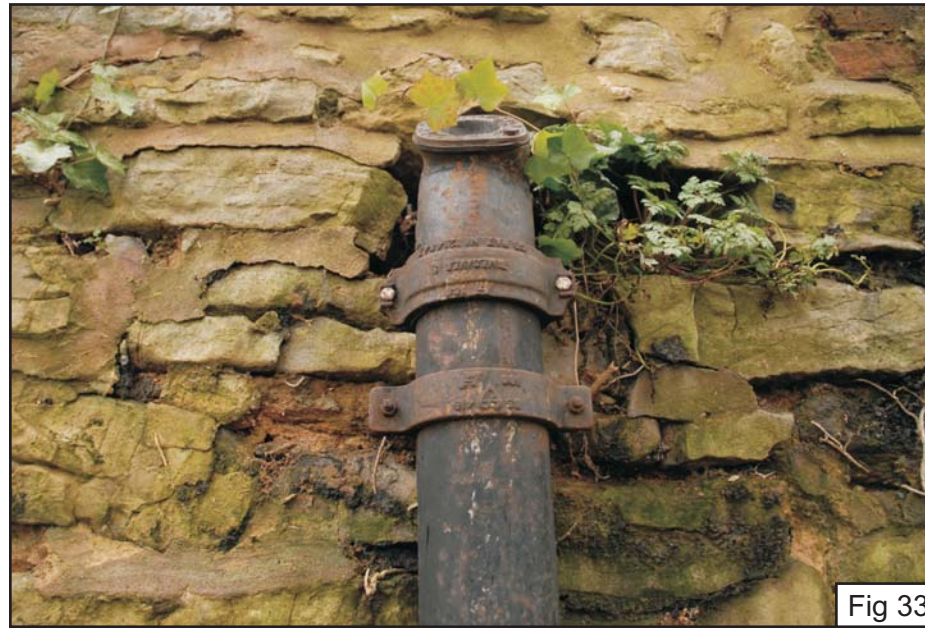
Fig 33 Detail of cast iron drain pipe

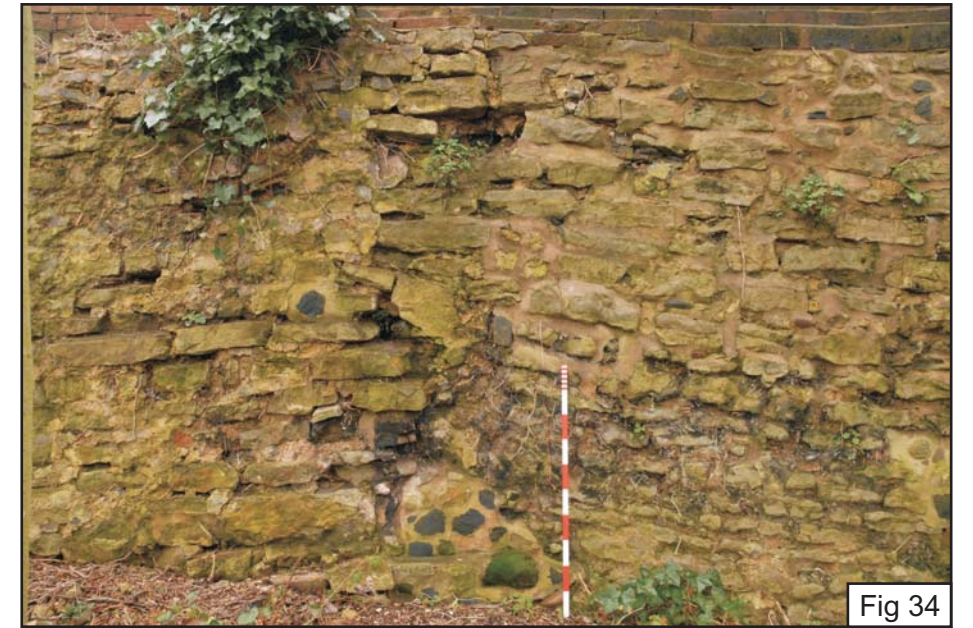
Fig 34 18th-century coursed stone showing subsidence

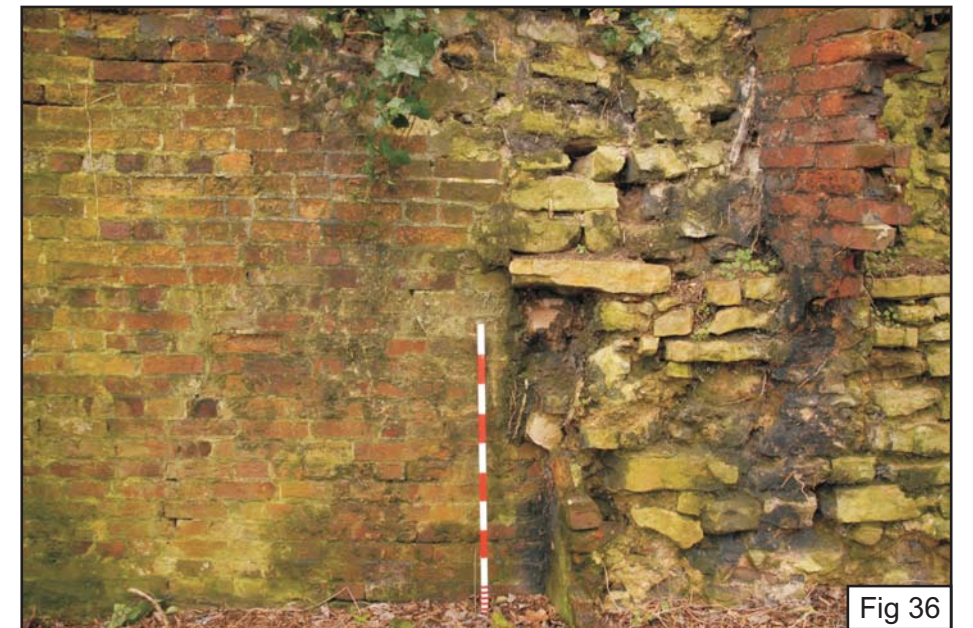
Fig 36 19th-century brick repair of 18th-century coursed stone

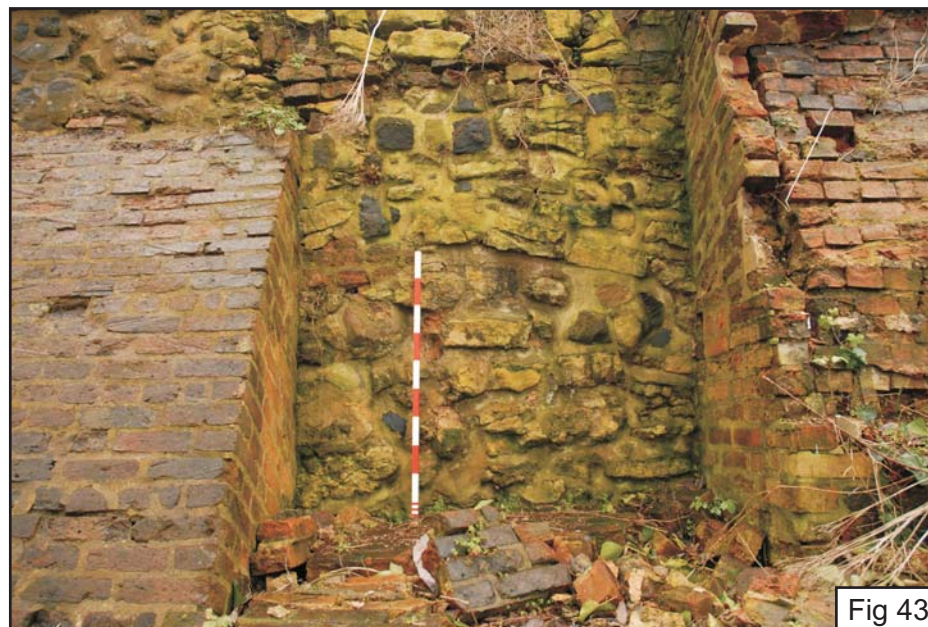
Fig 43 Coursed stone between buttresses B5 and B6

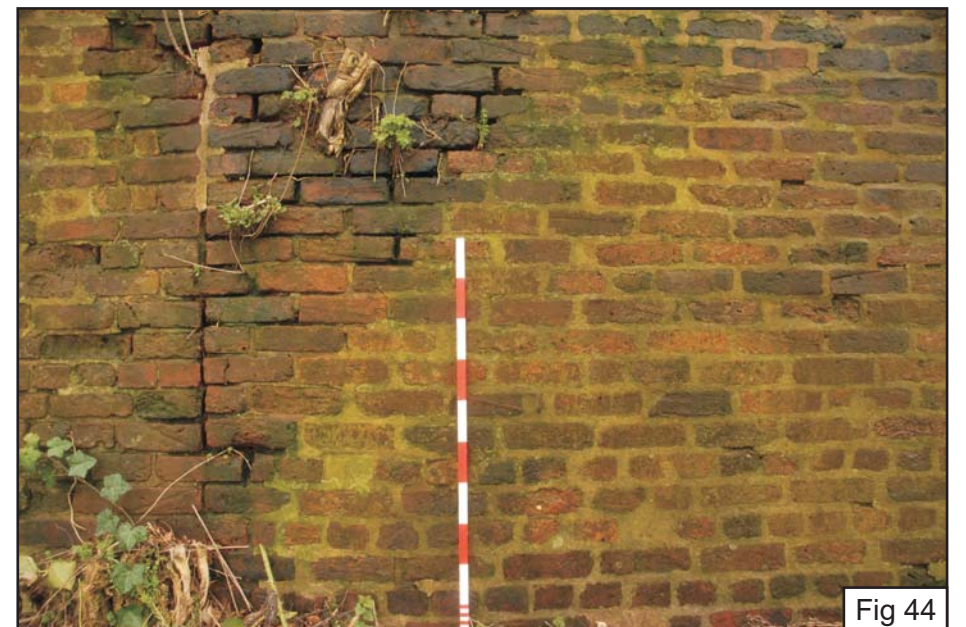
The eastern edge of B7 marks the beginning of a c9m stretch of brick re-skinning and thickening of the retaining wall (Figs 25 & 44). This is flush with B7 and rises to approximately ground level on the church side of the wall. It is constructed of handmade, reddish-purple bricks in a pink lime mortar, largely in English Garden Wall bond, with three courses of stretchers between single header courses. The brickwork has been repaired with later cement re-pointing in several places. At its eastern extent the brick skin tapers and steps back to the wall. The brickwork thickens towards the base of the wall to strengthen the structure (Fig 46).

Fig 44 Detail of modern cement repointing of buttress B7, also showing the vertical joint between the buttress and the brickwork to the east
