**Archaeological Building Recording
at Dollman Farm, Crick Road
Hillmorton, Rugby
Warwickshire
April 2015**

Report No. 15/96

MOLA Northampton carried out archaeological building recording of a group of agricultural buildings and farmhouse at Dollman Farm, Hillmorton, Rugby, Warwickshire. The recorded buildings included barns, stables, garage, sheds, workshop and farmhouse. These structures largely date to the mid-late 19th and early 20th centuries with a range of modern additions and alterations.

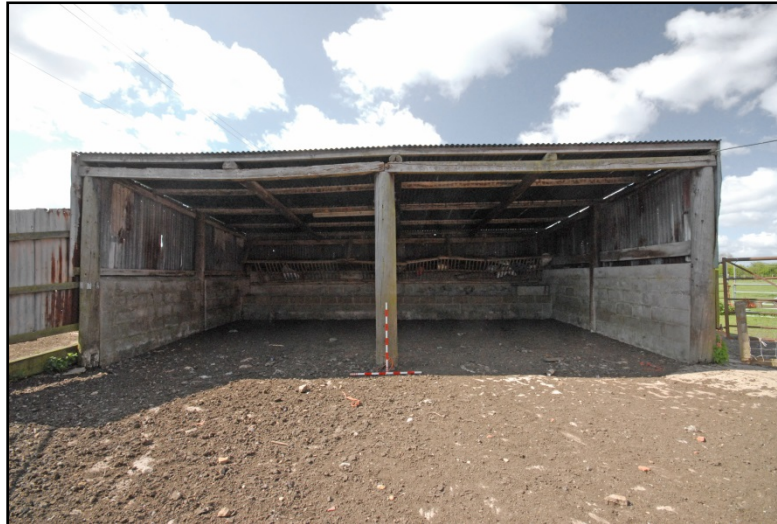
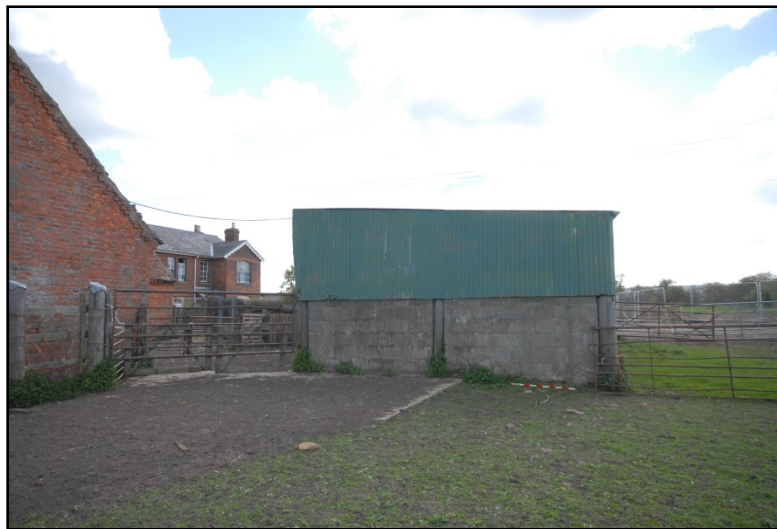
Located to the south of the western stables, this is a single-storey building with an earth floor, open-fronted to the north. It has blockwork dwarf walls with corrugated sheeting over, stretching between vertical timbers that support the timber roof

structure. Raised wooden mangers survive *in-situ* against the rear wall. The shed faces a yard to the north which is shared by the adjacent stables.

Cow Shed, looking north-west Fig 7

Cow Shed, looking south-east Fig 8

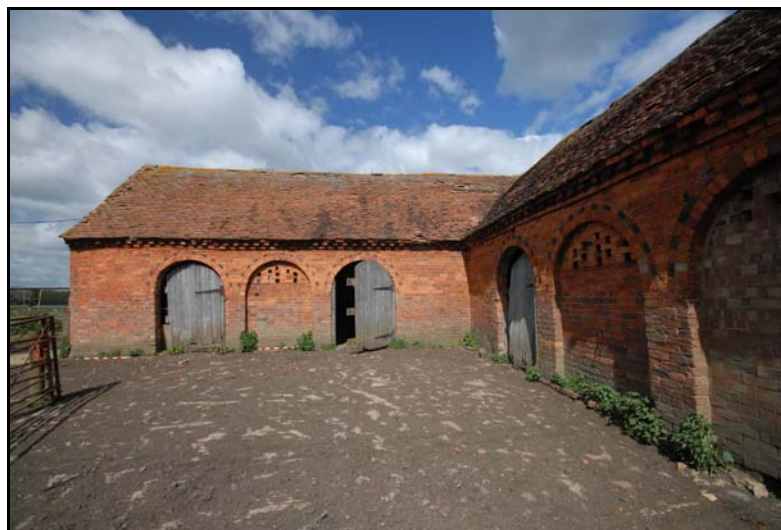
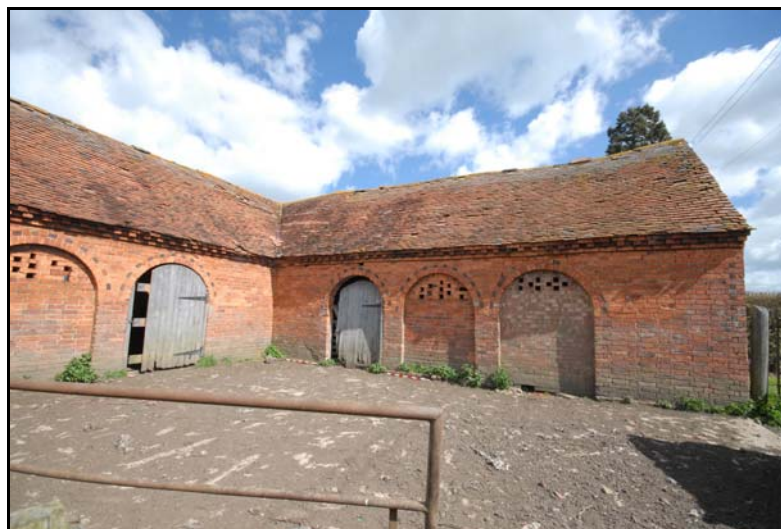
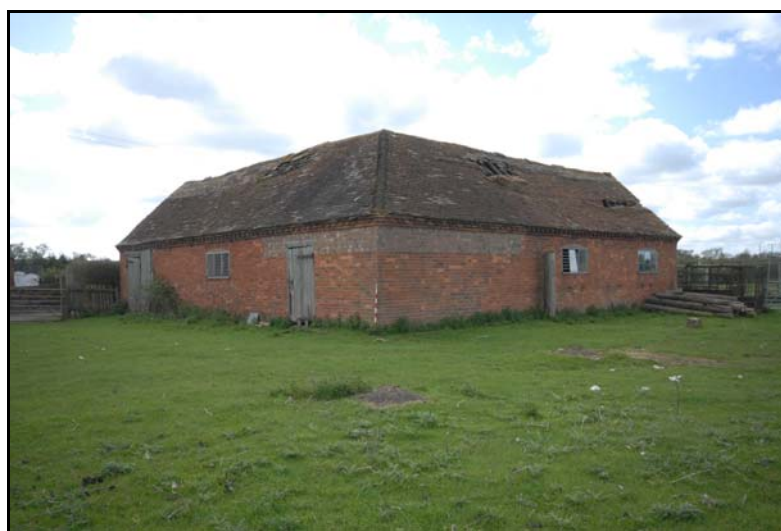
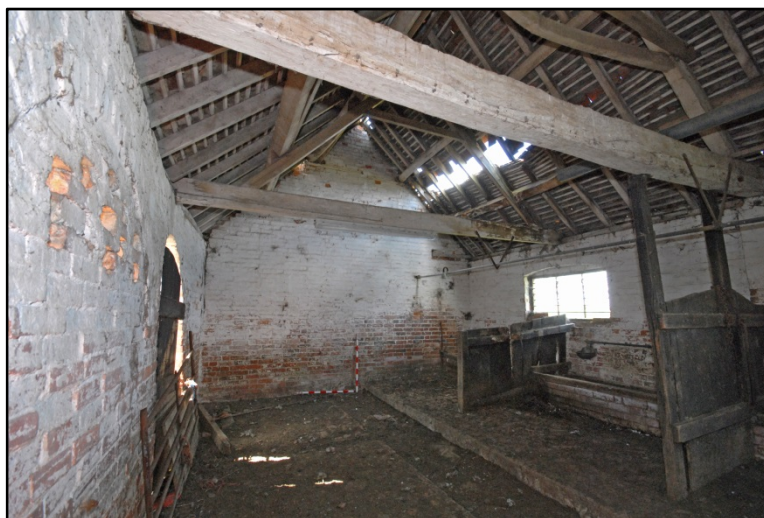
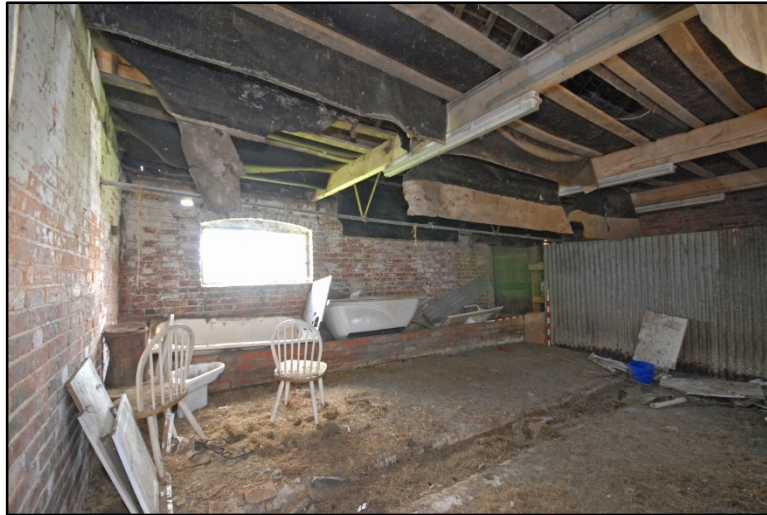
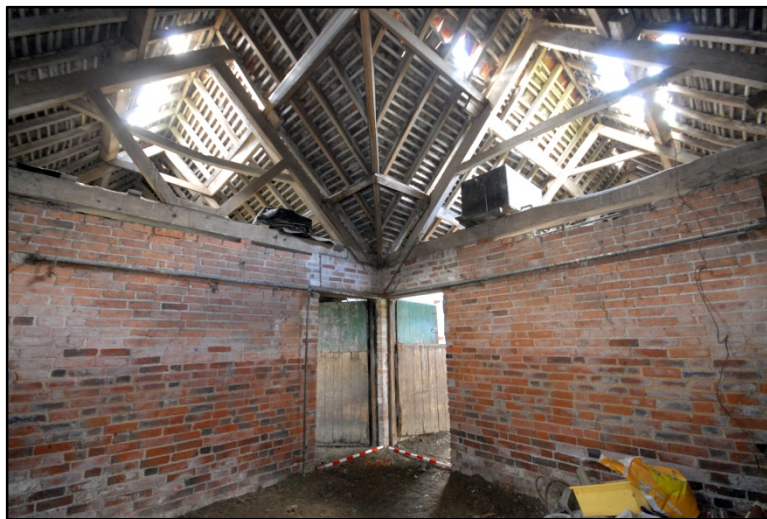
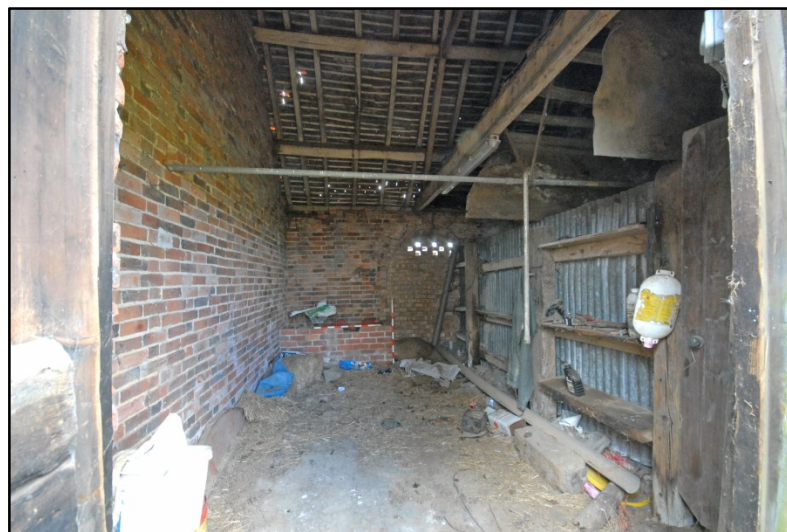
To the north-east are two secondary doorways flanking a fixed window with wooden louvers. Two further louvered windows are in the north-west elevation. A low level opening, blocked in brick can also be seen in this elevation. Six courses of modern brick repair can be seen below the eaves around the north corner.

Each range houses a stable and a barn is located at the intersection of the stables, in the north corner of the building. The eastern extent of the east range has been partitioned into a small storage area. Each range has two large, arched doorways facing the yard, flanking a central, blind arched recess with a ventilation panel within the arch. The easternmost door of the east range has been blocked in brick. The doors are plank and batten, with cast iron strap hinges.

The stables have raised brick floors and brick troughs are built against the north walls with timber stall partitions and iron mangers against the walls. Sunken drainage channels run central to the stable rooms.

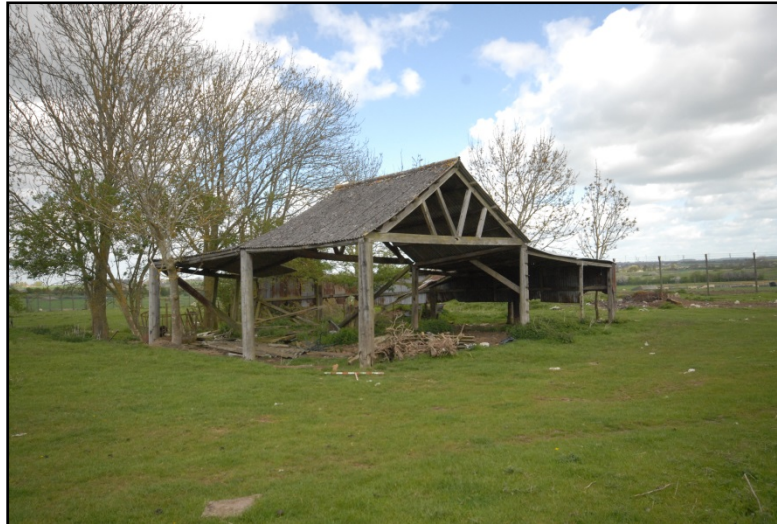
This is located to the north-west of the farm and is an open-sided structure with an earth floor, with upright timber beams supporting a wooden roof frame with corrugated sheet covering. Some remnants of corrugated sheeting at the north side suggest that formerly the building was formerly clad in corrugated sheets. The barn was derelict and ruinous by this survey.

The Pole Barn, looking north-east Fig 16

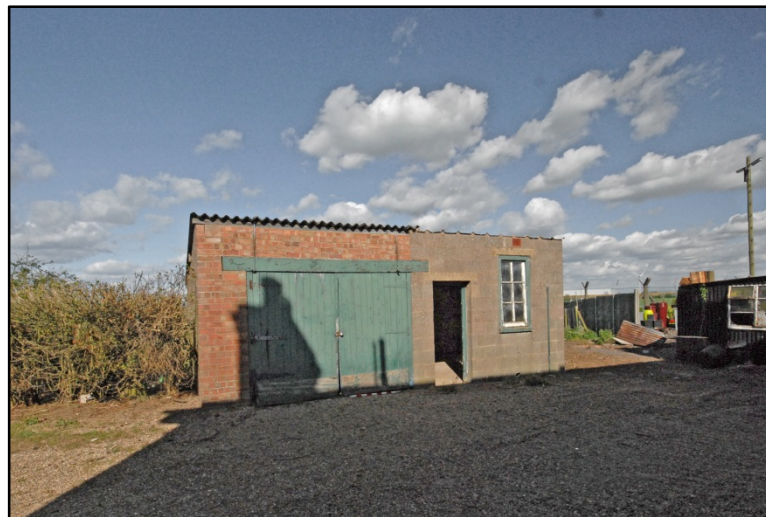
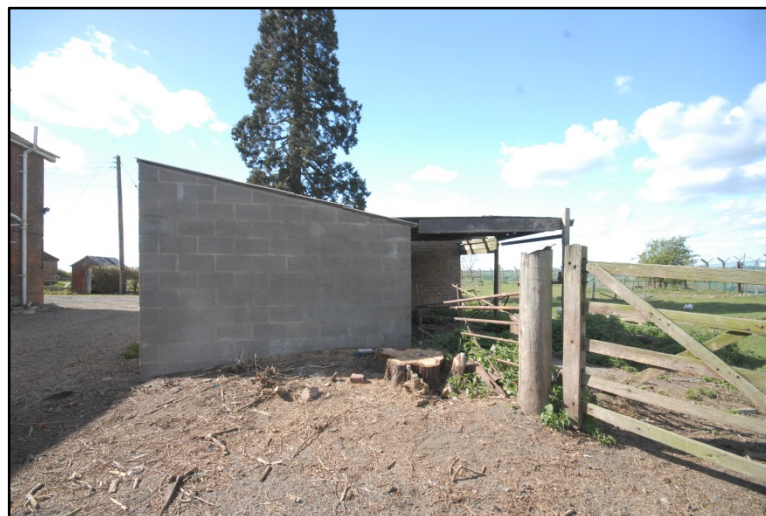
A modern brick garage with smaller concrete block extension is located at the north-east of the farm. This has a wide double door with timber lintel opening to the south-west, adjacent to a regular door opening and tall six light window in timber frame. The brick structure has a flat roof of corrugated sheeting and the concrete extension has a cat slide roof of steel sheets.

Garage 1, looking north-east Fig 17

Garage 1, looking north-west Fig 18

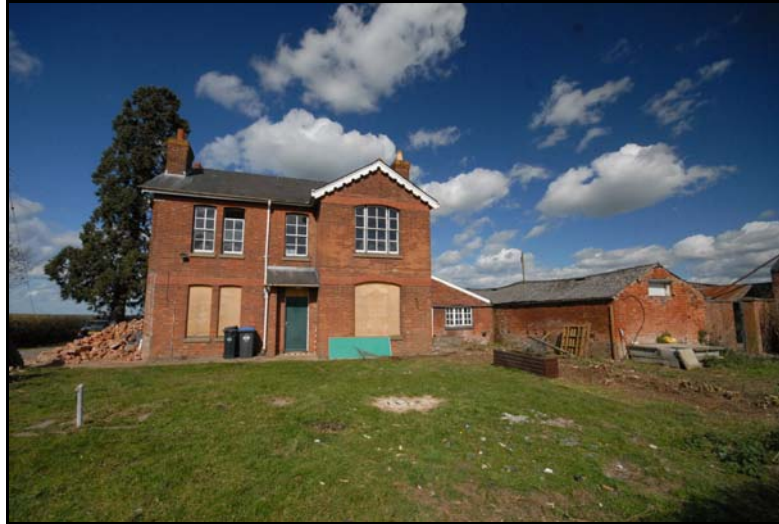
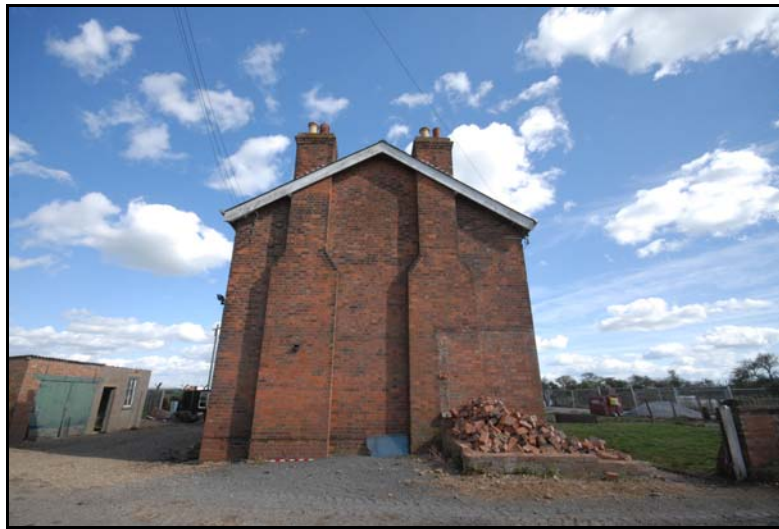
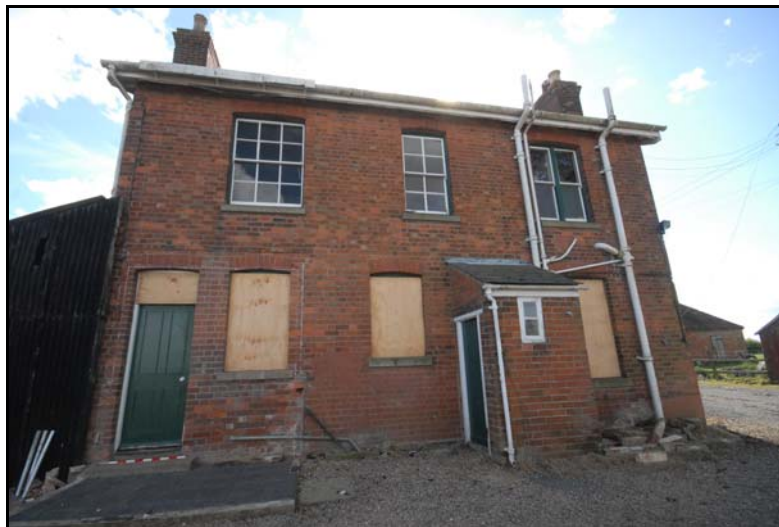
The west gable elevation is plain, with two brick chimneys projecting from the wall, rising from ground level. The chimneys are shouldered midway and the flue interrupts the roof eaves to project slightly over the ridge level. A single storey brick-built, rectangular plan extension formerly abutted the corner of this elevation but had been largely demolished by this survey.

The Farmhouse, looking north-east Fig 19

The Farmhouse, west elevation Fig 20

The Farmhouse, looking north-west Fig 21

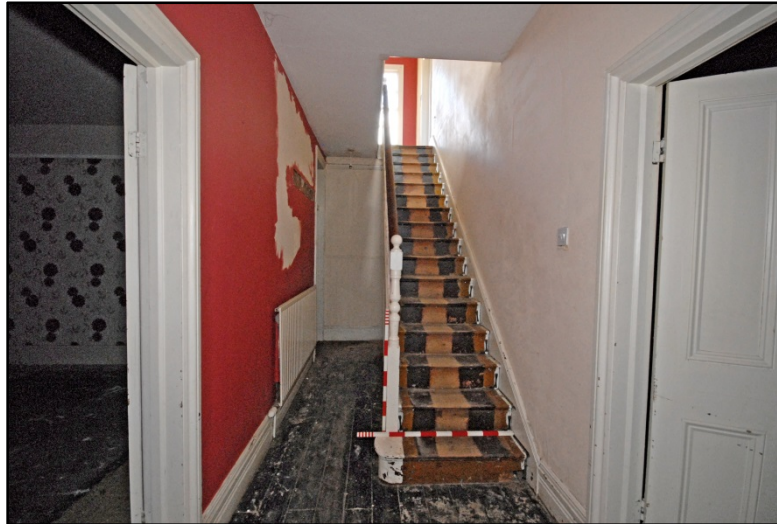
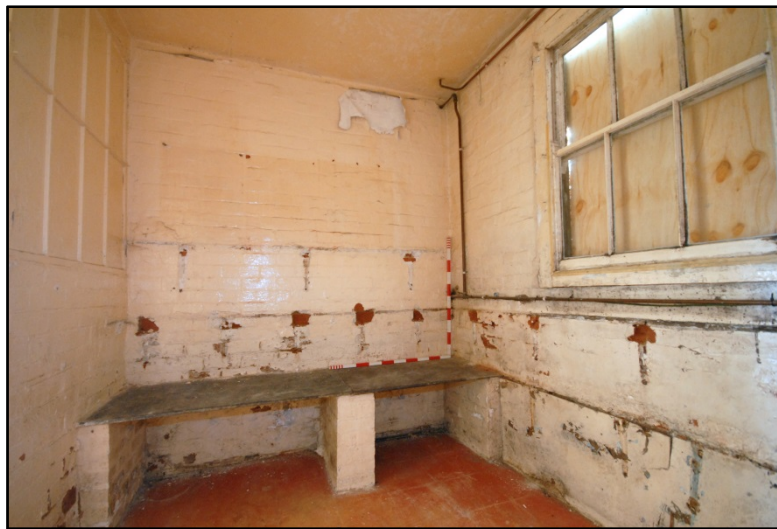
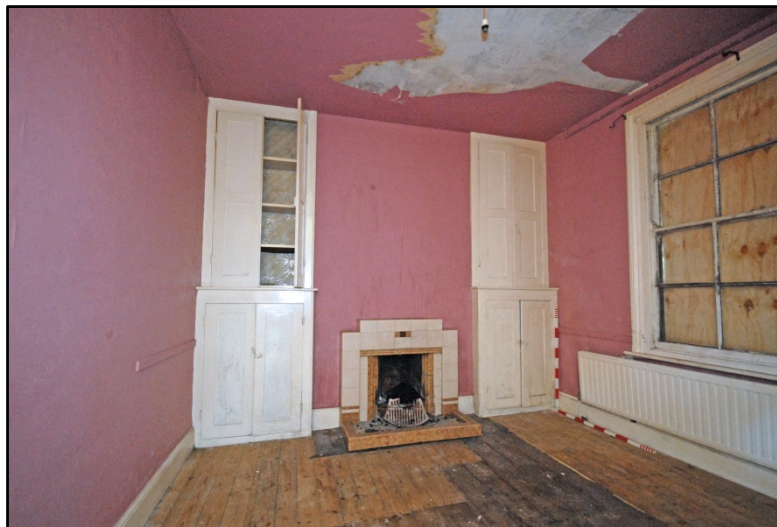
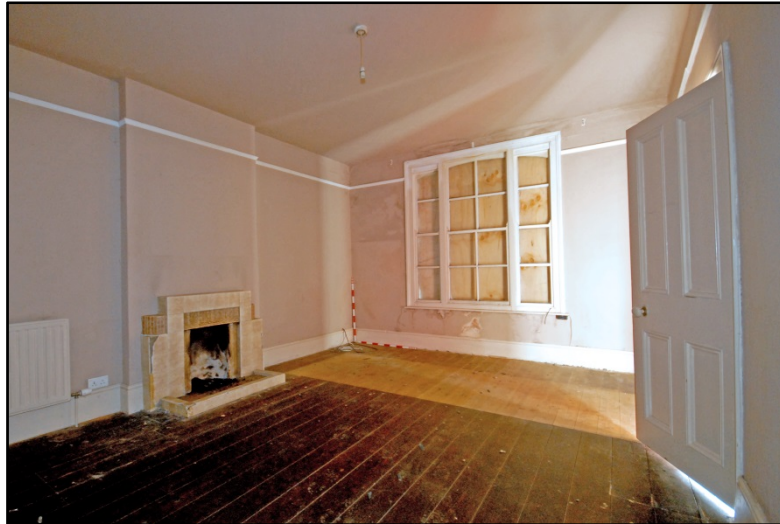
At ground floor the farmhouse was divided into a larder, kitchen, hall and sitting/dining rooms, arranged around a central hall and landing (Fig 6). The ground floor has undergone some internal refurbishment in the 1930s and the original fireplaces have been replaced with 1930s tile fireplaces. The larder retained a red quarry tile floor and a stone work surface with brick supports. This stretched the full length of the west wall of the room. The kitchen had partially tiled walls and modern utilities as well as a niche in the east wall which formerly held the cooker, and originally likely held an Aga range. The three sitting and dining rooms (G1-G3) were fairly plain with painted walls. All furnishings had been removed prior to the survey. Each room retained a 1930s style tile fireplace, these likely replacing earlier cast iron fireplaces.

The Farmhouse, ground floor landing Fig 22

The Farmhouse, ground floor, larder Fig 23

The Farmhouse, ground floor, room G1 Fig 24

The Farmhouse, ground floor, room G3 Fig 25

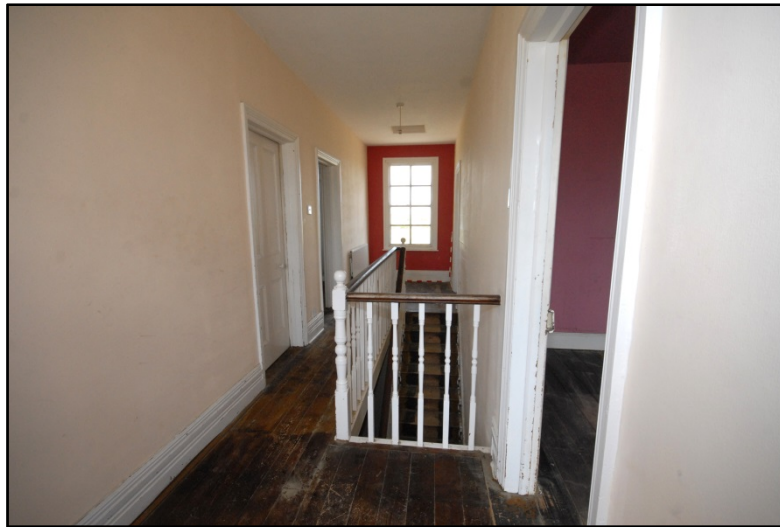
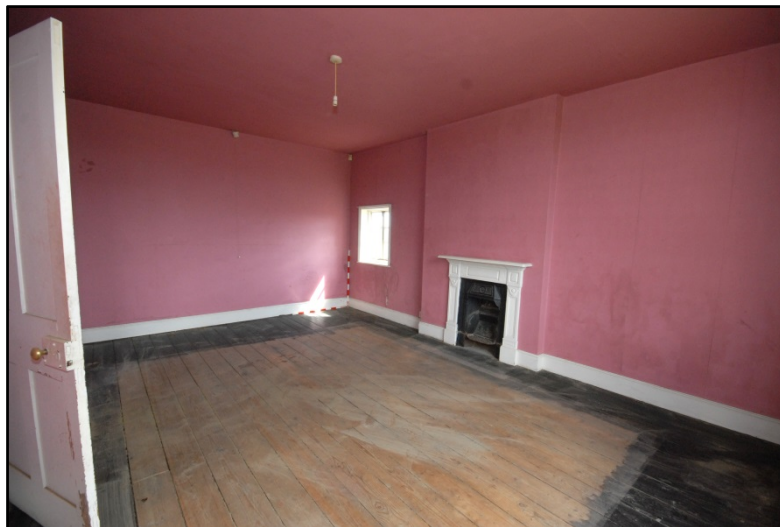
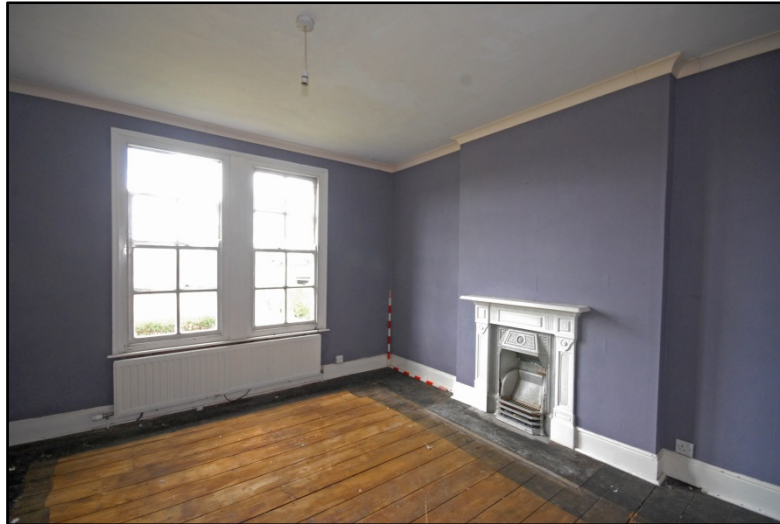
The first floor space was divided into three bedrooms, WC and bathroom arranged around the central landing. The bedrooms (F1-F3), are plain with painted walls and a simple skirting scheme. Each room retained a late Victorian style fireplace with decorative cast iron inset and decorative wooden surround. The WC and bathrooms were formerly a single bedroom, later subdivided into three rooms.

The Farmhouse, first floor landing Fig 26

The Farmhouse, first floor, room F1 Fig 27

The Farmhouse, first floor, room F3 Fig 28

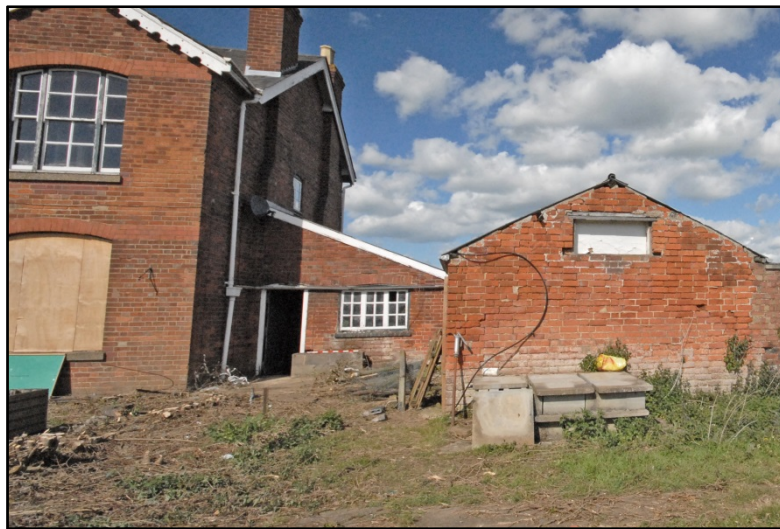
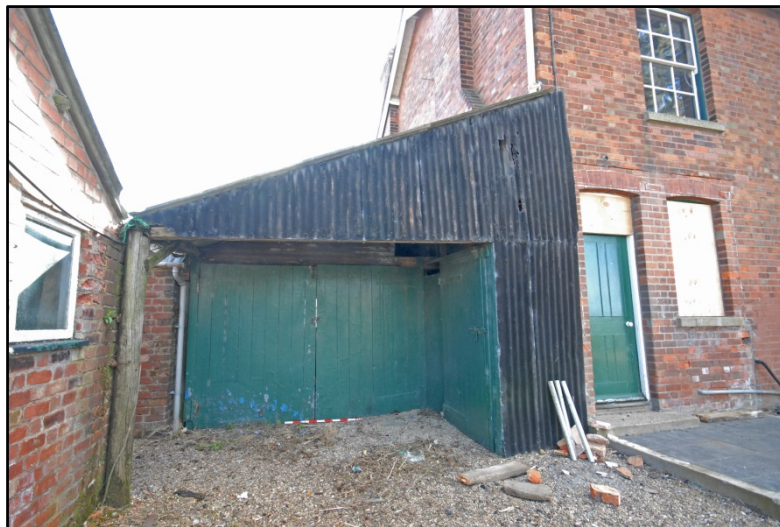
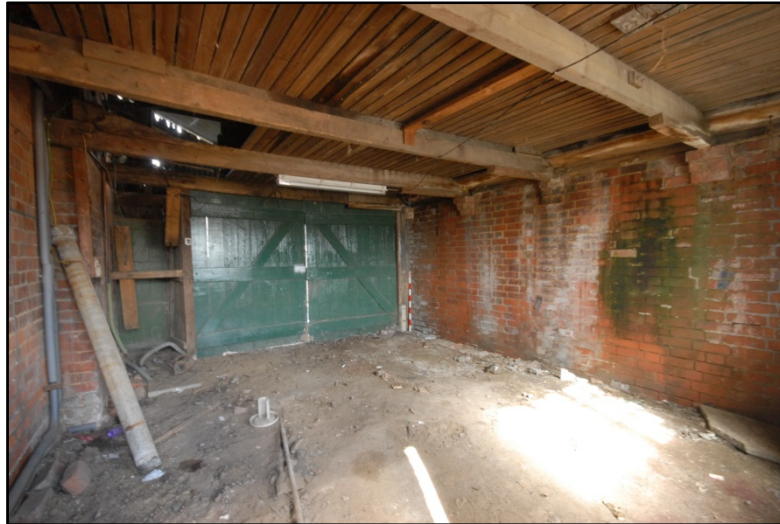
Abutting the eastern side of the farmhouse and the western side of the adjacent stable is a single storey red brick garage with a cat-slide roof to the farmhouse. This structure is contemporary with the farmhouse and its window and door openings are in the same style with arched brick lintels and brick sills. Vehicular entry is from the north through a wide, double door and to the south is a regular door opening. The roof has been projected to the north with corrugated sheeting to provide a covered porch over the entrance.

Internally, the room is sparse with no fixtures or fittings remaining. The walls are unpainted and the underside of the roof is covered with light wooden planks supported over timber beams.

Garage 2, looking north-east Fig 29

Garage 2, looking south-west Fig 30

Garage 2, interior, looking north-east Fig 31

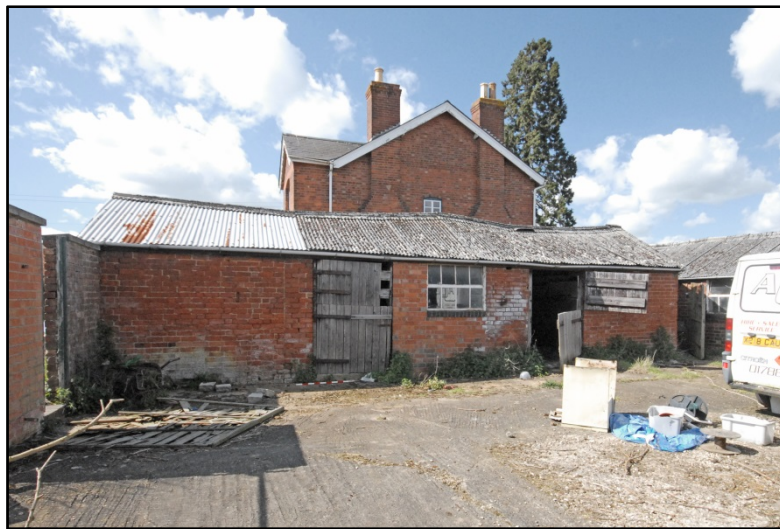
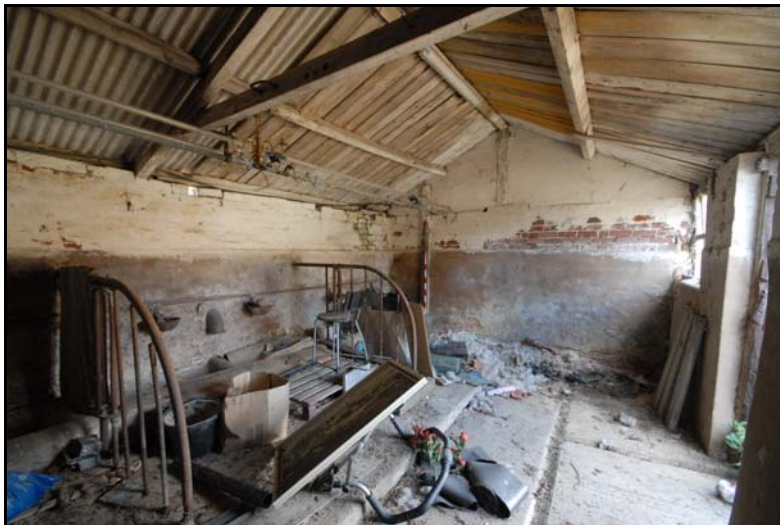
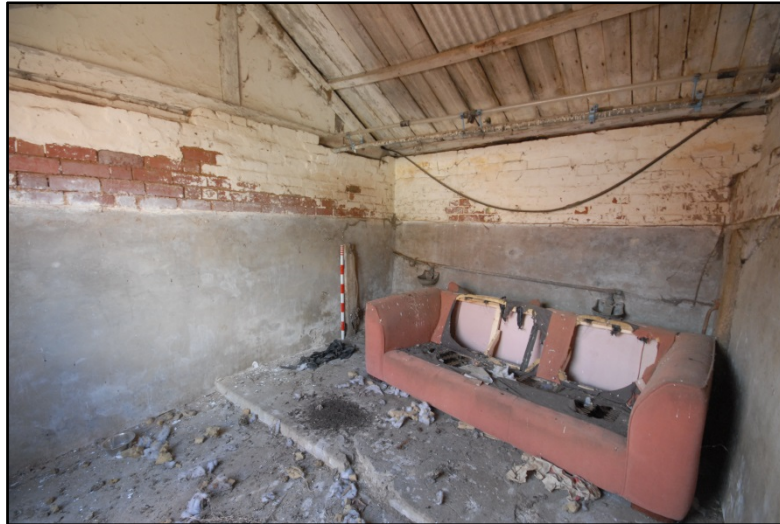
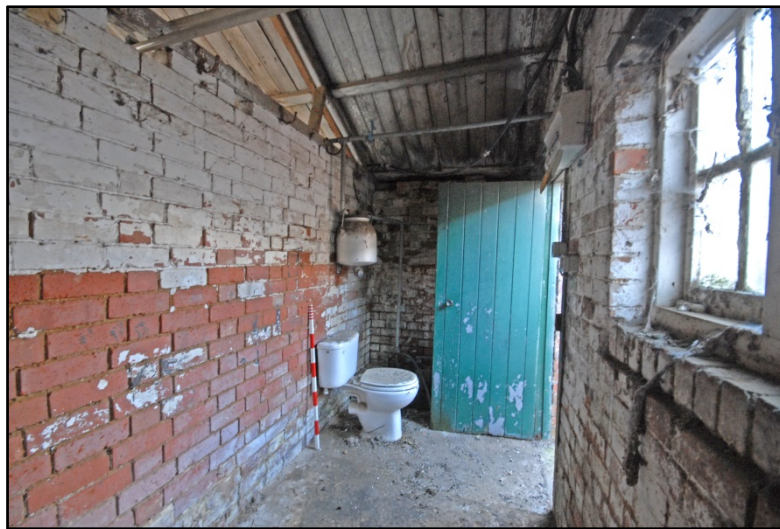
This is a single storey building on a rectangular plan, aligned north-east to south-west. Historic mapping suggests that this building pre-dates 1880 and was formerly part of a larger L-plan building with a north range which had been demolished by 1900 (Figs 3 & 4). It is constructed of red brick in Flemish bond with a gable roof of corrugated sheeting. Access to the building is from the east, through a pair of top and bottom opening stable doors with iron strap hinges. These flank a fixed eight light window with a timber frame and purple brick sill. The building has been subdivided into two equal-sized stables and a WC at the northern end. A low concrete trough runs the length of both stable rooms with iron stall divisions surviving *in-situ* in the south room. The floor across the whole building is of concrete and contains sunken drainage channels. The walls are rendered to head height with whitewashed brickwork exposed over. The roof structure is simple with braced pine collars supporting pine ridge and purlins. The underside of the corrugated sheeting is hidden by unpainted planks.

Stable 2, east elevation, looking north-west Fig 32

Stable 2, southern room, looking north-east Fig 33

Stable 2, northern room, looking west Fig 34

Stable 2, WC Fig 35

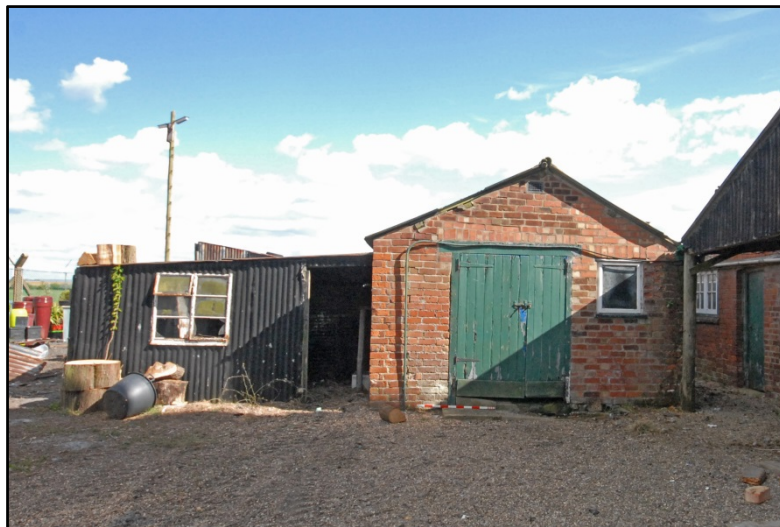
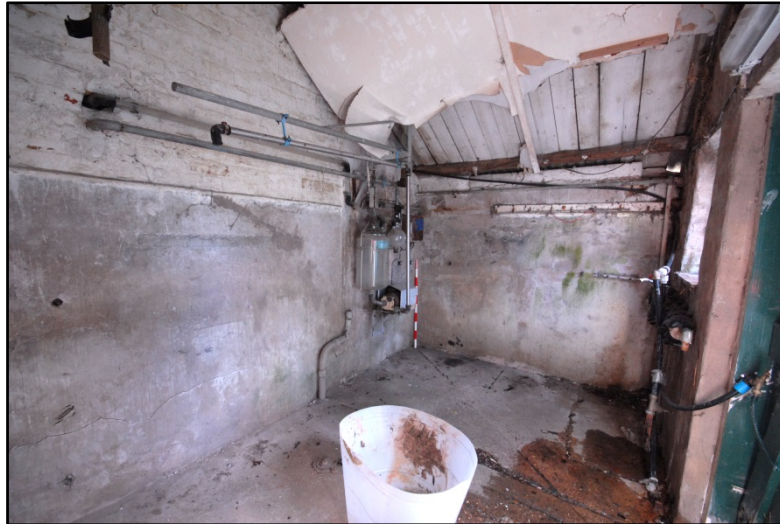
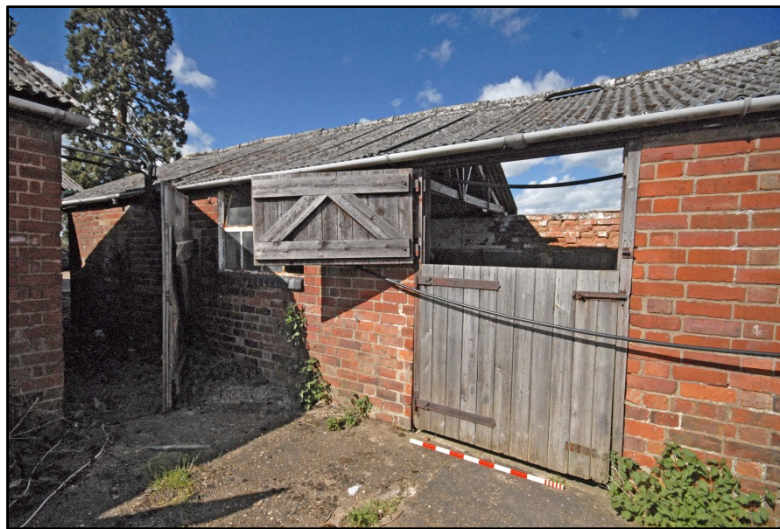
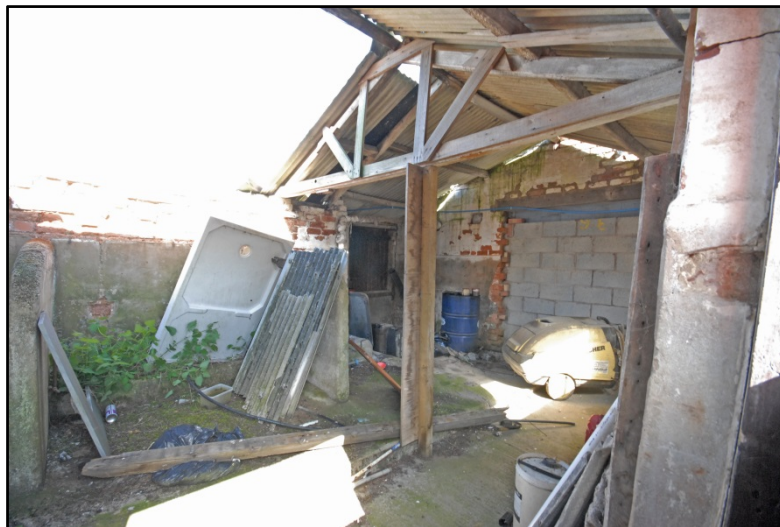
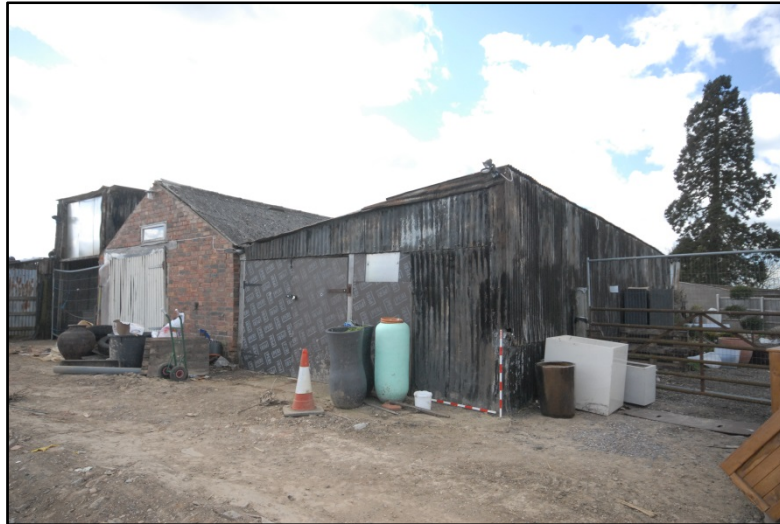
A long range of brick built stables is located to the north-east of the site with modern chicken sheds abutting these to the north. The stables comprise two rectangular plan structures, the westernmost being of an earlier date and visible on the Ordnance Survey map of 1900 (Fig 4). This is constructed of red brick in Flemish Garden bond with stable doors opening to the south and a double door to the north. The structure has been re-roofed with corrugated sheeting which had partly collapsed in places. The rooms were deemed unsafe to enter but it could be seen that they retained concrete troughs and stall partitions along the northern walls. Similarly, the eastern stable block was constructed of brick in Flemish Garden bond, with a gable roof of corrugated sheets. A double garage door was located at the east elevation. Access to the interior of this building was not possible.

The chicken sheds are modern, constructed of concrete blockwork and corrugated sheeting with light timber framework. They have a cat-slide roof of corrugated sheets which forms a valley against the roofs of the adjacent stables.

Stable 3 and Chicken Sheds, looking south-east Fig 36

Western extent of Stable 3 Fig 37

Stable 3 and Chicken Sheds, looking north-east Fig 38

Stable 3, interior Fig 39

Stable 3 and Chicken Sheds, looking west Fig 40

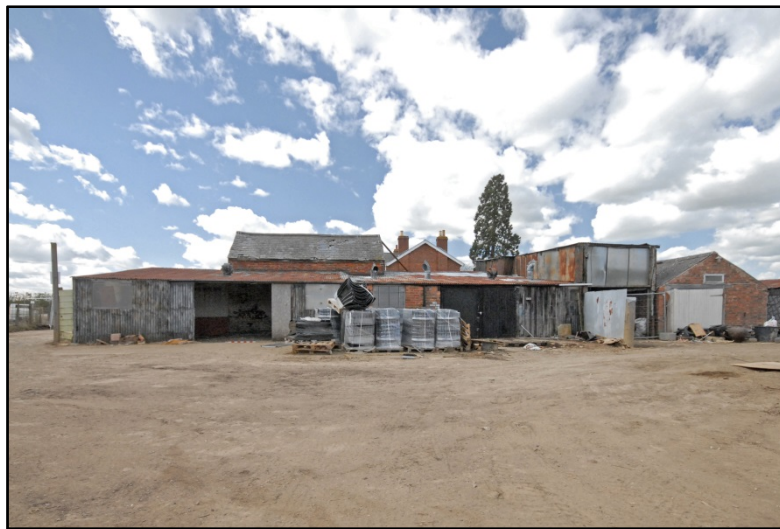
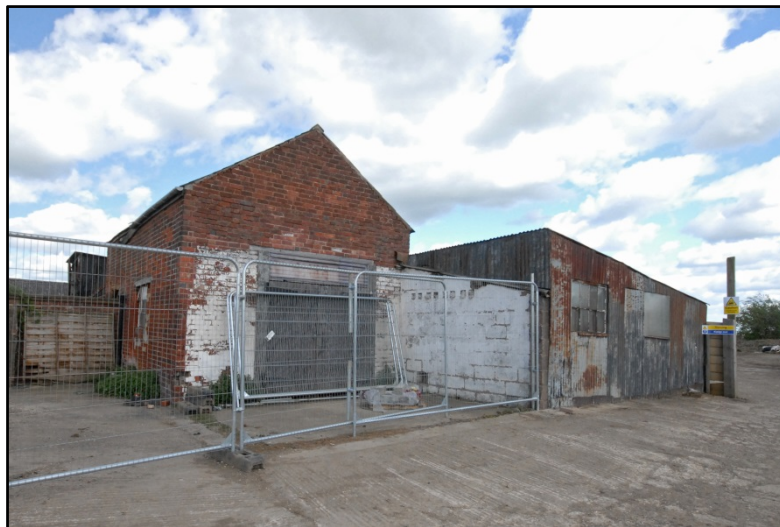
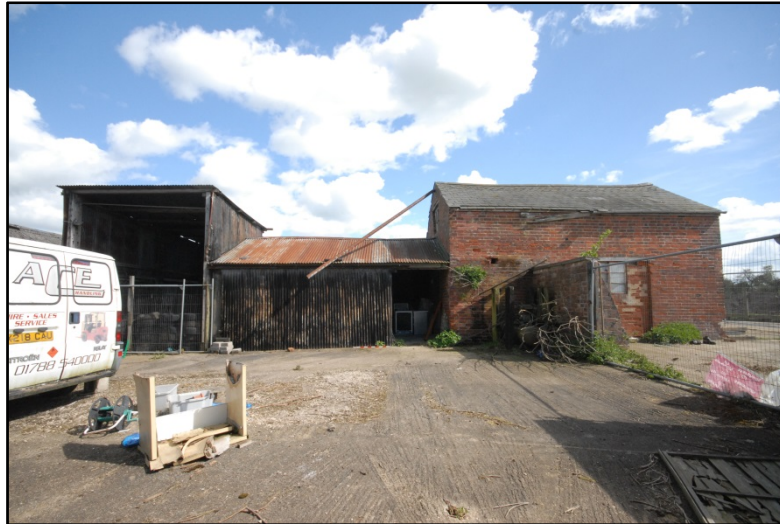
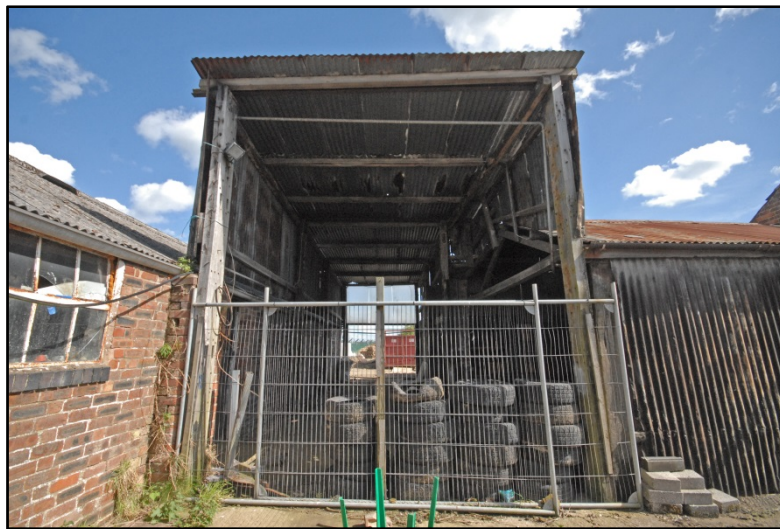
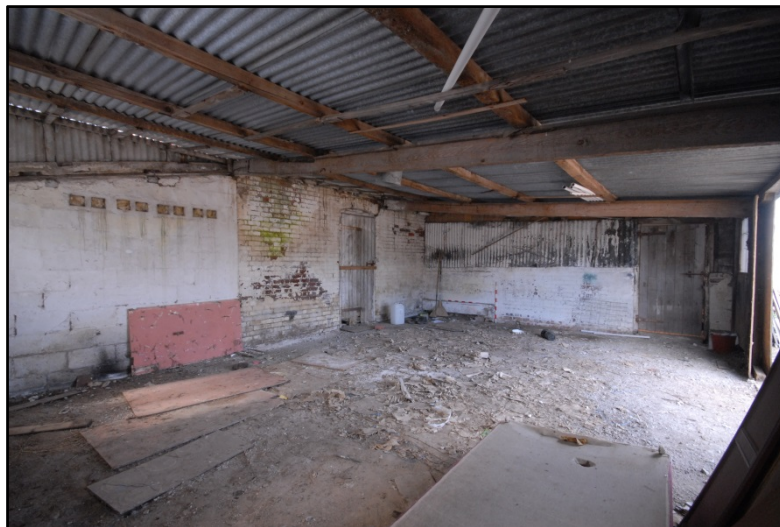
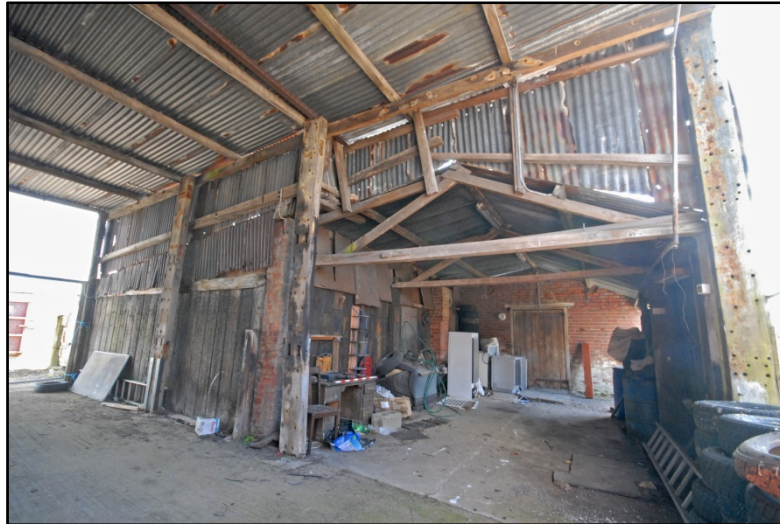
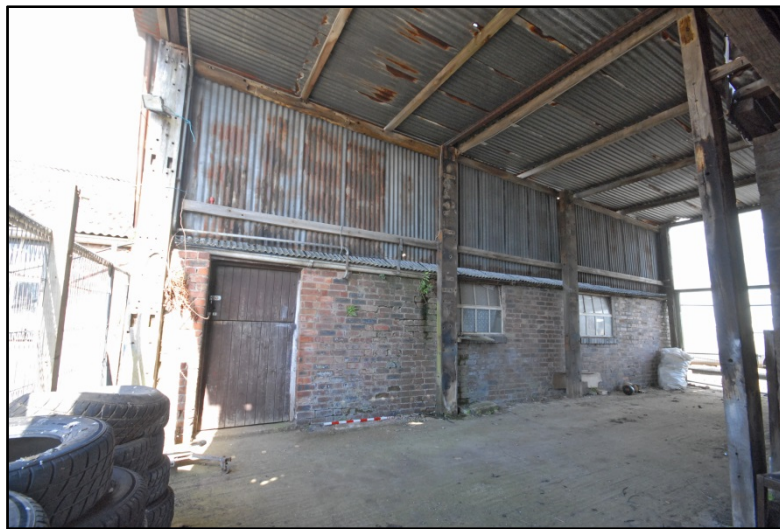
Wall bond with a gable roof of slate. A former door opening in the west elevation has been blocked in brick and reduced to a window. A lean-to structure formerly abutted the south elevation. A stable door allows access eastward into the adjacent shed. This shed is rectangular in plan, aligned north-east to south-west and is a modern structure constructed of concrete blockwork and corrugated sheeting, with a concrete floor and a light timber roof structure. No internal features remained. Immediately to the north of the shed is a similar modern structure of blockwork and corrugated sheeting which partly incorporates the remains of an earlier brick structure.

To the north of the group is a modern garage or shed constructed of concrete blockwork and corrugated sheeting with a light timber frame. This is on an L-Plan and abuts the barn to the south.

East Barn and Sheds, looking north-west Fig 41

East Barn and Sheds, southern extent, looking east Fig 42

East Barn and Sheds, looking south-east Fig 43

East Barn and Sheds, northern extent, looking south-east Fig 44

East Barn and Sheds, interior of southern shed, looking north-east Fig 45

East Barn and Sheds, interior of north shed, looking south Fig 46

East Barn and Sheds, north shed, looking north toward Stable 3 Fig 47
