**Historic Building Recording at
Rye Hill Farm Barns, Eydon
Northamptonshire
May 2015**

Report No. 15/104

MOLA was commissioned by Mr G Wood to undertake a Level 2 photographic survey of a complex of agricultural buildings associated with Rye Hill Farm, Eydon, ahead of the conversion of the buildings to a residential dwelling. The surveyed buildings date largely to the mid-19th century with intermittent alterations and repair work in the following years. The buildings had a range of functions and included a barn, stable, cart shed, cow shed and a modern shelter. The buildings were found to be derelict, partly unroofed and overgrown.

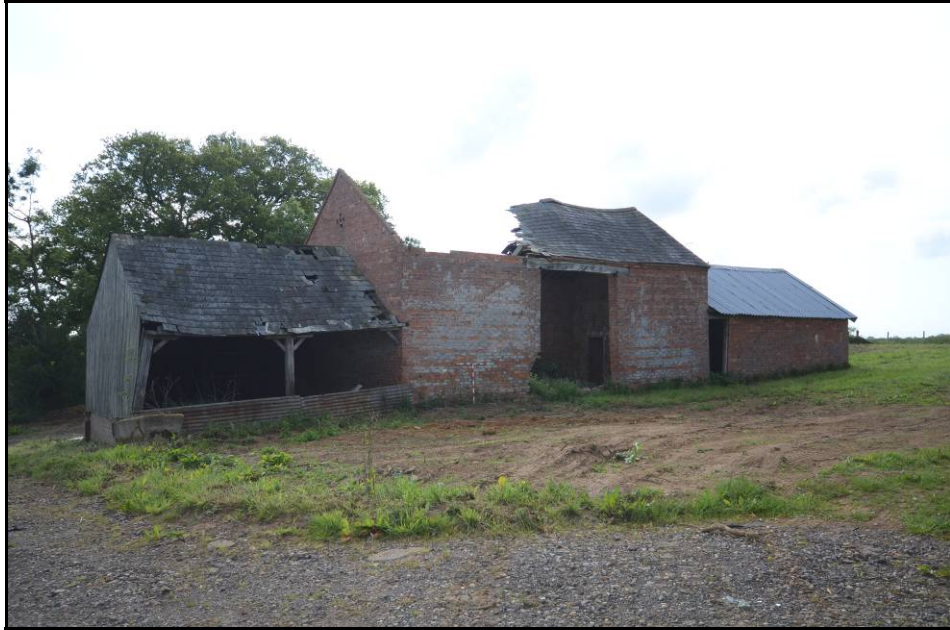
The buildings were generally in a poor state of repair, partly unroofed with vegetation ingress into the brickwork (Fig 8). Large cracks were visible particularly around the weaker areas of the structures such as the window and door openings.

General view of the buildings, looking south-east Fig 8

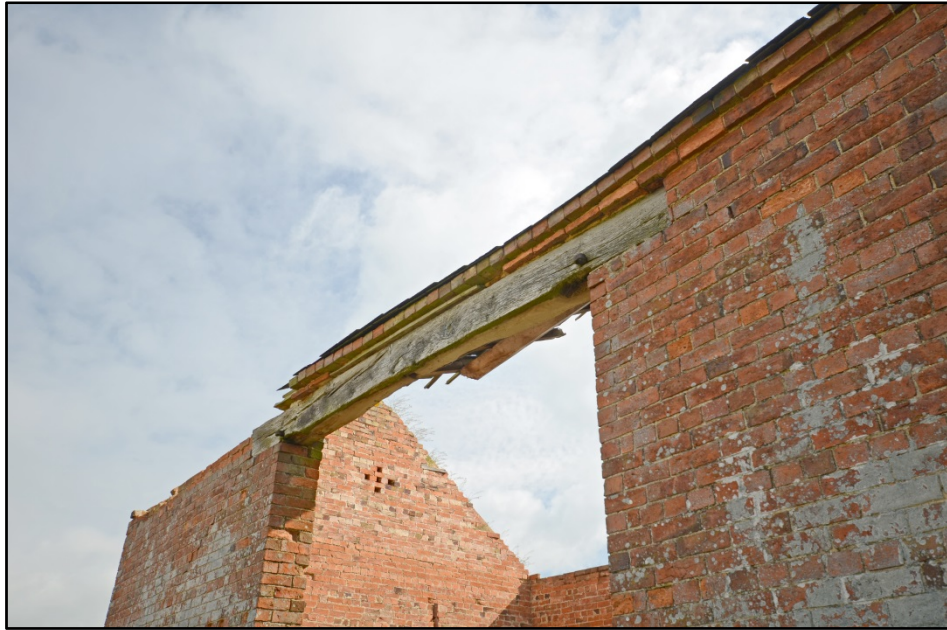
The main entrance is to the west through a full height double-width opening central to the west wall (Fig 15). A substantial timber lintel carries the wall plate over the doorway (Fig 16). Iron pegs were located at the distal ends of the lintel.

The Barn, detail of timber lintel Fig 16

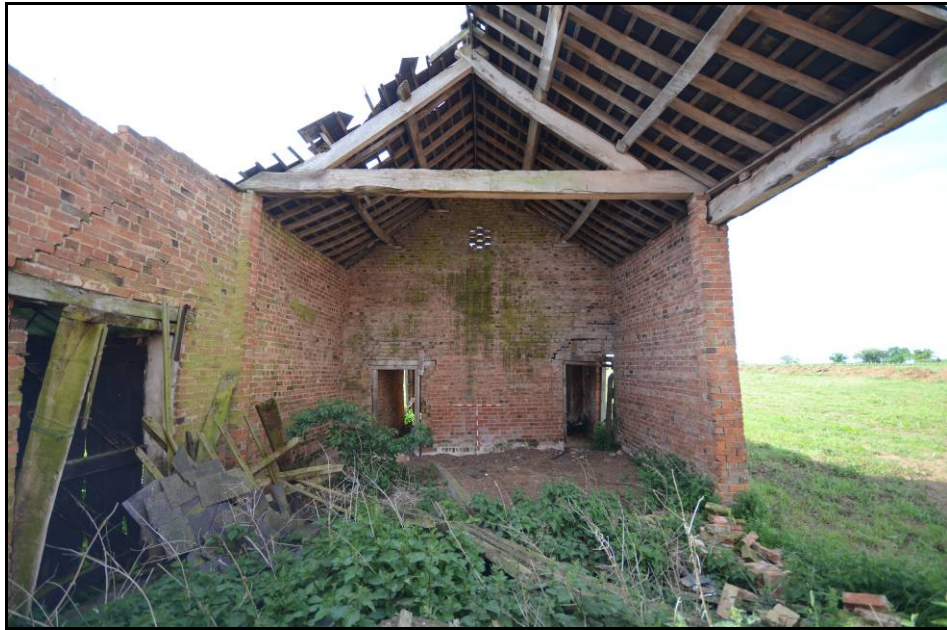
Two further door openings are located in the south wall, providing access into the adjacent stable (Fig 18). These are a later addition to the barn, being inserted with the construction of the stable. These have timber door frames and timber lintels. No doors were within the openings and it is possible that these were always simply openings with no doors. The insertion of the openings has resulted in the weakening of the overlying wall and significant cracking and warping of the wall is visible around the openings.

The Barn, interior, looking south Fig 18

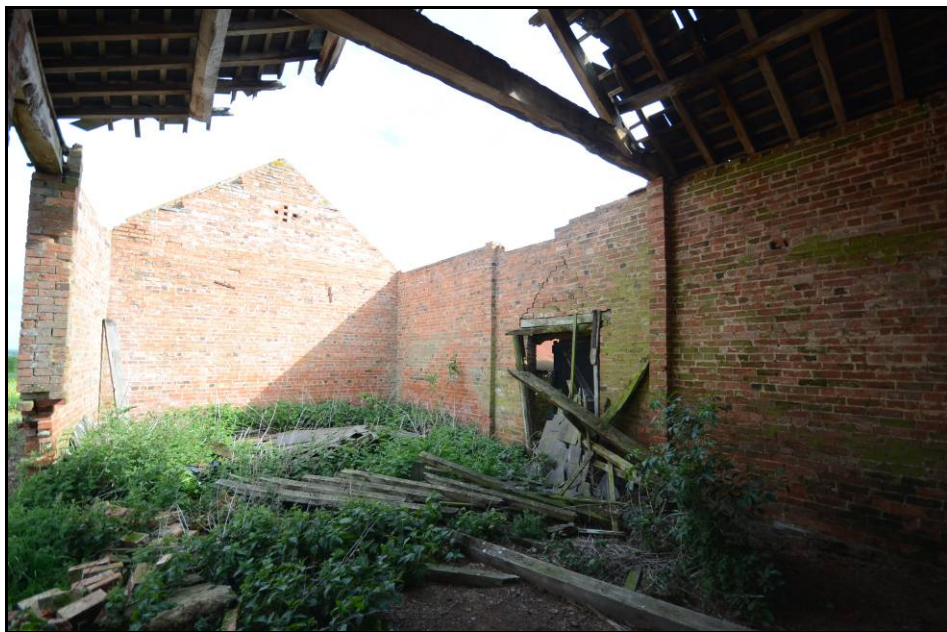
The roof had completely collapsed at the north and central area with only the southern extent remaining at the time of this survey (Fig 19). The collapsed roof remained where it fell within the room. The roof structure is fairly simple with roughly cut, partly waney edged tie beams supporting principal rafters, these being much thicker than the common rafters, and carrying trenched purlins. The principal rafter are jointed and pegged to each other at their peak and carry the ridge. The ends of the tie beams are supported by short brick pilasters which project into the room. They are also cut at the distal ends to allow for the angle of the roof.

The Barn, interior, looking north Fig 19

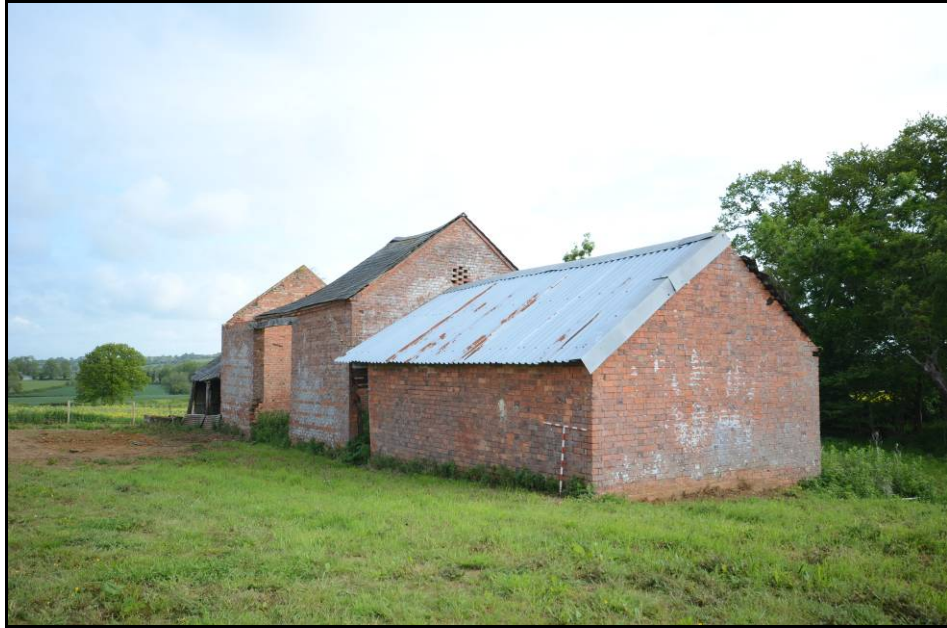
The roof is an open gable, re-roofed to the west with corrugated sheets whilst retaining slate tiles to the east. The ridge is also of metal sheeting folded over the apex. Overlapping metal sheets have been folded over the southern edge of the roof and wall to make the structure more watertight (Fig 22). The internal roof structure comprises a pair of machine-sawn, pine, kingpost trusses with iron rods through the kingposts, with diagonal bracing connecting the kingposts to the top chords (Figs 6, 25 & 26). The western ends of the trusses are supported over the projecting pilasters. A pair of pine purlins are carried over the trusses, braced from below. At the far ends, the purlins are keyed into the end walls. The rafters are a mix of machine sawn pine and waney edged branches, roughly hewn and many retaining bark (Fig 25). The two types of rafters are evenly disbursed to the east and west sides of the roof. They are carried over the top of the wall by a timber wall plate. On the east side of the roof the slate tiles are nailed to pine battens.

General view of the Stable, looking north-east Fig 22

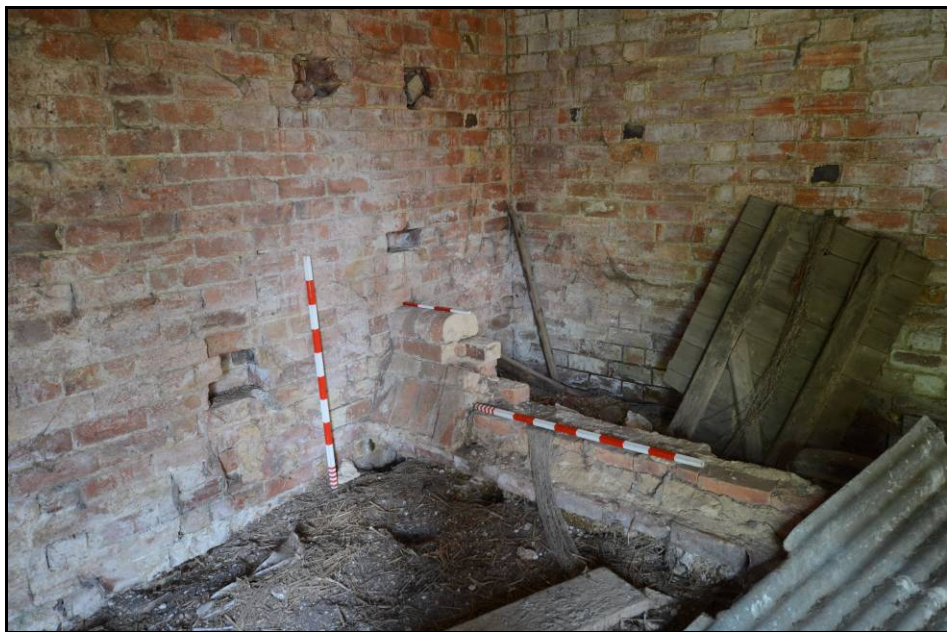
A brick trough formerly extended the full length of the room, running north-south against the western wall (Figs 6 & 7). This has been largely demolished but survived to full height at the southern end (Fig 27). The trough is c350mm at its widest and c800mm in height, enclosing a space c720mm in width. It is capped with double bullnose bricks to prevent injury to feeding animals, likely horses. A single timber stall divider partly survived below the northernmost truss to which it is fixed (Figs 6 & 25). The divider has a square profile post at its eastern end to which one horizontal and one diagonal brace are jointed. At the west, the braces are jointed to a post which rises to the overlying truss. For this post the carpenter utilised the natural curve of a branch or trunk. A number of planks are nailed to southern side of the braces. These are cut diagonally, in line with the diagonal brace. The stall is aligned with the truss and brick buttress and it is very likely that another was formerly located to the south, in line with the southern truss and buttress.

The Stable, detail of brick trough Fig 27

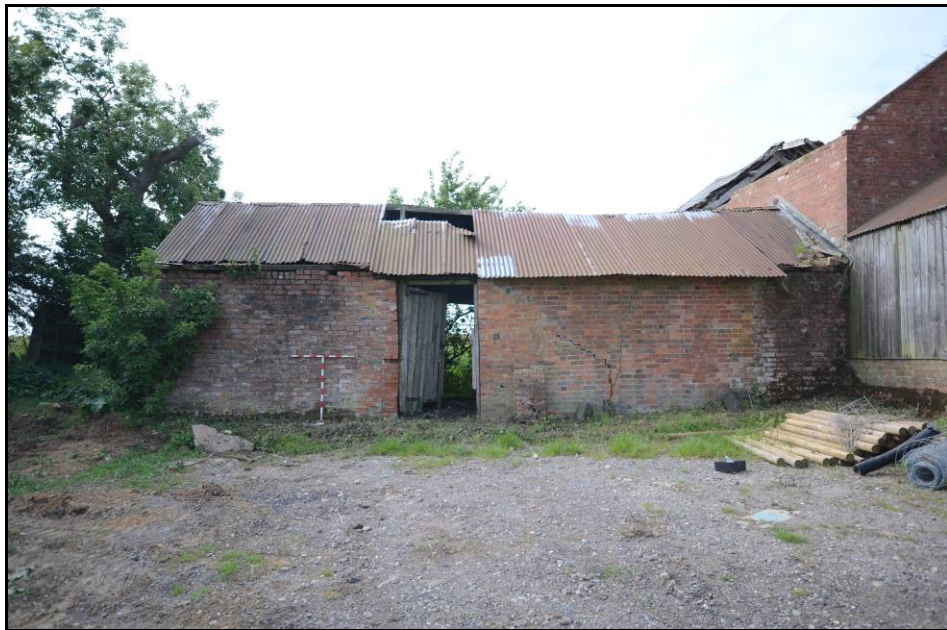
The Cow shed is located perpendicular to the main range and abuts the barn to the north-east, against its eastern wall (Fig 7). The larger part of the building is open fronted to the south, facing the yard. The eastern end of the building is fully enclosed and likely formerly served as a loosebox. The principal construction of the barn is of red brick in Flemish Garden Wall bond (Fig 33), however, the eastern gable wall, the partitioning wall of the loosebox and shed, and the southern wall of the loosebox are in English Garden Wall bond, and appear to be of a different phase to the main structure, indicating that this room is a later addition (Figs 7 & 32). The partitioning wall has an extra skin of brick internally to the loosebox (Figs 7 & 39). Off-centre to the north wall, at the north-east corner of the shed is a timber plank door with cast iron strap hinges, set within a timber frame with timber lintel carrying the timber wall plate over (Fig 33). This north wall is weaker at this point has suffered warping and cracking in the area

The Cow shed, the north elevation, looking south Fig 33

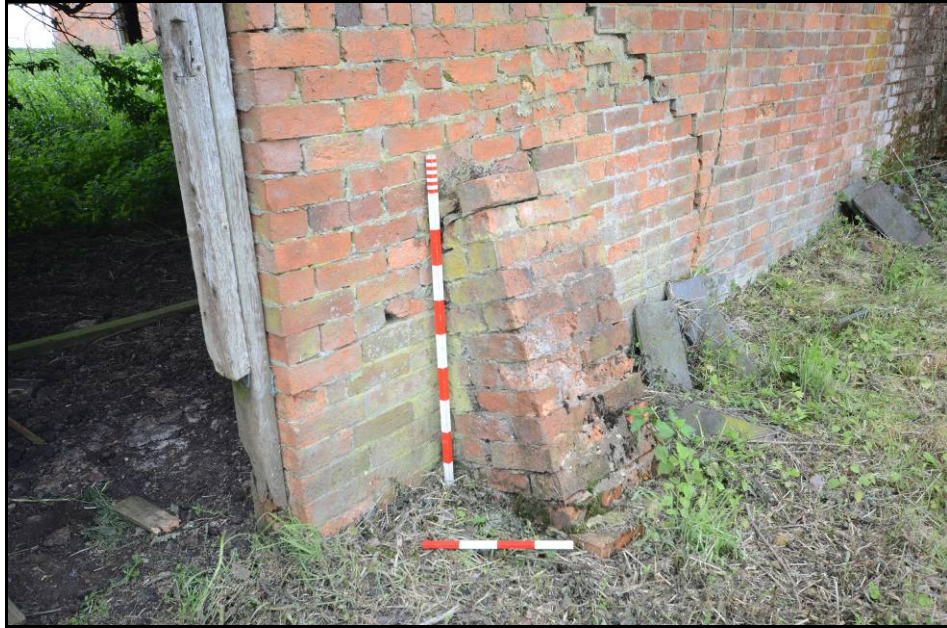
around the door. The brickwork here has been replaced and re-pointed and a row of headers has been inserted to attempt to strengthen the wall. A short brick buttress has also been constructed against the wall adjacent to door to help mitigate the structural weakness (Fig 34). It is likely that this door is a later insertion, contemporary with the enclosing of the loosebox.

The Cow shed, detail of buttress adjacent to door Fig 34

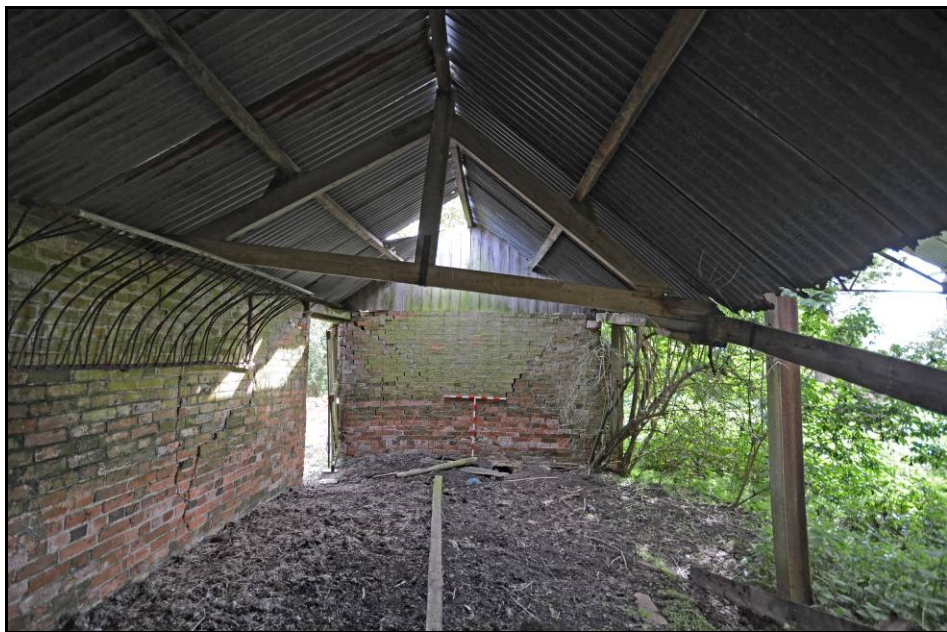
The building is covered with corrugated iron, replacing an earlier slate roof. The roof is supported over two machine-sawn kingpost trusses which carry a pair of purlins and the ridge (Fig 35). The eastern truss has been incorporated into the partitioning wall of the loosebox and is faced with vertical planks on its western face (Figs 38 & 39). To the south the roof has largely collapsed and the western truss has become disconnected from its supporting post.

The Cow shed, interior, looking east Fig 35
