**Photographic building recording survey
of the overbridges at M1 Junction 11a
A5-M1 Link Road
January 2016**

Report No. 16/32

Photographic Building Recording Survey of the overbridges at M1 Junction 11a A5-M1 Link Road

January 2016

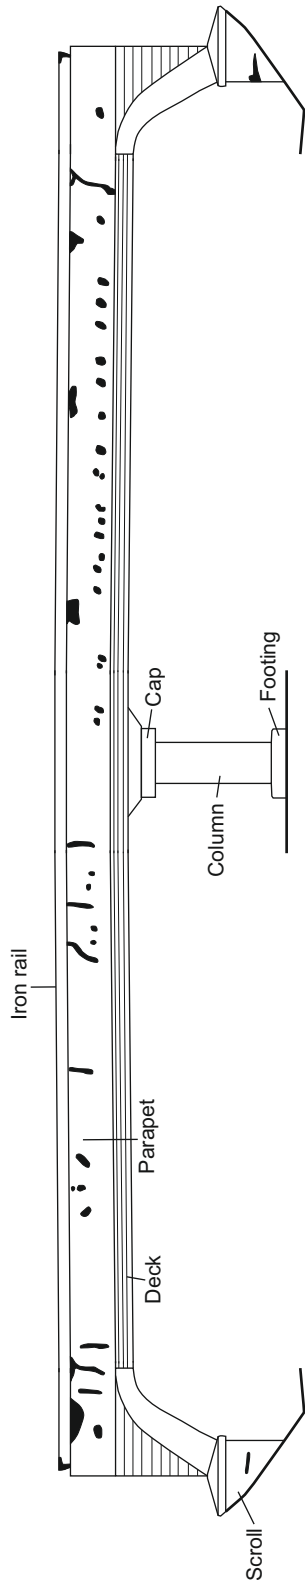
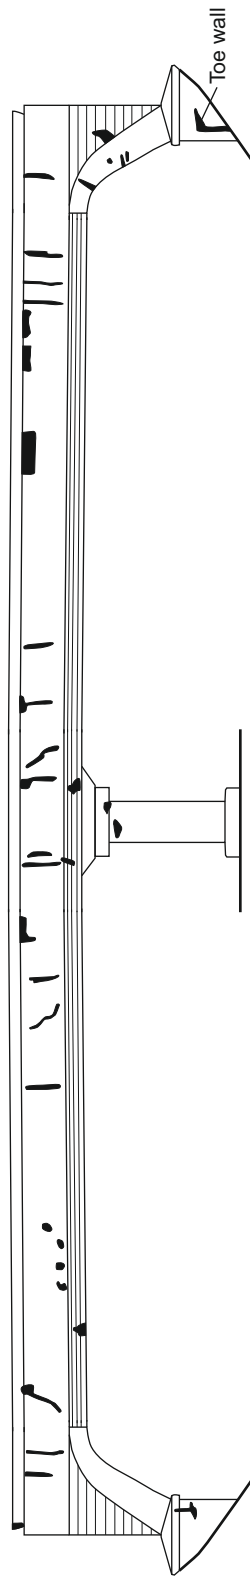
North elevation

In respect to the age of the bridge there was some damage and repairs. Their approximate locations were noted only on the elevations (Figs 18, 19 and 46). The condition of the bridge was such that concrete was flaking off the parapet and exposing some of the steel rebar, some of which have been patched (Figs 27, 33, 47 and 48). Concrete section joints were in-filled with a grey rubber compound, over time cracks were treated the same (Figs 48 and 49).

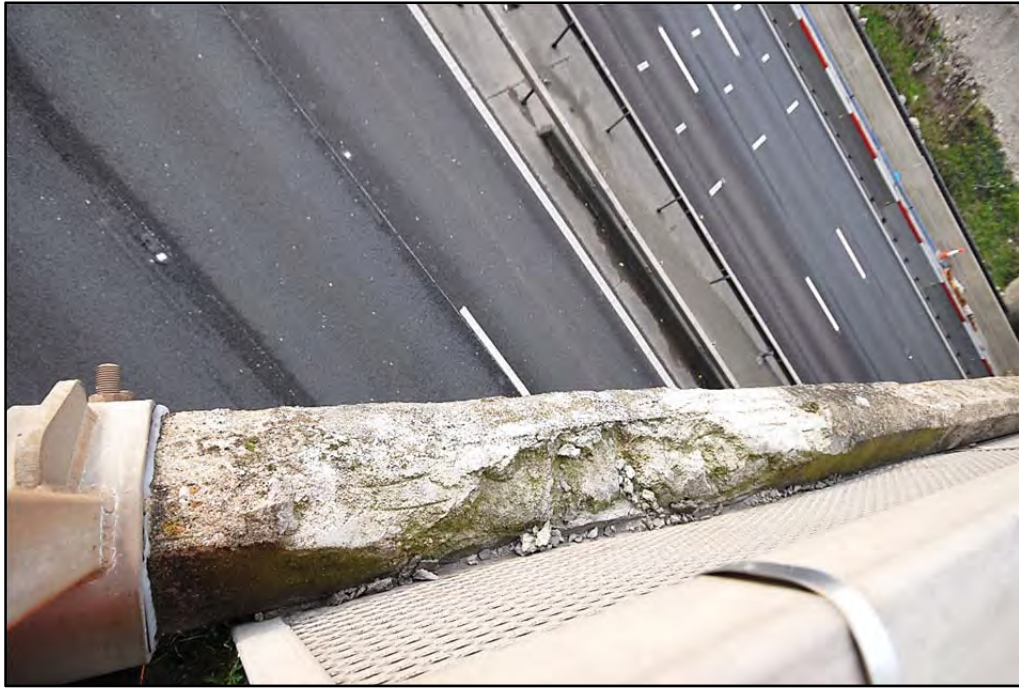
Damage on south parapet Fig 47

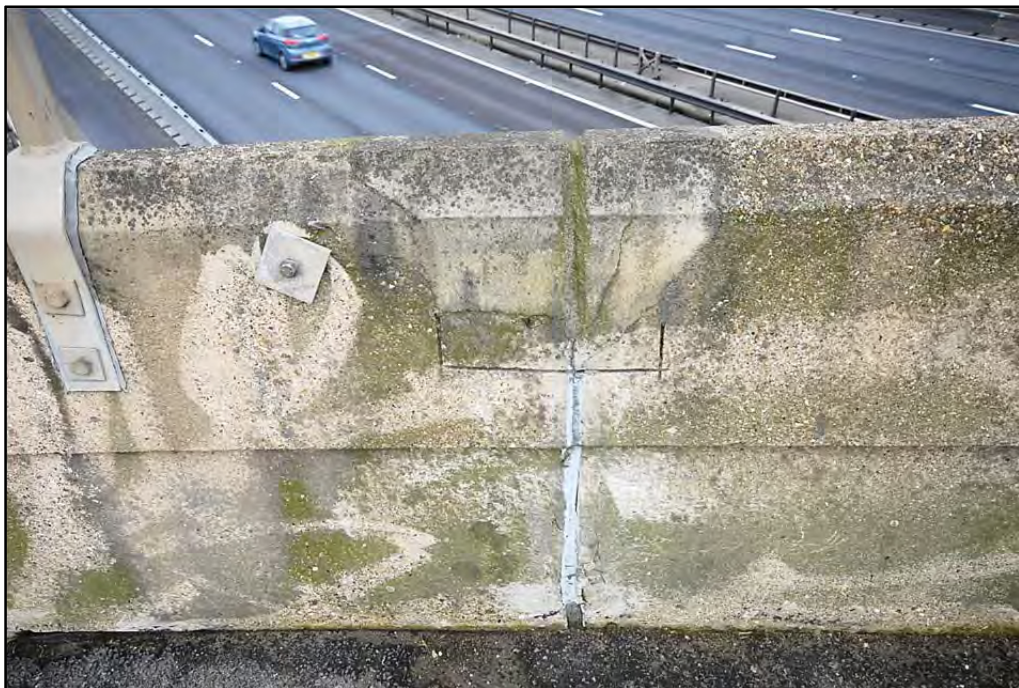
Damage and repair on north parapet Fig 48

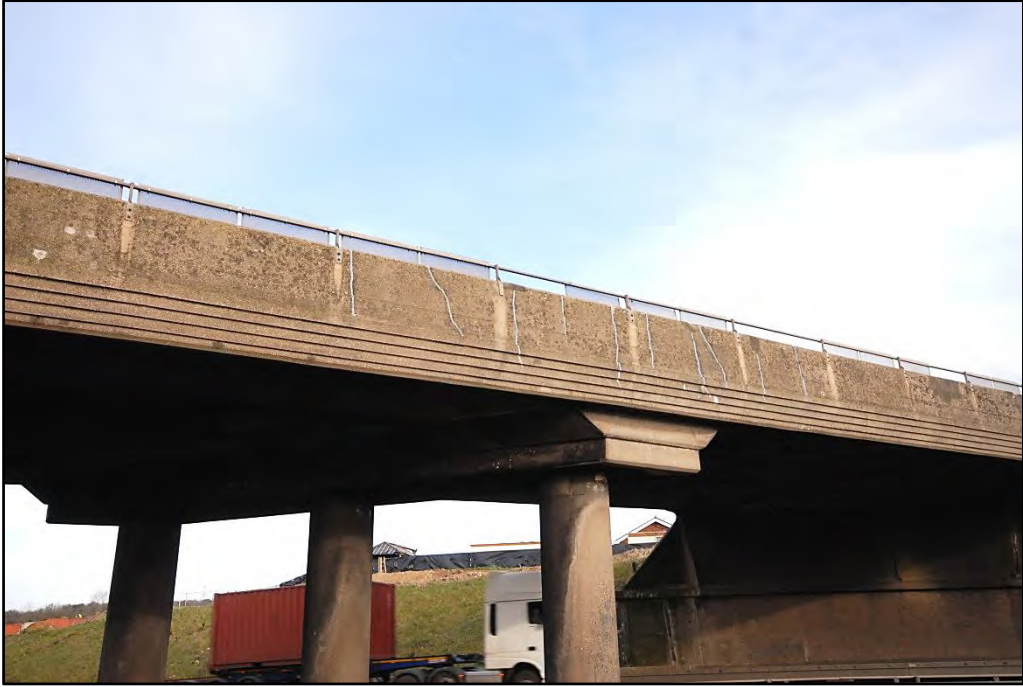
In-filled cracks/joints on the external south elevation of the parapet Fig 49

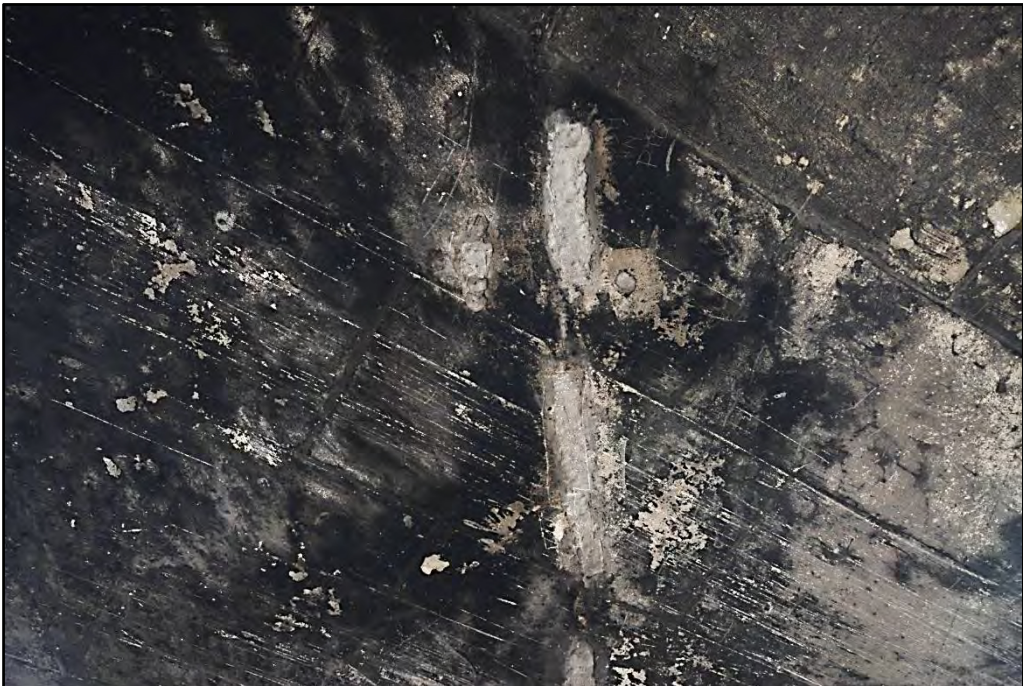
Under the deck on the northbound side frequent parallel scratches could be seen, possibly due to strikes from high-sided vehicles. The underside of the deck has been also patched in the past (Figs 50 and 51). The abutment walls and scrolls all show cracks, areas of blown concrete exposing rebar poles, and water marks from water seepage (Figs 52 to 54). Only one written marking beside the bridge number was noted on the south bound side stating the location of communications cable (Fig 55).

Scratches and damage on the underside of deck, northbound Fig 50

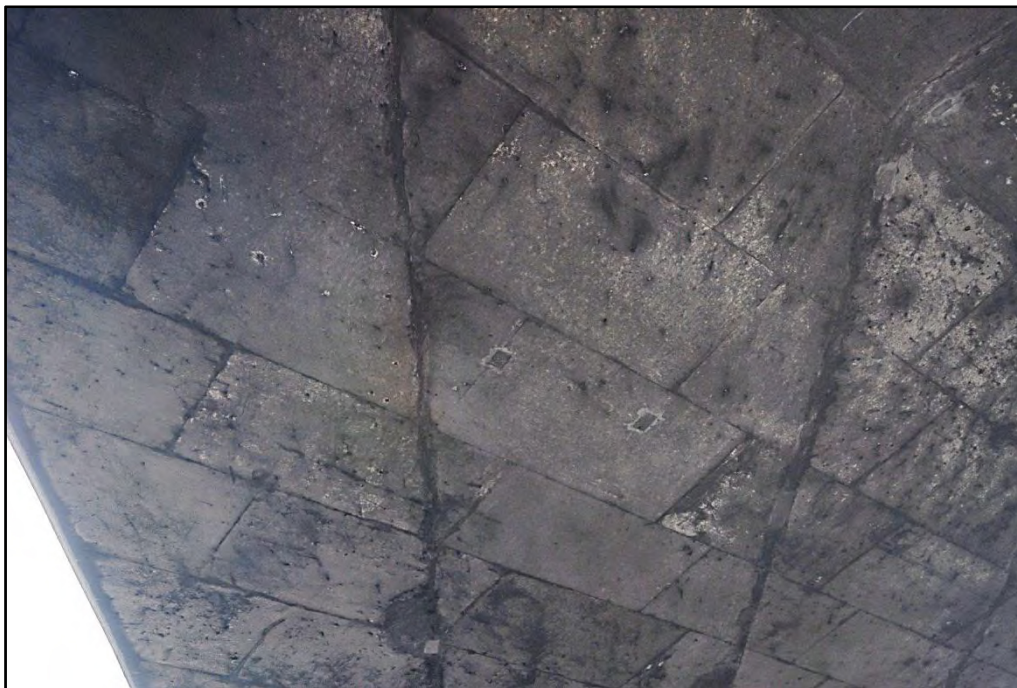
Repairs on the underside of deck, southbound Fig 51

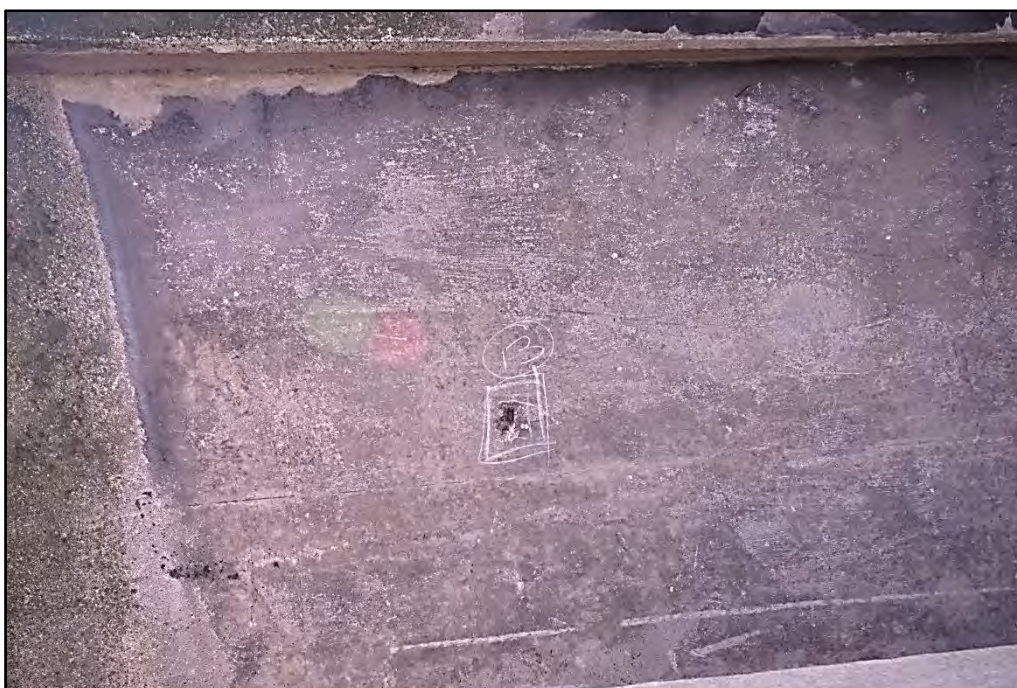
Blown concrete showing the steel reinforcement and scratches on west abutment wall Fig 52

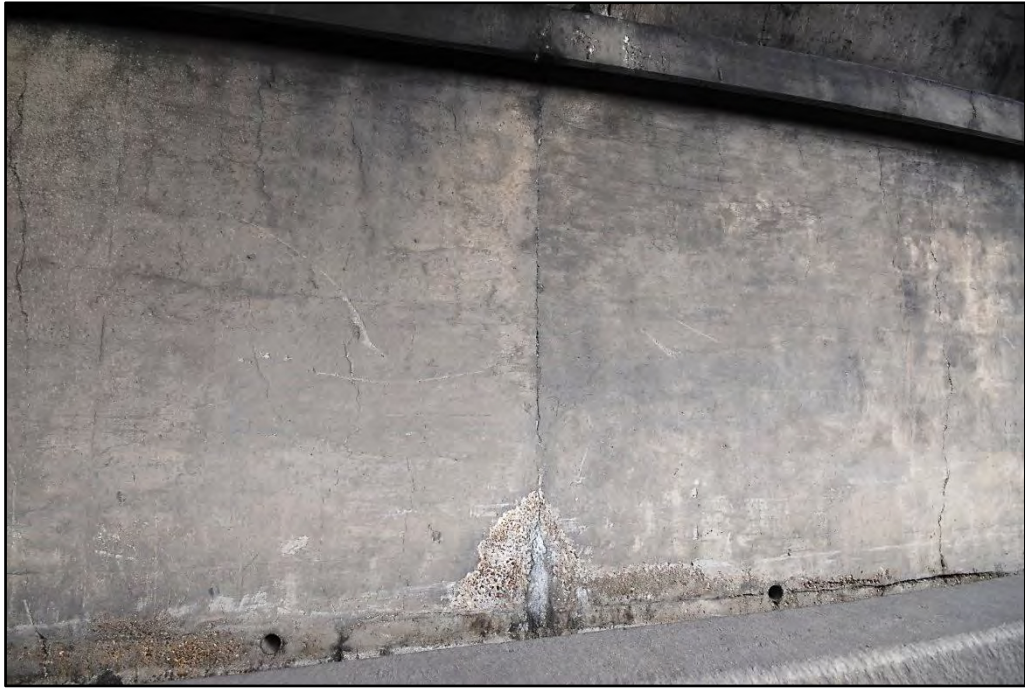
Scratches, cracks and water seepage on east abutment wall Fig 53

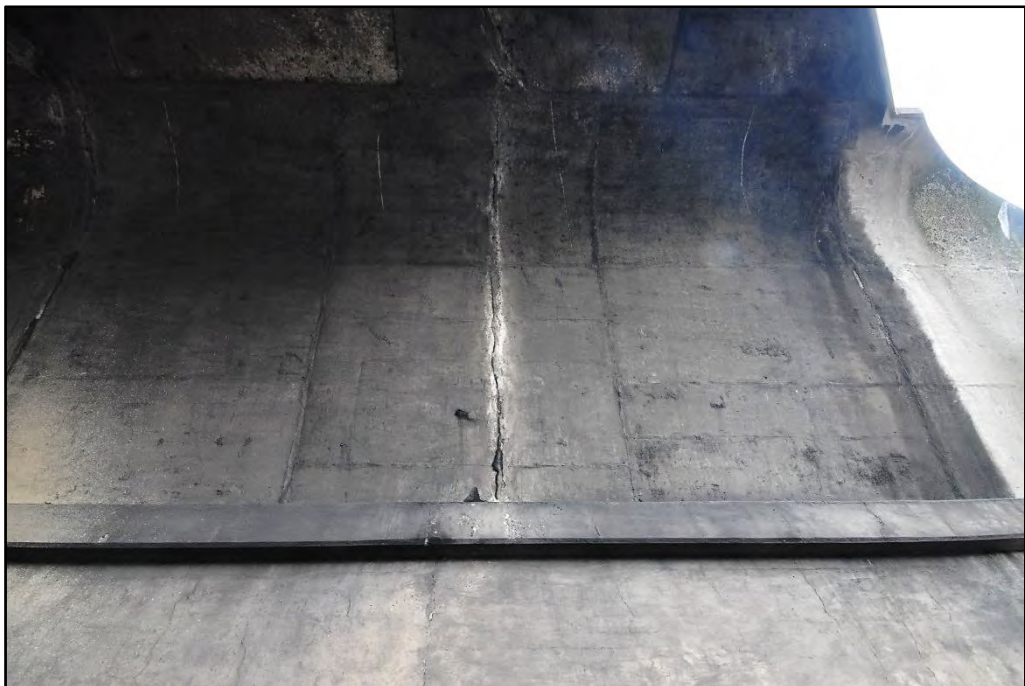
Crack with water deposit Fig 54

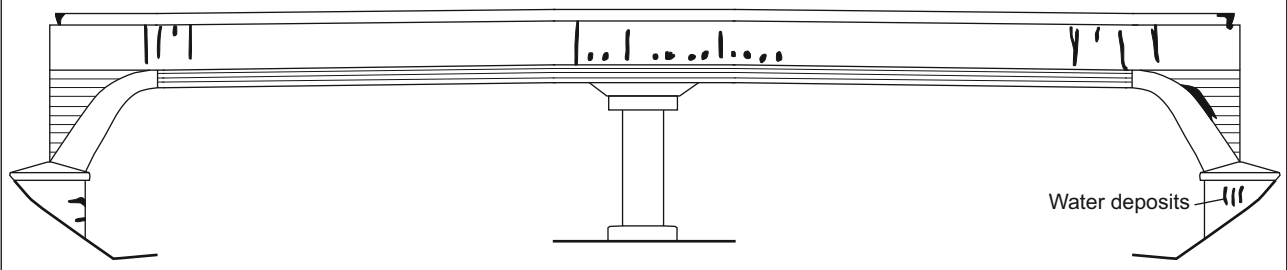
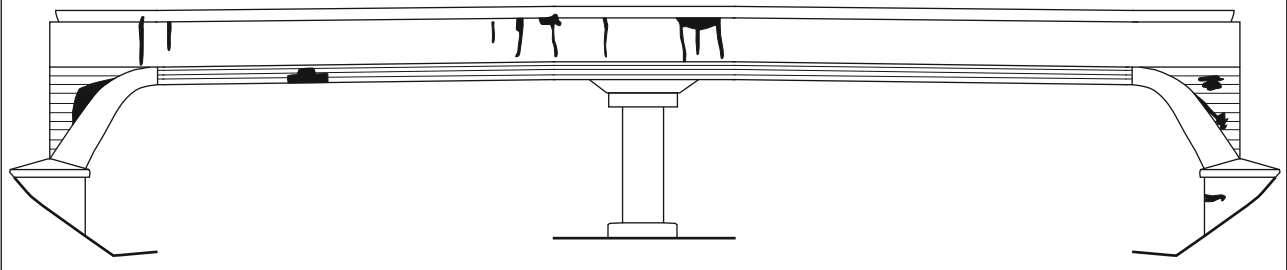
North elevation

In regards to the age of the bridge there was some damage and repairs, only the elevations were noted with approximate locations (Fig 75). The condition is similar to the Chalton Bridge with similar problems.

Concrete was flaking off the parapet and exposing some of the steel rebar, some of which have been patched. Concrete section joints were in-filled with a grey rubber compound, over time cracks were treated the same (Figs 66, 69 and 75).

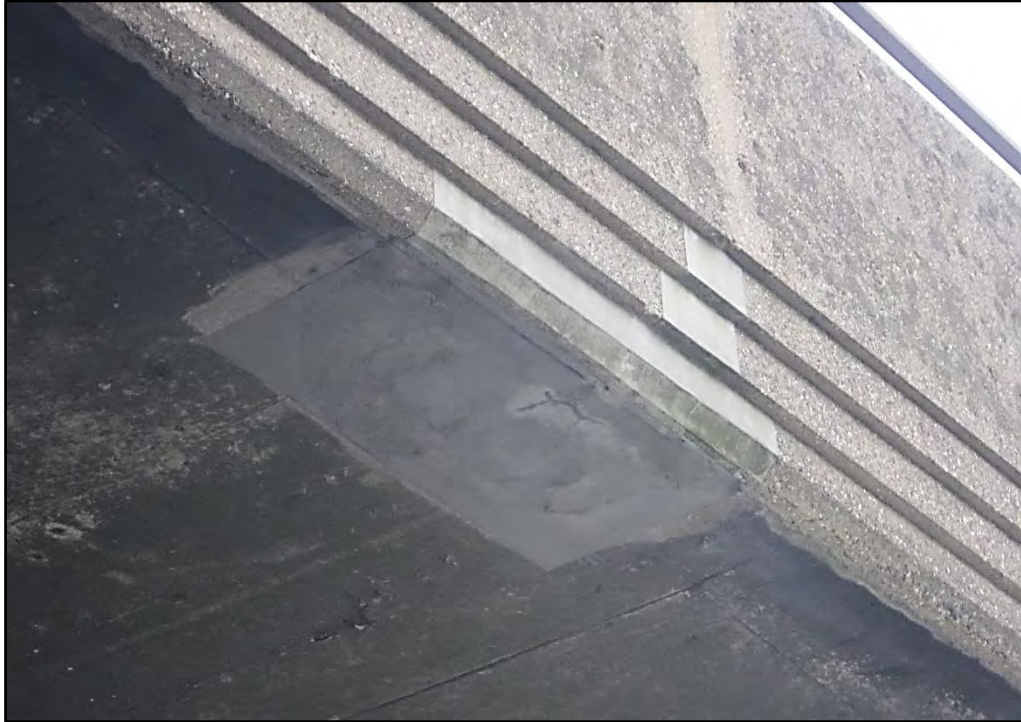
A repair was undertaken of the deck on the northbound side where a vehicle possibly clipped the bridge (Fig 76). The underside of the deck has been patched in the past. The abutment walls and scrolls all show cracks, areas of pitting, and water marks from water seepage (Figs 77 to 88).

Repair on underside of deck on south elevation Fig 76

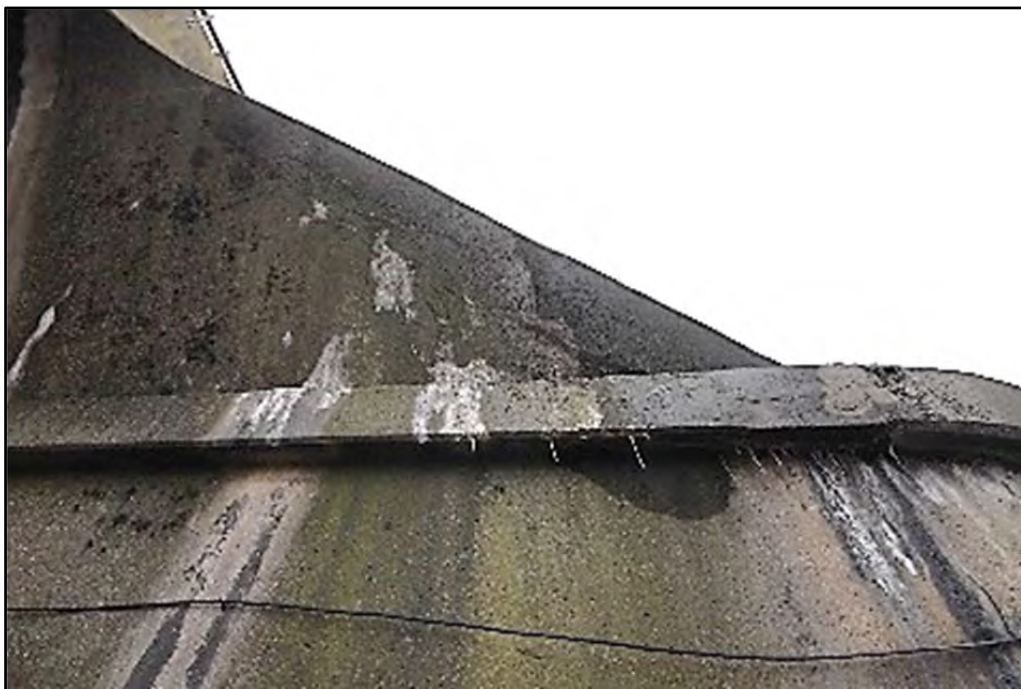
Water issues on north-west scroll Fig 77

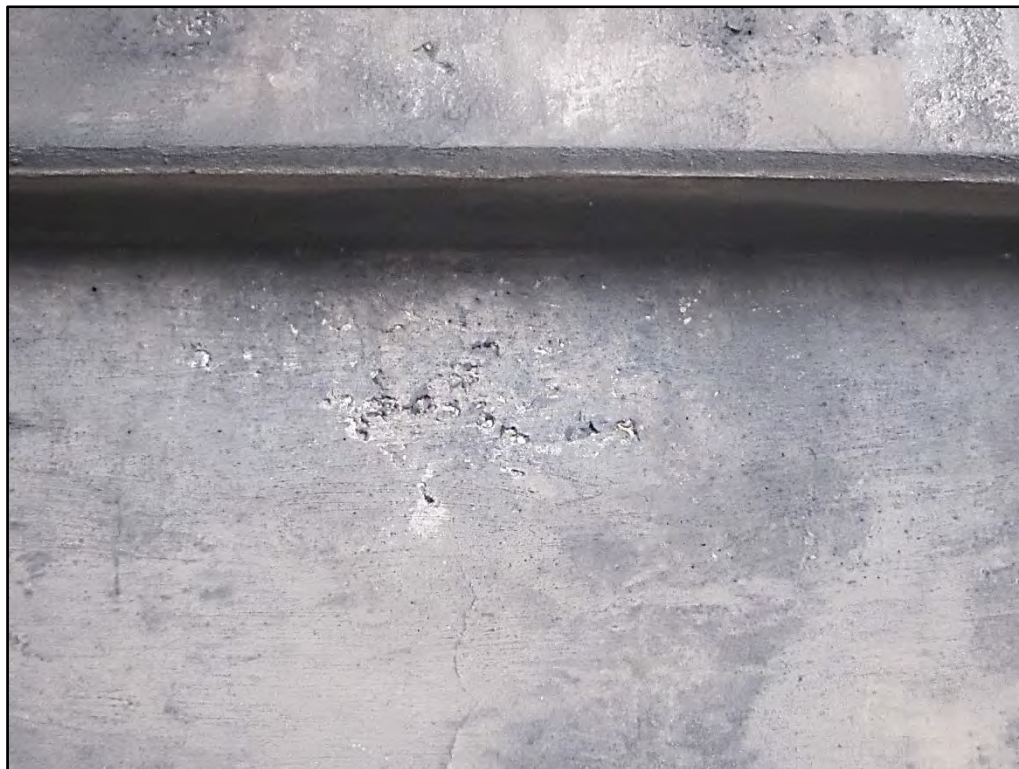
Pitting on the structure Fig 78

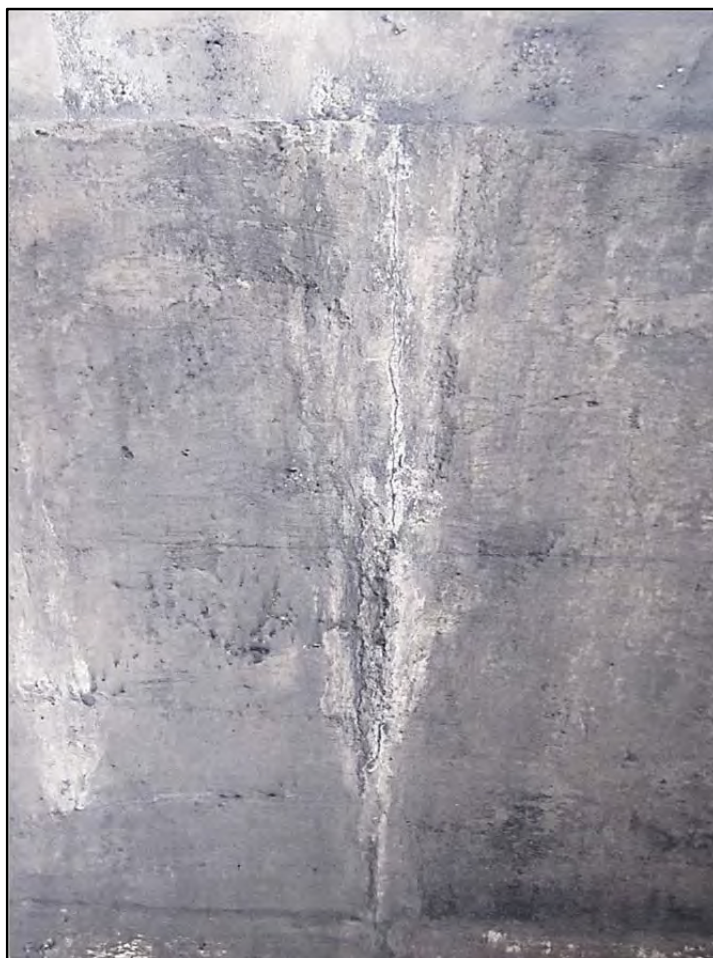
Decay of the concrete Fig 79

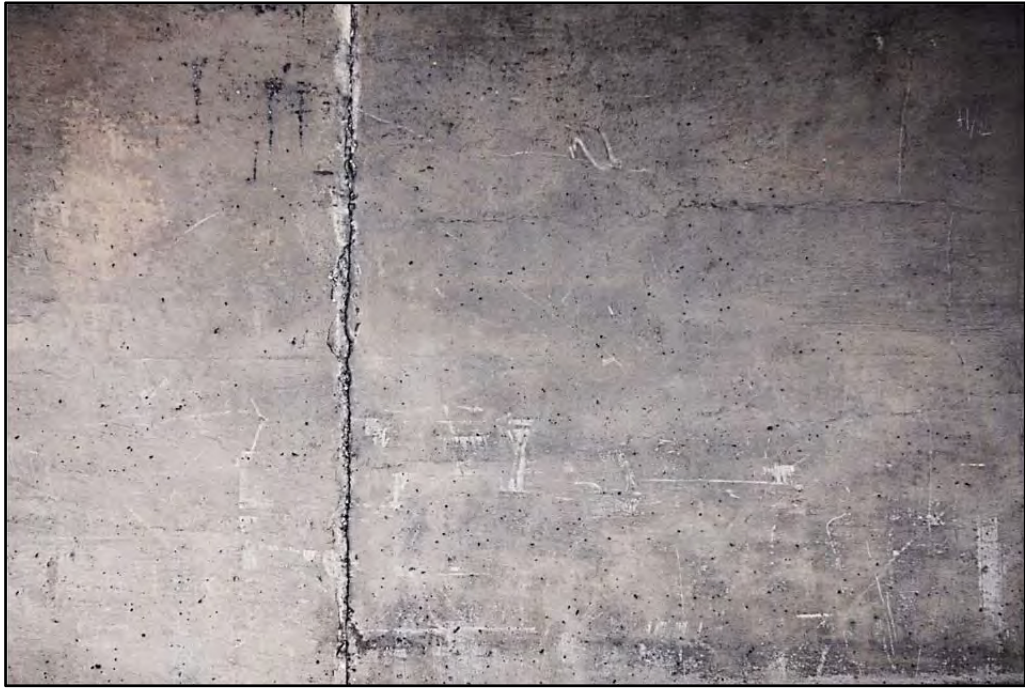
Wear and markings on the east abutment wall Fig 80
