**Historic building recording and archaeological
observation at the Church of St Mary the Virgin
Keysoe, Bedfordshire
January 2016**

Report No 16/38

MOLA Northampton was invited to undertake a programme of historic building recording and archaeological observation at the Church of St Mary, Keysoe, during groundworks associated with the installation of a new single storey extension containing a small kitchenette, toilet facilities and associated services. The existing doorway and the area surrounding it were photographically recorded and a measured drawing was produced. Four carved marks around the door were noted. The groundworks comprised the reduction of ground level within this area and the excavation of pipe trenches. A small amount of disarticulated and disturbed human remains and a possible layer of medieval or post-medieval demolition material were identified and recorded.

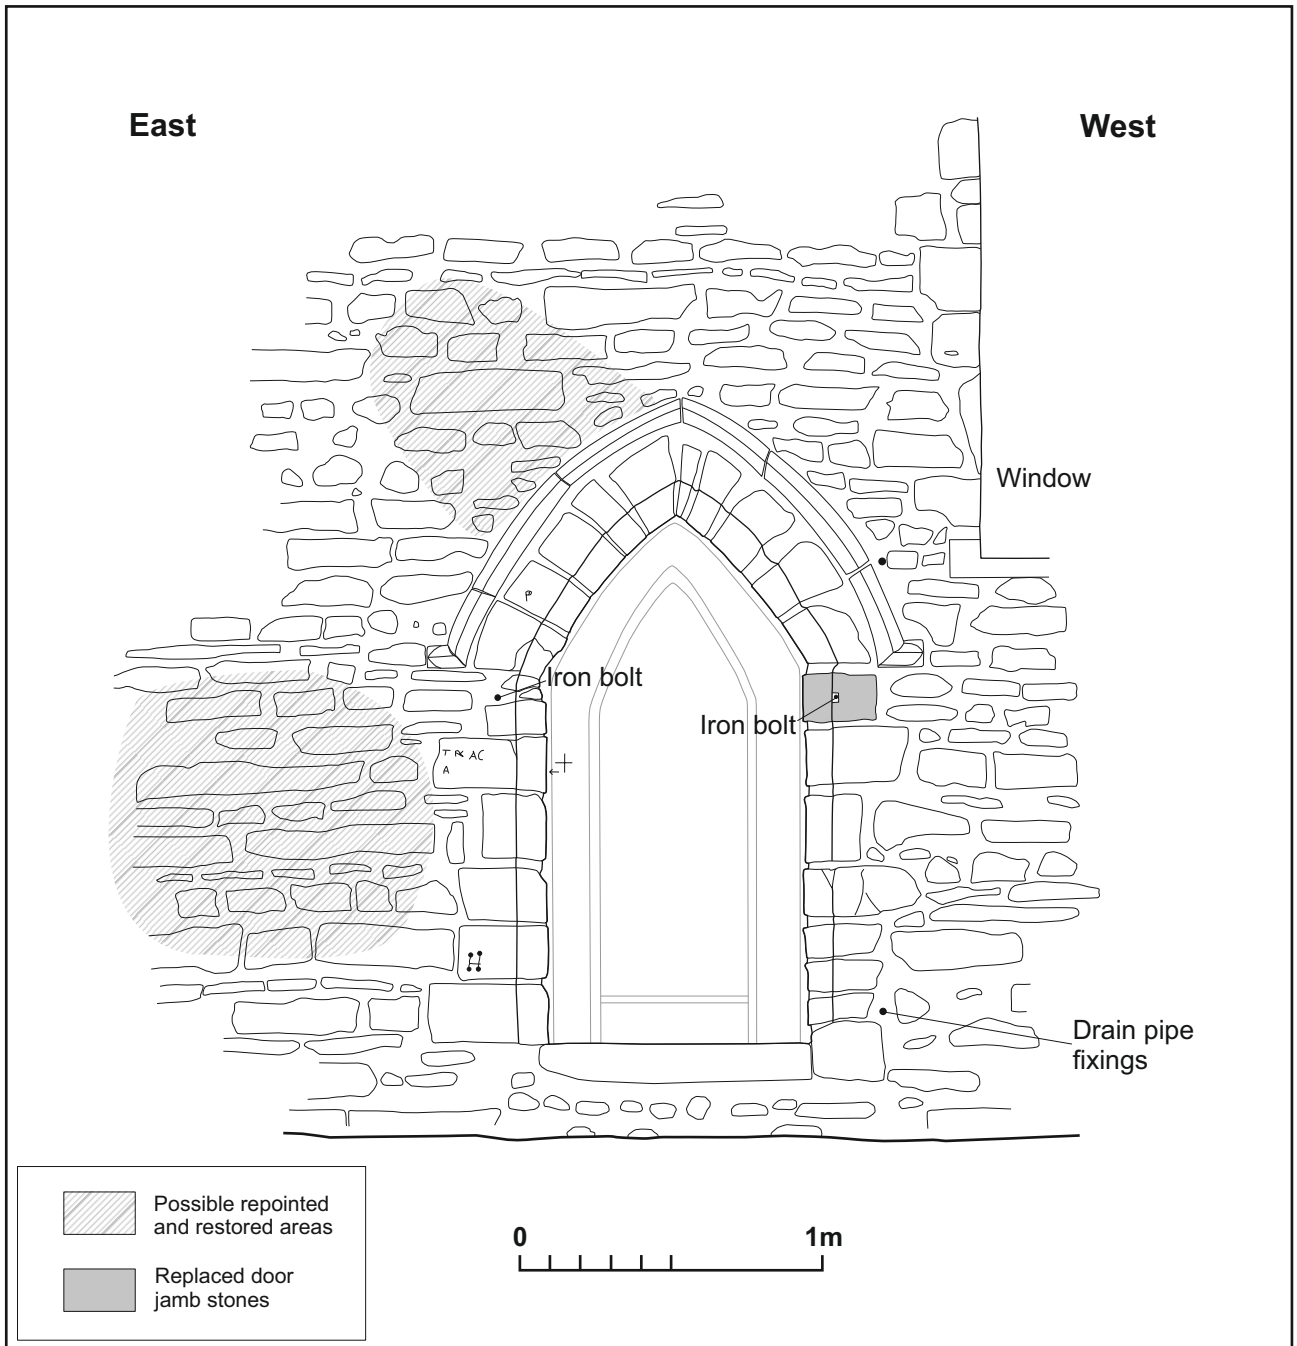
North doorway elevation Fig 7

Part of a more recent phase of restoration in the area of interest, marked in light orange, may have involved the replacement of stone and repointing. This stone and mortar is fresher in colour (Figs 7 and 8).

The doorway itself appears to have had a few of the stone blocks making up the door jamb replaced, marked in dark orange (Figs 7 and 8).

Externally the doorway is a pointed equilateral arch (Figs 7 and 10). The door jambs, like the arch, comprise individual blocks of stone with an ovolo moulded edge (Fig 11). The doorway has a hood moulding outlining the lintel stones with label stops, turned horizontally away from the door (Figs 12 and 13). The stone immediately below the spring line is replaced, along with stones probably at the base of the door jamb (Figs 7 and 10).

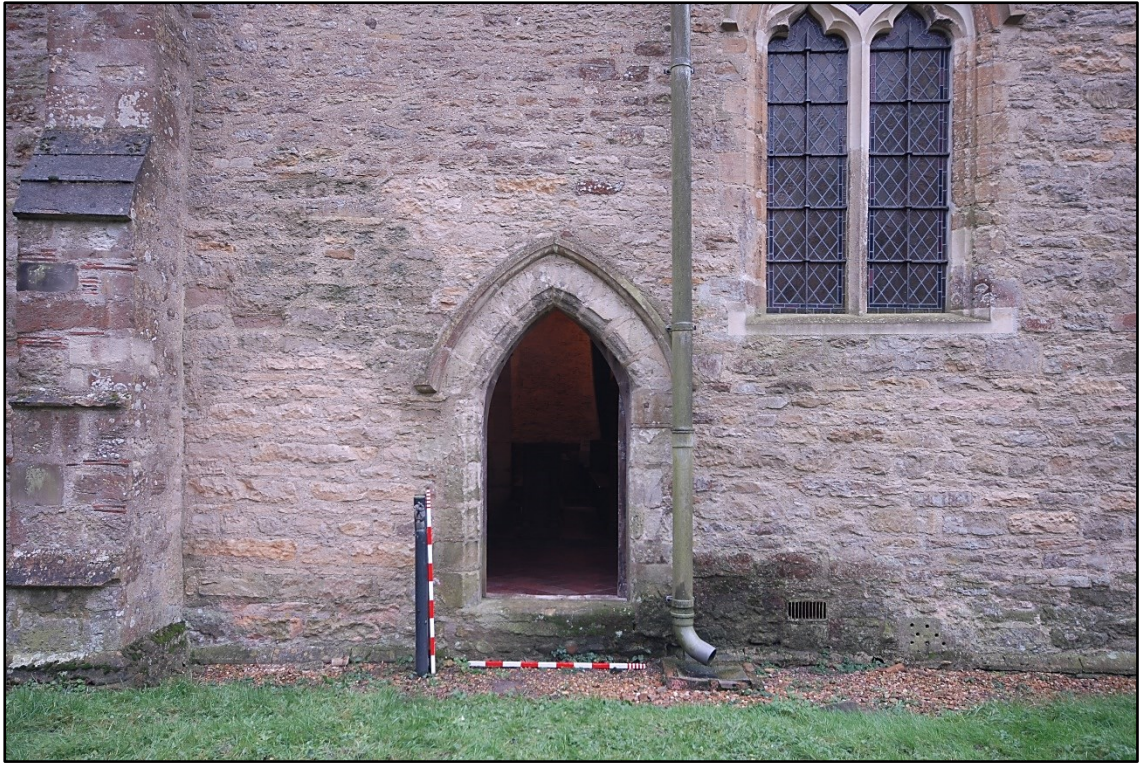
The elevation with north door, looking south Fig 8

The panelled oak door reflects the pointed arched shape of the external elevation (Fig 8). The inner segment of the door can be opened independently leaving the external iron grating. This will leave the door secure whilst letting air inside.

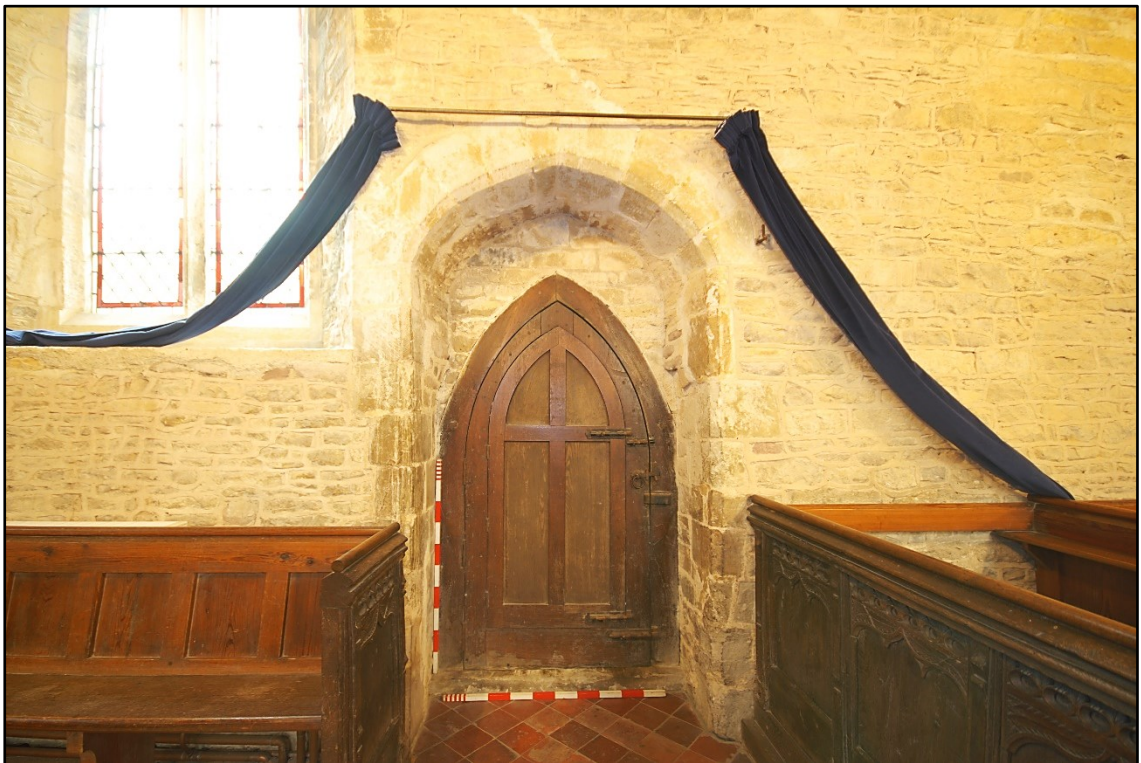
Internal view of area around north door, looking north Fig 9

Internally the doorway comprises a compressed arch formed of individually carved blocks of stone with a simple chamfered edge. The tympanum, the space above the door, is plain. However, towards the back it bulges out into the tympanum (Fig 9).

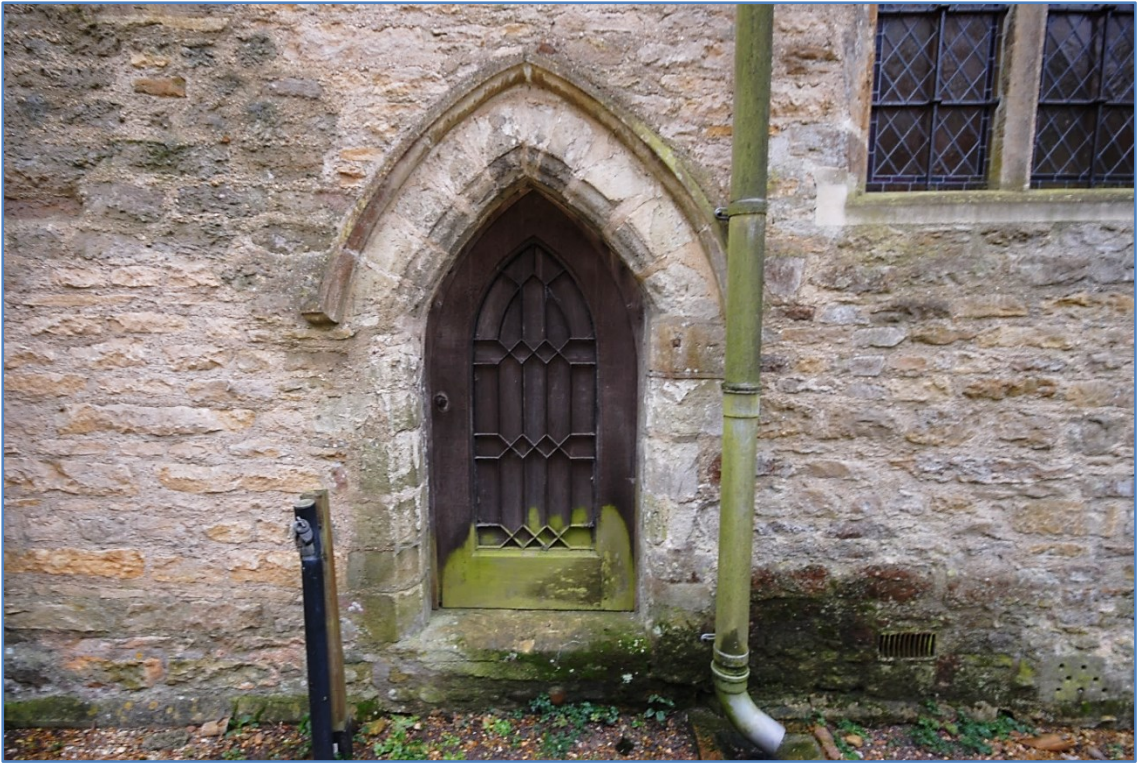
The doorway, looking south Fig 10

During the recording four marks around the door were identified (Fig 10). On the left side of the door, behind the water pipe, is an *H* with holes on all ends (Fig 15). Graffiti with letters *T*, *A*, *C* and a possible a *K* or *R* was identified on the left side of the door (Fig 16). A *P* was carved into one of the lintel stones (Fig 17). A cross † was noted on the inside of the door jamb at the height of the door pull (Fig 18).

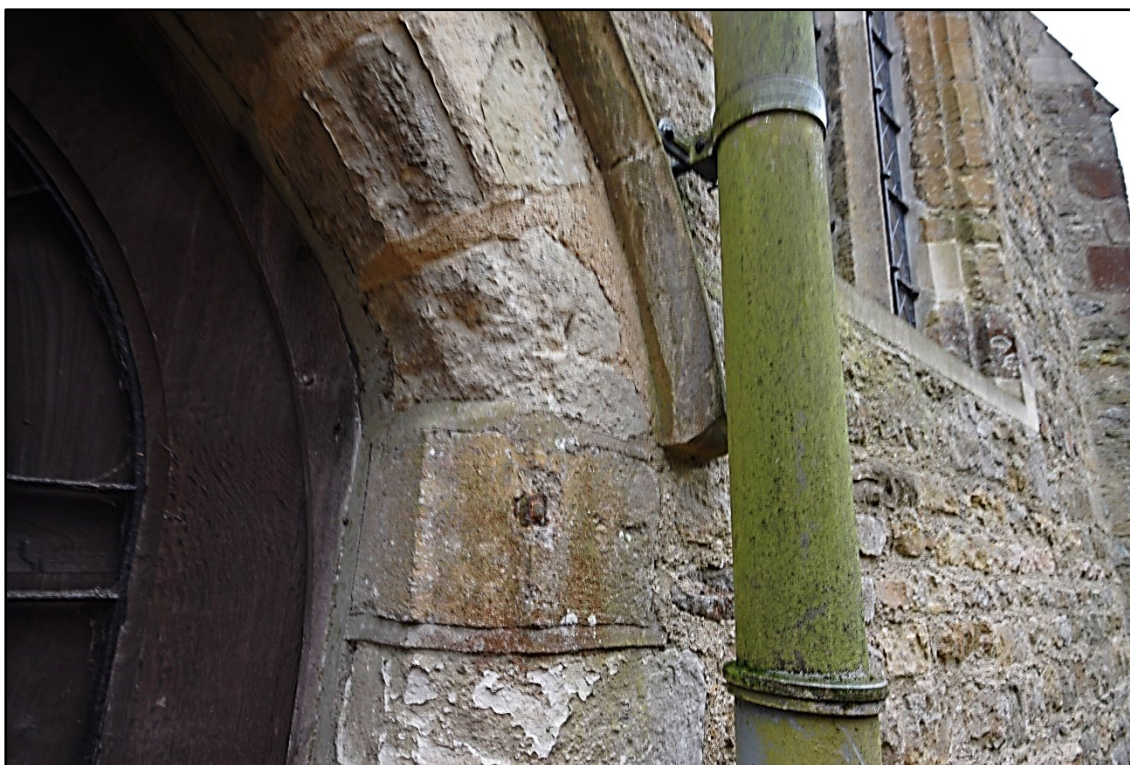
The replaced jamb stone under the spring line with an iron bolt Fig 14

During the visit on the 11 January the area surrounding the north door was photographically recorded, and a drawn elevation was made of the area immediately surrounding the door. Due to the extensive repointing phasing was difficult to identify, some work could be identified by lighter, cleaner patches that were also present to the left of the door. Some of the door jamb stones have been replaced, one on the right side under the spring line had more recent mortar.

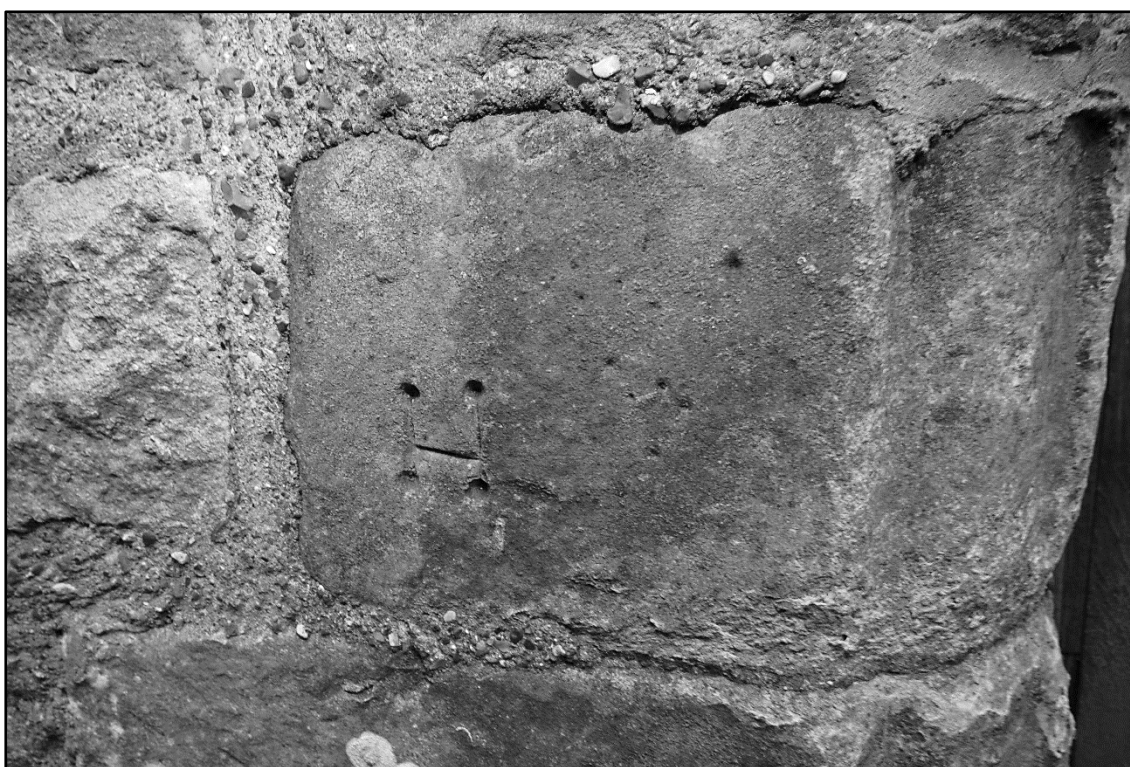
Carved *H* on lower left part of door frame Fig 15

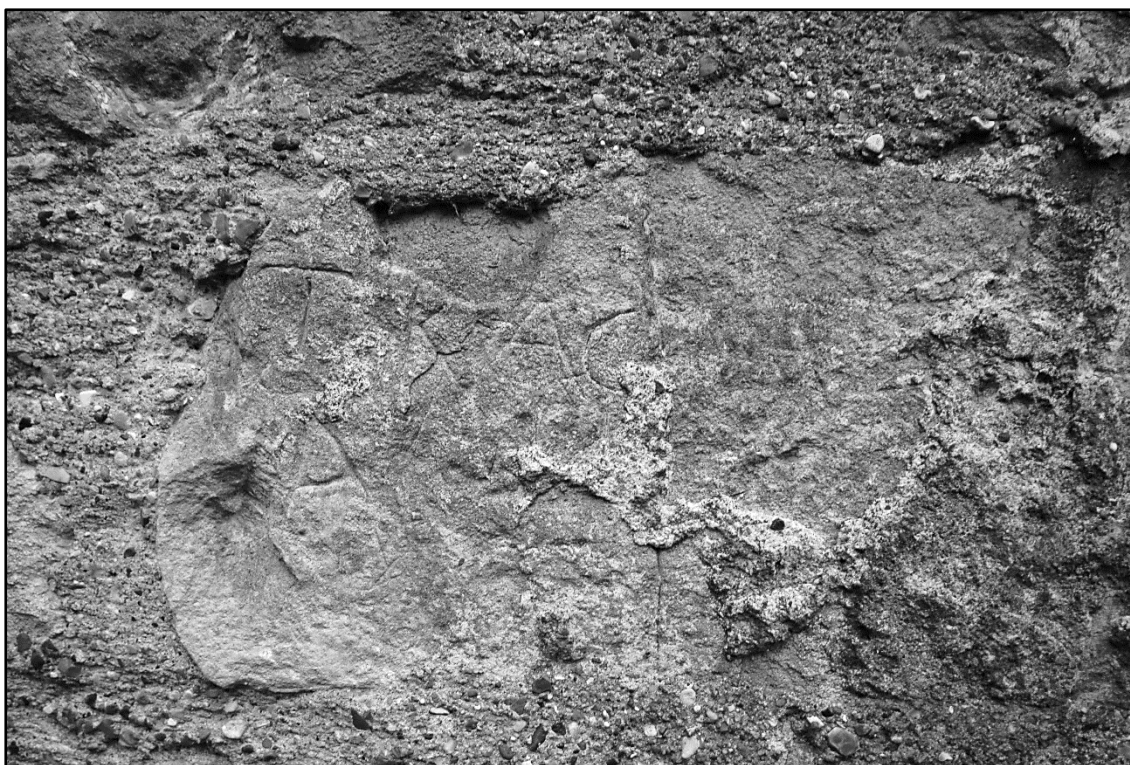
Graffiti, on stone left side of door jamb Fig 16

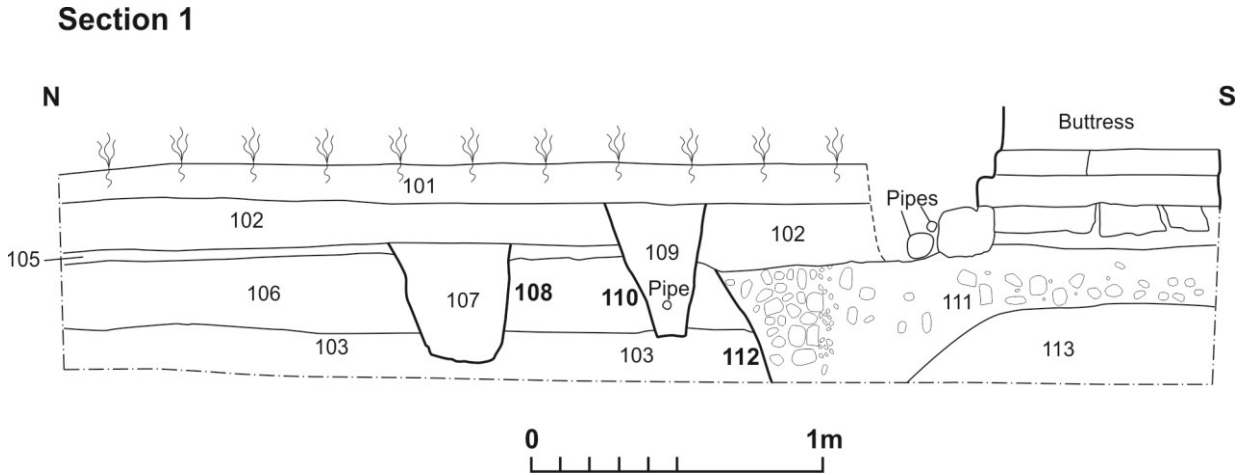
Section, east face of Trench 1 Fig 19

A foundation trench [112], c 1.80m wide, was observed parallel to the church wall (Figs 4 and 19). In the south corner the fill (113) comprised compact yellow-brown sandy clay with small chalk inclusions. This was overlain by fill (111), which consisted of dark yellow-brown sandy clay with numerous small to large sized fragments of flint and chalk (Fig 23).

A possible tree bole [108], was noted in the Trench 1 section (Fig 19). The feature had steeply sloping sides and a slightly rounded base. The fill (107) consisted of a compact yellow-brown sandy clay loam with a few small chalk fragments and a small of tile fragment, which was not retained. There was tree root disturbance present.

A water stand pipe was present outside the north door. The modern narrow, water pipe trench [110], modern back fill (109), was aligned east to west alignment approximately 1m to the north of the stone buttress (Figs 19, 23).

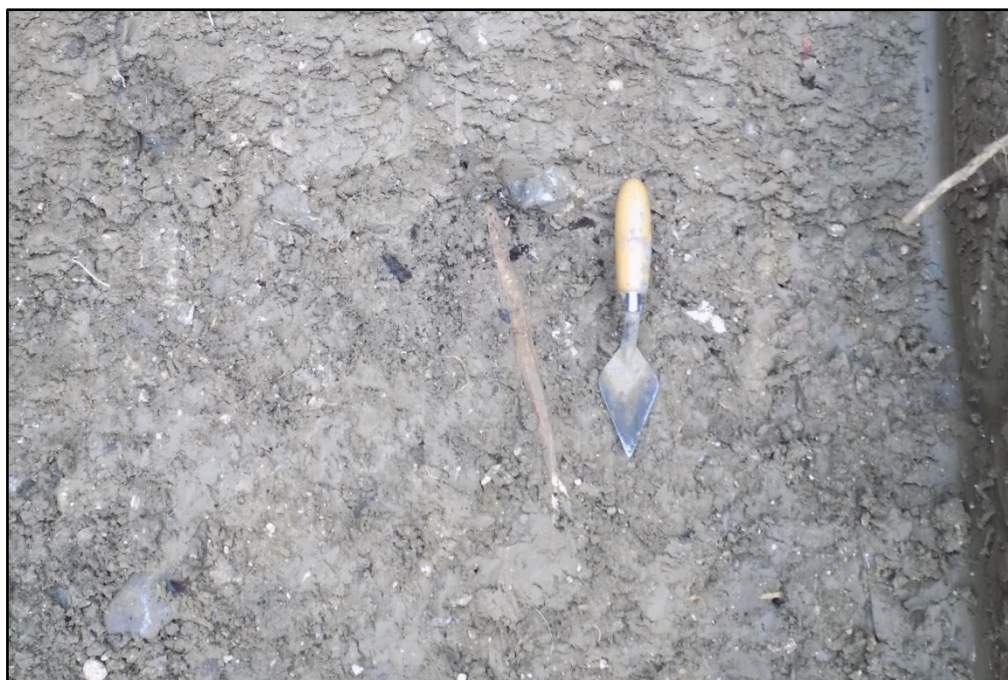
Trench 2, disarticulated human bone, looking east Fig 26

Due to the relatively shallow nature of the excavation trenches, no graves were positively identified. However, a possible grave cut was recorded close to the eastern balk of Trench 1 and on the floor of Trench 2; some disarticulated human bone was noted.
