# Historic Building Recording at the former Anchor Brewery, Mill Road Oundle, Northamptonshire May 2015 – March 2016

Report No. 16/51  
Author & Illustrator: Amir Bassir

© MOLA Northampton 2016  
Project Manager: Amir Bassir  
Planning ref: 15/01967/FUL  
NGR: TL 03740 87920  
Event No. ENN108310

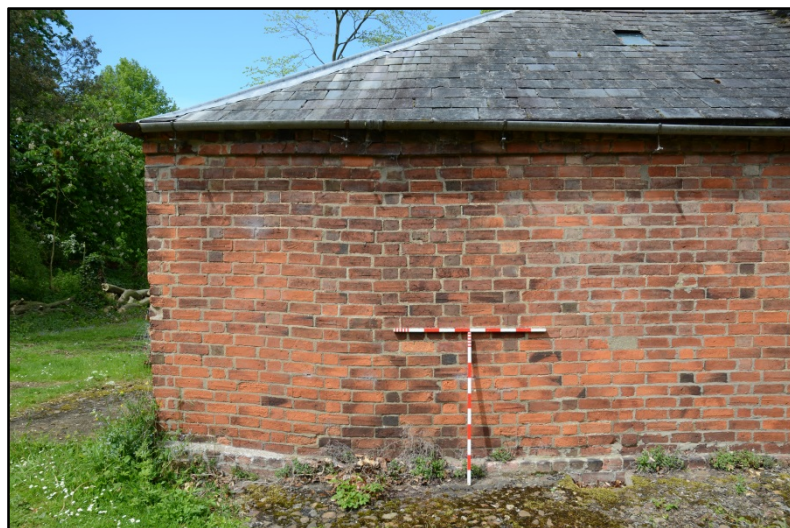
Stable 4, detail of subsidence in the brickwork Fig 88
