**NOS. 11 & 12, HIGH STREET  
WISBECH  
FENLAND DISTRICT  
CAMBRIDGESHIRE**

**SURVEY AND ANALYSIS  
HISTORIC BUILDINGS REPORT**

Research Department Report Series 75/2006

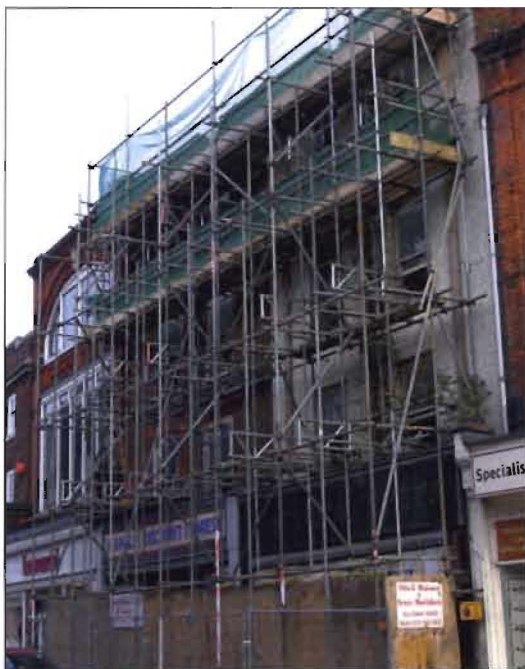
***Figure 1. The main north-west front, now covered in scaffolding.  
Pete Smith 5/10/2006***

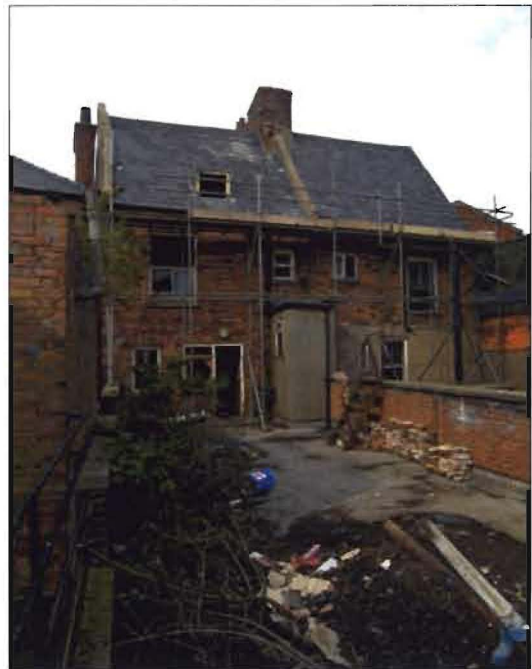
***Figure 2. The rear south-east front, from the roof of the ground floor rear extensions.  
Pete Smith 5/10/2006***

The attempt to join two different roof types has caused the rear slope of the rear roof to sag and put pressure on the rear wall of the building. This probably explains why the rear walls of both these buildings had to be rebuilt at some time in the 20<sup>th</sup> century. The roof itself has been strengthened at the same time.

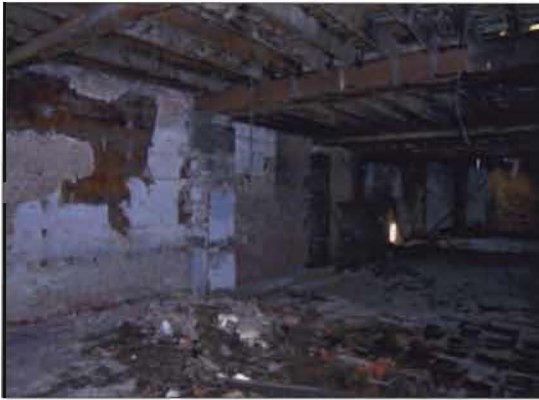
*Figure 3. The ground-floor shop interior.  
Pete Smith 5/10/2006*

Internally on the ground floor the internal walls have been removed and a number of brick piers now support the steel girders which support the floor above.

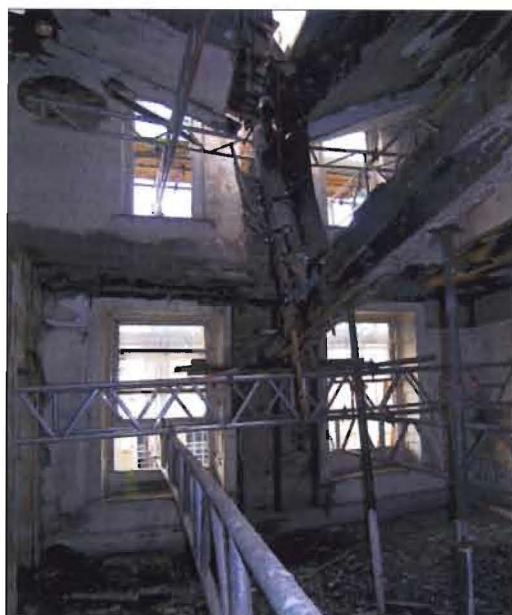
*Figure 4. The first floor interior showing the recently collapsed roof internal beams.*  
*Pete Smith 5/10/2006*

been replaced. Timber partitions survive dividing the rear rooms from the staircases. No original fireplaces were found. The relatively broad timber winder staircases survive largely unaltered. The internal divisions on the upper two floors of No. 11 have been seriously compromised by the recent collapse of the roof. Most of the upper rooms have surviving chamfered beams, three to each room on the upper floors. The roofs are somewhat unusual. The front sections of these buildings are roofed with double shallow pitched hipped roofs which are not visible behind the brick parapets. These roofs appear to have been replaced with sawn timber structures in the 19<sup>th</sup> century. But the rear section is roofed by a more steeply pitched cross roof with no hips - it has raised and coped gables visible from the rear. The timbers of this pine roof are now exposed and they have a staggered purlin form. This roof structure has a number of mortice holes visible which do not relate to the present structure and suggest that this roof was constructed of re-used timbers. It seems likely that this rear roof was constructed in the early 18<sup>th</sup> century re-using older timbers.

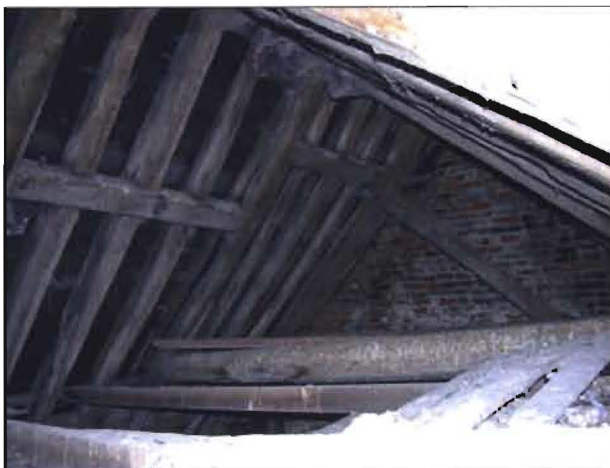
**Figure 7. Interior of rear roof.**  
**Pete Smith 5/10/2006**

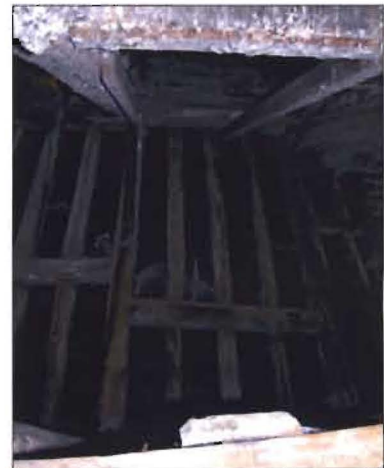
**Figure 8. Detail of rear roof.**  
**Pete Smith 5/10/2006**
