Centre for Archaeology Report 73/2003

**Tree-Ring Analysis of Timbers from the Church of St Mary
Magdalene, East Ham, London Borough of Newham**

Dr Martin Bridge and Richard Bond

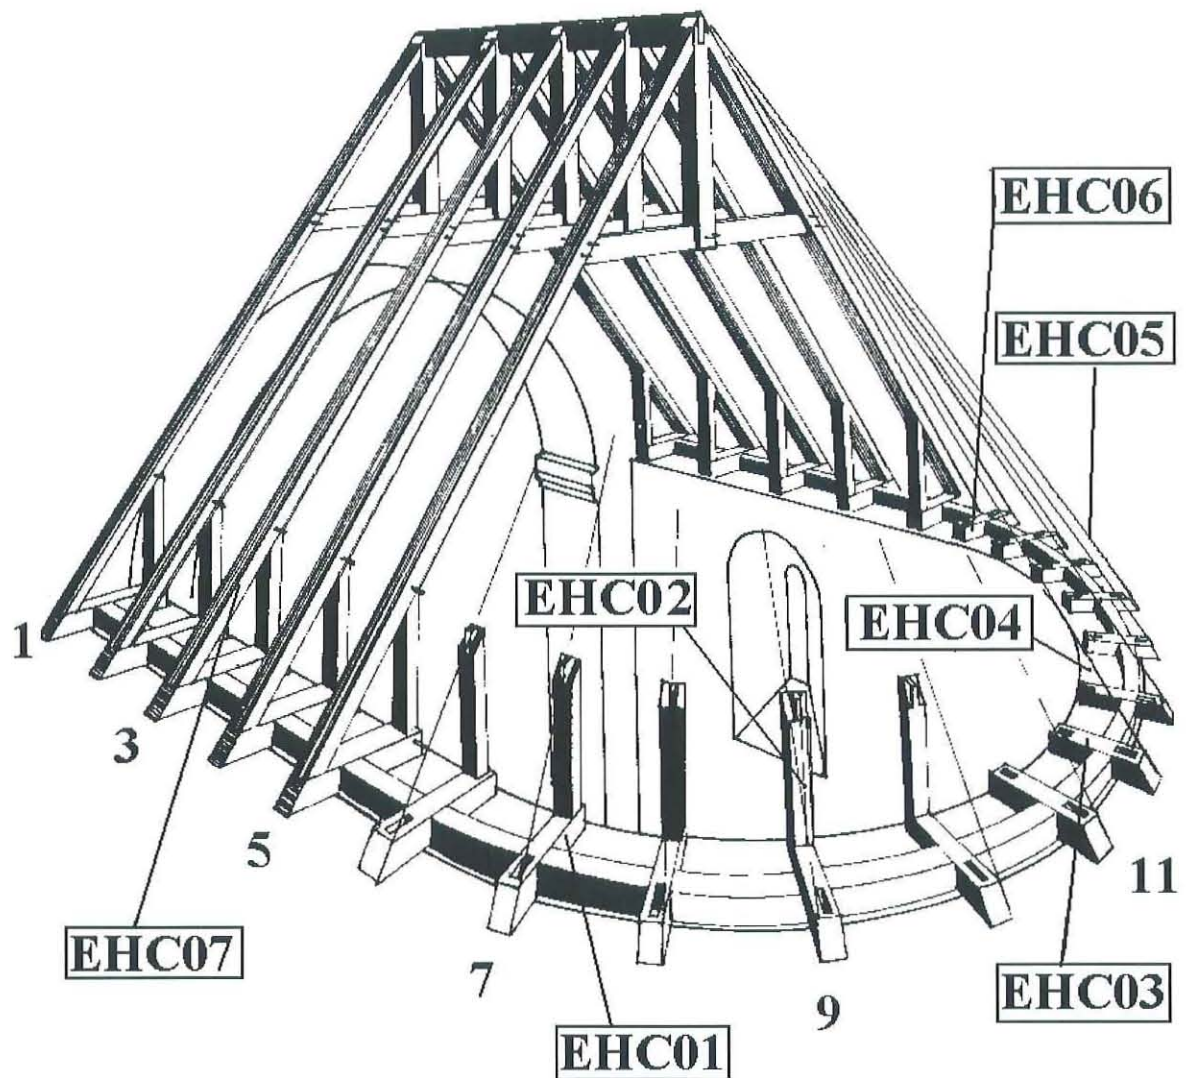
Figure 2: The apse roof at East Ham, showing the timbers sampled for dendrochronology. Based on an original drawing by Hewett (1980; 37)

All the timbers investigated in the apse roof were of oak (*Quercus* spp.). Sampling was limited by the lack of suitable timbers, ie timbers having sufficient numbers of rings and sapwood edges. Details of the samples taken are given in Table 1, and their locations are shown in Figure 2. Three samples were rejected as they had too few rings for further analysis. Samples EHC03 and EHC06 matched each other ($t = 7.3$ with 65 years of overlap). They were combined into a single sequence for further analysis. Neither this sequence, nor any of the other unmatched individual series gave acceptable consistent matches when compared with the reference material. The data for the analysed series are given in Table 2.

Plots of the two series which crossmatched (EHC 03 and 06) strongly suggest that these two sole pieces could have come from the same parent tree. None of the few timbers sampled were dated, but a number of observations were made which suggest that this roof has been dismantled and reassembled on at least one occasion, and that new timbers have been inserted.

The existing sole pieces and ashlar pieces appear to post-date the existing rafters. At least one of the sole pieces displays circular saw marks upon its surface; and many, if not all, of them have numbers drawn on them in pencil. The numbers run in sequence starting at the south-west corner (rafter 1) and finishing at the north-west corner (rafter 23). In some cases, the ashlar pieces and/or the rafter are numbered instead of the sole pieces. These numbers are also in pencil, and the numbering sequence corresponds to the numbering of the sole pieces. Many of the horizontal battens linking the rafters were made using a mechanical saw; both circular saw marks and band saw marks are in evidence. On the rafters themselves there are no carpenter's marks present, and all that can be said about them is that they probably pre-date the existing ashlar pieces, sole pieces, and horizontal battens. The battens are held in place in shallow housings cut into the sides of the rafters. In at least one case, the setting-out lines for the housings are not scribed lines, but are again drawn in pencil. Some of the joints between the rafters and ashlar pieces have been re-pegged (there are redundant peg holes alongside the present filled peg holes), and the tenons of many of the ashlar pieces fit very poorly with the mortices in the rafters. By contrast, the joints between the collars and the rafters (and between the collars and king posts) show no obvious signs of having been reassembled; there are no redundant peg holes and the joints all seem to be close fitting. The surface appearance of the collars is very much at variance with that of the rafters (albeit the rafters themselves are of a very uneven quality). Whereas the rafters were produced by handsaw and side axe, and have smooth surfaces, the collars appear to have been made with an adze, and the timbers have a significantly cruder, rough-hewn quality. The same is also true of the majority of the king posts. Only the easternmost collar and its king post look to be of a piece with the rafters in terms of scantling, finish and quality of timber.

Two anomalous features were noted. Whereas in couples one, two, four, and five the ashlar pieces are tenoned into the underside of their rafters, in the central couple there is evidence of an alternative method whereby the ashlar pieces were halved over the sides of the rafters instead. In this couple, the northern rafter has a redundant mortice with an empty peg hole passing horizontally through it, suggesting that the present halved joint is a later alteration. The southern rafter, by contrast, employs the standard mortice and tenon joint, but includes immediately above it the sawn-off tenon of an earlier ashlar, still halved into the side of the timber. The remnant tenon is attached to the rafter with a single nail. The nail has an approximately 10mm-diameter head, and is hand-made. In the next paired-rafter couple to the east, rafter couple 4, each rafter has a tenoned ashlar piece; however in both rafters there is a second, redundant, peg hole passing horizontally through the timber a short distance above the present (pegged) mortice for the ashlar piece. Whether these holes are simply a mistake, or played some part in the former roof construction, is unclear. (Normally, of course, the mortices in a frame would have been cut before the holes for their pegs were drilled, not after).

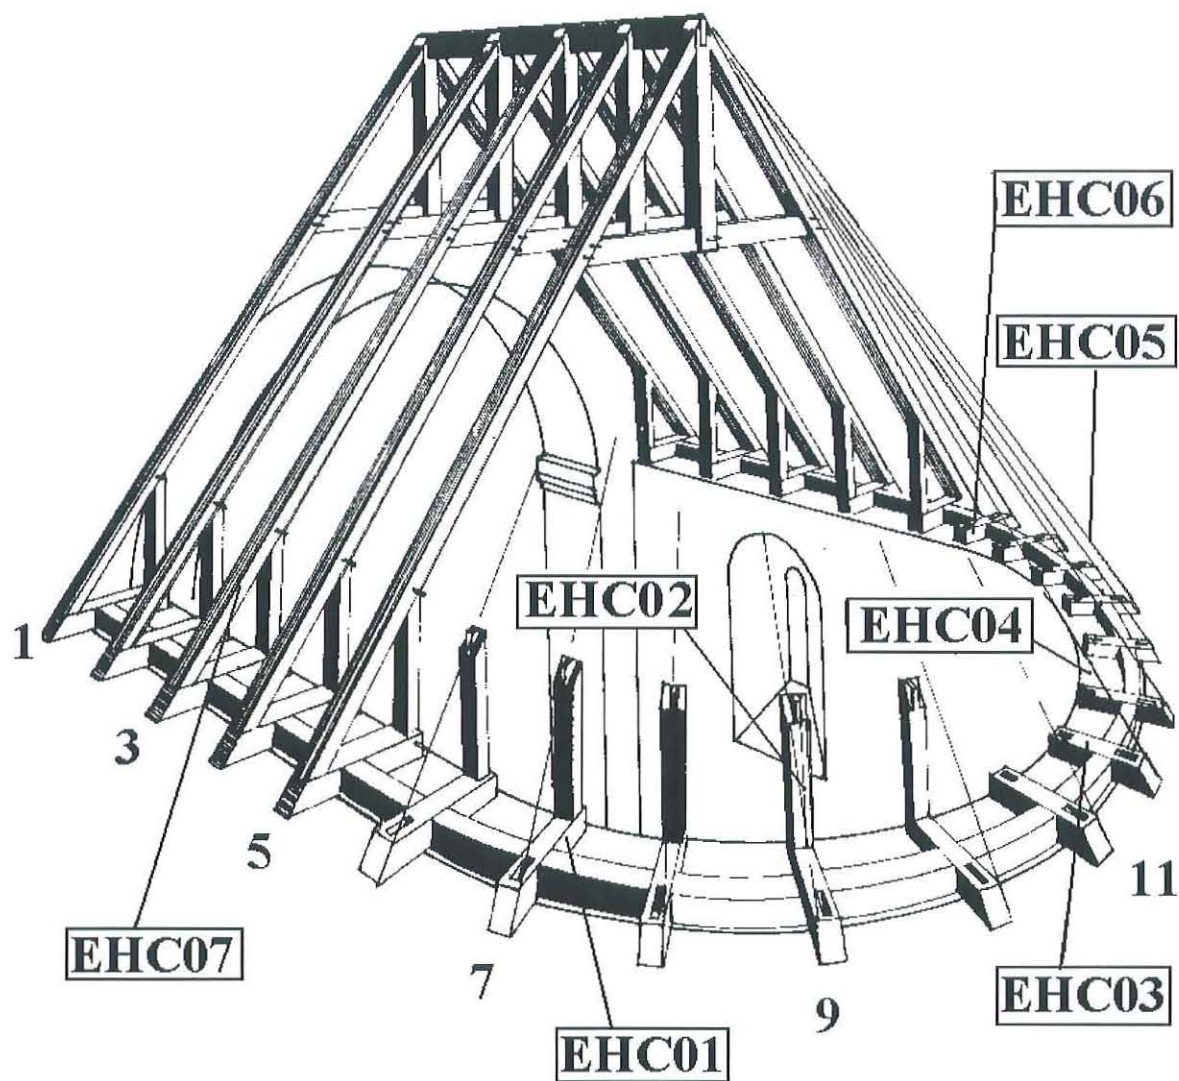
Figure 2: The apse roof at East Ham, showing the timbers sampled for dendrochronology. Based on an original drawing by Hewett (1980; 37)

All the timbers investigated in the apse roof were of oak (*Quercus* spp.). Sampling was limited by the lack of suitable timbers, ie timbers having sufficient numbers of rings and sapwood edges. Details of the samples taken are given in Table 1, and their locations are shown in Figure 2. Three samples were rejected as they had too few rings for further analysis. Samples EHC03 and EHC06 matched each other ($t = 7.3$ with 65 years of overlap). They were combined into a single sequence for further analysis. Neither this sequence, nor any of the other unmatched individual series gave acceptable consistent matches when compared with the reference material. The data for the analysed series are given in Table 2.

Plots of the two series which crossmatched (EHC 03 and 06) strongly suggest that these two sole pieces could have come from the same parent tree. None of the few timbers sampled were dated, but a number of observations were made which suggest that this roof has been dismantled and reassembled on at least one occasion, and that new timbers have been inserted.

The existing sole pieces and ashlar pieces appear to post-date the existing rafters. At least one of the sole pieces displays circular saw marks upon its surface; and many, if not all, of them have numbers drawn on them in pencil. The numbers run in sequence starting at the south-west corner (rafter 1) and finishing at the north-west corner (rafter 23). In some cases, the ashlar pieces and/or the rafter are numbered instead of the sole pieces. These numbers are also in pencil, and the numbering sequence corresponds to the numbering of the sole pieces. Many of the horizontal battens linking the rafters were made using a mechanical saw; both circular saw marks and band saw marks are in evidence. On the rafters themselves there are no carpenter's marks present, and all that can be said about them is that they probably pre-date the existing ashlar pieces, sole pieces, and horizontal battens. The battens are held in place in shallow housings cut into the sides of the rafters. In at least one case, the setting-out lines for the housings are not scribed lines, but are again drawn in pencil. Some of the joints between the rafters and ashlar pieces have been re-pegged (there are redundant peg holes alongside the present filled peg holes), and the tenons of many of the ashlar pieces fit very poorly with the mortices in the rafters. By contrast, the joints between the collars and the rafters (and between the collars and king posts) show no obvious signs of having been reassembled; there are no redundant peg holes and the joints all seem to be close fitting. The surface appearance of the collars is very much at variance with that of the rafters (albeit the rafters themselves are of a very uneven quality). Whereas the rafters were produced by handsaw and side axe, and have smooth surfaces, the collars appear to have been made with an adze, and the timbers have a significantly cruder, rough-hewn quality. The same is also true of the majority of the king posts. Only the easternmost collar and its king post look to be of a piece with the rafters in terms of scantling, finish and quality of timber.

Two anomalous features were noted. Whereas in couples one, two, four, and five the ashlar pieces are tenoned into the underside of their rafters, in the central couple there is evidence of an alternative method whereby the ashlar pieces were halved over the sides of the rafters instead. In this couple, the northern rafter has a redundant mortice with an empty peg hole passing horizontally through it, suggesting that the present halved joint is a later alteration. The southern rafter, by contrast, employs the standard mortice and tenon joint, but includes immediately above it the sawn-off tenon of an earlier ashlar, still halved into the side of the timber. The remnant tenon is attached to the rafter with a single nail. The nail has an approximately 10mm-diameter head, and is hand-made. In the next paired-rafter couple to the east, rafter couple 4, each rafter has a tenoned ashlar piece; however in both rafters there is a second, redundant, peg hole passing horizontally through the timber a short distance above the present (pegged) mortice for the ashlar piece. Whether these holes are simply a mistake, or played some part in the former roof construction, is unclear. (Normally, of course, the mortices in a frame would have been cut before the holes for their pegs were drilled, not after).
