Ancient Monuments Laboratory  
Report 19/97

WALL PAINTING CONDITION AUDIT,  
CASTLE ACRE PRIORY, PRIOR'S  
LODGINGS, NORFOLK

J Davies

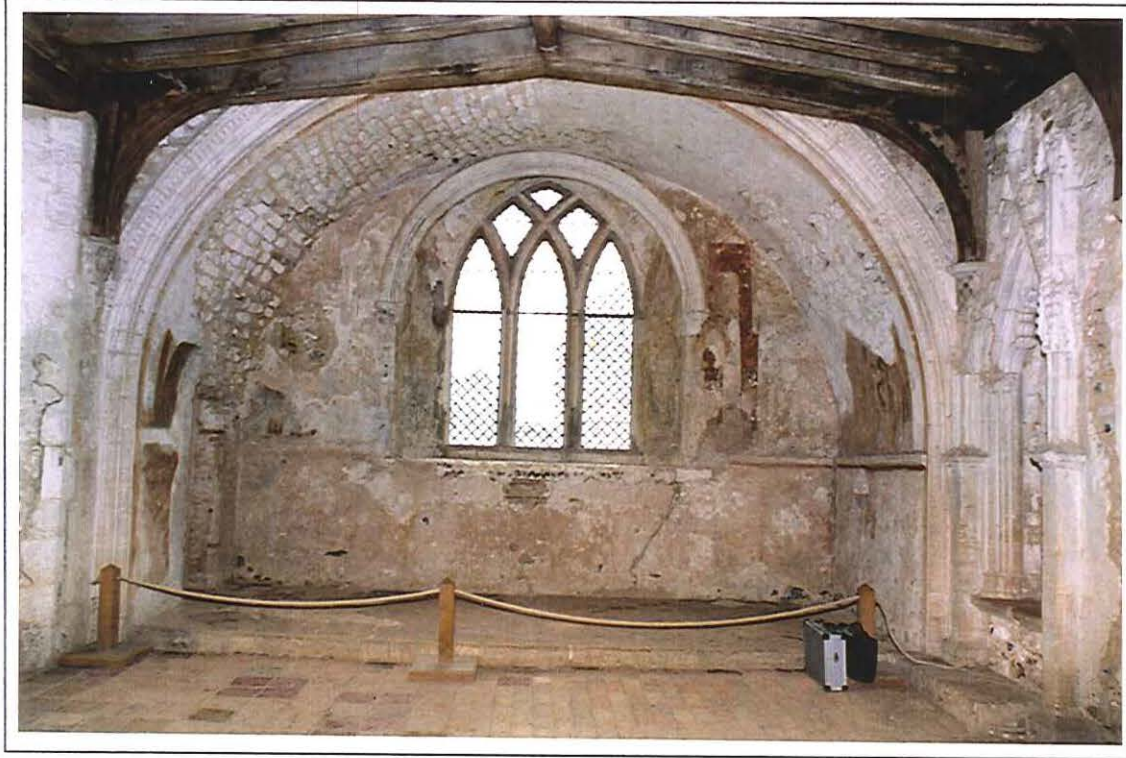
Prior's Chapel, general view to east

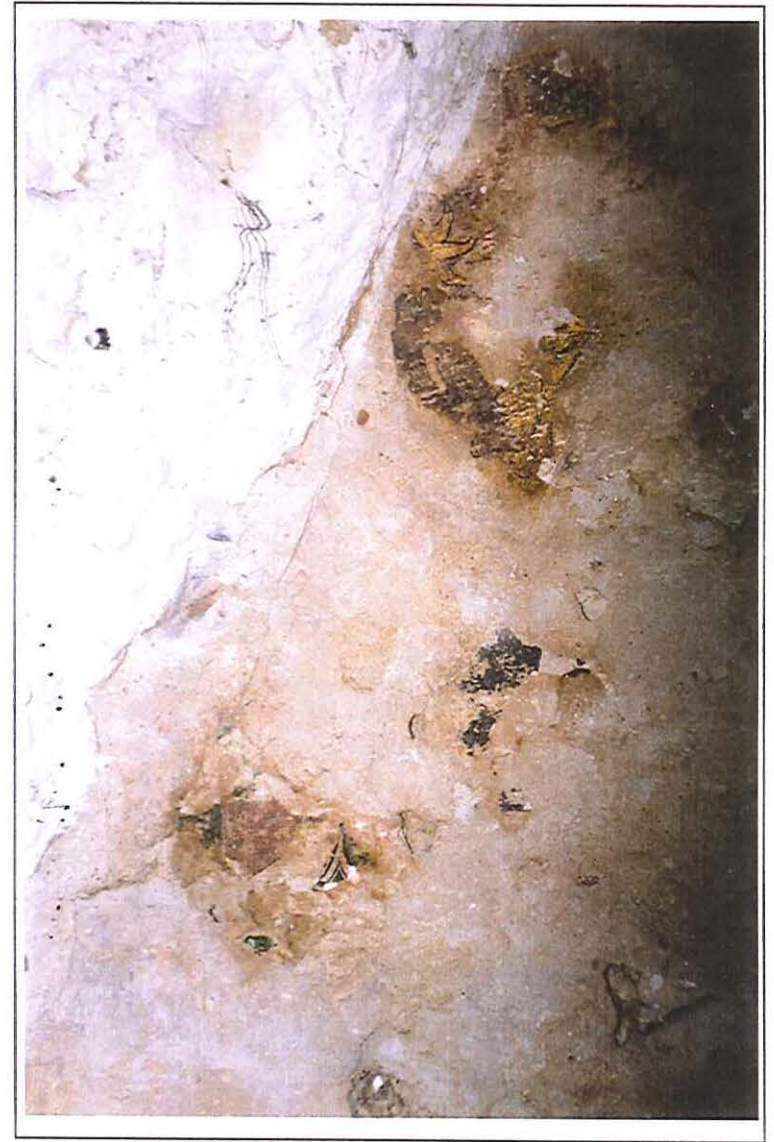
The paintings are fragmentary, however some fine passages of decoration remain, for example, the south side of the arch reveal bears traces of gold leaf with stars and leaves painted over it in fine black lines.

Gilding is present on the south reveal of the arch. Stars and gold leaves with overlying black line decoration were noted. This ornamentation is very finely executed.

Prior's Chapel, east end, detail south side, showing remains of high quality painted and gilded decoration

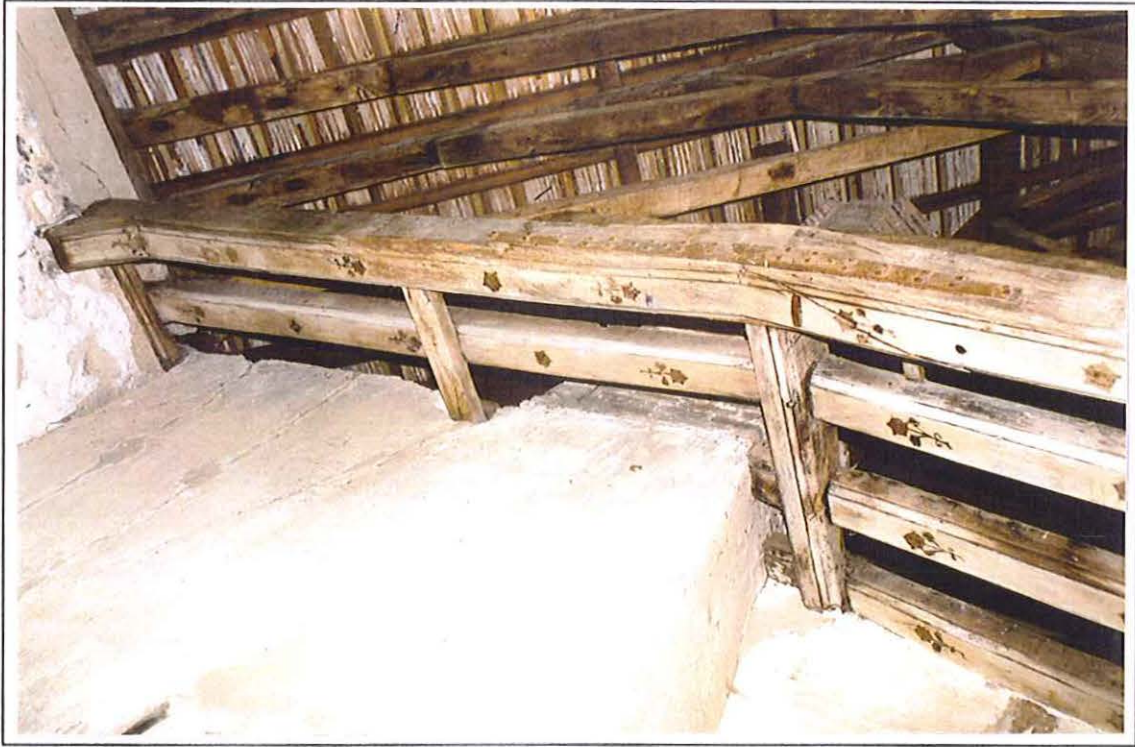
Full access to the ceiling beams was not possible during the present audit, but the painted decoration appeared to be stable.

The timber ceiling, which is both smooth and carved, is partially lost and it appears that some structural repairs have been carried out. Decoration remains on both timber beams and intervening panels. There are traces of similar decoration on the carved stone fireplaces.

Prior's Lodgings, ceiling

No conservation treatment appears to be necessary at present. However, the painting should be fully recorded and documented, and the condition of the ceiling should be monitored periodically.

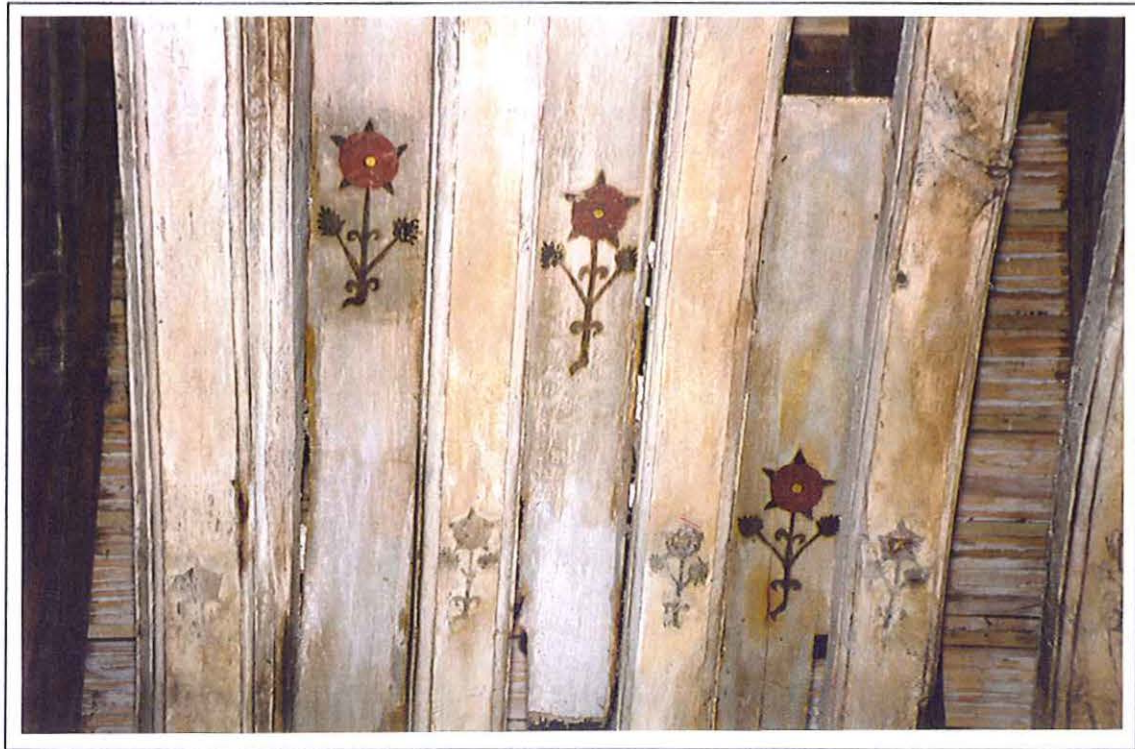
The paint layer has suffered some loss and flaking in the past. In addition the surface may be friable. Access was limited during audit inspection. Pigments include white, red, green and black.

Detail, painted decoration on ceiling timbers

**Comments** The decoration should be fully recorded and documented. The condition of the ceiling should be monitored periodically.
