Ancient Monuments Laboratory
Report 17/97

WALL PAINTING CONDITION AUDIT,
LITTLE CASTLE, BOLSOVER
CASTLE, DERBYSHIRE

J Davies
S Stewart

This condition audit of wall paintings at Little Castle, Bolsover Castle, includes a wall painting record, general audit information, documentation of original materials and execution of the painting, and deterioration and damage including previously used materials and treatment, as well as proposals for treatment and monitoring strategies.

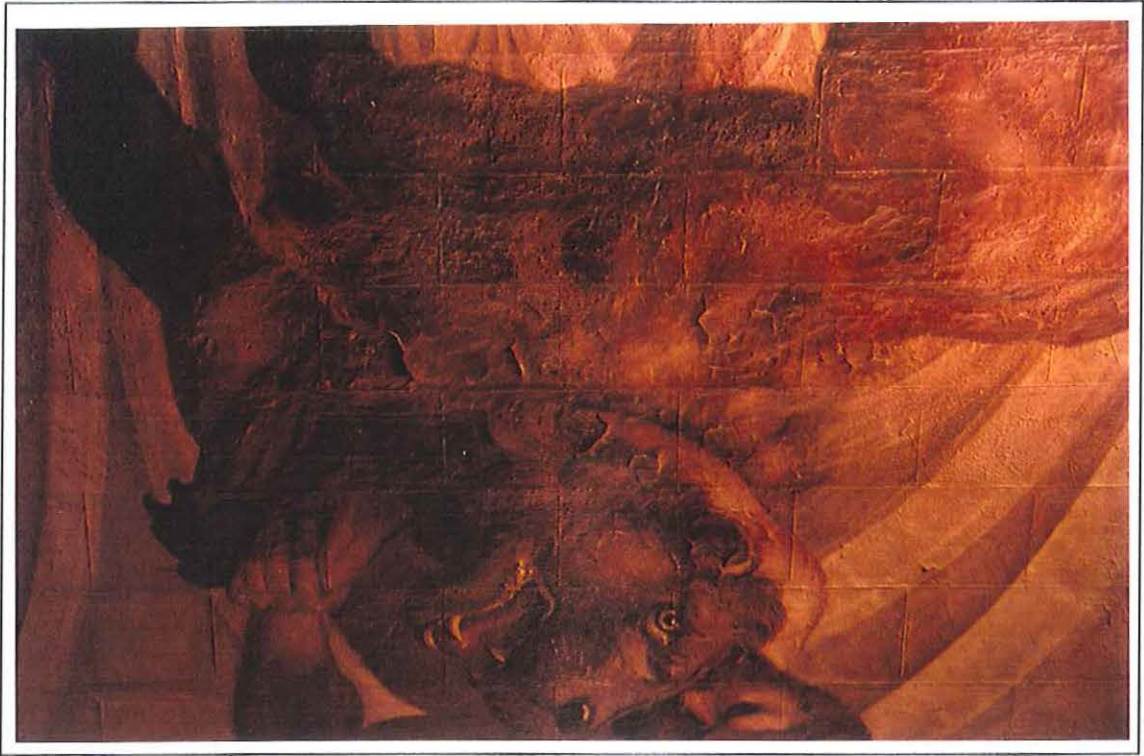
Hall, *Nemecan Lion* lunette, detail centre, in raking light

Comments 'Sheet' flaking of the paint layer and ground, especially on the 'Nemean Lion' scheme and the 'Cretan Bull' painting. This is particularly serious. Some of the delaminating areas measure up to 10cm and are raised by up to 1cm. There is also some fine cracking associated with these areas. This type of deterioration is not visible on photographs taken c. 1975 and may therefore be a new phenomenon, possibly associated with thickly applied varnish layer.

- surface cleaning to remove the obscuring layer of dirt and dust
- urgent fixing of the paint layer/ground on the 'Nemean Lion' and 'Cretan Bull' lunettes (other lunettes may require similar treatment following further examination at closer access)
- an extensive programme of environmental monitoring to assist in defining the underlying causes of deterioration

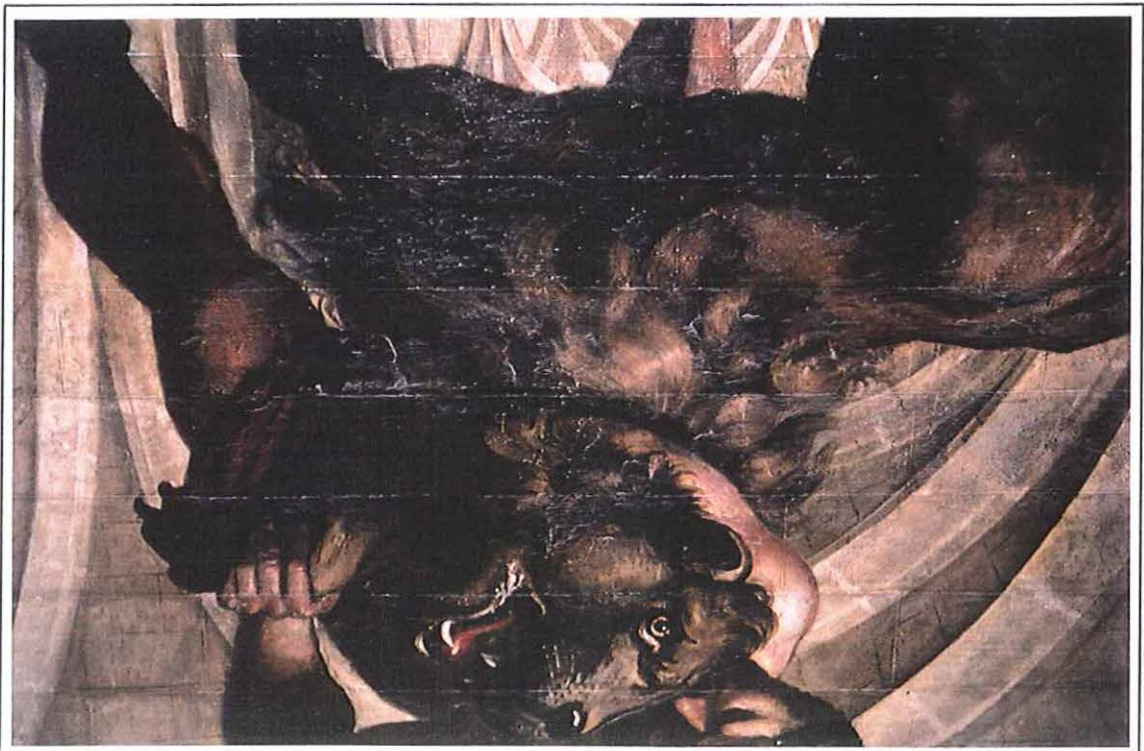
Hall, *Nemecan Lion* lunette, detail centre

Type cement
Location Visible at lower edge of 'Nemean Lion' lunette.
Comments A cement type repair is visible. More are probably present. Deep repairs were undertaken by a builder in 1976 (pers. comm. A. Buckley). See also past treatment.

Type modern plaster
Location Visible at lower edge of 'Nemean Lion' lunette.
Comments More are probably present. Surface repairs were undertaken by D.O.E conservators using 'Polyfilla' in 1976 (pers. comm. A. Buckley). See also past treatment.
