Ancient Monuments Laboratory
Report 22/97

WALL PAINTING CONDITION AUDIT,
GOODRICH CASTLE, HEREFORDSHIRE

J Davies
T Manning

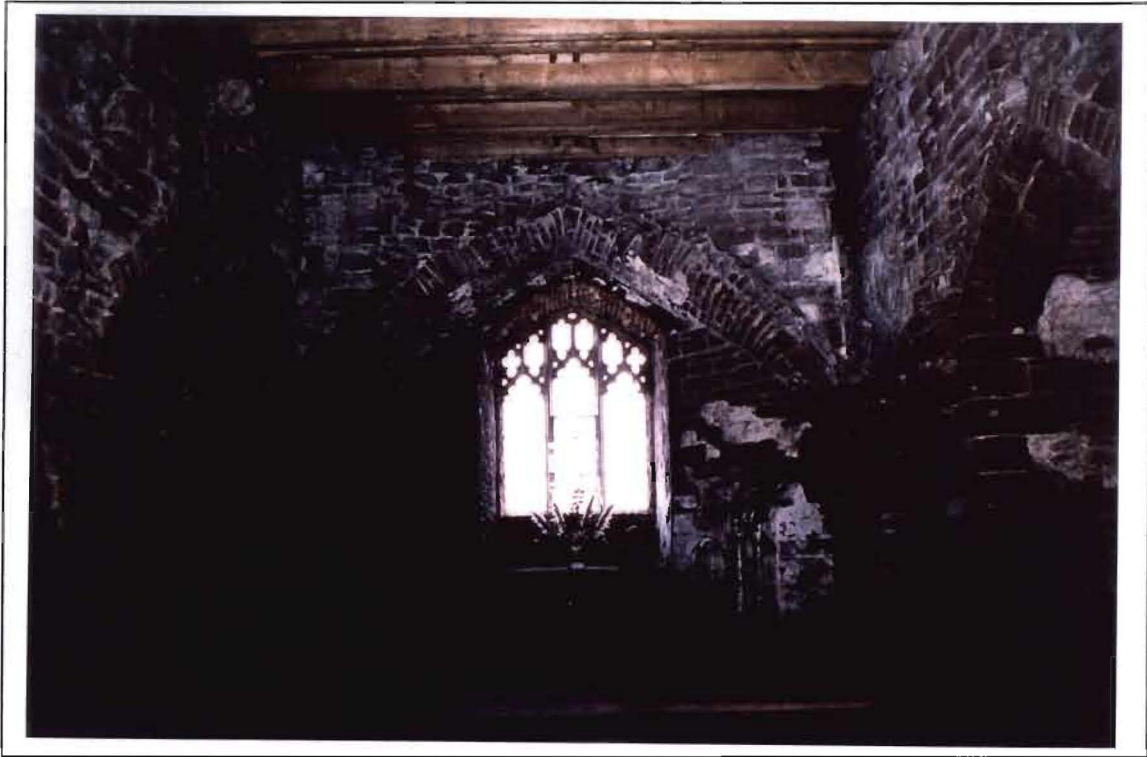
Chapel, general view to east

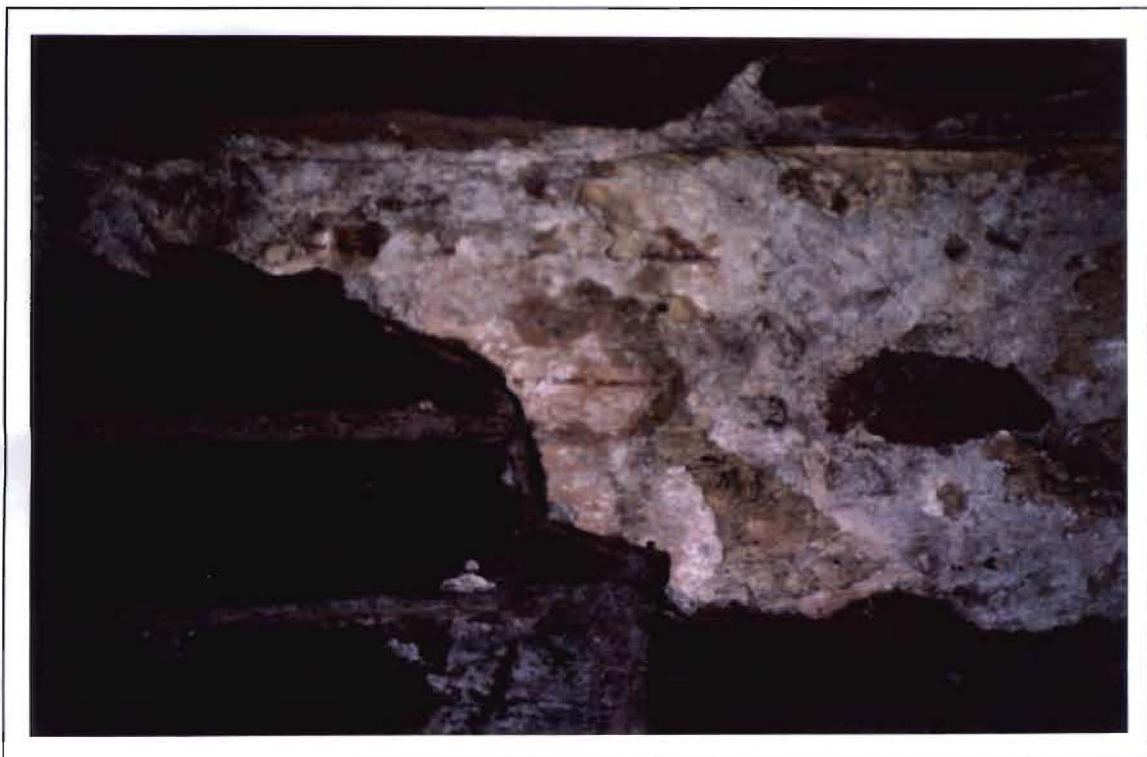
South wall, east window recess, soffit, remains of painted plaster
