Ancient Monuments Laboratory
Report 28/97

WALL PAINTING CONDITION AUDIT,
ARCHER PAVILION, WREST PARK,
BEDFORDSHIRE

J Davies
T Manning

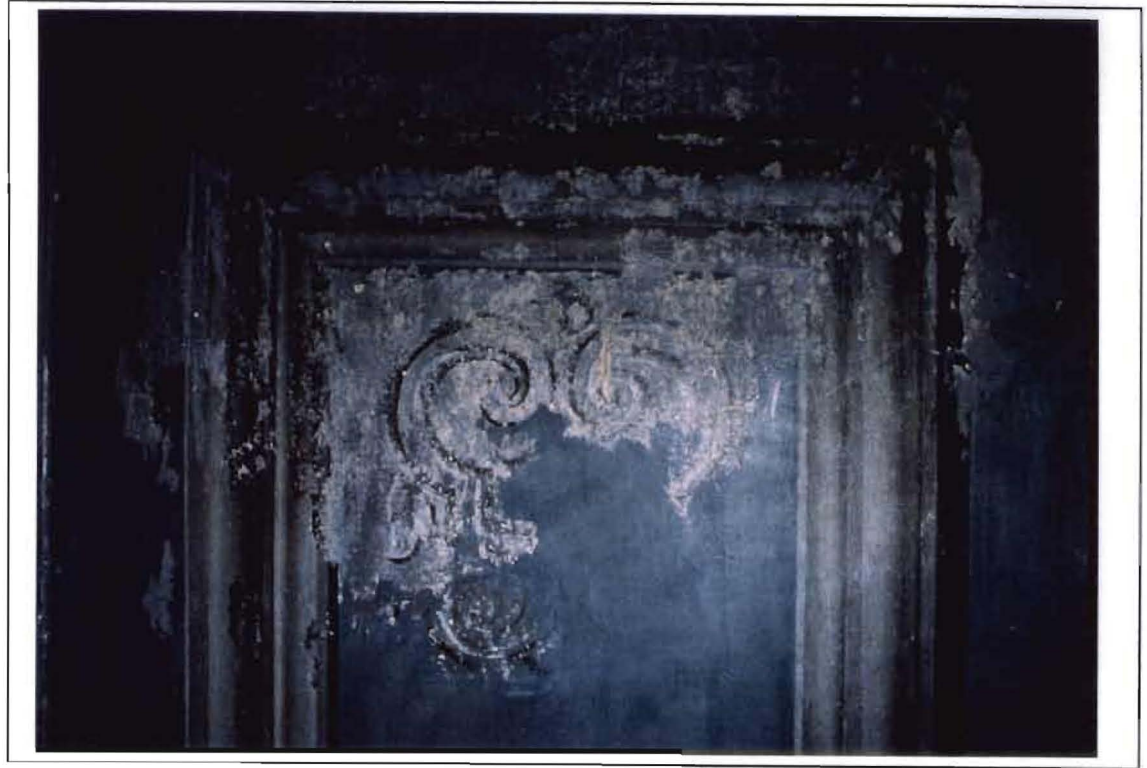
Heavily abraded paint layer. Entirely repainted, except for one area uncovered in 1990 (east side, lower part of northeast chamber). Medium probably oil. Original painted scheme in muted colours of brown on greyish-white.

Comments A small area on the north reveal of the arch leading to the northeast ante-chamber was uncovered during research undertaken by Helen Hughes in 1990. She stated: 'From the cross-sections I was able to identify an earlier paint scheme on the reveals leading into the small rooms on the ground [floor]. (This arabesque design was indicated below the existing overpaint when the wall was viewed in raking light). With the help of Caroline Babington, I have been able to reveal a small section of this design. The pattern is in brown on a white background.'

Northeast ante-room, north side, area uncovered in 1990
