Ancient Monuments Laboratory  
Report 26/97

WALL PAINTING CONDITION AUDIT,  
STOKESAY CASTLE, SHROPSHIRE

J Davies  
T Manning

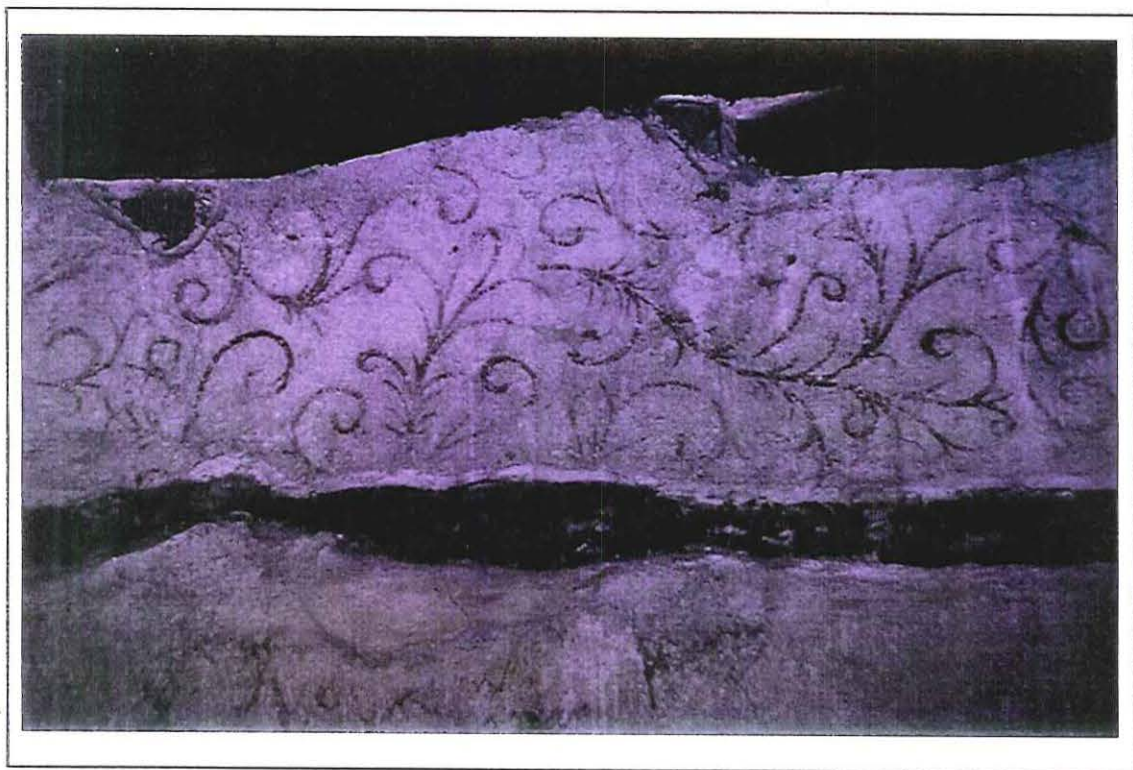
North Tower, basement, (Buttery), northwest wall

The room is damp, with biodeterioration present along the lower parts of the walls. However, the windows are unglazed and there may be adequate ventilation. Monitoring of the environmental conditions within the room and moisture movement within the walls may serve to highlight underlying causes of deterioration.

**Type** delamination (render layer)  
**Location** Render layer 1, W., N. and S. walls.  
**Comments** There are numerous hollow pockets at low level. Access was not possible at frieze height, however it is known that grouting of the upper area was undertaken in 1991 (Babington, 1991).

**Type** cracking  
**Location** Various, especially E. side S. wall and W. side, N. wall.  
**Comments** Render layers 1 and 2 have suffered cracking, apparently associated with delamination. Several of the cracks are hairline (and wider) and some may still be moving.

**Comments** There has been general loss due to weathering of the soft mudstone support, resulting in loss of render, ground and possibly paint (which may have only been applied to upper areas) from the lower walls. Old cement-type repairs now stand proud of the original stone support where the surface of the stone has been lost.

**Comments** Green algae is present on lower walls, probably indicating high moisture levels within the lower areas.

Some conservation treatment is required to secure lower areas of the painted plaster, preferably within the next few years. This should include insertion of repairs and grouting [Approximate timescale: 2-3 weeks].

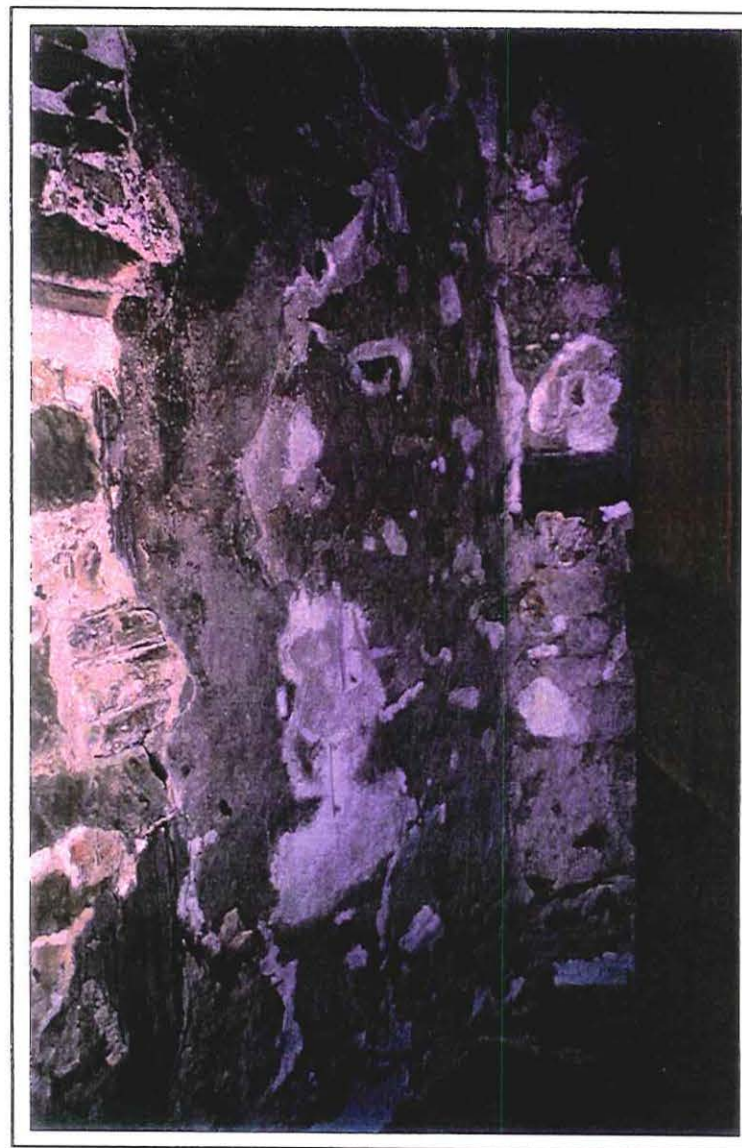
Interior, passage block, garderobe, east and southeast walls

The wall painting is currently being damaged by the impact of the door into the south east wall. It is opened and closed frequently by visitors and there is visual mechanical damage to the original plaster. This is potentially extremely serious but could be halted by the insertion of a door stop into the floor. It is therefore recommended that this is undertaken as a matter of priority.

**Comments** The current damage caused to the wall plaster by the impact of the door is potentially serious. This damage could easily be prevented by inserting a door stop in the floor slightly in front of the wall.

**Type** cement  
**Location** S.E. wall.  
**Comments** These cement-type repairs have dripped down the surface of the plaster. They are similar to those observed in the Buttery (North Tower, Basement) which were thought to be related to injection grouting.

Some conservation treatment is urgently required to clean and secure the painting. This would require one conservator (as the interior space is extremely limited) and should include surface cleaning, insertion of repairs, flake fixing and grouting [Timescale: 1-2 weeks].

Comments The wall painting is being damaged by the impact of the door into the delicate plaster of the S.E. wall. By introducing a (visually sympathetic) doorstep this potentially serious damage could be instantly halted.
