Ancient Monuments Laboratory  
Report 29/97

WALL PAINTING CONDITION AUDIT,  
BELSAY CASTLE, NORTHUMBERLAND

C Babington  
S Stewart

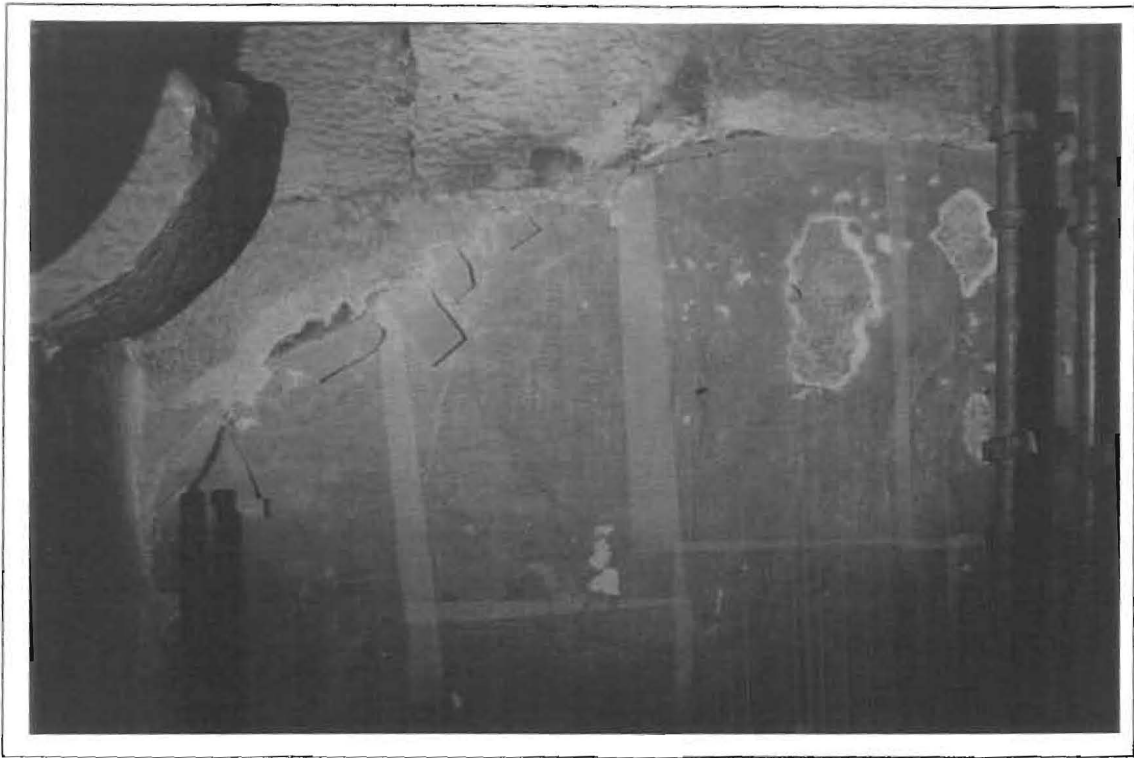
**Type** facing paper  
**Location** south and north walls  
**Comments** Applied over ship and heraldry scene. Note in Studio files (5 October 1981, A. Stanzyck?) states that 'the overriding priority at this stage should be the protection of the paintings to stop any further deterioration in their condition. This could be achieved by the application of a protective facing which could then be removed just before the final restoration takes place. I would suggest that the facing should be applied before any building work commences and not removed until it is complete. If there is to be major work, roofing etc. requiring scaffolding some more substantial form of protection, for example hardboard on a wooden frame erected approximately four inches from the face of the painting would be desirable'.

South wall, east side, naval scene, *before* removal of tissue facing and Polyfilla repairs, May 1996

**Comments** The tissue facing should be removed as part of an overall campaign of conservation.

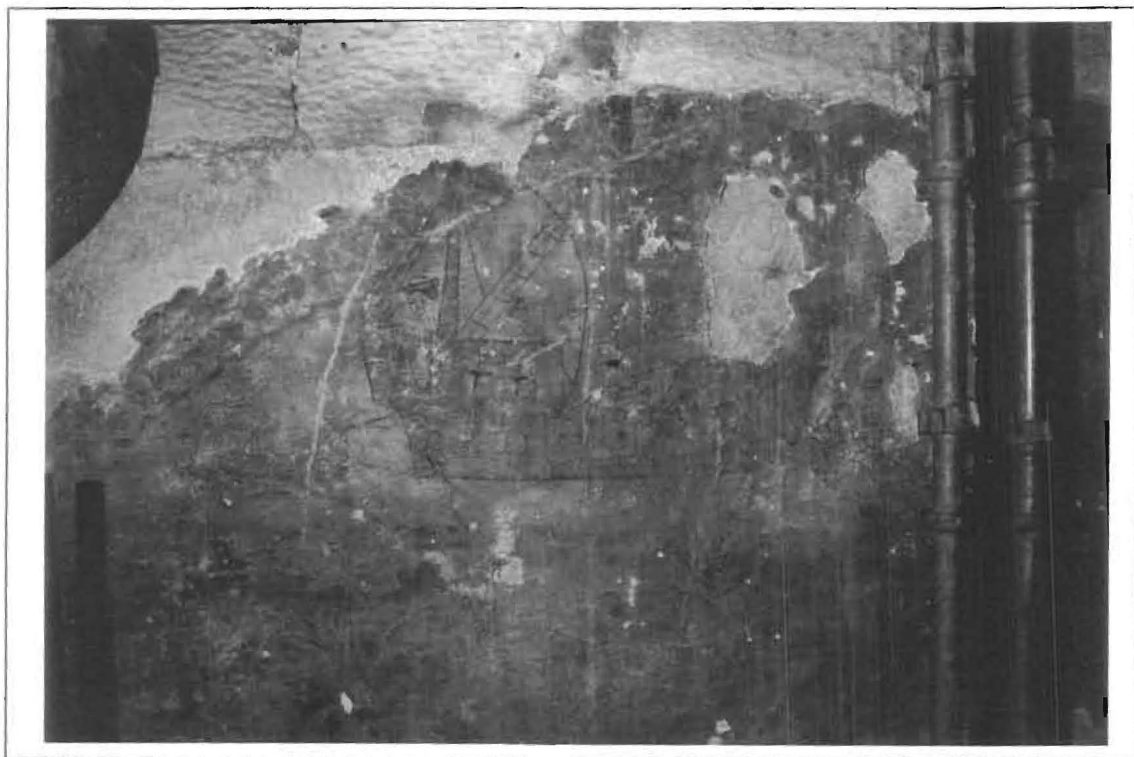
South wall, east side, naval scene, *after* removal of tissue facing and *during* removal of Polyfilla repairs, June 1996

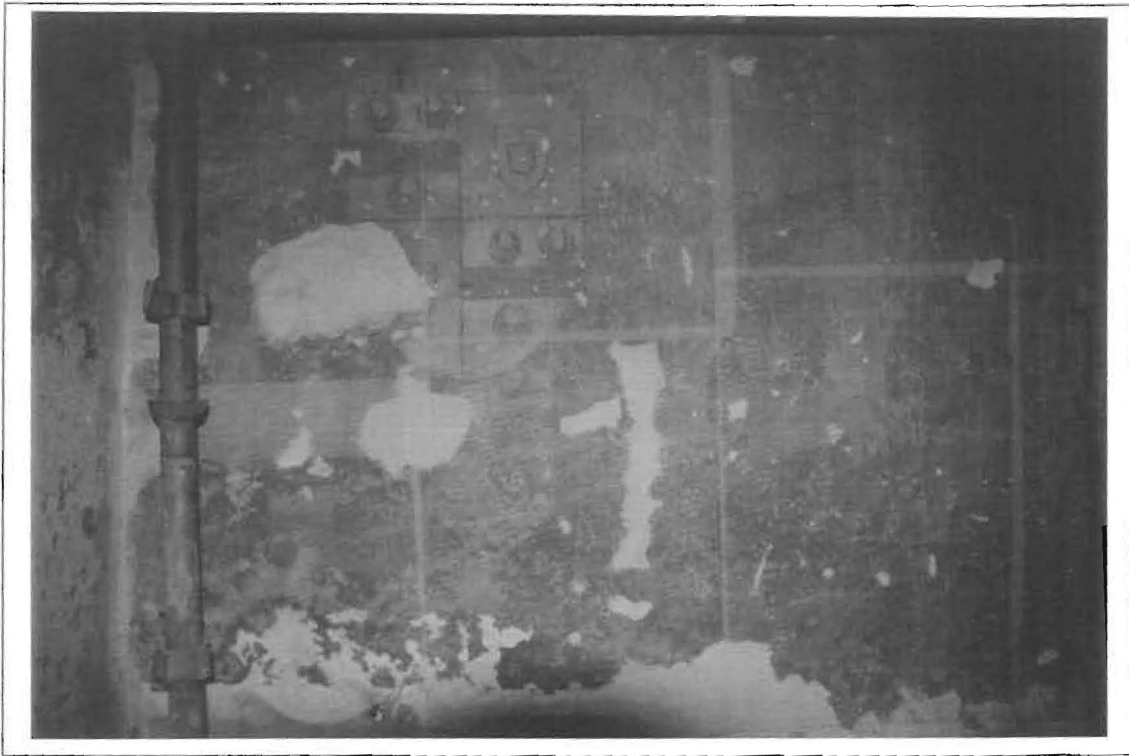
**Type** gypsum  
**Location** south and north walls  
**Comments** Plaster of paris or probably pollyfilla applied in the mid 1980s. All repairs have an untidy application and are unlikely to be functioning efficiently. Used as repairs for large losses throughout.

South wall, east side, area of fictive tapestry and heraldry, *before* removal of tissue facing and Polyfilla repairs, May 1996

**Comments** All of the plaster of paris and cement repairs should be removed and replaced with a more suitable material.

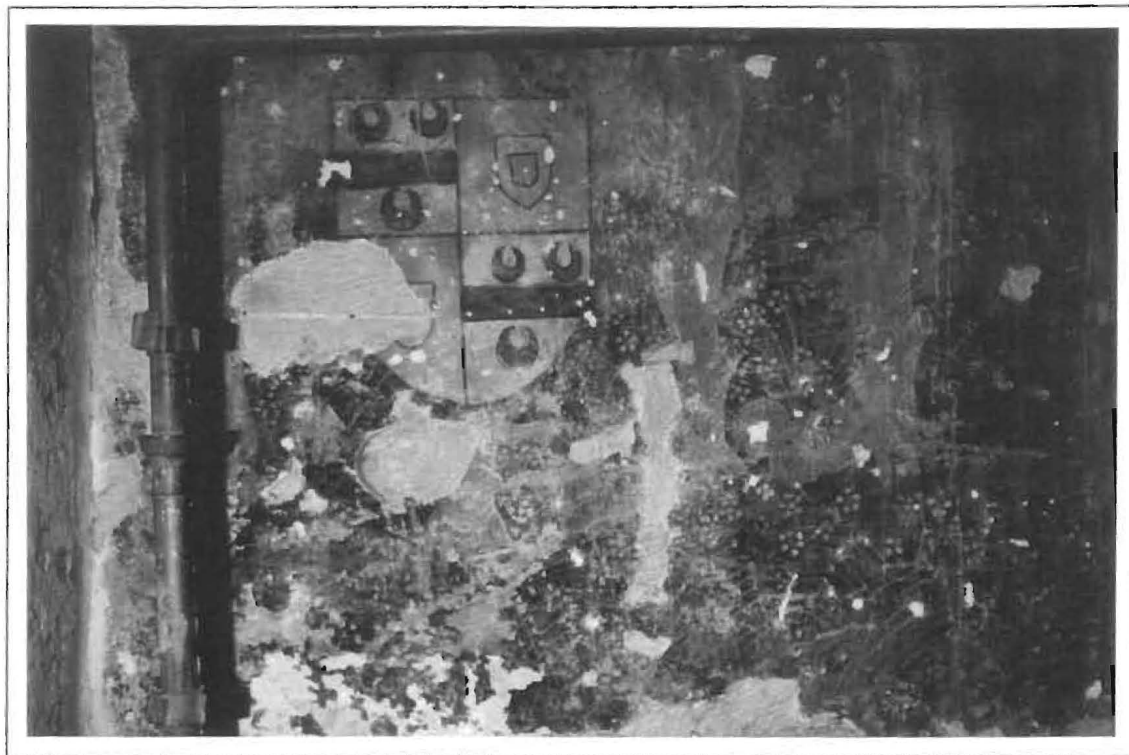
South wall, east side, area of fictive tapestry, *after* removal of tissue facing and *during* removal of Polyfilla repairs, June 1996
