Ancient Monuments Laboratory
Report 30/97

WALL PAINTING CONDITION AUDIT,
BRINKBURN PRIORY,
NORTHUMBERLAND

J Davies
T Manning

Property name	BRINKBURN PRIORY		
Region	North	County	Northumberland
Location of painting	North-west pier, crossing		
Orientation	SOUTH		
Century	17 th	Date	
		Height (cm)	75
		Width (cm)	50
Subjects included			
Text(s)

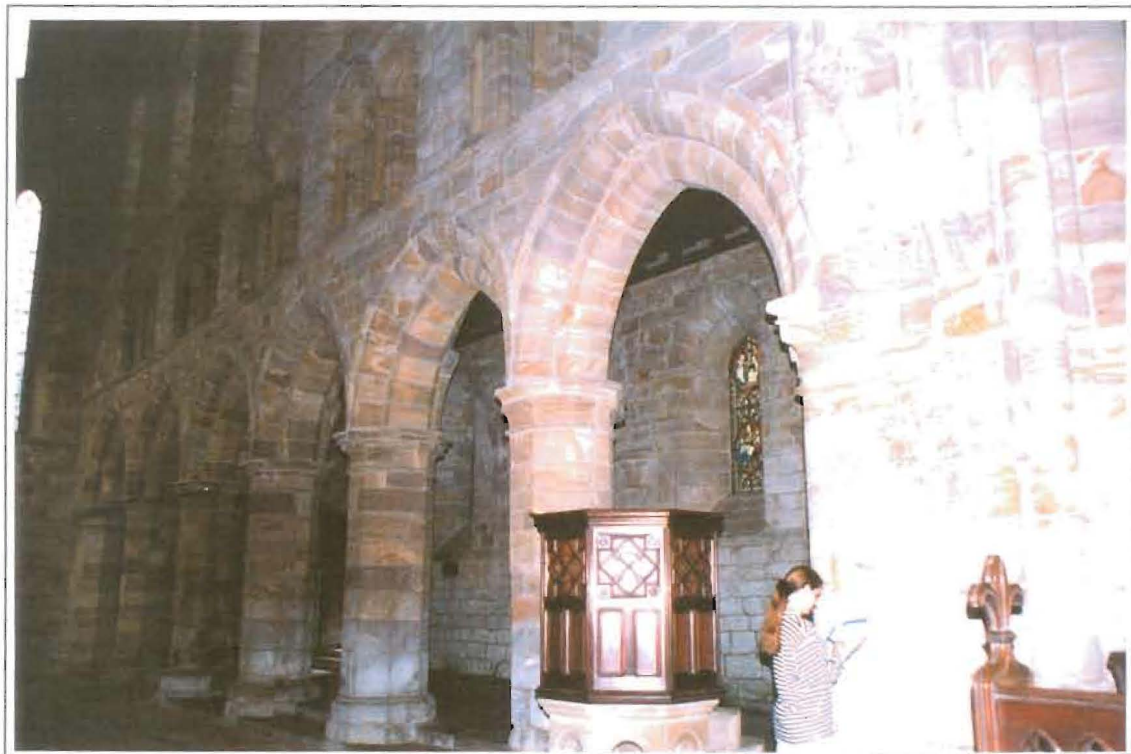
Nave, north side, looking northwest: fragment of painting located on NW pier of crossing, seen on right side of the photograph

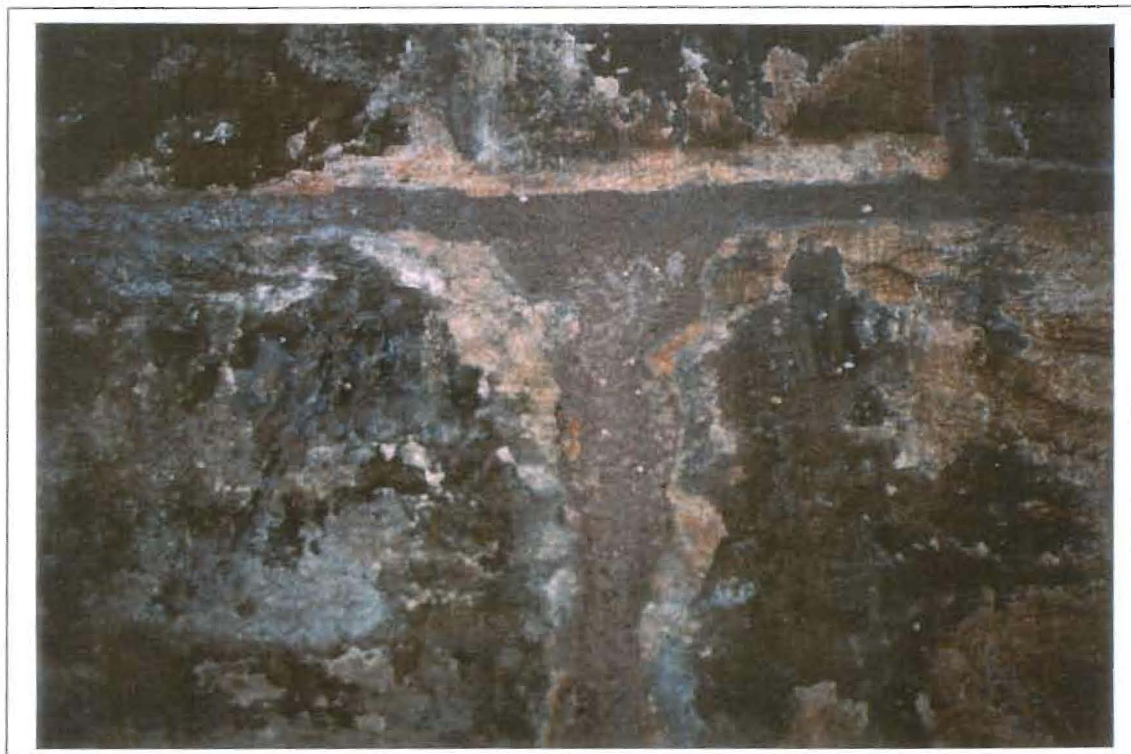
Fragments of black inscription are present. Sadly not enough of the paint layer remains for the inscription to be legible.

Comments Several areas of the limewash ground appear to be lifting, loose and in danger of flaking away from the support.

Comments A white efflorescence is visible. (The stone support and repointing are deteriorating due to spalling, powdering and blistering of the surface; this deterioration is possibly due to the presence of soluble salts.)

Comments The stone support and repointing are deteriorating due to spalling, powdering and blistering of the surface; this deterioration is possibly due to the presence of soluble salts.

Detail, NW pier, traces of painting,

Comments Some very minor edge repairs to vulnerable edges of the limewash ground are recommended.

Comments Some flake fixing of the limewash ground is recommended.

Comments Salt efflorescences are visible in areas on the surface of the support and painting. These could be carefully removed where possible.
