Ancient Monuments Laboratory
Report 31/97

WALL PAINTING CONDITION AUDIT,
BRODSWORTH HALL, SOUTH
YORKSHIRE

J Davies
T Manning

Brodsworth Hall

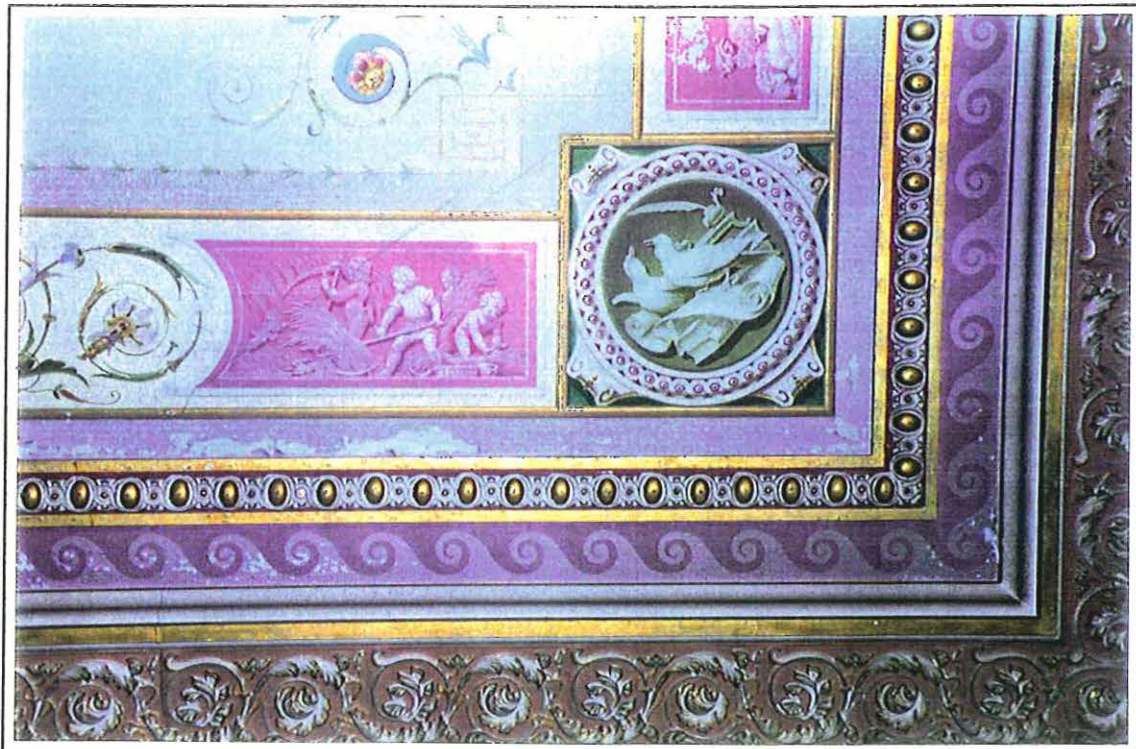
Drawing Room, ceiling, detail, before conservation in 1993

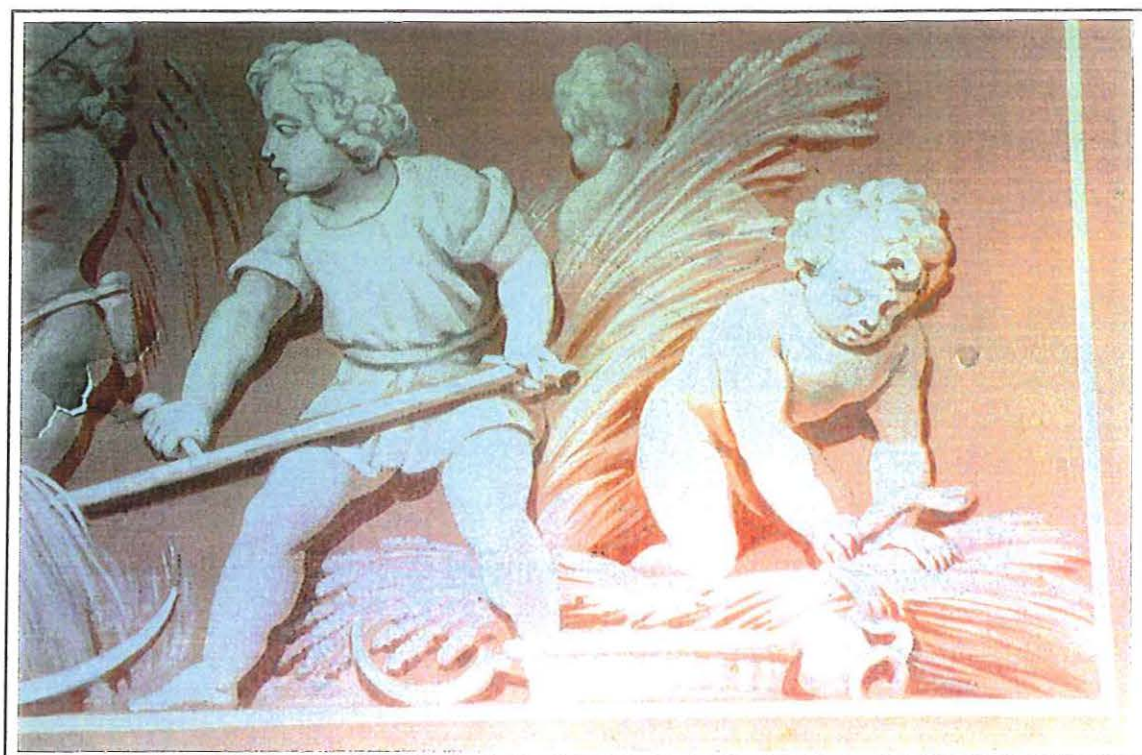
Drawing Room, ceiling, detail

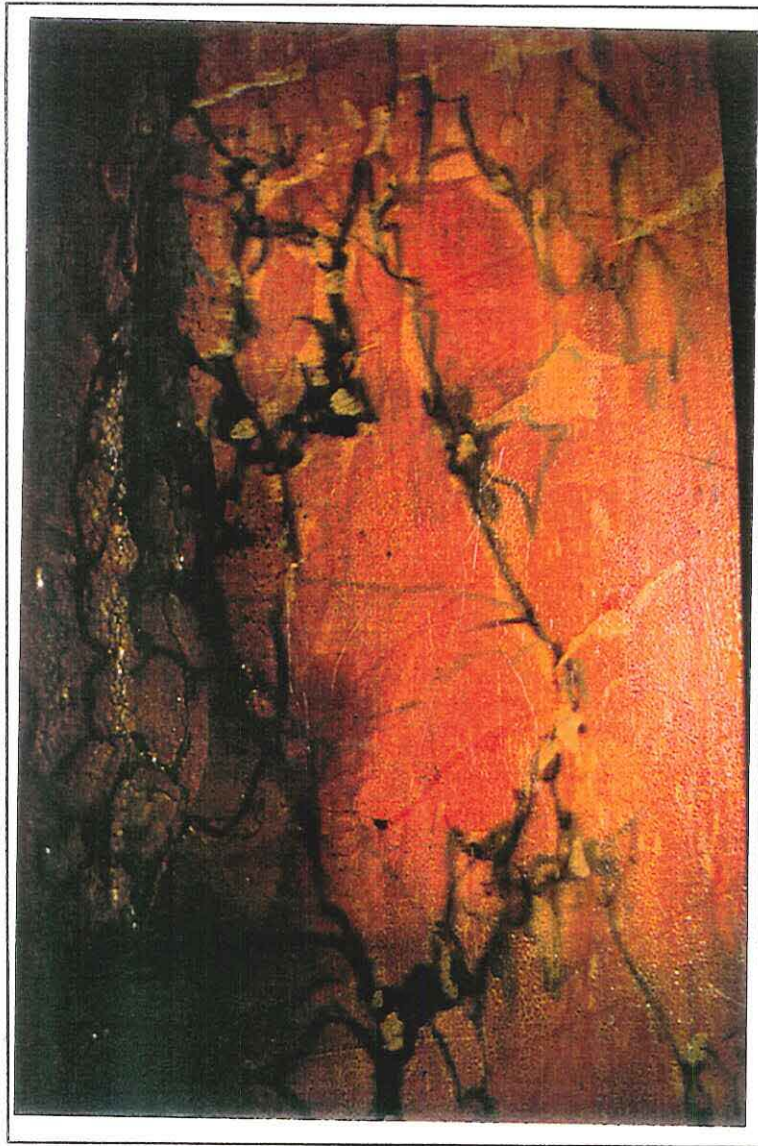
Entrance hall, detail of marbling

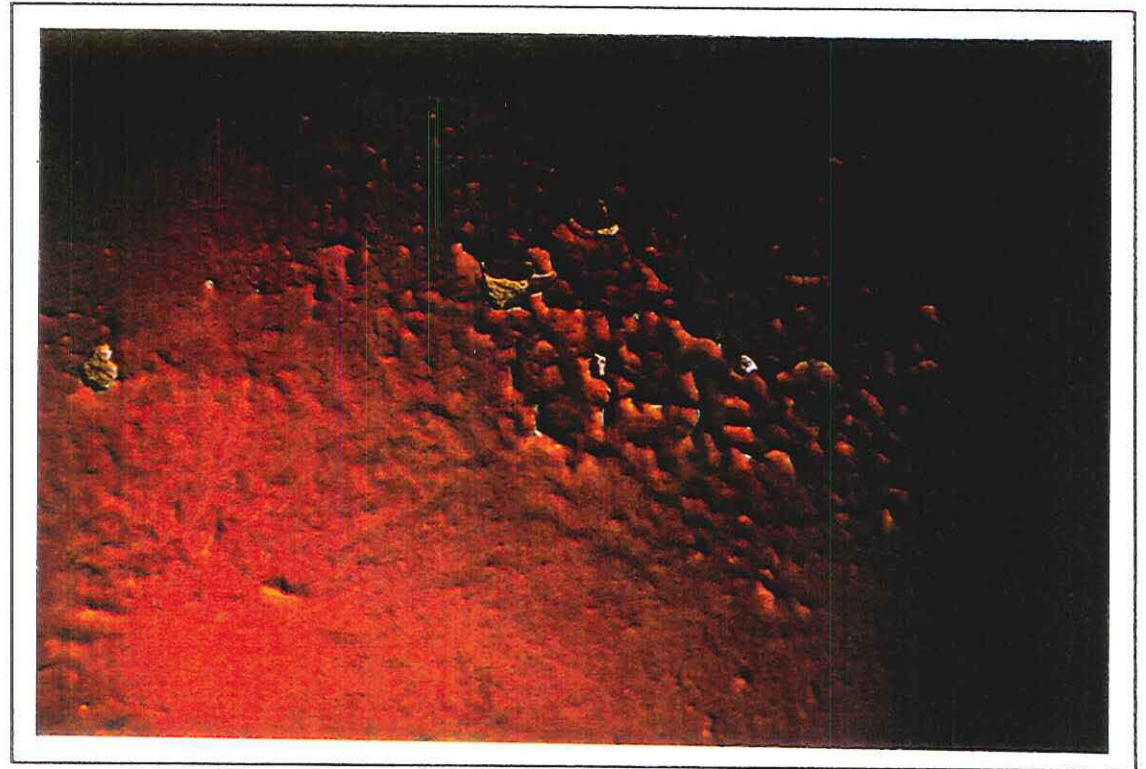
Comments Areas of flaking were fixed c. 1993-4, obviously further deterioration has occurred, indicating that the underlying cause is still active. Further flake fixing to the following areas is required:

GC1- S. and E. walls; FC1- S. and E. walls; FC3 - N. wall below windows; FC9 - E. wall; FC10 - W.wall, N.end (n.b. wood graining to door rebate to Bedroom 15); GC8 (stairs to FC8) N. and S. walls; GC9 - E. wall, above and S. of lift door.

First floor, corridor, detail of typical flaking found throughout the marbled decoration, in raking light

Further flake fixing to the following areas is required: GC1- S. and E. walls; FC1- S. and E. walls; FC3 - N. wall below windows; FC9 - E. wall; FC10 - W.wall, N.end (n.b. wood graining to door rebate to Bedroom 15); GC8 (stairs to FC8) N. and S. walls; GC9 - E. wall, above and S. of lift door.[Timescale: 2 conservators, 4 weeks].
