Ancient Monuments Laboratory  
Report 35/97

WALL PAINTING CONDITION AUDIT,  
FINCHALE PRIORY, DURHAM

J Davies  
T Manning

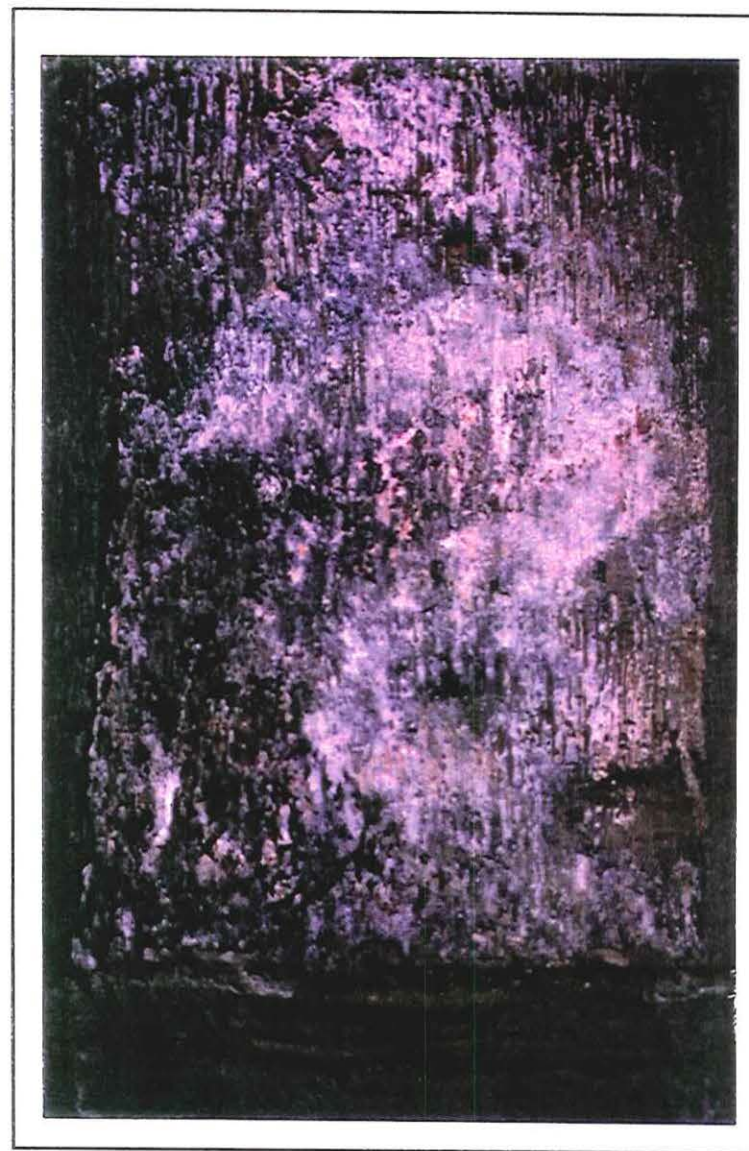
The paintings have deteriorated significantly over the past 70 years, and as of the August 1995 audit only the chevron pattern (on the first pier) and part of a roundel (on the second pier) was barely visible.

Detail, embedded column with traces of red chevron pattern
