Ancient Monuments Laboratory
Report 36/97

**WALL PAINTING CONDITION AUDIT,
FURNESS ABBEY, CUMBRIA**

Property name	FURNESS ABBEY		
Region	North	County	Cumbria
Location of painting	Chapter house vestibule		
Orientation	NORTH-WEST		
Century 13 th	Date	Height (cm) 20	Width (cm) 20
Subjects included			
masonry pattern, double-line

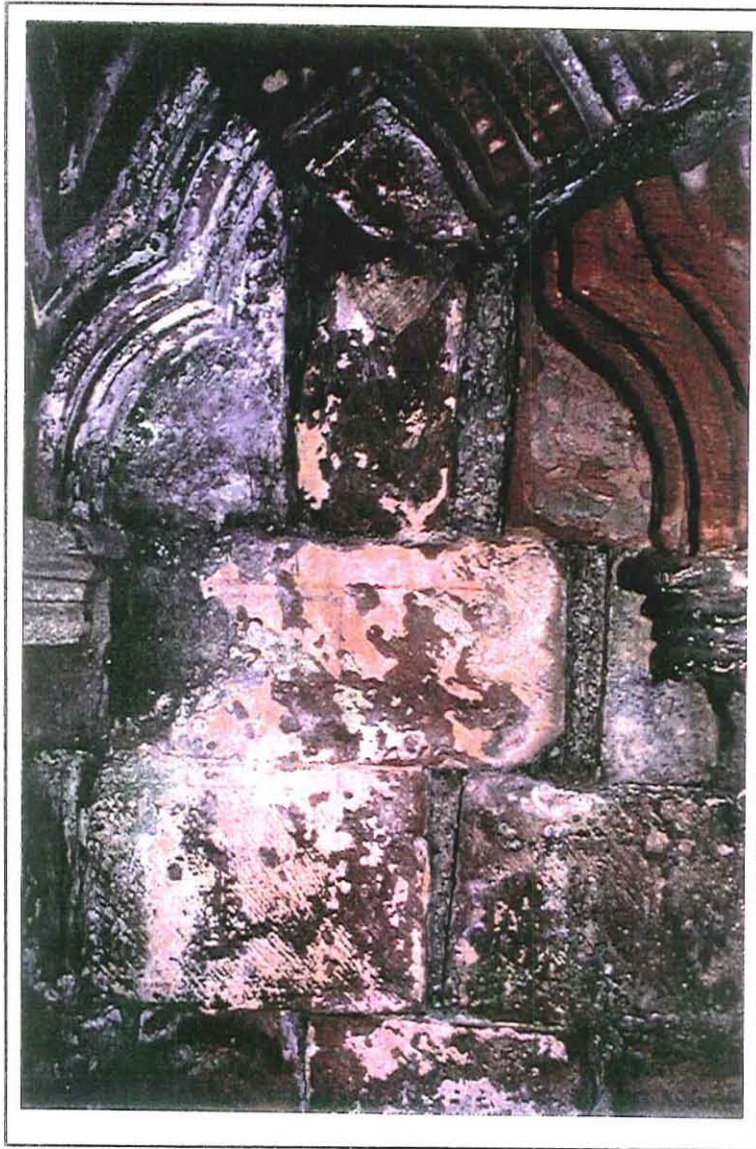
Vestibule into Chapter House, northwest blind arcade, north side

The red sandstone support is in poor condition. Efflorescent salts are visible over many areas and the stone itself is spalling and eroded. The remains of painted surface are fragmentary and the paint is only present where the walls are relatively sheltered. The pointing has been much repaired with hard unsuitable cement-type mortar, which now stands proud of the eroded stone in many places.

The fragments of masonry pattern are in poor condition and urgently require remedial conservation treatment. (In addition the stone support is in poor condition and could also benefit from conservation.)
[Time scale: 2 conservators, 1-2 weeks, as soon as possible].

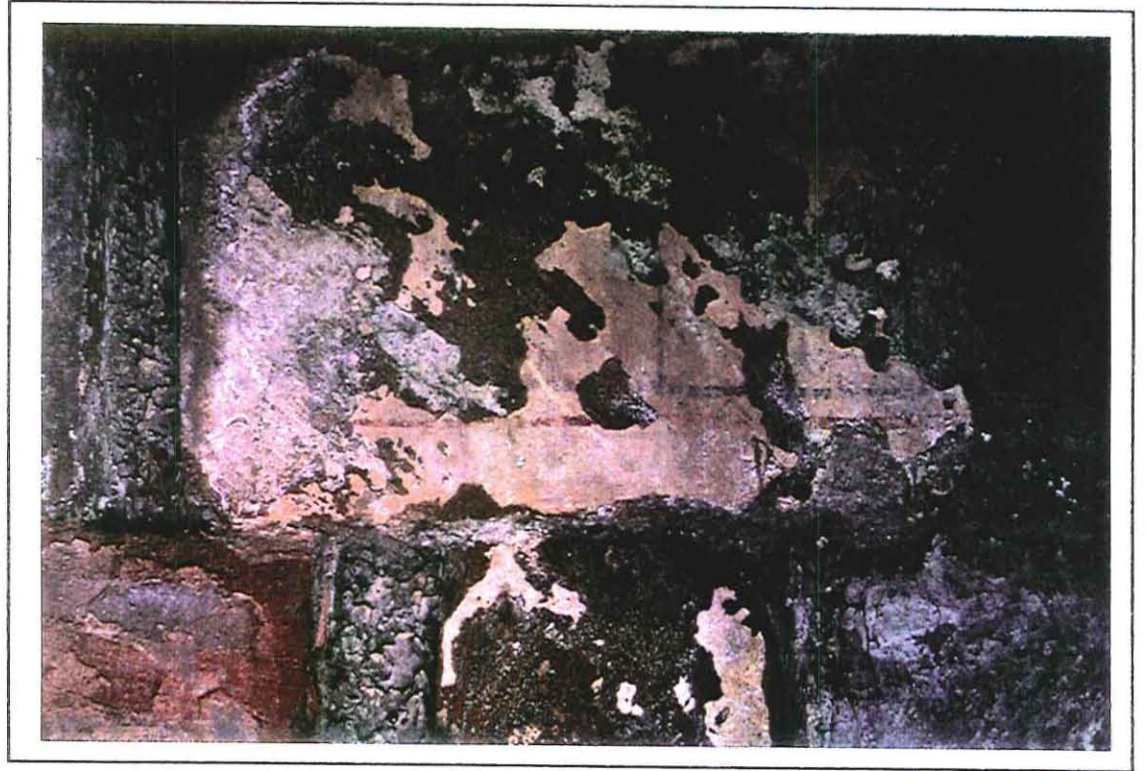
The paint layer is fragmentary but appears to comprise red and black double-line masonry pattern, with red rosette ornamentation.

Comments Extensive and severe flaking has occurred and still appears to be active. Flaking is probably associated with cycles of salt crystallisation. White cubic crystals are visible in areas of paint loss due to flaking.

Detail, masonry pattern within northwest blind arcade

Comments Flake fixing of the limewash ground and paint layers is urgently required.
