Ancient Monuments Laboratory
Report 39/97

**WALL PAINTING CONDITION AUDIT,
ROCHE ABBEY, SOUTH YORKSHIRE**

J Davies
T Manning

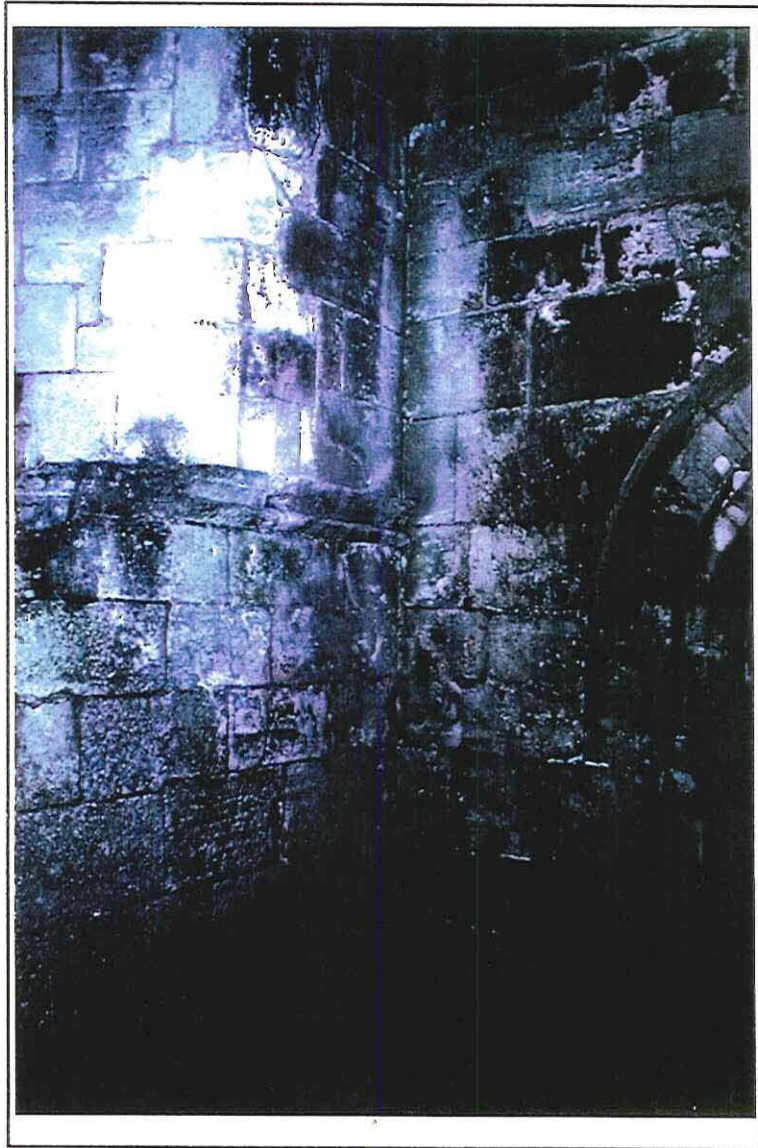
North transept, southeast corner, general view

This is an extremely exposed site which survives as a ruin. The limestone fabric is heavily weathered and there is extensive lichen growth. However, it appears to be well-maintained, with lead caps on much of the stonework, and several tell-tales throughout the site to monitor structural movement.

Comments Exposed structure which survives as a ruin. Directly affected by driving rain and wind. This has caused a general erosion of the pointing and support. The paint, where it does survive, adheres better to the pointing than to the support (which appears to be more vulnerable).

Comments Green microbiological growth and lichen throughout support. Elsewhere in the north transept, at the base of the walls, there exists more fully-developed algae and moss.

Comments The existence of these scant remains of painting has been recorded, and the fragments photographed. The custodian should be made aware of their existence, in order to ensure their safety during building repairs. However, the remains are now purely of archaeological interest, and as long as they are recorded properly, do not warrant any conservation treatment.

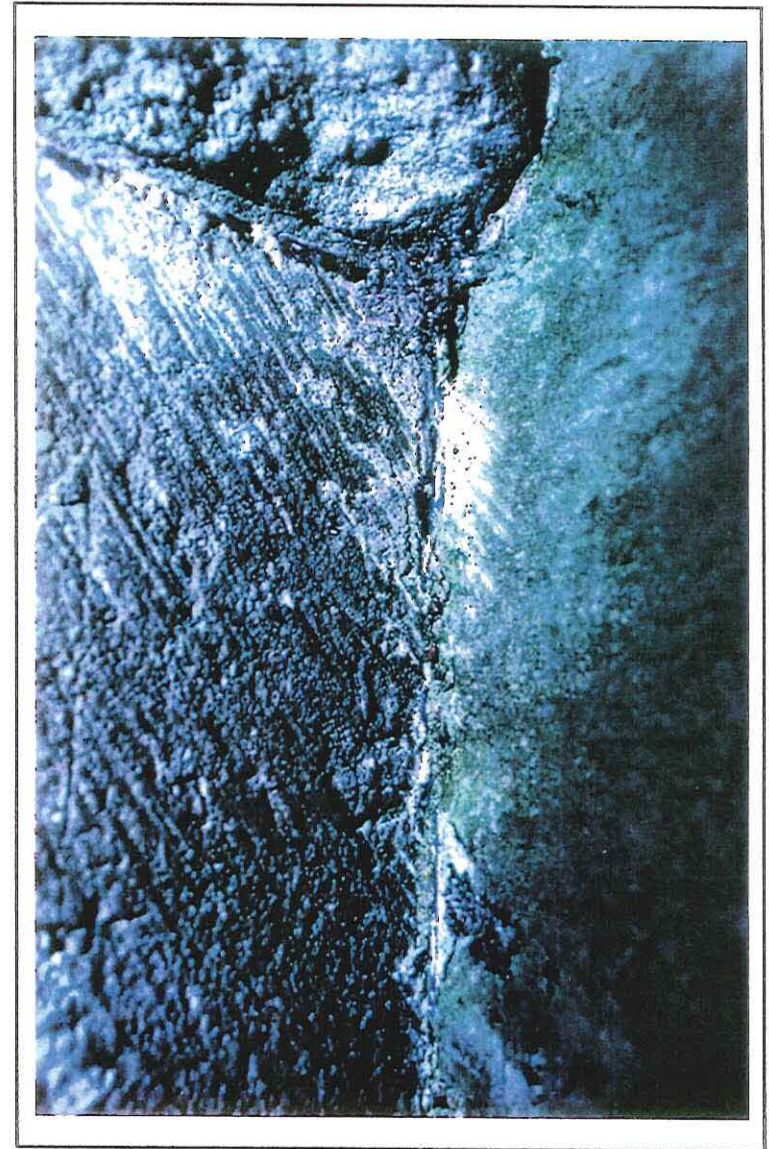
Minute traces of decoration survive in the north transept, within the southeast corner of the southern chapel. These consist of late 12th- or early 13th-century single black line masonry pattern. This was recorded in the 19th century, and again noted by D. Park in 1981. However, little now survives (D. Park noted traces of red as well but these are no longer visible).

Black paint visible.

Detail, traces of single black-line masonry pattern
