Ancient Monuments Laboratory  
Report 41/97

WALL PAINTING CONDITION AUDIT,  
TYNEMOUTH PRIORY, TYNE AND  
WEAR

J Davies  
T Manning

<b>Property name</b>	TYNEMOUTH PRIORY		
<b>Region</b>	North	<b>County</b>	Tyne and Wear
<b>Location of painting</b>	Percy chantry vault		
<b>Orientation</b>	CEILING: NORTH, SOUTH, EAST, WEST		
<b>Century</b> 19 <sup>th</sup>	<b>Date</b>	<b>Height (cm)</b>	<b>Width (cm)</b> 300
<b>Subjects included</b>	Various decorative motifs

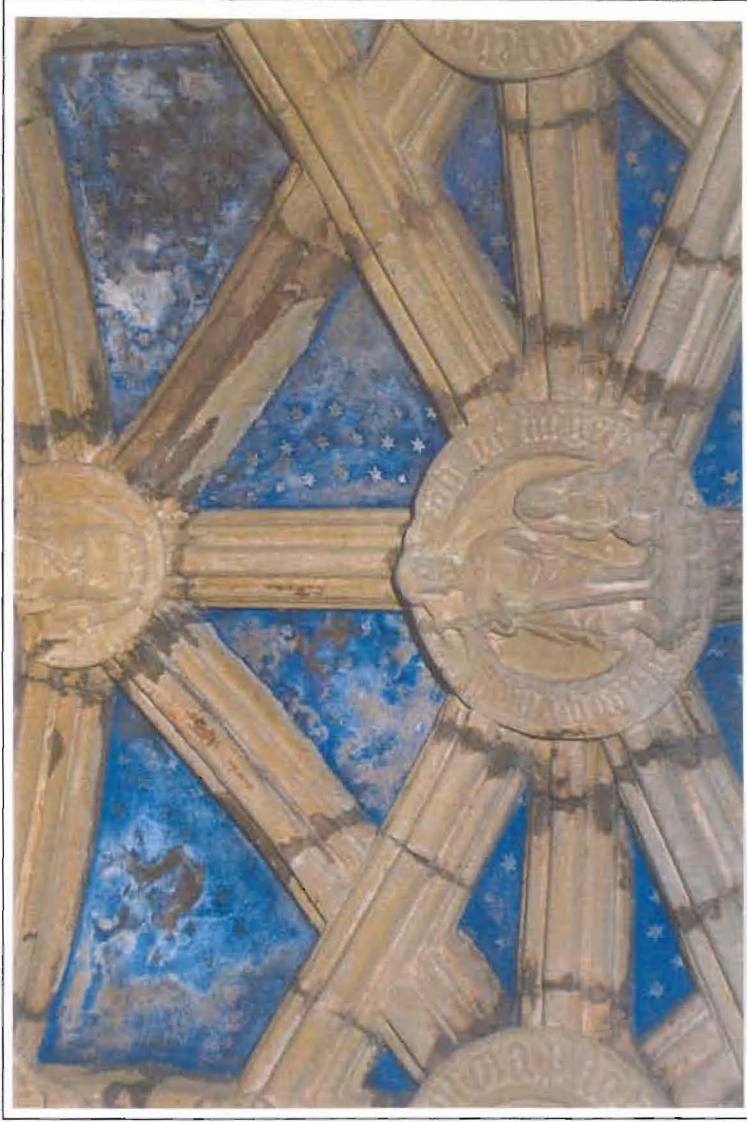
Detail, painted decoration between ribs

The scheme consists of a bright purple/blue field (possibly cobalt, or French ultramarine) upon which silver stars are scattered.

**Type** flaking  
**Location** general, paint layers 1 and 2  
**Comments** Much loss has occurred due to flaking which appears to be still active.

**Type** loss of cohesion  
**Location** general, paint layers 1 and 2  
**Comments** The surface of the paint layers has a soft 'powdery' appearance in many areas. If the paint layers have lost cohesion it may result in loss of pigment particles.

**Comments** Paint layers 1 and 2 require consolidation in several areas.

**Comments** Paint layers 1 and 2 require flake fixing in several areas.
