Ancient Monuments Laboratory
Report 43/97

WALL PAINTING CONDITION AUDIT,
BATTLE ABBEY, EAST SUSSEX

J Davies

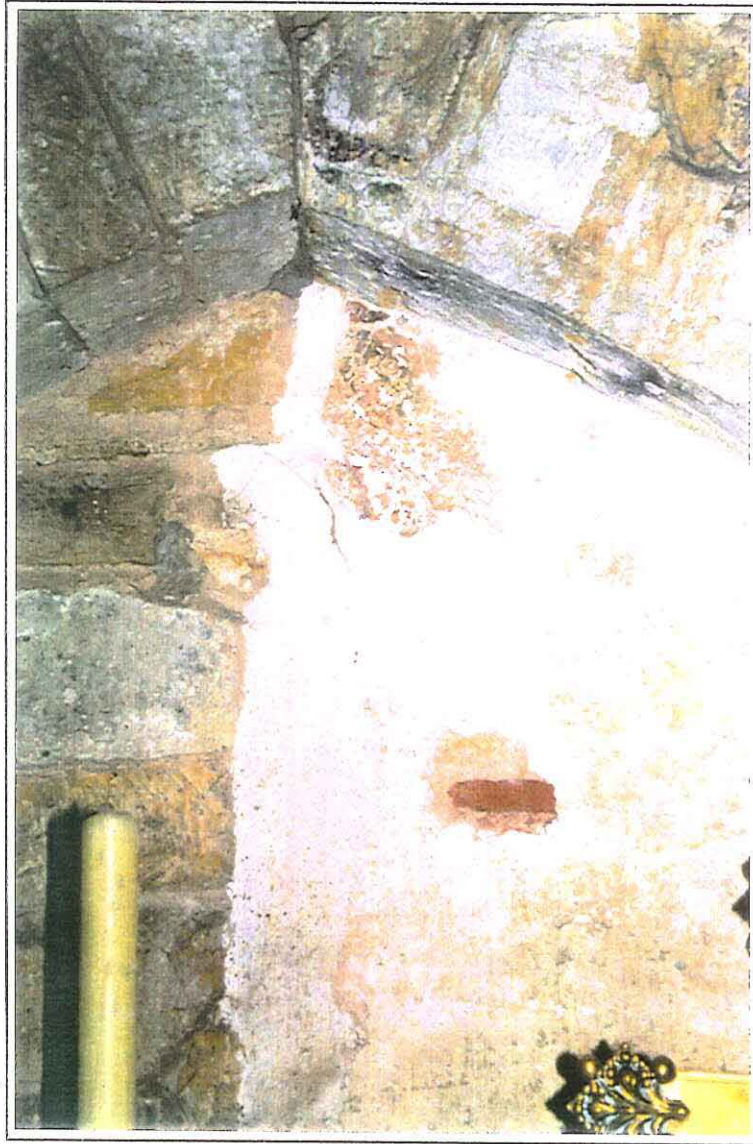
Abbot's chapel, east wall, altar recess

Red and yellow earth, black and white pigments appear to be present. Paint layer is discoloured, brown and flaking, which obscures the original pattern.

Comments The paint layer is suffering from extensive and severe flaking.

Comments The plaster support is bulging from the wall, and several losses of plaster have occurred.

Comments Cracking appears to be associated with delamination of the render layers and consequent movement.

Comments There are two holes through render layers below the remaining area of paint which appear to be the result of the insertion of nails, possibly for hanging of decorations.

Comments Hard, dense and dark grey repairs appear to have been carried out in cement to apex of arch soffit and general area.

Fixing of flaking paint, grouting and edge repairs to delaminating plaster are urgently required [Time scale: 2 conservators, 1 week, within 3 years].

Comments East wall, altar recess: flaking paint is in a fragile condition and requires consolidation urgently.

Comments East wall, altar recess: grouting to refix the delaminating plaster renders to the support is required. However, the paint layer is in a very fragile condition and consolidation of the paint layer is recommended before any grouting is initiated.

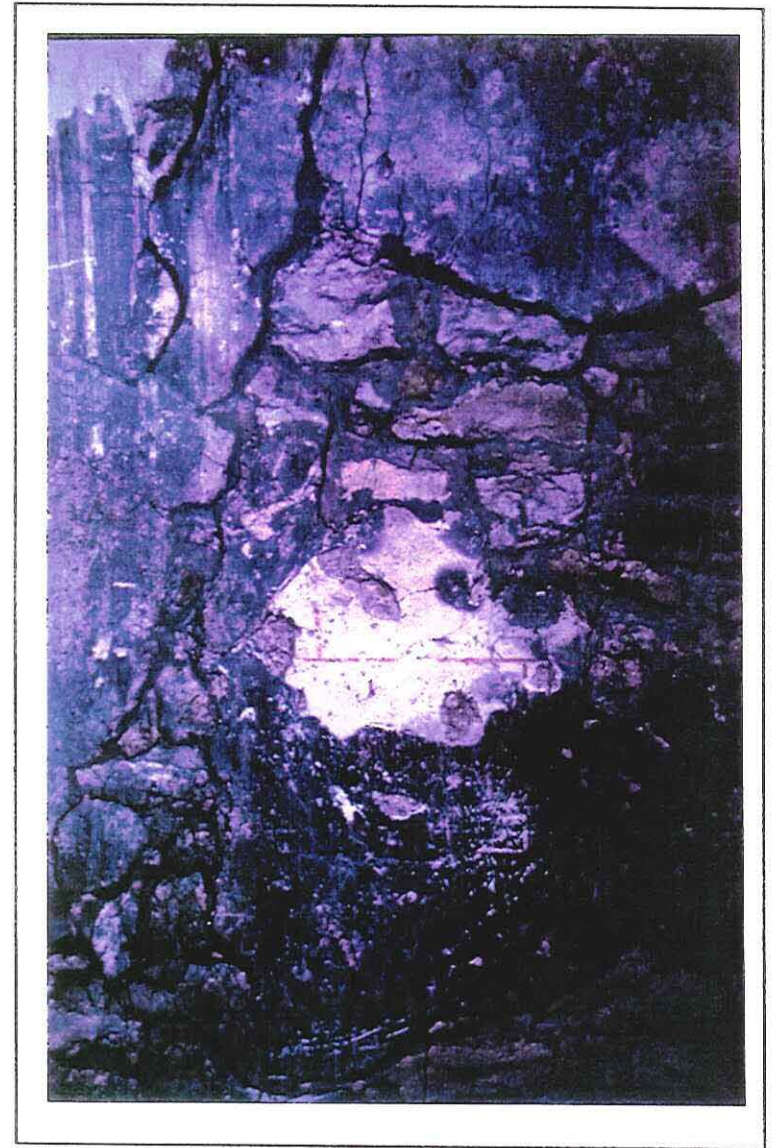
Abot's chapel, north wall, overall view of masonry pattern

The support has very obvious repairs and repointing in a grey mortar, possibly cement. Several areas of early plaster still remain. No original pointing is visible.

Red masonry pattern.

Comments General wear and tear probably accounts for abrasion and minor scratches on plaster surface.

Comments Edge repairs and repointing have been carried out in what appears to be a cementitious mortar.

Further areas of masonry pattern probably exist below smoke deposits, limewash and repairs and uncovering tests may reveal the extent of painted decoration. In the meantime further edge repairs are required to remaining early plaster. Light surface cleaning could also improve the appearance of the painting [Timescale: 2 conservators, 1 week, within 3 years].

Comments North wall: examination and trial uncovering tests may reveal further areas of painted decoration.
