Ancient Monuments Laboratory  
Report 44/97

WALL PAINTING CONDITION AUDIT,  
BAYHAM ABBEY, EAST SUSSEX

J Davies

This condition audit of wall paintings at Bayham Abbey includes a wall painting record, general audit information, documentation of original materials and execution of the painting, and deterioration and damage including previously used materials and treatment, as well as proposals for treatment and monitoring strategies.

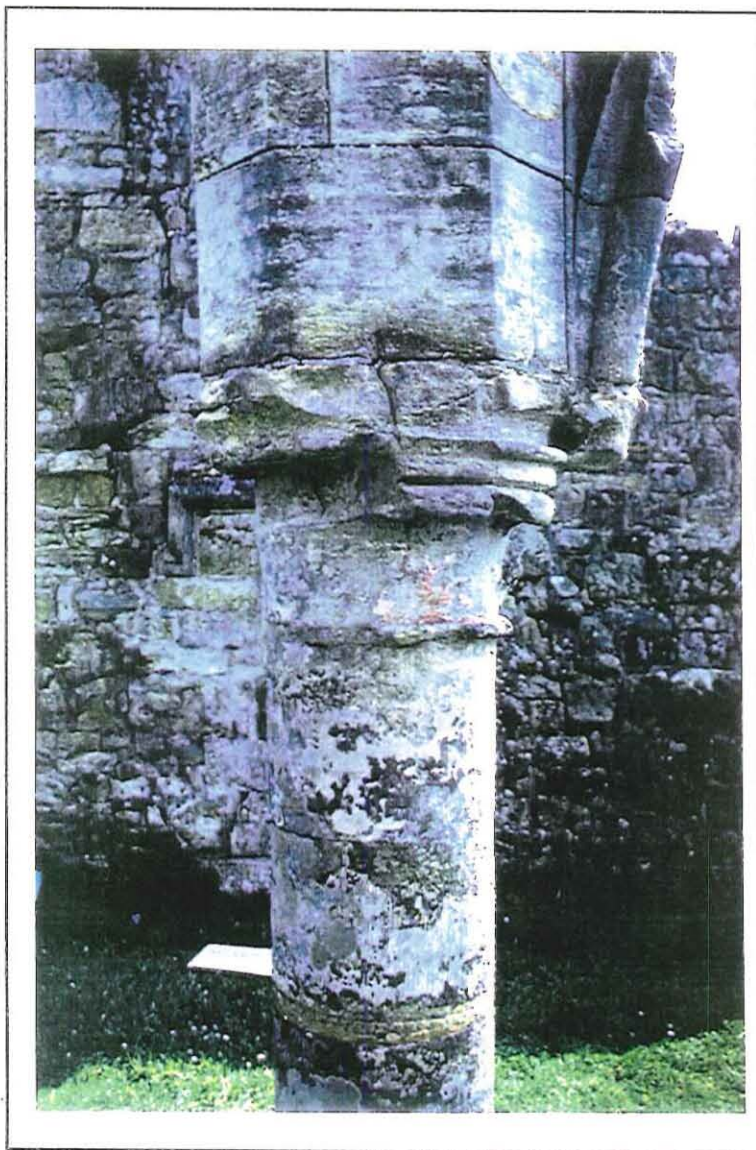
Courtauld Institute files (5/90) record traces of red pigment on the capitals in the chapter house. These were still in situ during the current audit (7/94). The capitals are picked out with red and black over white limewash. There are eight main areas of fragments, and paint survives mainly in the recesses of carved elements.

Chapter house, central arch, corbel with traces of red pigment

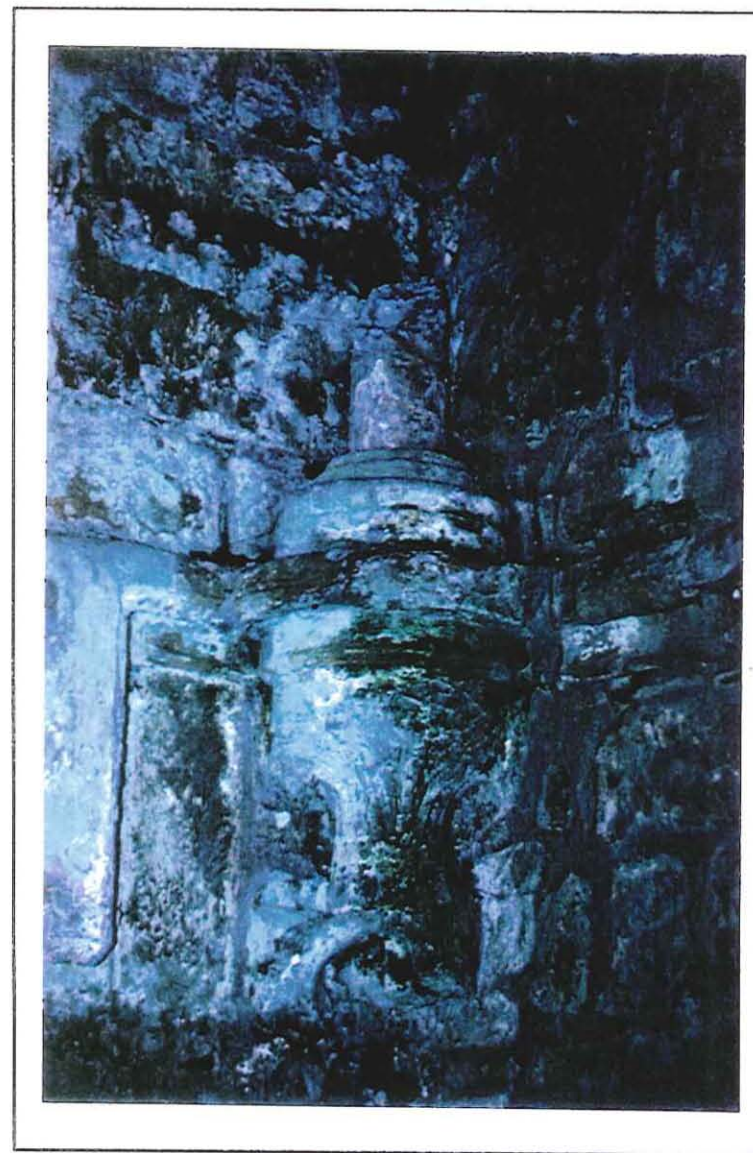
New north transept, south chapel, traces of pigment on pillar base
