Ancient Monuments Laboratory
Report 47/97

WALL PAINTING CONDITION AUDIT,
FORT CUMBERLAND, HAMPSHIRE

T Manning
S Stewart

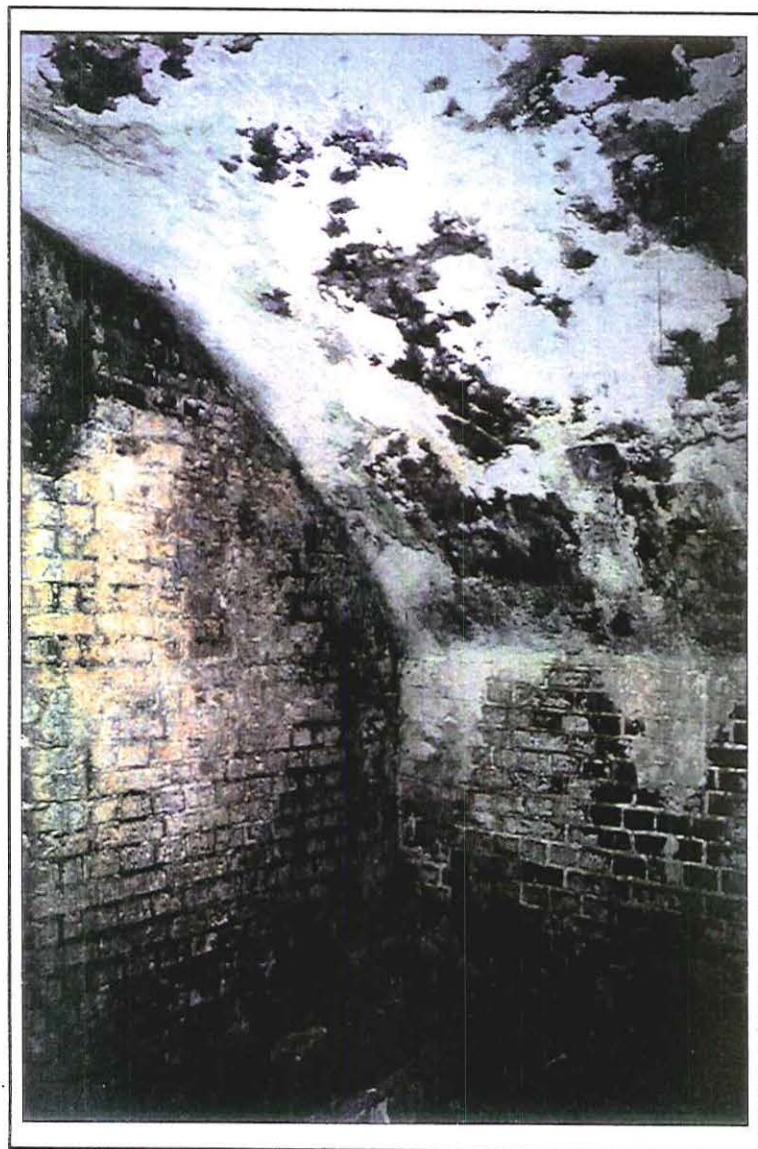
Detention block, general view of corner with inscription

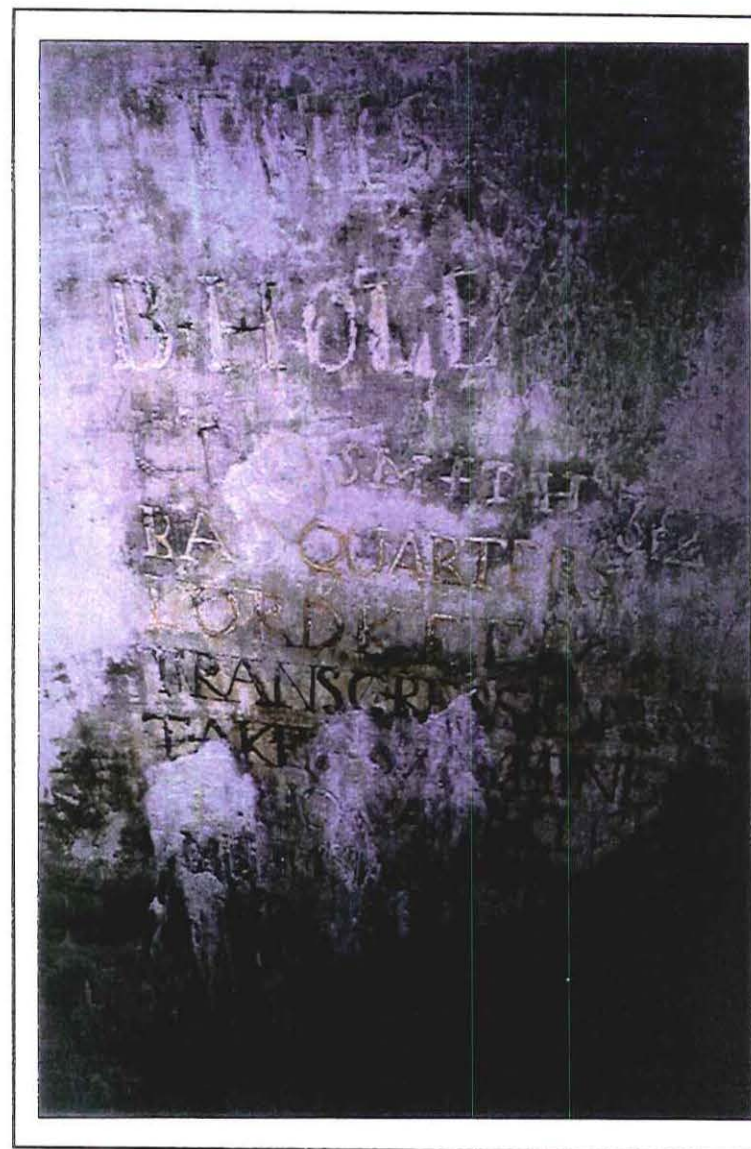
Detail, incised inscription
