Ancient Monuments Laboratory  
Report 48/97

WALL PAINTING CONDITION AUDIT,  
HURST CASTLE, HAMPSHIRE

T Manning  
S Stewart

**Summary**

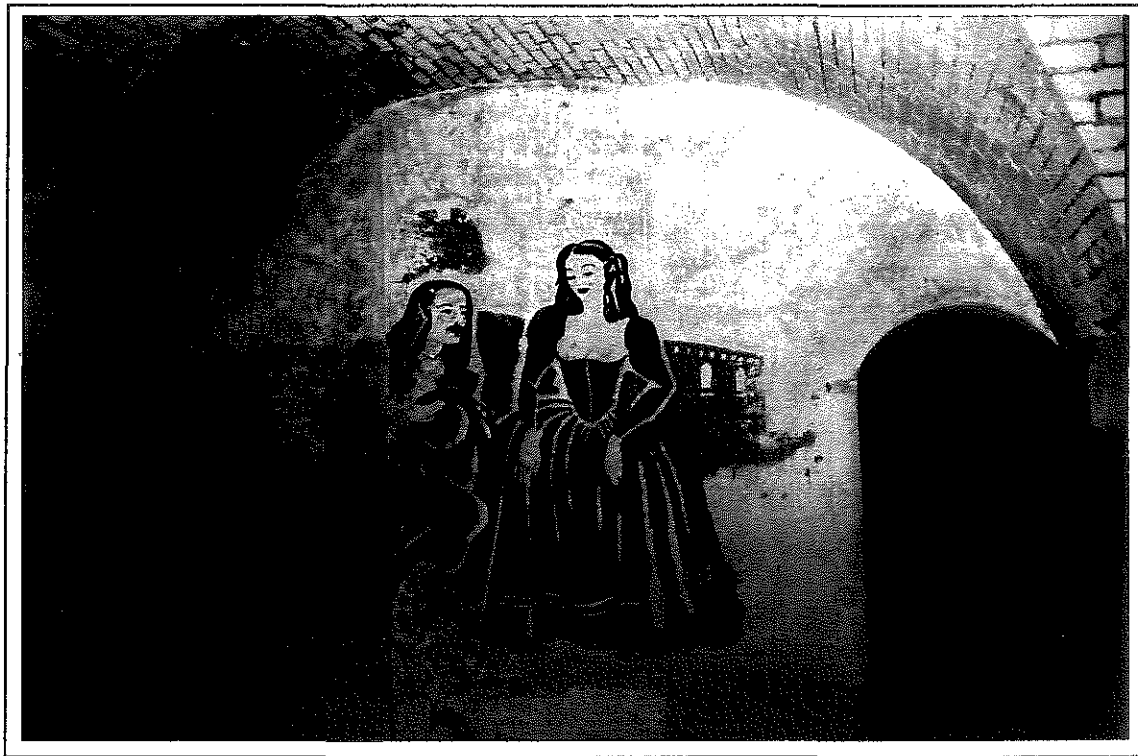
General view of theatre

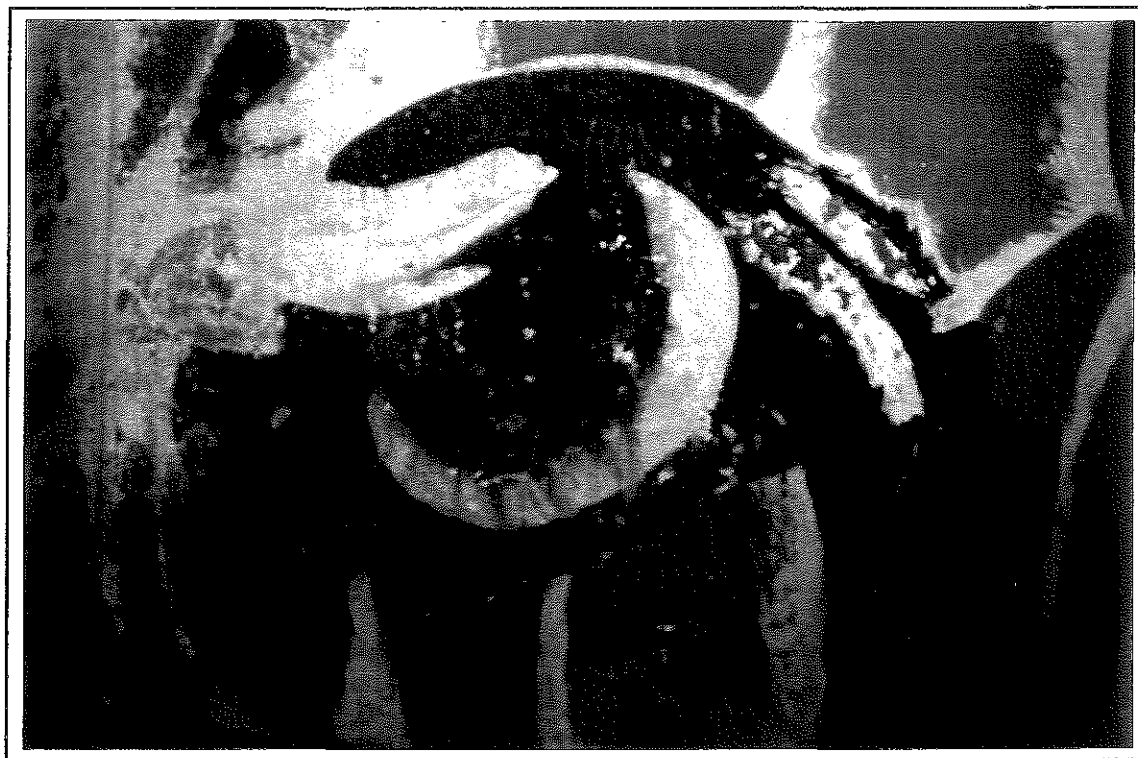
Detail of paint layer
