Ancient Monuments Laboratory
Report 49/97

WALL PAINTING CONDITION AUDIT,
LULLINGSTONE ROMAN VILLA, KENT

J Davies

Property name	LULLINGSTONE ROMAN VILLA		
Region	South East	County	Kent
Location of painting	Deep room		
Orientation	SOUTH WALL, NICHE		
Century 2 th	Date	Height (cm) 95	Width (cm) 60
Subjects included			
Figure(s) Female

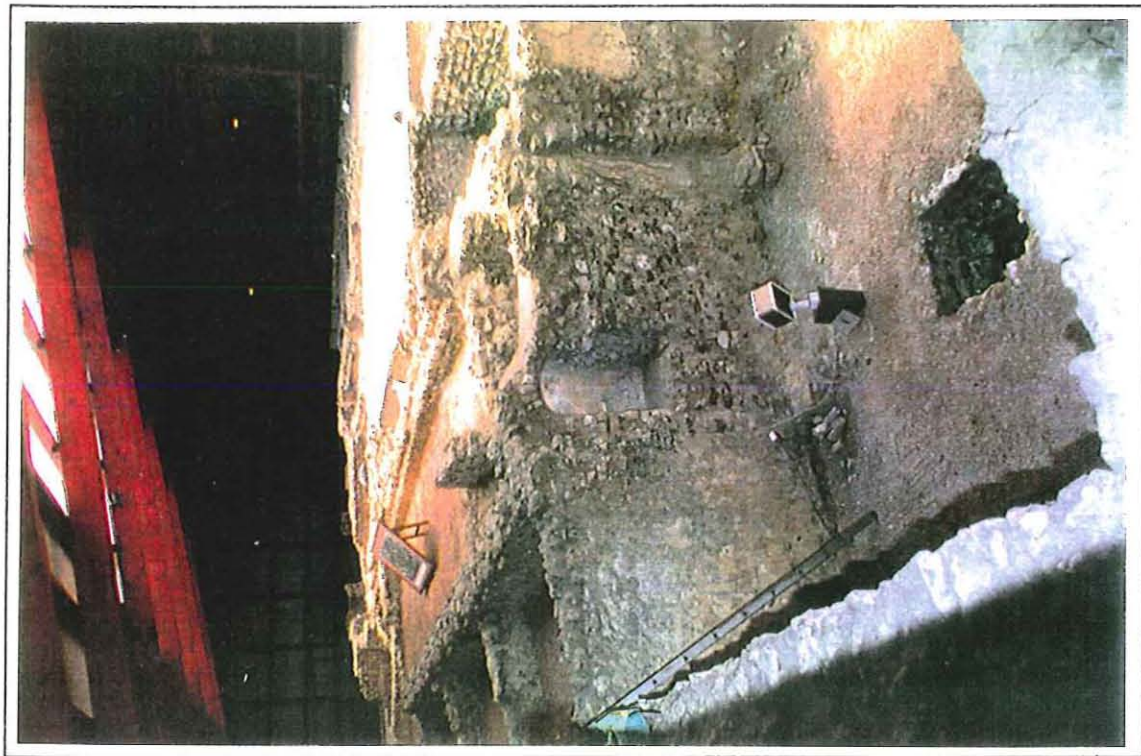
Deep room, general view to south

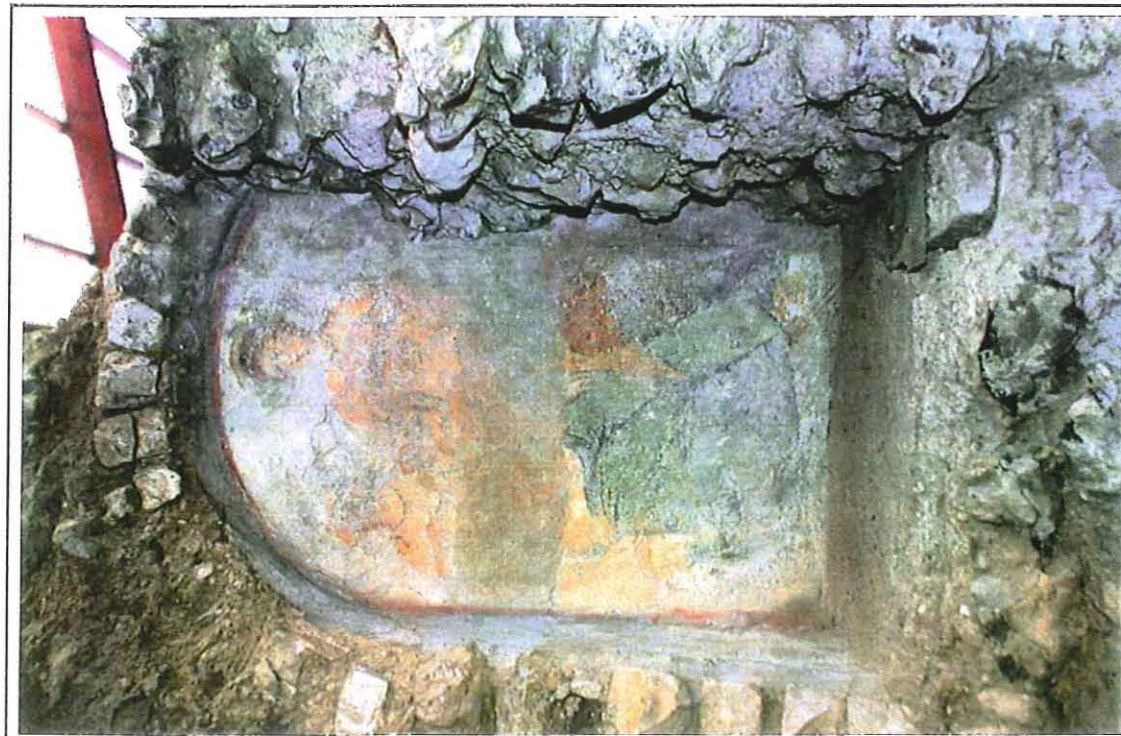
The condition of this highly important painting appeared stable and no active deterioration was apparent. However, the current system of environmental control, which consists of a fan in front of the niche and a thermostat underneath, is unsightly and its efficacy (for example, is it creating excessive air movement which may exacerbate flaking?) should be assessed. The installation of environmental monitoring may therefore be a prudent measure to assess the condition of the surrounding microclimate. In addition the painting should be inspected every 3 years.

Comments Erosion probably occurred when the painting was buried.

Comments Large horizontal loss across centre (approx 10 cm high)

Detail, south wall, niche

Comments Surface cleaning should be undertaken to remove dirt, dust and cobwebs.
[Timescale: 2 days within 3 years].

Comments The condition of the painting appears stable and no active deterioration was apparent. However, it would be a prudent measure to install environmental monitoring equipment to assess the stability of the surrounding microclimate and to assess the impact of the fan which has been placed directly in front of the niche. In addition, the painting should be inspected every 3 years.
