Ancient Monuments Laboratory  
Report 50/97

WALL PAINTING CONDITION AUDIT,  
NETLEY ABBEY, HAMPSHIRE

J Davies  
T Manning

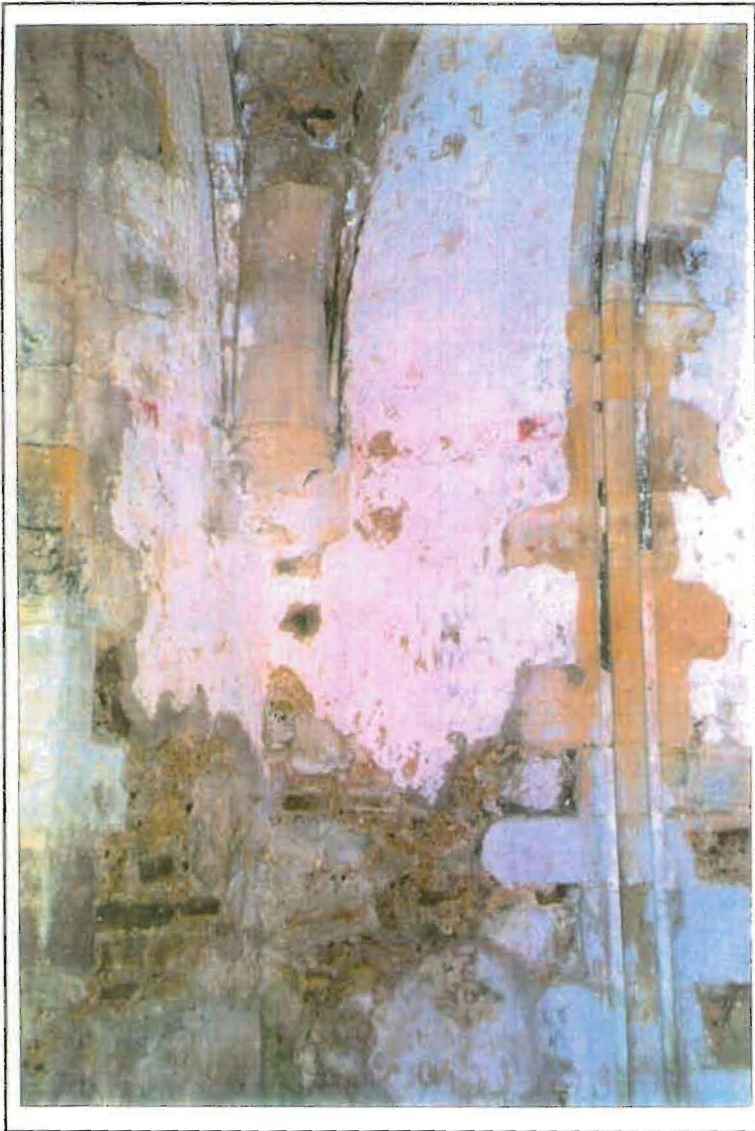
Reredorter-over-Infirmary, detail northeast corner

Although the remains of painted decoration are very fragmentary, deterioration is active and the site is very damp. Photography and brief documentation have been undertaken, however visual monitoring at regular intervals is recommended.

**Comments** Coarse mortar and damp conditions have caused de-cohesion generally, and delamination in areas, especially towards the edges of the fragments.

**Comments** Coarse mortar, and damp conditions have caused a loss of cohesion. It is soft and crumbles away easily.

**Comments** Damp (and biodeterioration) has affected the support, renders and paint layers. The room is situated over a water source, and the structure is open to infiltration.

**Comments** Painting only fragmentary. Biodeterioration has undercut the render (west wall). Loss also at vulnerable edges, and due to brittle edging repairs.

**Comments** The graffiti consists of carved and etched names. Because the fragments are covered with a limewash, it is difficult to ascertain the level of damage to the original paint layer.

**Comments** The limewash has flaked away in areas, exposing the painting. It pre-dates both the plaster loss, and old graffiti.

**Comments** These have not been positively identified as cement, but appear extremely hard, dark grey and smooth.

**Comments** Access limited, due to the height of this repair, but it appears yellowish and softer.

Consolidation and edge repairs to the plaster in this area are urgently required. [Time scale: 2 people, 2 weeks, within the next 2 years].

**Comments** Many edges are still vulnerable, and edging repairs may be the only treatment necessary to ensure the stability of the fragments. This should be done using a soft, coarse aggregate lime mortar due to the softness and elasticity of the original.

**Comments** Due to the delamination of several areas of the render, this is a treatment that can be considered, but only after closer inspection. Edging repairs may be sufficient.

**Comments** Much of the paint layer is obscured by a limewash layer. This could be uncovered, but is by no means necessary and would probably jeopardize what does survive. The decoration is visible enough for recording and study.

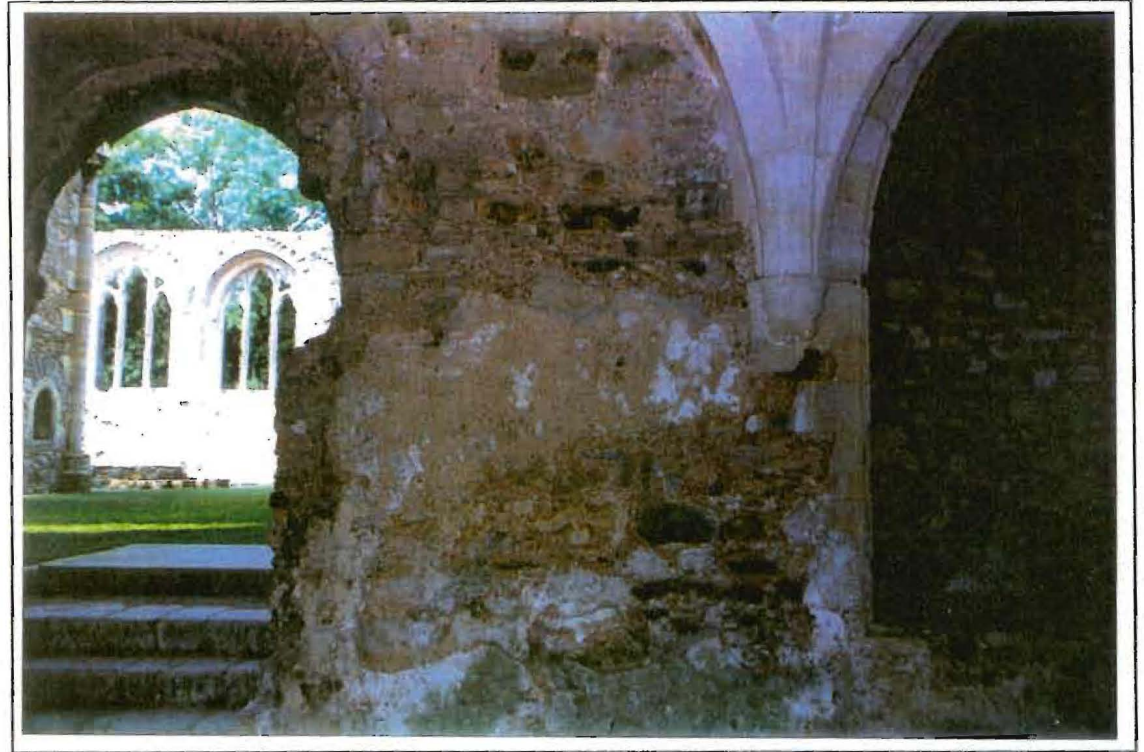
Chapel, north wall, area of plaster with faint traces of paint

The remains of decoration are very fragmentary and there are only scant remains of pigment. The site is very damp and deterioration appears to be active. Photography and brief documentation have been undertaken. Visual monitoring at regular intervals is recommended.

**Comments** The paint fragments remain on a very damaged plaster piece. All damage is associated with damp and the general ruined condition of the building.

**Comments** All damage is associated with damp and the general ruined condition of the building. Condition of plaster remains is so poor that evidence which might have indicated mechanical damage has been lost.

**Comments** All damage is associated with damp and the general ruined condition of the building.

**Comments** Probably black biodeterioration on surface in areas.

**Comments** Porous but grey-looking (cement?) now in poor condition themselves, and standing proud of friable and degraded surface. Losses of repairs have occurred.

**Type** FILLS/REPAIRS INSERTION      **Date** 01/01/01  
**Person** Unknown  
**Comments** Grey porous-looking cement (?) repairs. No longer performing any protective function.

Consolidation and edge repairs to the plaster are urgently required. [Time scale: 1 person, 1 week, within the next 2 years].

**Type** FILLS/REPAIRS INSERTION      **Date**  
**Person**  
**Comments** Edge repairs need repair or replacement urgently.

**Type** CONSOLIDATION      **Date** 16/08/94  
**Person** JD  
**Comments** Consolidation of plaster layers required urgently.
