Ancient Monuments Laboratory
Report 51/97

WALL PAINTING CONDITION AUDIT,
OSBORNE HOUSE, ISLE OF WIGHT

Osborne House Isle of Wight

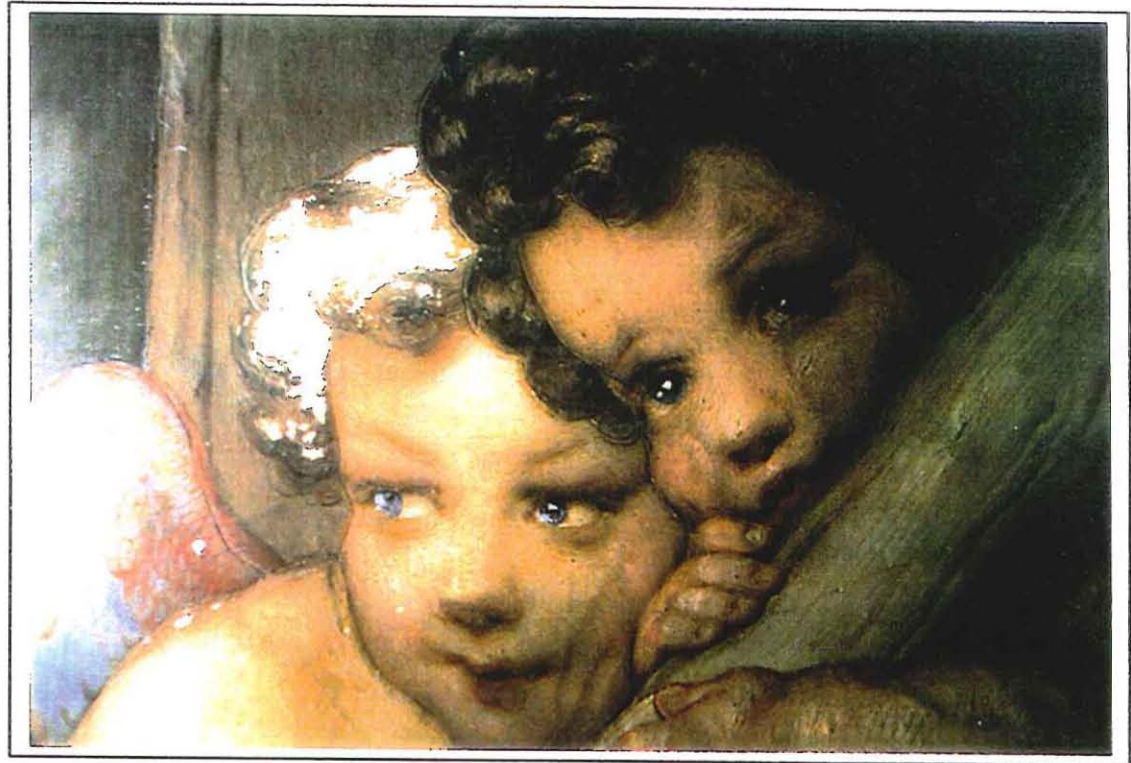
Prince Albert's Bathroom, SW wall, framed painting, detail lower right corner

Comments In limited areas (secco paint?) quite extensive loss due to flaking has occurred. In several areas losses have been retouched and then further losses have taken place, leaving islands of retouching. This is an indication that deterioration may be active.

Comments Cracking of the render has occurred in several places. Some minor flaking, associated with the cracking, has taken place.

Some treatment, including, flake fixing, light dusting/cleaning and sympathetic reintegration, is required. However, the present audit was undertaken without removal of the perspex sheet, and without access to the back of the painting. Any proposed timescale for treatment can therefore only be produced after the painting has been investigated directly and the technique and condition of the painting are better understood.

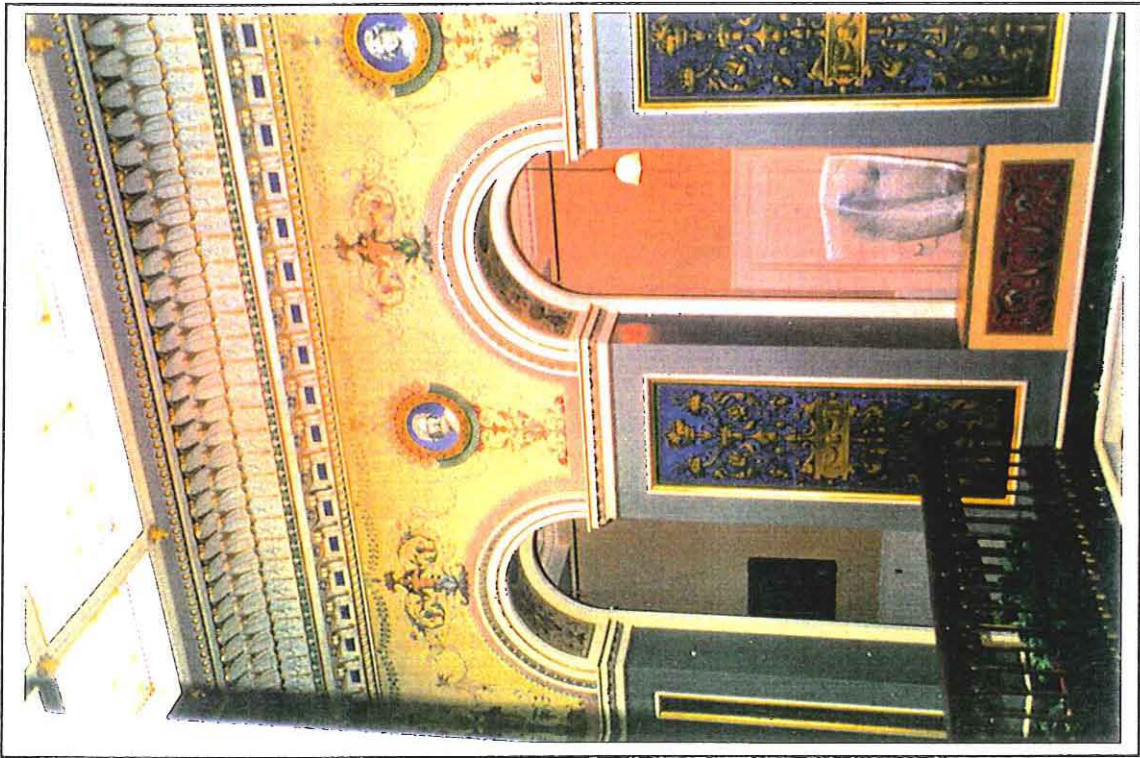
· · Nursery Landing, general view of decorative scheme

Comments Flaking and loss of paint has occurred to the painted perimeter of the ceiling at the south-east side. This deterioration appears to be associated with moisture ingress.

Ingress of moisture from the glazed ceiling above the painted decoration is known to have caused considerable damage in the past to both paint and plasterwork. During the audit inspection evidence of continuing infiltration was noted and therefore further remedial building works are required to repair the ceiling.

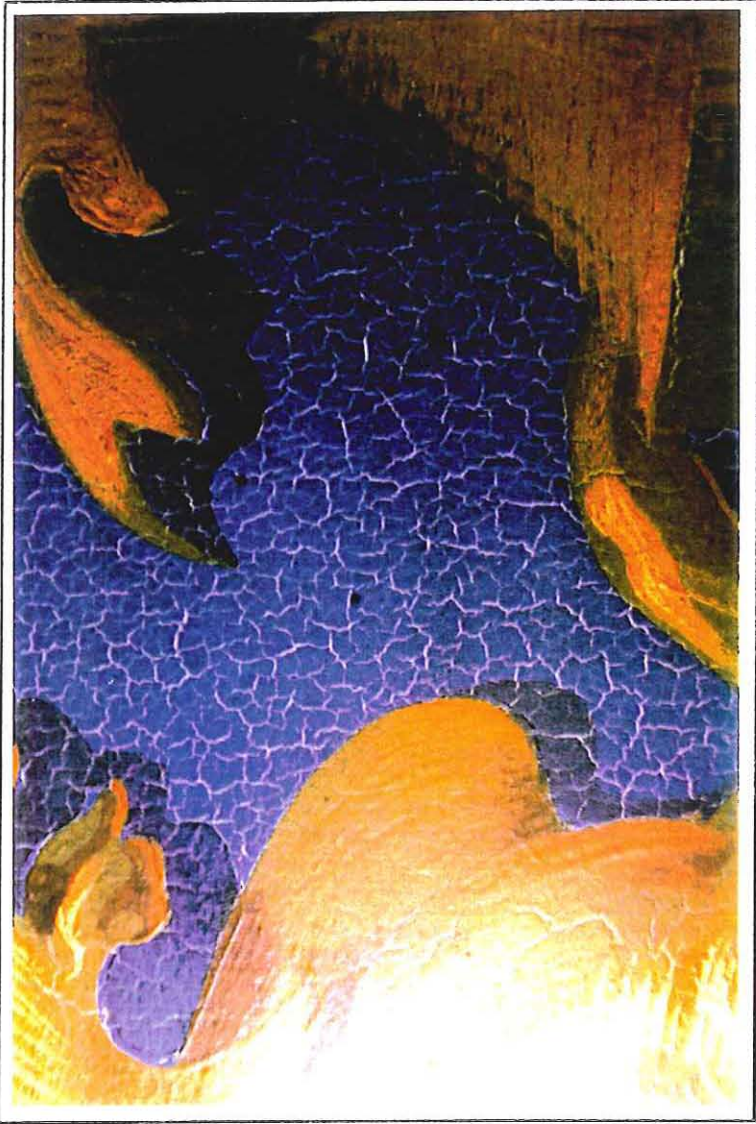
Detail, showing crackleure of painted surface

Comments Drying or 'alligator' cracks were noted to blue background areas. These cracks are likely to have occurred relatively soon after drying and may be considered an aspect of the original scheme.
